Incorporating a new wicking geotextile in northern, low volume highways to mitigate pavement edge cracking

Paper prepared for presentation
at the *Innovation in Geotechnical and Materials Engineering* Session

of the 2017 Conference of the
Transportation Association of Canada
St. John's, NL

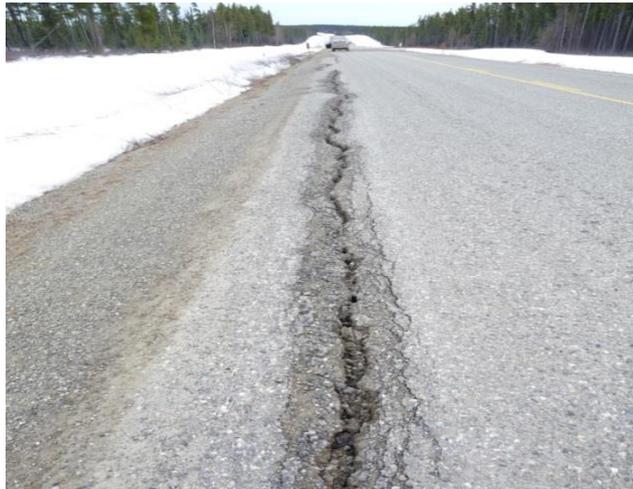
Some thin-surfaced low volume pavements in the north develop a unique form of edge cracking—the causes of which are not well understood. Figure 1 illustrates edge cracking in northern Canada.

Figure 1. Edge cracking can be wide, deep and extensive.

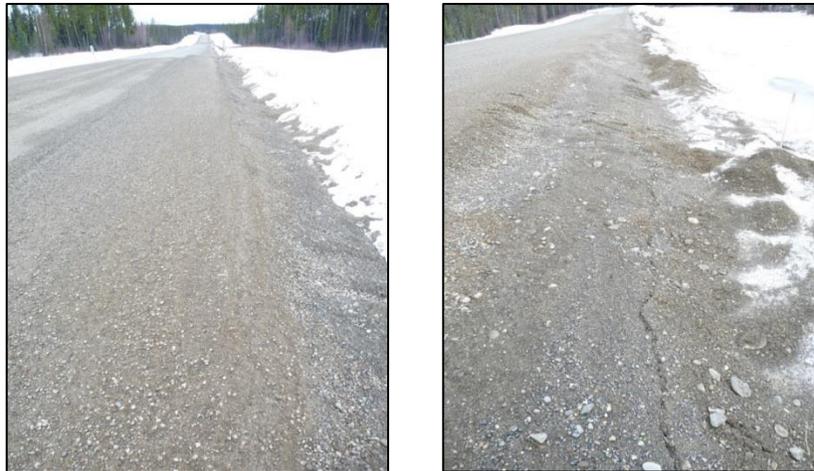
- The southwest (SW) quadrant of site 4 was observed to have a relatively high flow (2.4 ml/s) out of its ABS edge drain pipe about two to three hours after a heavy rain event.
- Minor edge cracking was observed at sites 4 and 6 in May 2016. Severe edge cracking (up to 10 cm wide) was found approximately 40 m north of site 6. Some of the edge cracking noticed outside of sites 4 and 6 was deep enough to have reached the subbase layer (i.e., 15+ cm deep). Figure 8 illustrates edge cracking on sites 4 and 6. It was also noticed that edge cracks on treated sites 4 and 6 appear less severe than the cracks on untreated sections.

Figure 8. Edge cracking at site 6 looking south (left), and at site 4 looking north (right), spring 2016.

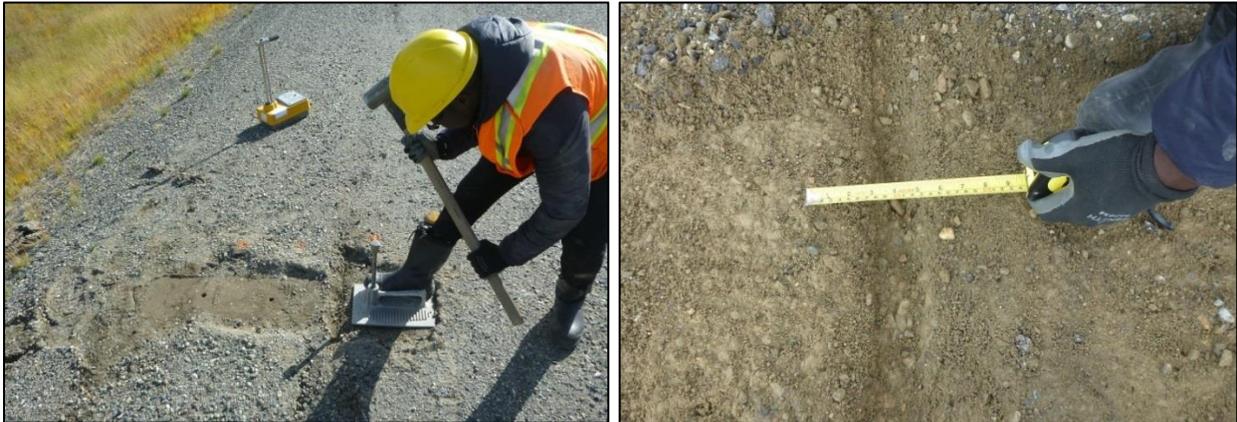
Figure 9. Measuring road density with a nuclear density gauge (left), and edge crack filled with gravel (right) at km 40.

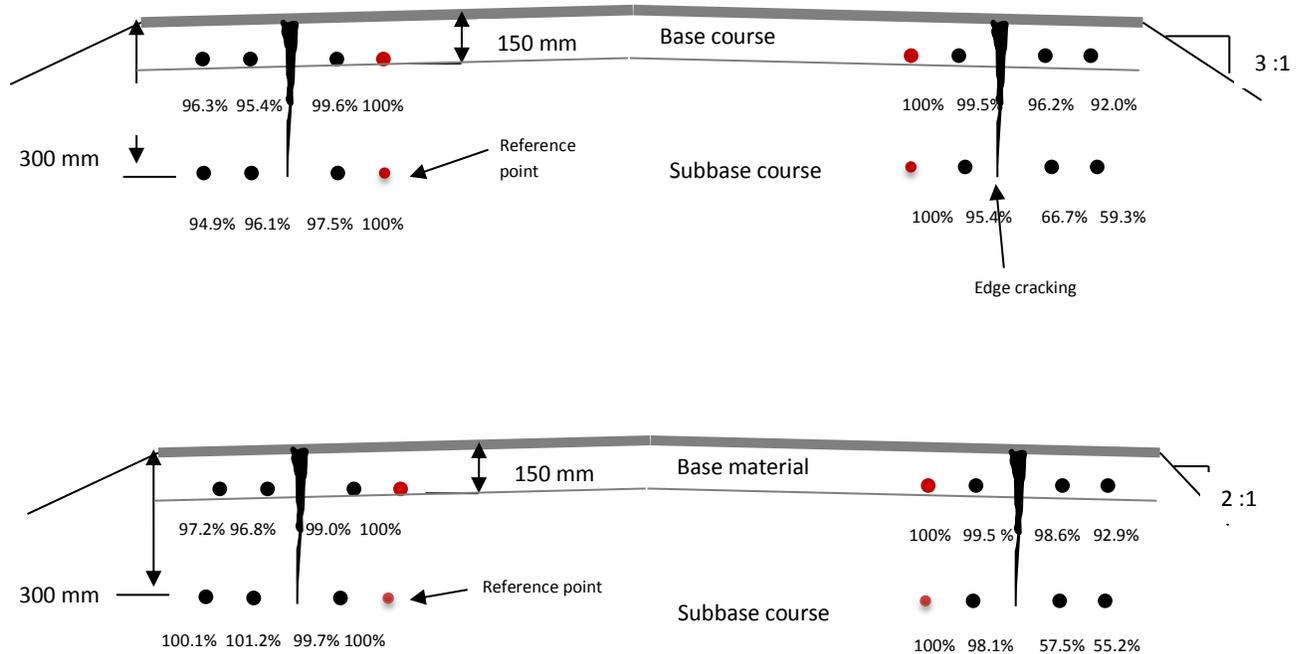
Figure 11. Relative dry density of roadbed materials at km 40 (top) and km 66.275 (bottom).

- Materials outside of the edge crack were less dense than inside (i.e., closer to the road centre). Base materials were as much as 8% less dense outside of edge cracks, whereas the uppermost 150 mm of subbase material was as much as 45% less dense outside of edge cracks.
- The level of compaction in the road increased from the surface downwards. Comparing the reference points of site 4, the base course dry densities were 85% to 90% of the corresponding subbase dry densities. Km66+275 showed a negligible difference for the reference densities on the cutslope side of centerline; however, because of very high subbase densities the base course was only 55% of the subbase reference density on the steep slope side.

The most advanced state of edge cracking was noticed on the fill slope side of the road section located at km 66.275. Both site 4 and the site at km 66.275 had dramatically reduced soil densities (55%-59%) outside of edge cracks in the top of the subbase. The road at km 66.275 had a deeper fill and steeper sideslope than at km 40. At this time, it is difficult to correlate the level of compaction with sideslope. However, there is strong evidence that there is a relationship between a roadbed's level of compaction and its porosity and ability to soak up precipitation. Less dense roadbed materials have a more open

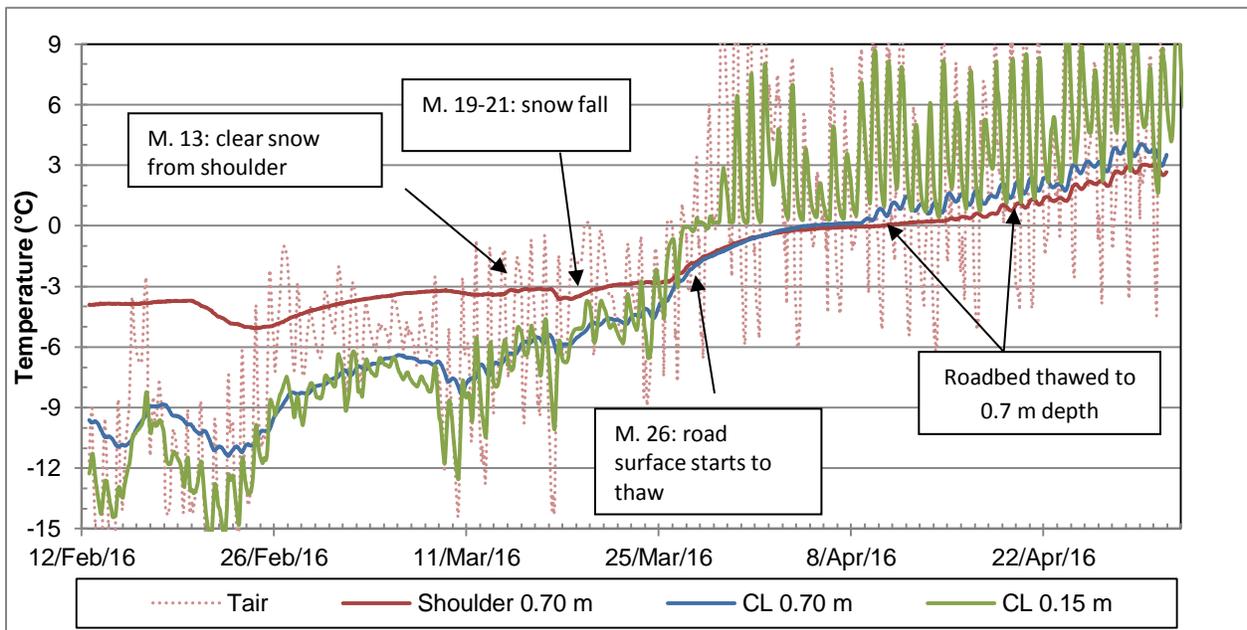
Knowing that edge cracking develops along the Campbell Highway between March and May, a correlation was sought between roadbed temperature and time. Figure 15 compares centreline and shoulder temperatures at site 4 during late winter to spring 2016. Centreline temperature was as much as 5°–6° C colder than the shoulder in the winter. The main reason for the differences between

centreline and shoulder temperatures is believed to be the insulating effect of compact snow and ice accumulated on the road shoulders by winter maintenance. The presence of snow on the road shoulders both created a temperature differential between centreline and shoulder, and eliminated diurnal temperature fluctuation at the road shoulder. The shoulder temperatures fluctuated slowly during the winter and in Figure 15 appear as very smooth lines. In contrast, the centreline temperature appears as a very jagged line indicating rapid, diurnal, variation in the absence of snow on the road surface. On March 13, a snow plow removed most of the snow from the road shoulder and this initiated diurnal temperature variation in the shoulder at 0.7 m depth. This diurnal variation continued until a snow event from March 19 to March 21 again provided shoulder insulation. By March 26 the roadbed started to melt despite there being some snow cover on the road shoulder—temperatures at centreline and shoulder rose together. On April 7, spring maintenance was conducted to remove deep snow from the road shoulder and sideslope by blading and winging it to the back slope of the ditch (Figure 16). The lines for centreline and shoulder temperature at 0.7 m started to display diurnal temperature variation on April 8 and April 16, respectively, when they thawed.

Figure 15. Temperature at shoulder and centreline, site 4, late winter- early spring 2016.

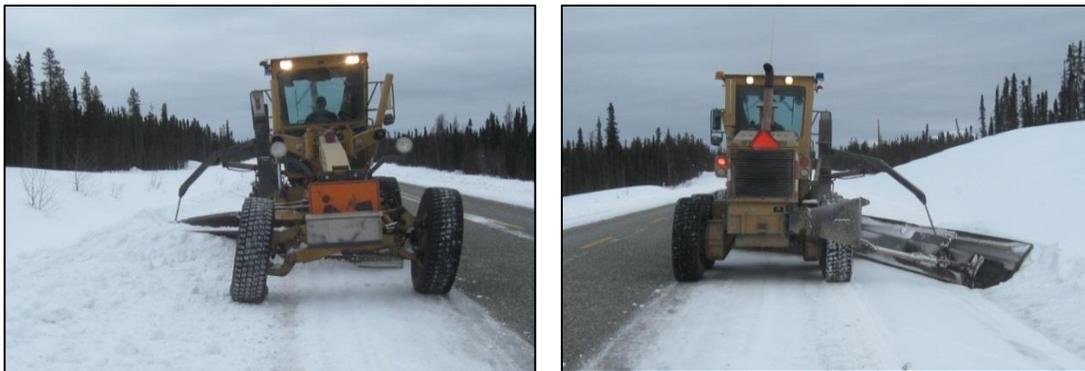
Figure 16. Blading and winging snow off of the road shoulder and sideslope, 7 April 2016.

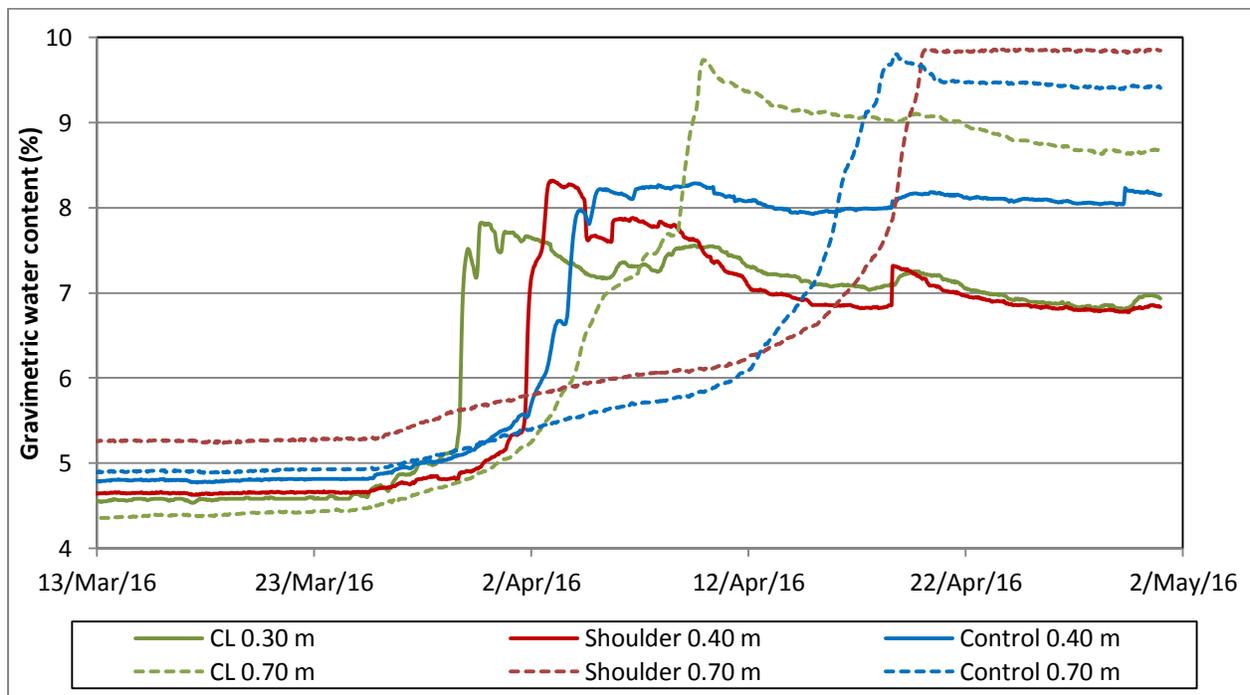
Figure 17 below presents moisture data from site 4 during spring 2016 and compares road centreline to road shoulder at two different depths. The centreline thawed several days before the road shoulder, and the untreated shoulder thawed slightly slower than did the shoulder with Mirafi® H₂Ri. Under the Mirafi® H₂Ri geosynthetic at site 4 (at a depth of 0.7 m), the roadbed thawed nine to ten days earlier at centreline than at the road shoulder. Higher moisture levels were recorded at 0.7 m than at 0.3 m and 0.4 m. This is likely because, at deeper depths, there are more fine grained soils and these retain more moisture but may also be due to the action of the Mirafi® H₂Ri geosynthetic. The moisture contents of the frozen shoulder also were higher than at centreline indicating a wetter fall condition and, possibly, that more water migrated to the freezing front in the shoulder due to its more porous condition. An analysis of temperature data, presented in Figure 15 for the same spring 2016 period, showed that the centreline thawed faster than the shoulders. This statement is substantiated by the thawing patterns illustrated in Figure 17. On both charts, thawing starts on March 25, 2016.

Figure 17. Moisture data, site 4, spring 2016.

Another important finding illustrated by Figure 17 is the ability of the geosynthetic to drain the roadbed. At both centreline (0.3 m) and shoulder (0.4 m) of the treated site, after the release of water by thawing, the moisture contents decreased by 1% to 1.5% indicating the geosynthetic was helping to drain the roadbed. In contrast to this, after thawing of the untreated shoulder, the excess water did not drain away. Also, field density tests show strong evidence of the shoulders being less compacted and, therefore, hold a higher void index, which has a tremendous impact on freezing. Therefore, based on increasing shoulder temperatures and moisture contents, the treated and untreated sections started thawing at the same time at both site 4 and site 6. This is believed to have occurred when the snow had melted away from on the shoulder. Also, thawing started at the shoulder of site 4 when temperatures at 0.4 m were about at -2°C (March 25th). A likely explanation of this is that soil salinity was considerable, and this lowered the freezing and thawing set points to below 0°C.

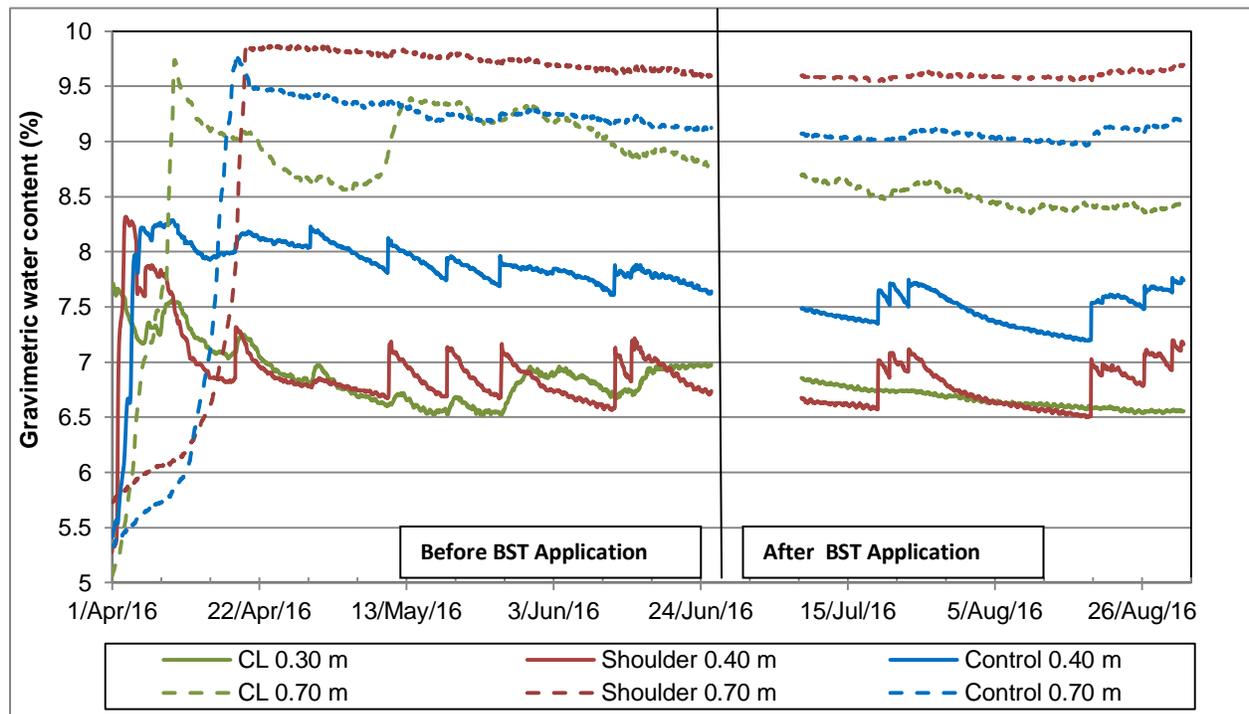
Figure 18. Moisture data, site 4, summer 2016.

Figure 18 presents moisture levels for site 4 during spring and summer 2016. The chart illustrates moisture levels above and under the geosynthetic both at the road centreline and the road shoulder (on the treated and untreated sections). Starting on March 25, frozen water in the roadbed started melting and being released at the thawing front as top-down thawing began. Moisture contents reached 7.8%

and 8.2%, respectively, at the road centreline (0.3 m) and the treated shoulder (0.4 m). Approximately 10 days later, a percentage of the moisture had dissipated and moisture contents were down to 6.8%, both at road centreline and treated shoulder. On the untreated shoulder, however, moisture content at 0.4 m depth increased to 8.2% after thawing but remained at this high level of moisture throughout the spring period. This is a strong indication of the ability of the Mirafi® H₂Ri geosynthetic to drain excess water that accumulates at the thawing front during spring top-down thawing. The geosynthetic also appears to drain water (and potentially to interrupt capillary rise) from the underlying roadbed materials. With reference to Figure 17, spring thaw moisture levels just under the geosynthetic at centreline at Site 4 peaked to 9.6% and then dropped to 8.6% in two weeks. Site 6 peaked to 9.6% and then dropped to 9.1% in three weeks. At both sites, moisture levels in the road shoulder, with or without geosynthetic, showed little to no drainage for the same time period. This is presumably because of prolonged frozen soil conditions followed by a relatively high water table in the ditch. During summer, the patterns of drainage initiated in the spring continued. At site 4, the lowest summertime moisture content was 6.5% and this occurred at both the centreline (0.3 m depth) and the shoulder (0.4 m depth). A number of factors caused this drying—the most important being the geosynthetic and roadbed heating due to high summer air temperatures and increased heat adsorption after the BST application. In this well-drained condition, the roadbed materials are near to their optimum moisture content and would have increased matric suction—both of which improve the strength and stability of the roadbed.

During spring and summer, the test site roadbeds above the geosynthetic experienced recurrent, rapid increases and decreases in moisture content (Figure 18). Moisture changes were, on average, 0.12% greater in the drier roadbed of the treated shoulder than in the wetter, untreated shoulder (May to September). The treated shoulder also drained away these increases in moisture more quickly than did the untreated shoulder. In order to better understand these events, a comparison with precipitation data was made. Precipitation data for the summer period were from Environment Canada's weather station located at Watson Lake airport (the Environment Canada weather station closest to sites 4 and 6). Figure 19 compares summer moisture contents at sites 4 and 6 with summer precipitation events. There was strong agreement between the precipitation events and increases in moisture above the geosynthetic. As anticipated, the agreement was weaker for moisture content under the geosynthetic.
