Ten Years of Edmonton's North East Roads Program

Marlis Foth, P.Eng., M.Sc., Director Open Space Planning and Design, City of Edmonton
Hugh Donovan P.Eng., Supervisor Research & Development, City of Edmonton

At the 2017 conference of the
Transportation Association of Canada
St. John's, NL

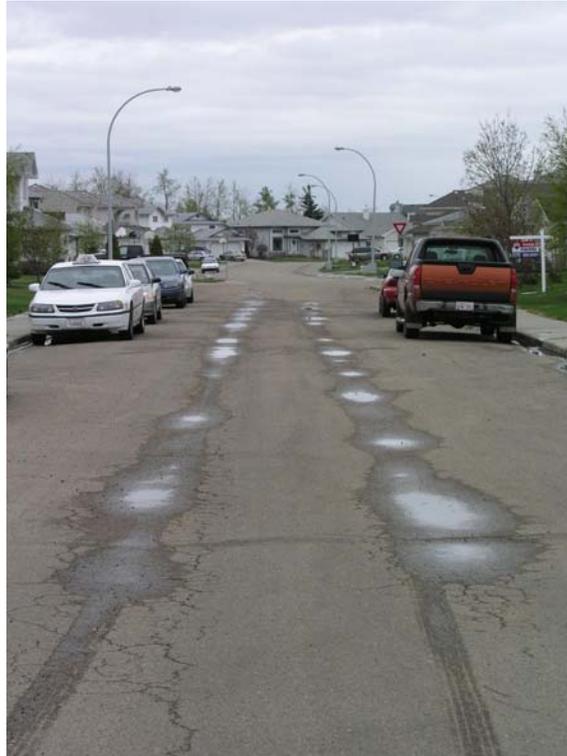
Photos of the types of failures observed are included in Figure 1 to Figure 5. Figures 1 and Figure 2 show settlement and water ponding in the wheel path. Figure 3 shows a typical structural failure observed in these neighbourhoods. Figure 4 shows typical water staining from private sump pump discharge to the sidewalk and finally, Figure 5 shows asphalt failures from a point type loading of the pavement. In looking at these photos one can see the ponding/standing water and failures which can be indicative of a soft and saturated subgrade layer. Also observed was significant sidewalk staining which is indicative of overland flow of water which was traced back to the residential sump discharge or discharge of roof leader systems.

Figure 1 Settlement and water ponding in wheel path

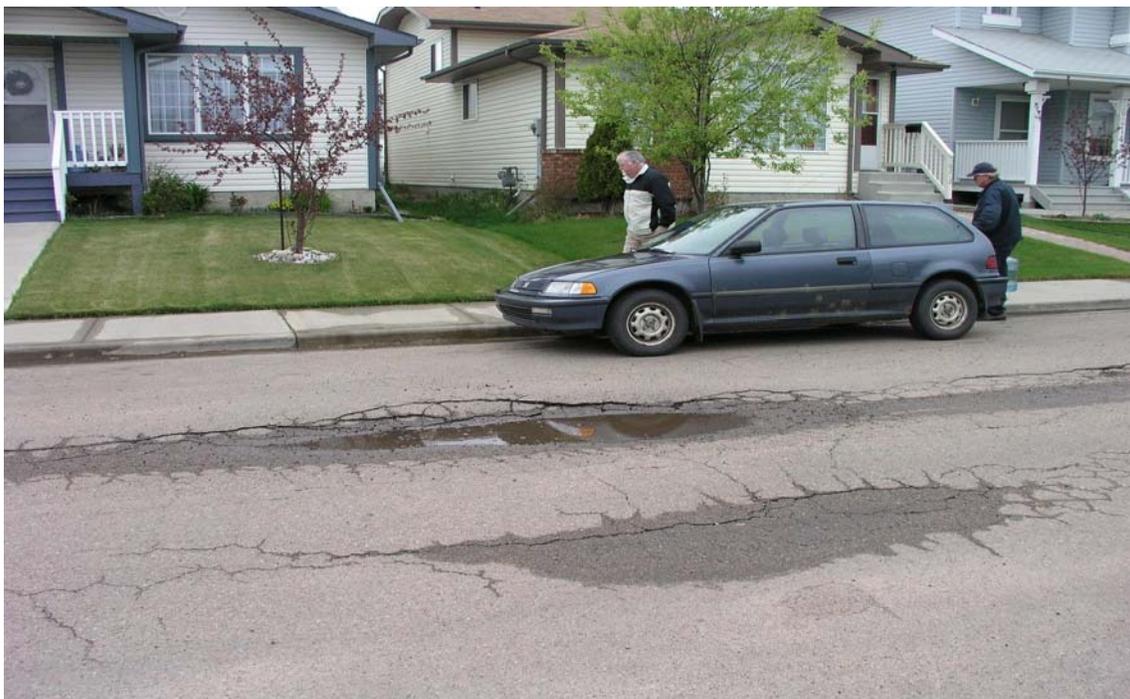
Figure 2 Settlement and water ponding in wheel path.

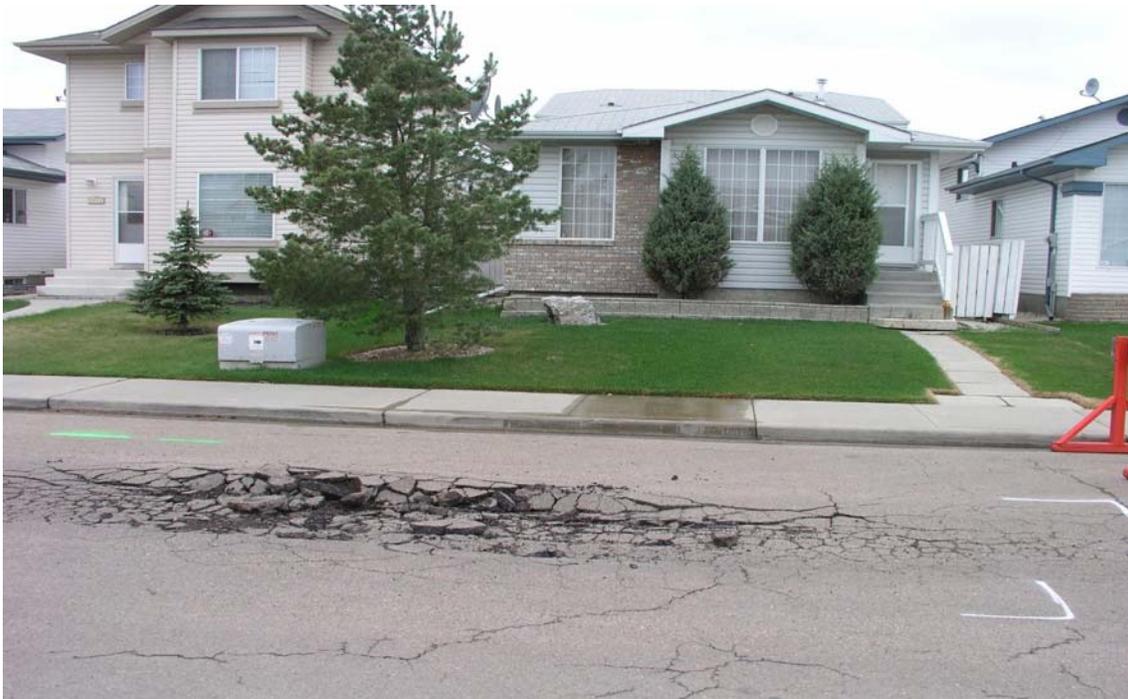
Figure 3 Structural Failure

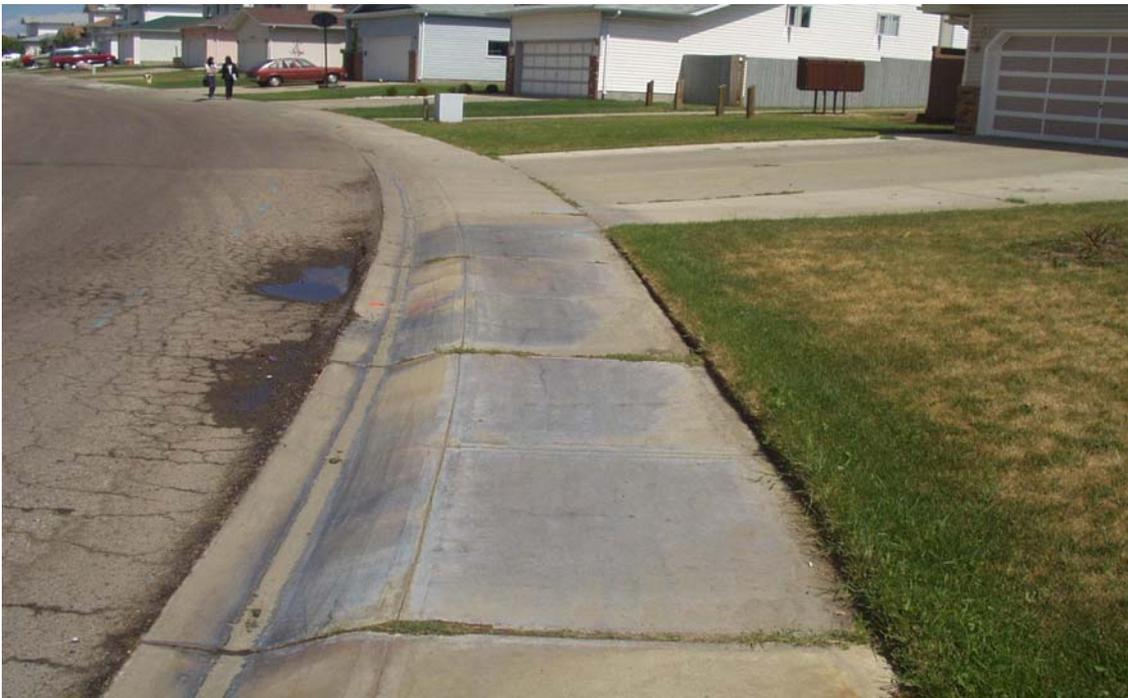
Figure 4 Water staining on sidewalk and alligator cracking on roadway.

Some locations have concentrated overland surface drainage where multiple lots are draining to one area. In the past this water has either crossed the sidewalk to enter into the drainage system causing stains and/or has saturated the ground and infiltrated into the roadway subgrade. To address this issue a drain well has been installed to capture the water at the back of the walk and then direct it into the sub-drain system.

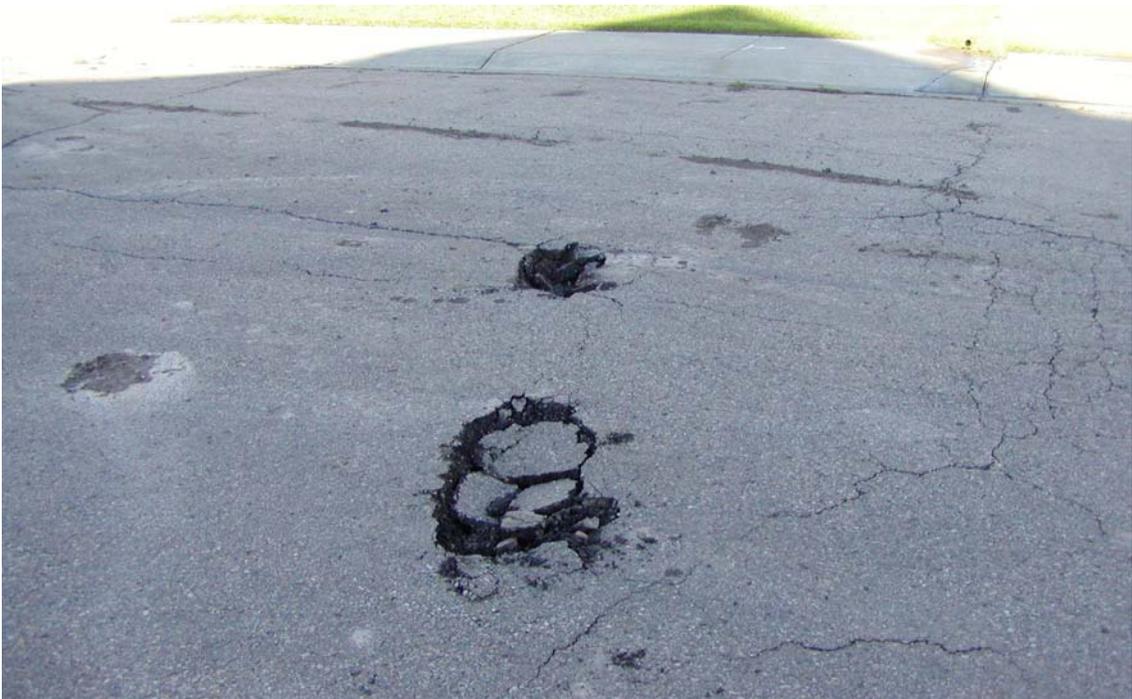
to the available water from the roof leaders and sump discharge penetrating into the subgrade soils under the roadway and through time weakening these soils to a point where they no longer provide support for the road structure and traffic loading.

Figure 5 Failures due to soft subgrade

After the report was completed, it was determined that rehabilitation of the affected roadways would consist of installation of 200 mm diameter sub-drains connected to the stormwater system along the periphery of the roadway on both sides, removal of the softened subgrade soils to a depth of approximately 800 mm (determined in the field), placement of nonwoven geotextile, 3-63 granular sub-base layer of varying depths with a layer of geogrid at approximately 300 mm up from the bottom of the fill, a 150 mm layer of 3-20 granular base followed by 100 mm of 10mm-LT asphalt (local roadways) and 50 mm of 10mm-HT asphalt and 100 mm of 20mm-B asphalt (for collector roadways). A typical cross section for residential and collector roadways were developed. These cross sections are shown in Figure 8 and Figure 9. The work completed in 2006 consisted of the replacement of approximately 550 m of roadway and installation of sub-drains for a cost of \$1.5 million. These developed structures that were proposed in 2006 are still being utilized in current rehabilitation projects in the North East Roadway Program.

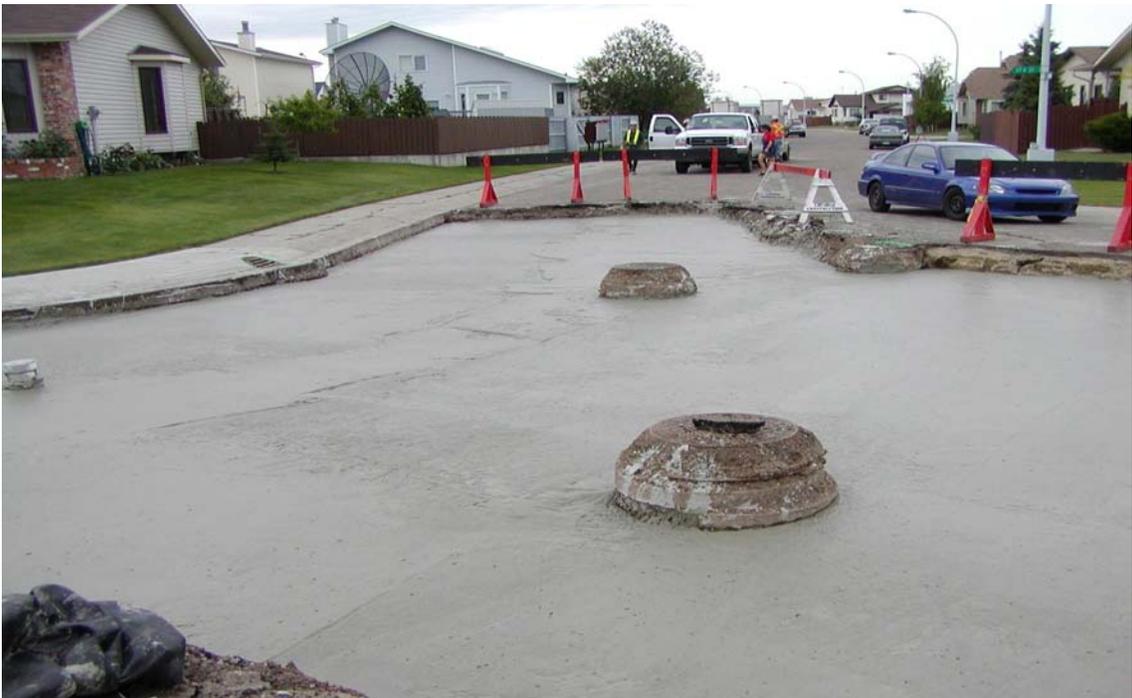
Figure 6 Cematrix Sub-base

intended that the Cematrix would also serve as an insulation material from frost heave and spring weakening of the existing wet subgrade soils. The proposed structure involved the excavation of the existing materials and the replacement structures as indicated in Table 1. Differing residential and collector structures were proposed based on the appropriate traffic volumes. The collector structure had an additional 60 mm of asphalt and an additional 50mm of 3-63 recycled base. Wick drains were proposed under the Cematrix at the periphery adjacent to the curb and gutter. Figure 6 shows the Cematrix sub-base installed. After the Cematrix was placed a rain event occurred and the water migrated under the Cematrix causing it to be pushed up and it began to float. This can be seen in Figure 7. The Cematrix was removed and replaced with the standard granular structure developed for the area and has had no issues since the work was performed.

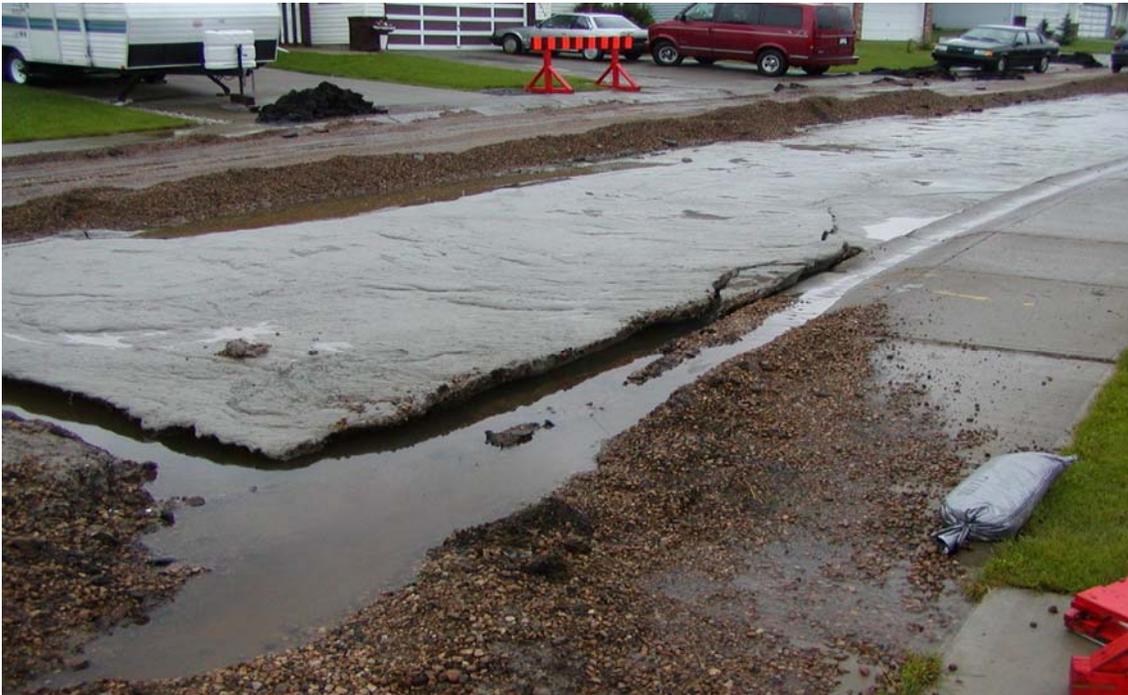
Figure 7 Cematrix Floating after Rainfall

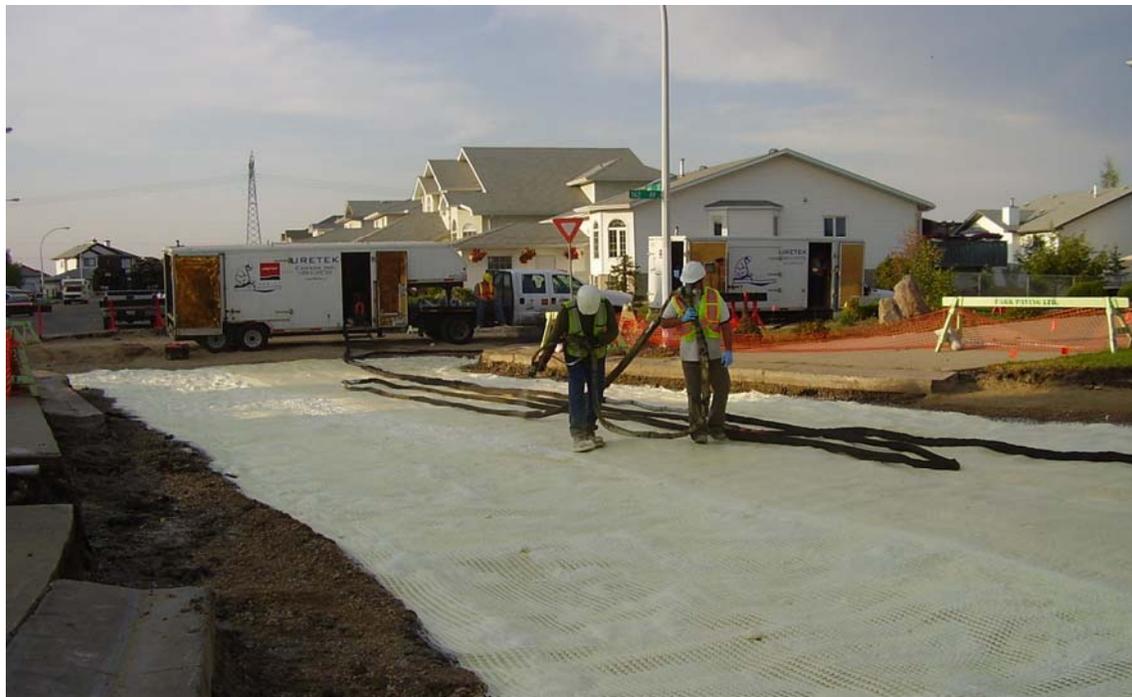
In 2009 another trial was undertaken with the use of Ureteck (Urethane foam) as a backfill material to replace some of the 3-63 granular sub-base. Figure 10 shows the Ureteck material that was used. The proposed structure included the excavation of 150 mm of the weak soft subgrade material, installation of the sub-drain system, placement of the non-woven geotextile, followed by placement of 150 mm of the Ureteck followed by the placement of the 150 mm of 3-20 granular base and the 100 mm of 10mm-LT asphalt. During completion of the granular base construction and prior to placement of the asphalt the section was proof rolled to ensure that the structure would be capable of carrying the paving equipment and trucks and it was found that that the overall structure was deflecting excessively. It was then decided to remove the Ureteck materials and proceed with reconstruction of this section with the standard cross section.

Figure 10 Uretek

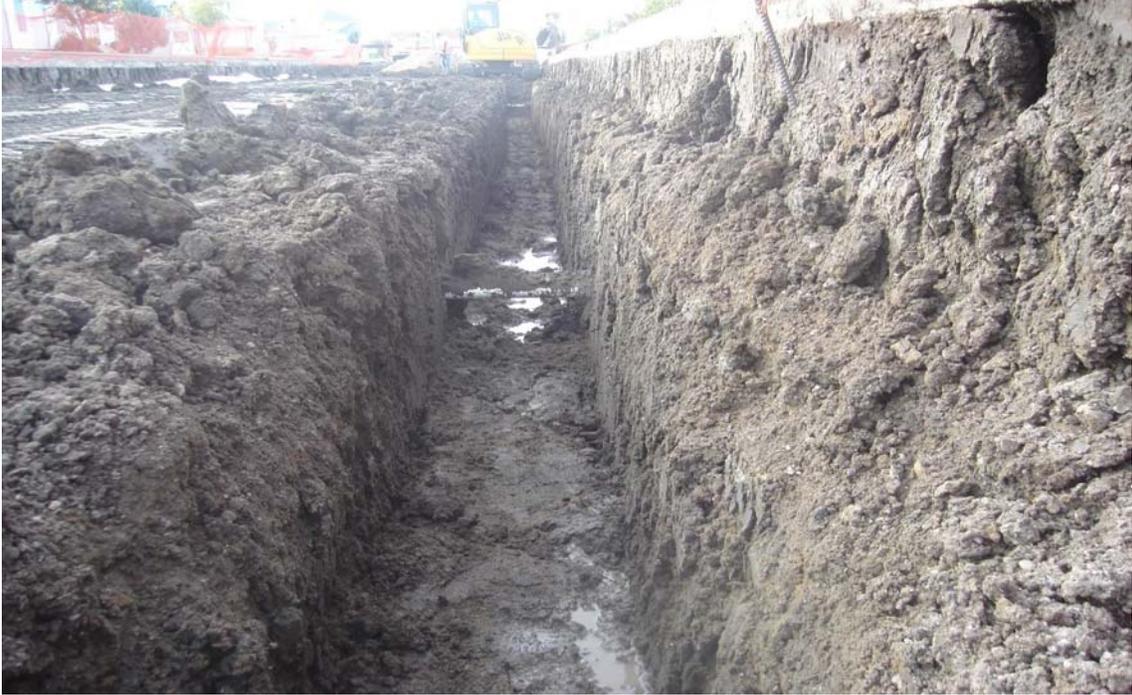
Figure 11 Sub-drain Excavation

The most common method for construction of the roadways is to first excavate for and install the sub-drains (Figure 11 and Figure 12), followed by the excavation of the road, installation of non-woven geotextile (Figure 13), installation of 3-63 recycled aggregate and geogrid (Figure 14 and Figure 15), installation of 3-20 granular base (Figure 16), concrete replacement as required (Figure 17) and finally asphalt paving (Figure 18). The main goal for NERP is to reconstruct the roadways component so only minor concrete repairs are completed to ensure that any surface water drainage is directed towards catch basins.

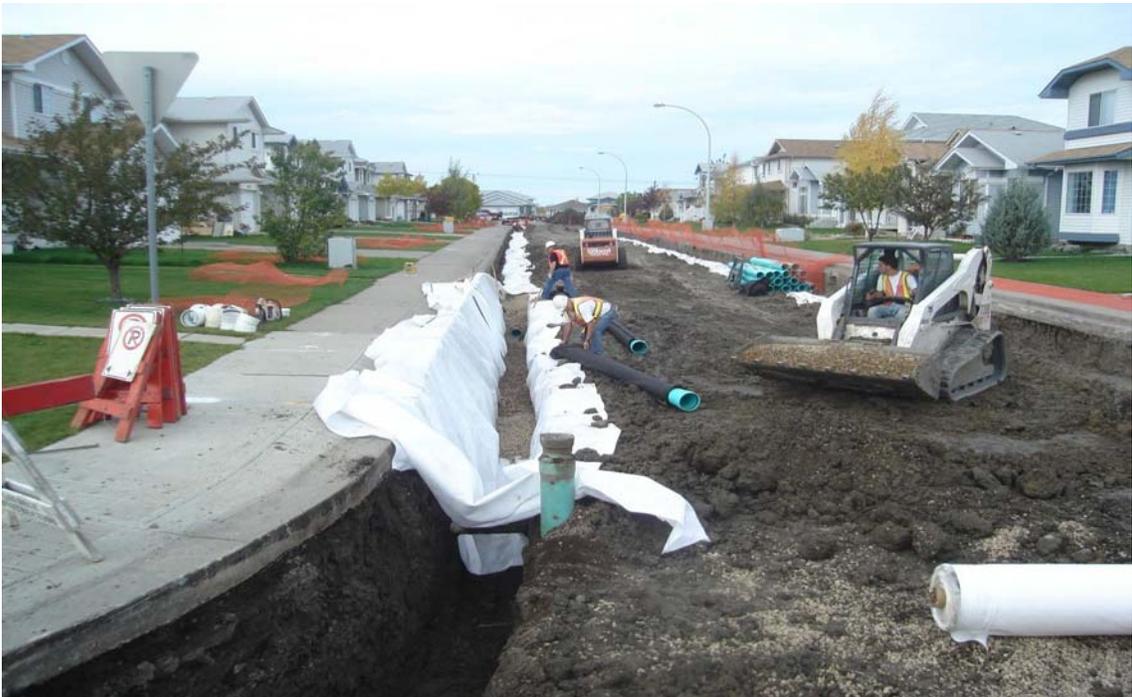
Figure 12 Sub-drain Installation

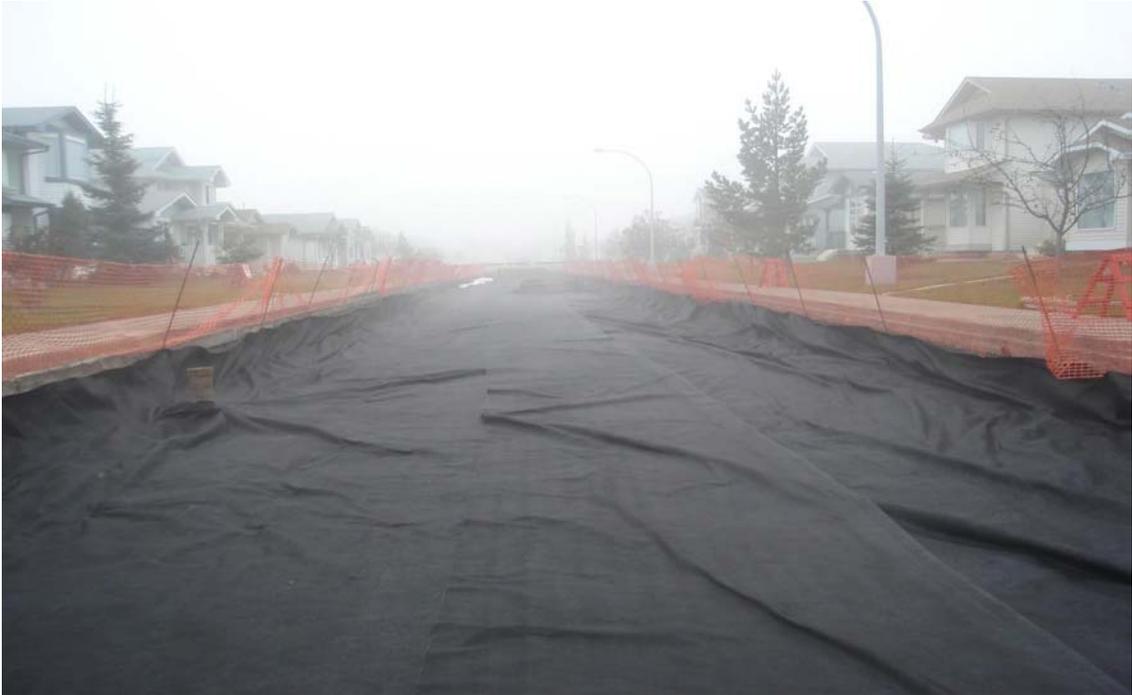
Figure 13 Installation Non-woven Geotextile

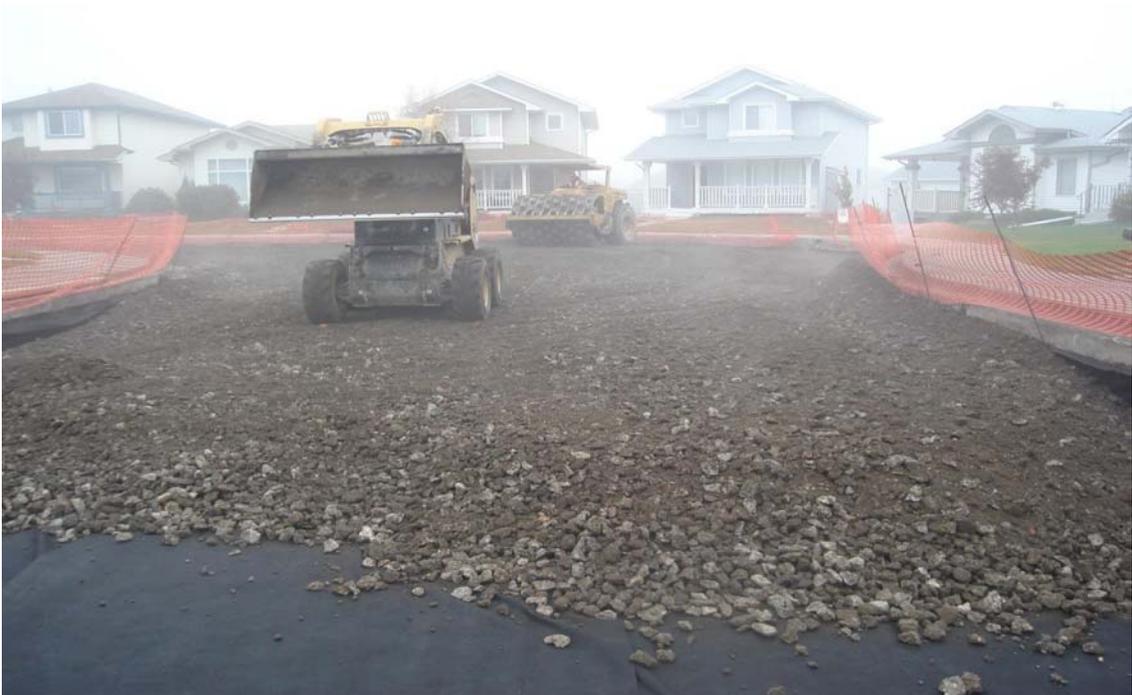
Figure 14 Granular Sub-base over Non-woven Geotextile

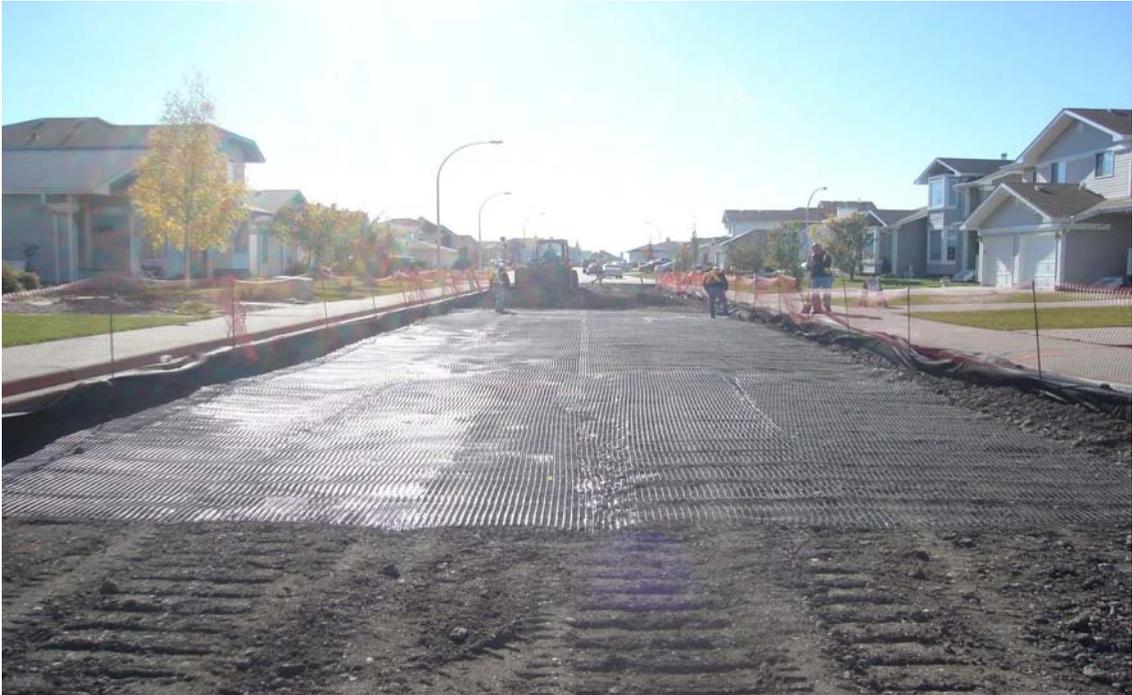
Figure 15 Geogrid Placement

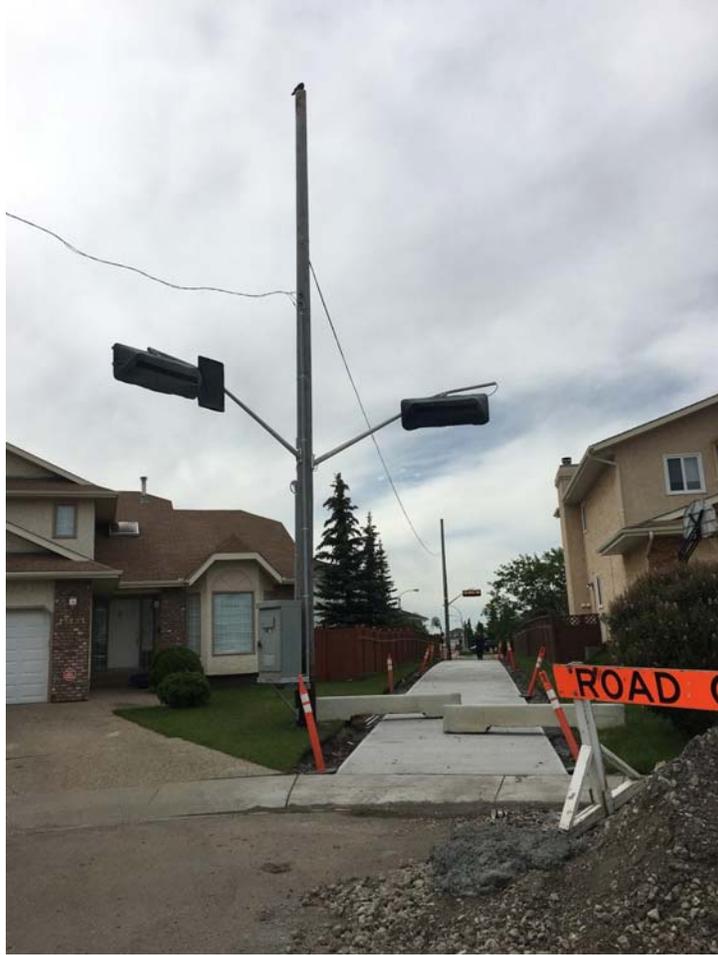
Figure 19 Temporary Signal for Access

In 2016 a 100 m section of roadway that had five longer cul-de-sacs attached was scheduled for reconstruction. In the worst case with one section of road being removed, 93 homes would lose access. The homes that would have been in the last construction stage would have lost access for the majority of the summer. To address these concerns an alternative access was considered. The only alternative access that was available was to change a 1.5 m wide walkway connection to a future 3.0 m emergency access and utilize it as a vehicle access with temporary traffic signal lights. See Figure 19. This allowed access to the homes that would have been cut off by construction.
