Comparison of Ground Penetrating Radar Deck Surveys to
Conventional Level 2 Deck Testing Results

Christopher L. Barnes, Ph.D., P.Eng., Senior Materials Engineer,
Wood Environment & Infrastructure Solutions
Junaid Iqbal, P.Eng., Bridge Materials Engineer,
Technical Services Branch, Bridge Engineering, Alberta Transportation

Paper prepared for presentation at the
SES - Innovations in Transportation Asset (s) Data Collection Session

of the 2018 Conference of the
Transportation Association of Canada
Saskatoon, SK

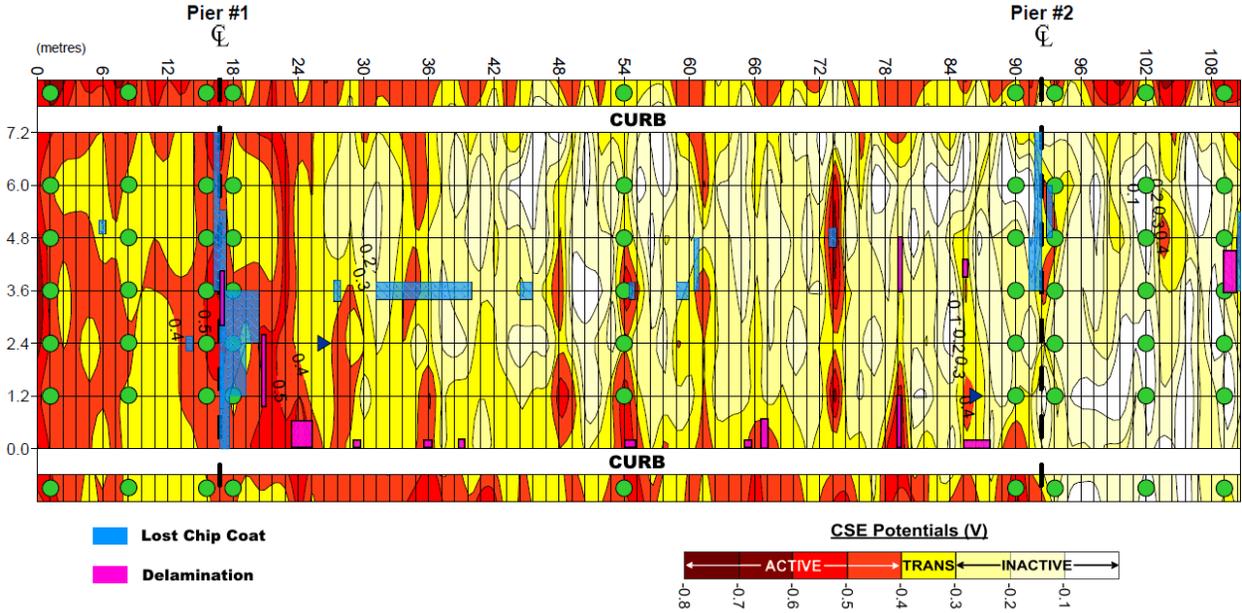
The map of the 2015 CSE and chain drag results shown in Figure 2 followed the typical expected trends with high readings along the curbs, the deck joints, and the transverse crack locations, especially at the 11 intermediate TH span panel points. Figure 2 also indicates the locations of the 32 m² (3.9%) of lost chip coat (light blue) and the 5 m² (0.9%) of delaminated concrete (fuchsia) on the main span. All of the delaminated areas appeared to coincide with high CSE readings. It appeared that the floor beam cracks heavily influenced the CSE readings on the main span. The CSE contours on the west RD span were very high, exhibited little topography, and did not agree with the contours on the east RD span. It was stated in the Level 2 testing report that the west span CSE readings were believed to be incorrect.

Figure 2. Plan view map of 2015 CSE testing and chain drag results for BF 13166-1 Pembina River Bridge.

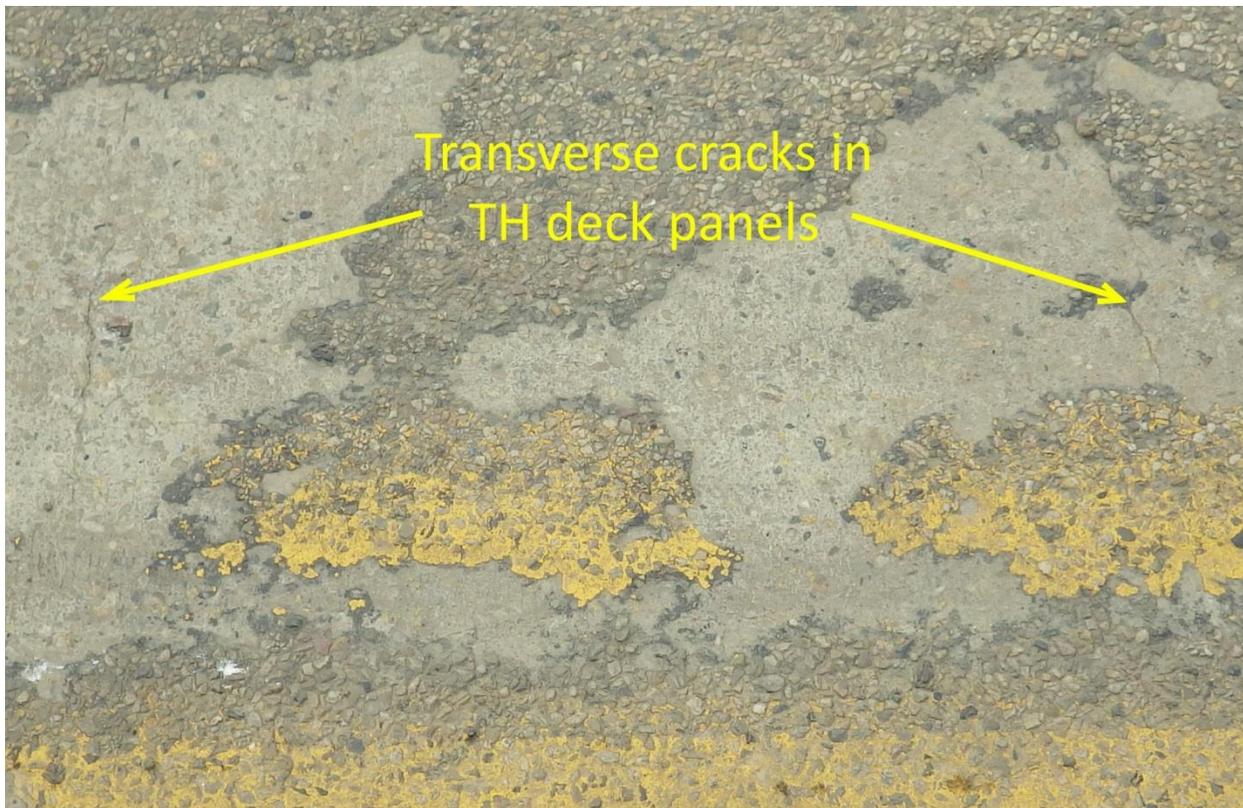
Figure 5 a) shows a plan view contour map of the GPR signal attenuation over the entire deck surface of the bridge using a consistent corrosion prediction threshold that was developed for reinforced concrete decks incorporating uncoated carbon steel bars. The TH span exhibits significantly higher levels of attenuation at the nodal points of the truss between the deck panels and also within the westernmost panel, which is consistent with the more negative CSE potentials measured in 2015. Many transverse lines of elevated attenuation levels, which are consistent with chloride levels approaching corrosion initiation, can be observed within the TH panels. However, no symptoms of corrosion were evident in these areas, nor did the CSE potentials indicate elevated risk of corrosion in these locations. Transverse cracks were observed during the GPR survey within the TH deck panels at locations where the chip coat had been lost, as shown in Figure 4.

Figure 4. Transverse cracks observed in TH deck panels.

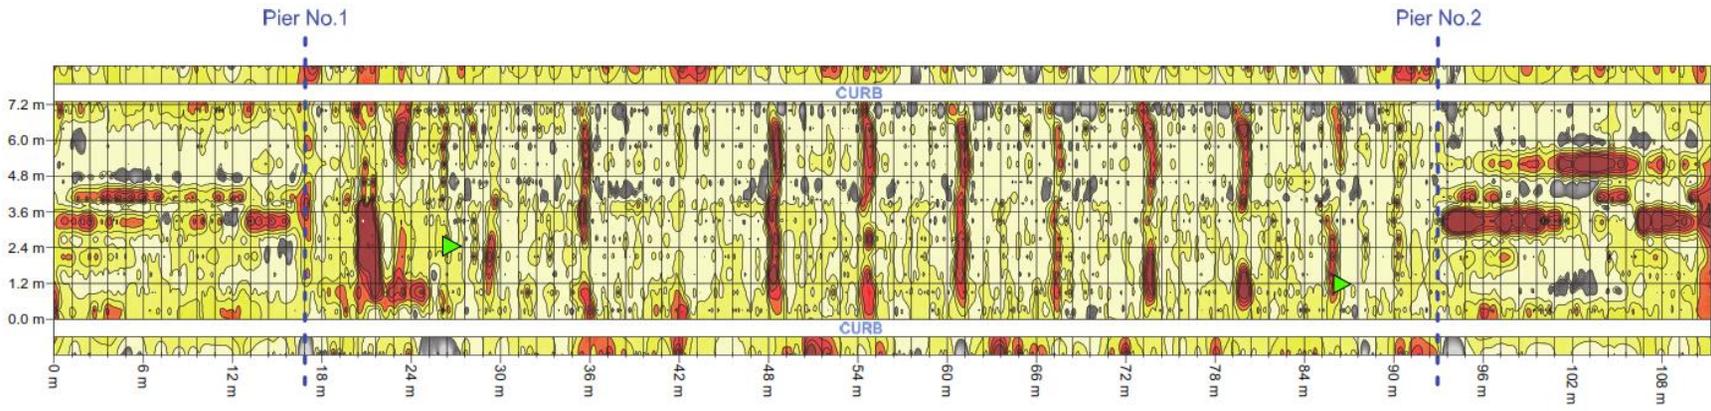
a) GPR results in all spans using corrosion threshold for uncoated carbon steel.

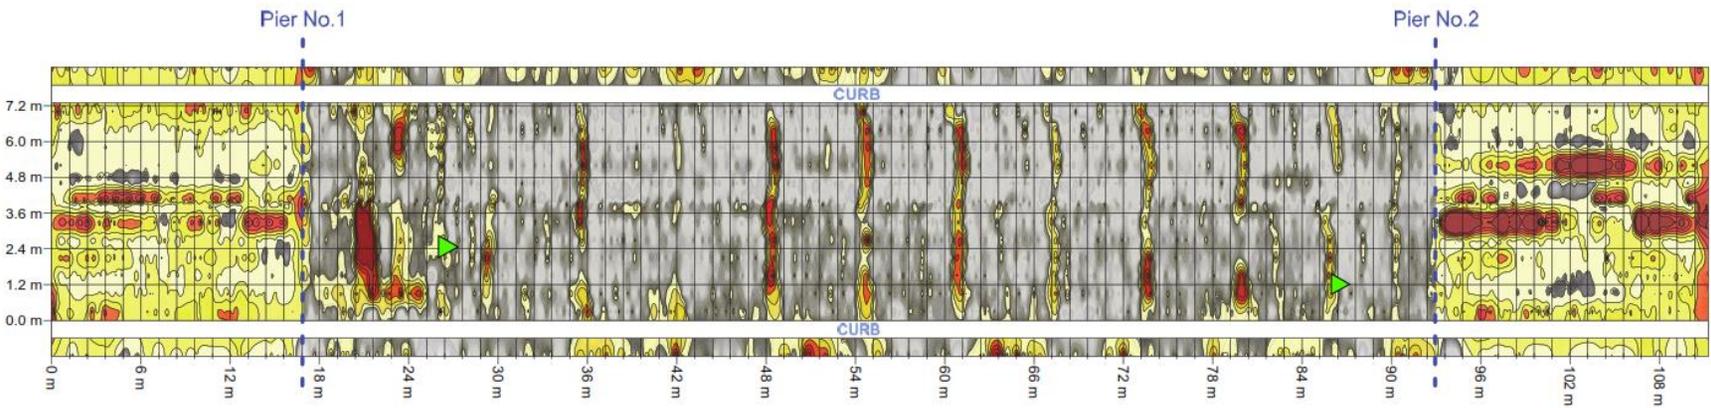
Figure 5 b) provides a plan view map of the variation in GPR signal attenuation over the deck surface, but utilizes these different threshold values for uncoated and galvanized carbon steel bars for the RD and TH spans, respectively. It is noted that the two locations where the reinforcement was exposed and inspected in 2015 do not exhibit signal loss levels in Figure 5 b) that would be associated with reinforcement corrosion when the threshold loss levels were adjusted to account for the presence of galvanized bars. It is unknown if the locations selected for inspecting the reinforcing steel were evaluated with consideration of any differences in the threshold values describing Inactive, Transition, or Active ranges that would occur due to presence of the galvanization on the bars. The majority of the deck surface in the TH span shown in Figure 5 b) exhibits GPR signal losses that would correspond to inactive CSE values, which is in agreement with the lack of corrosion identified via the two locations where the reinforcement was exposed and with the general conclusions made in the 2015 Level 2 deck testing report.

The areas of elevated GPR signal losses in Figure 5 b) generally appear to correlate well with areas of highly negative CSE values associated with active corrosion that were determined via the 2015 CSE testing results. High levels of chloride ingress are evident in transverse bands across the deck that are located at the TH truss nodal points in Figure 5 b), and the GPR losses levels suggested that sufficient chloride ingress to result in corrosion existed at many of these locations, even for galvanized bars. Corrosion staining, shown in Figure 6, was observed at a cracked panel point location approximately 23 m along the deck length in the westbound lane which exhibited these high levels of GPR signal attenuation. Relatively lower levels of GPR signal

attenuation and more positive CSE values are observed at cracked nodal points in the TH span at distances of 42 m and 66 m along the deck length, compared to the remaining locations. Additionally, high levels of GPR signal loss (chloride ingress) are observed near the middle of the westernmost TH deck panel in the eastbound lane, where both CSE values more negative than -500 mV and concrete deck delaminations were reported in the 2015 Level 2 testing report.

b) GPR results in TH span adjusted using corrosion threshold for galvanized reinforcing steel.

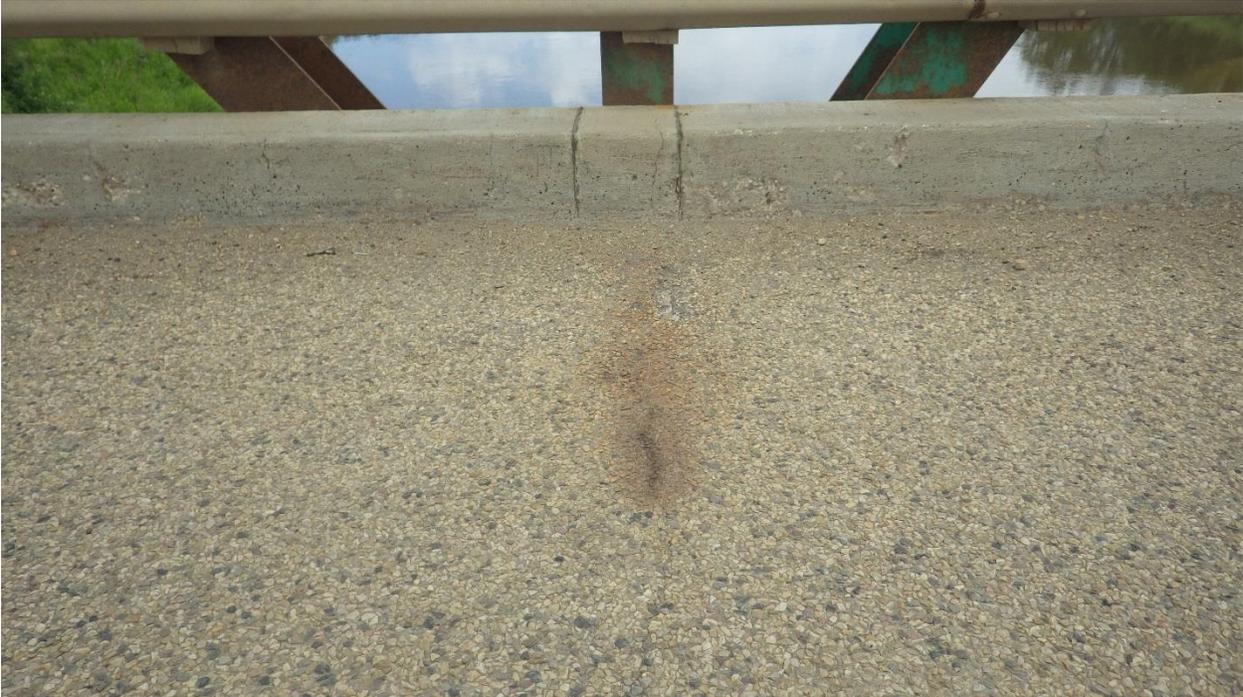
Figure 6. Corrosion staining in transverse deck crack at TH span nodal point located 23 m along the bridge length.

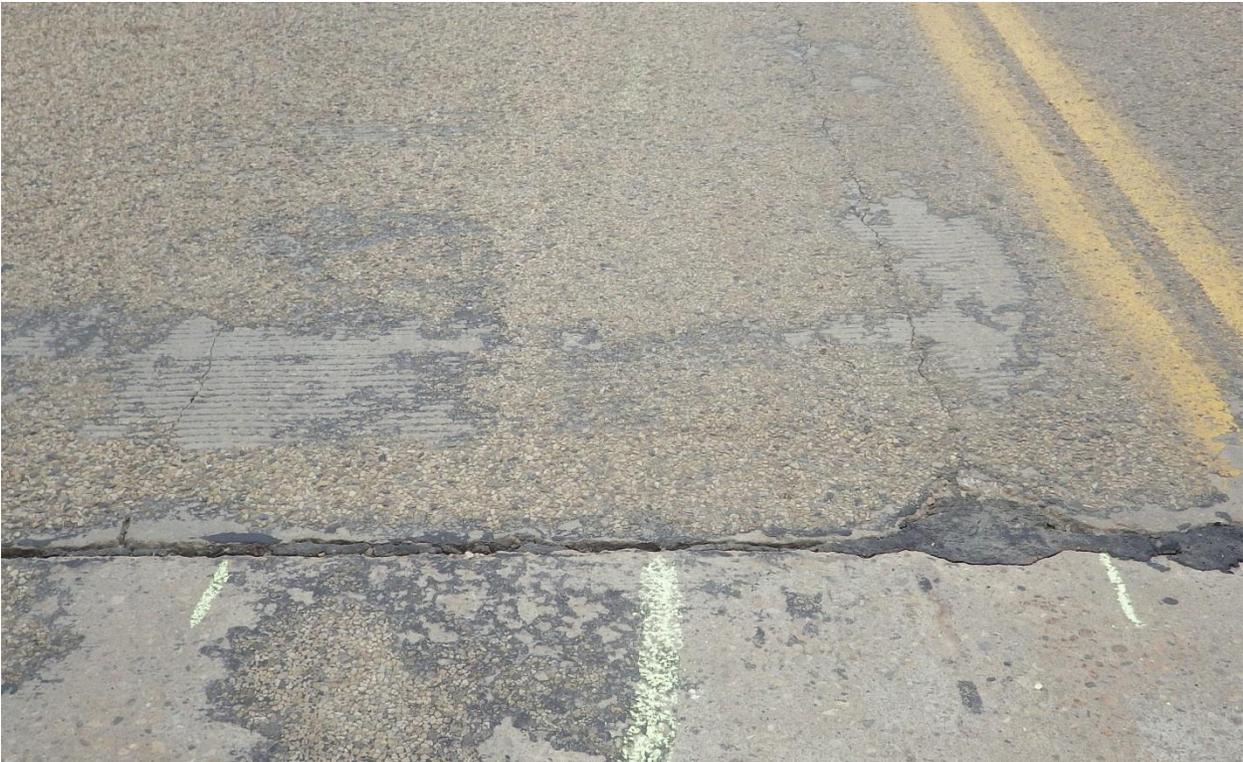
Also of note in Figure 5 a) and b) are several of higher GPR signal losses that occur longitudinally within the RD spans. Four areas can be observed in the eastern span and three within the western span. Initially, it was thought that perhaps the GPR data profile might have been positioned over bent bars leading from the upper flange to the webs of the girders, which would cause the GPR signal to reflect off the bars at an angle and reduce the amplitude of the measured response. However, signal attenuation losses could be observed throughout the full time range of the waveforms in these areas, indicating that the reduced amplitude was likely due to higher chloride levels. Two longitudinal cracks observed in the HDOL on the eastern span is shown in Figure 7, which correspond to the longitudinal areas of GPR signal loss at transverse distances of 4.0 m and 5.2 m across the deck width in Figure 5 a) and b). Subsequent review of the bridge inspection data forms for the bridge revealed that in 2011 inspectors had noted four longitudinal cracks in the eastern span and two in the western span, likely originating from failure of the grout keys connecting adjacent RD girders. Chloride ingress through all six of these cracks can be observed in the GPR results shown in Figure 5 a) and b), and based on the GPR results it appears that one additional crack exists in the western RD span. It is noted that the GPR profiles were not completely coincident with these cracks, but were offset by approximately 15 cm as indicated by the chalk marks observed in Figure 7. This provides some indication of the lateral extent that chloride ingress from these cracks into the deck has progressed. It is also noted that the CSE testing was not effective in identifying these areas of suspected chloride ingress, possibly due to a lack of electrical continuity in the RD spans.

Figure 7. Two longitudinal cracks by Pier 2 joint in the eastern RD span.

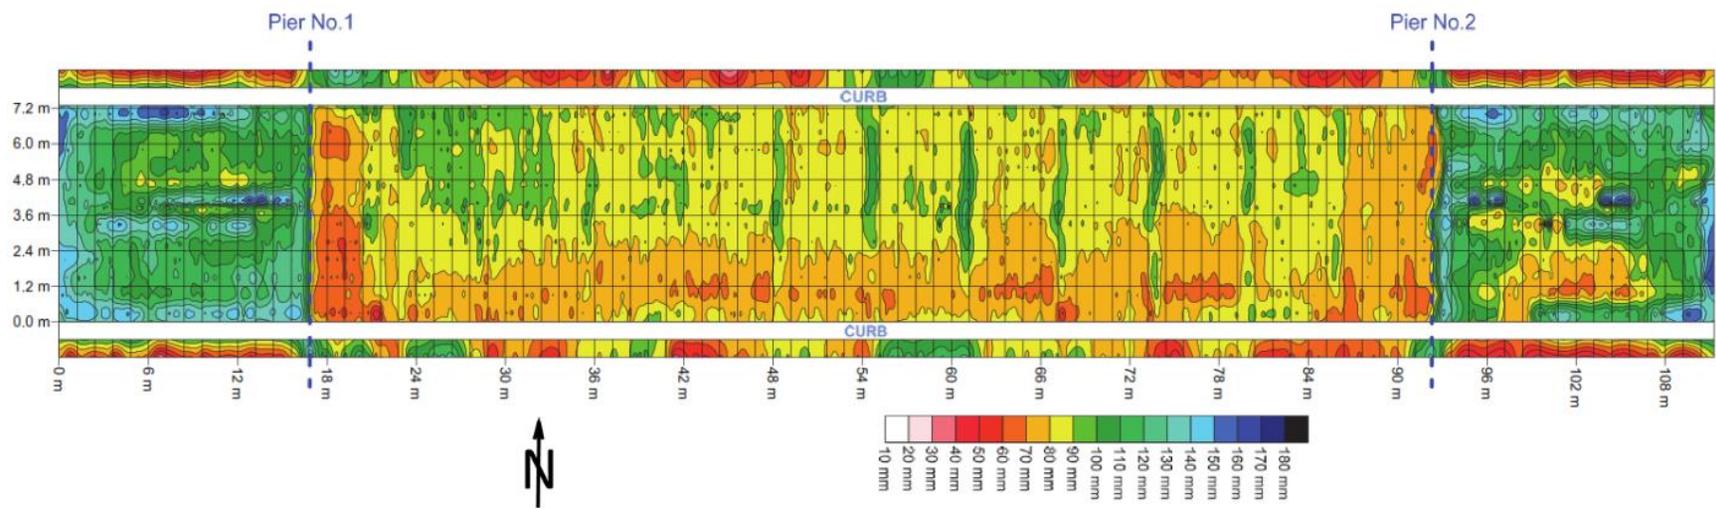
Figure 8 provides a plan view contour map of the estimated as-built cover thickness over the entire bridge deck surface. The difference in cover thickness between the RD and TH spans is highly evident in Figure 8. In general, the cover appeared to be slightly thinner in the eastbound lane, compared to the westbound lane. Thicker cover values ranging from 90-110 mm were estimated at the 11 nodal points in the TH span compared to the adjacent cover in the deck panels which generally ranged from 70-90 mm. This apparent increase in thickness may have resulted from higher moisture content due to the cracking at these locations which would increase the dielectric value and decrease the actual GPR wave speed, thus increasing the two-way travel time of the reinforcing bar reflections. Areas of shallow cover are noted adjacent to the deck joints located over the piers. The deck cover also appeared to be shallower in the western lane compared to the eastern lane.

It is noted that some cover measurements appear to be excessive in the RD spans within certain strips of GPR data near the deck centreline and curbs and laterally across the deck width adjacent to the abutment and pier joints. It is likely that the GPR data files exhibiting thick cover near the centre of the deck width were recorded over the section of the girder where the top layer has been bent downwards at an angle to extend down below the bottom layer into the underlying girder web. The thickening around the perimeter of the RD spans may be due to poor control of the HDOL layer thickness during its placement. Similarly, a relatively large region of shallow cover within the eastern RD span can also be observed.

Figure 8. Contour map of estimated as-built cover thickness.
