Use of Link Slabs in the Highway 17 Over Battle River Bridge Rehabilitation

Kelvin DeGrow, Team Lead Bridges, Stantec Consulting Ltd.

Paper prepared for presentation
at the Transportation Structures (PS) Session

of the 2020 Conference of the
Transportation Association of Canada

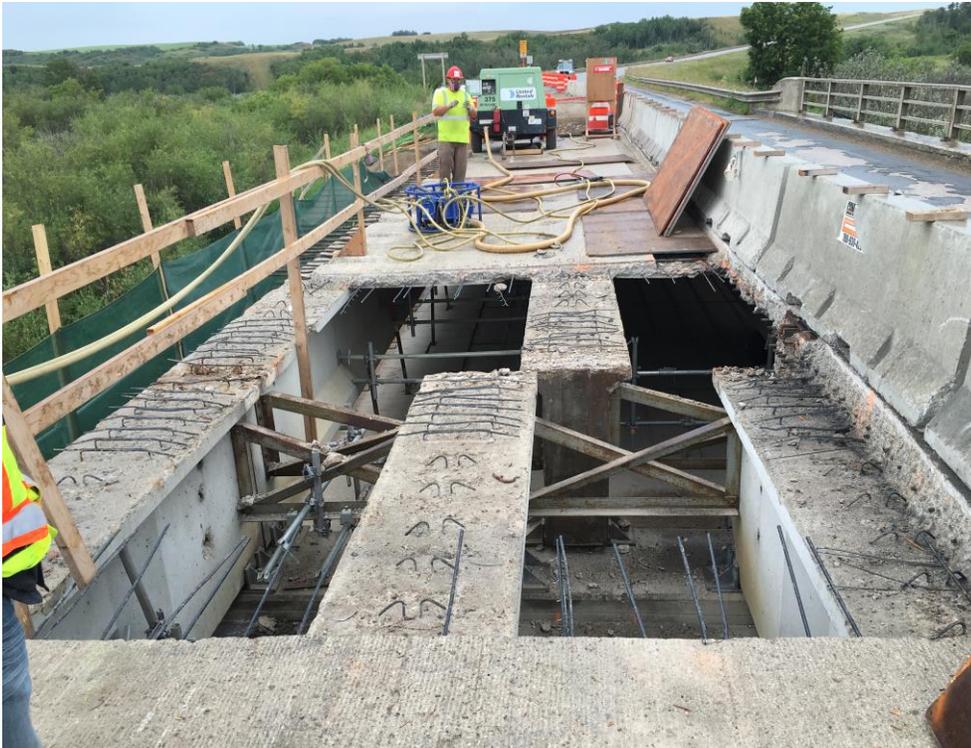
Figure 6 Demolition of the Deck at the Piers

The girders in the bottom of the photo are the five girders in the center span of the bridge and girders in the top of the photo are the four girders in the end spans. Reinforcing steel in the deck was salvaged so that new reinforcing could be lapped and joined to the existing reinforcing.

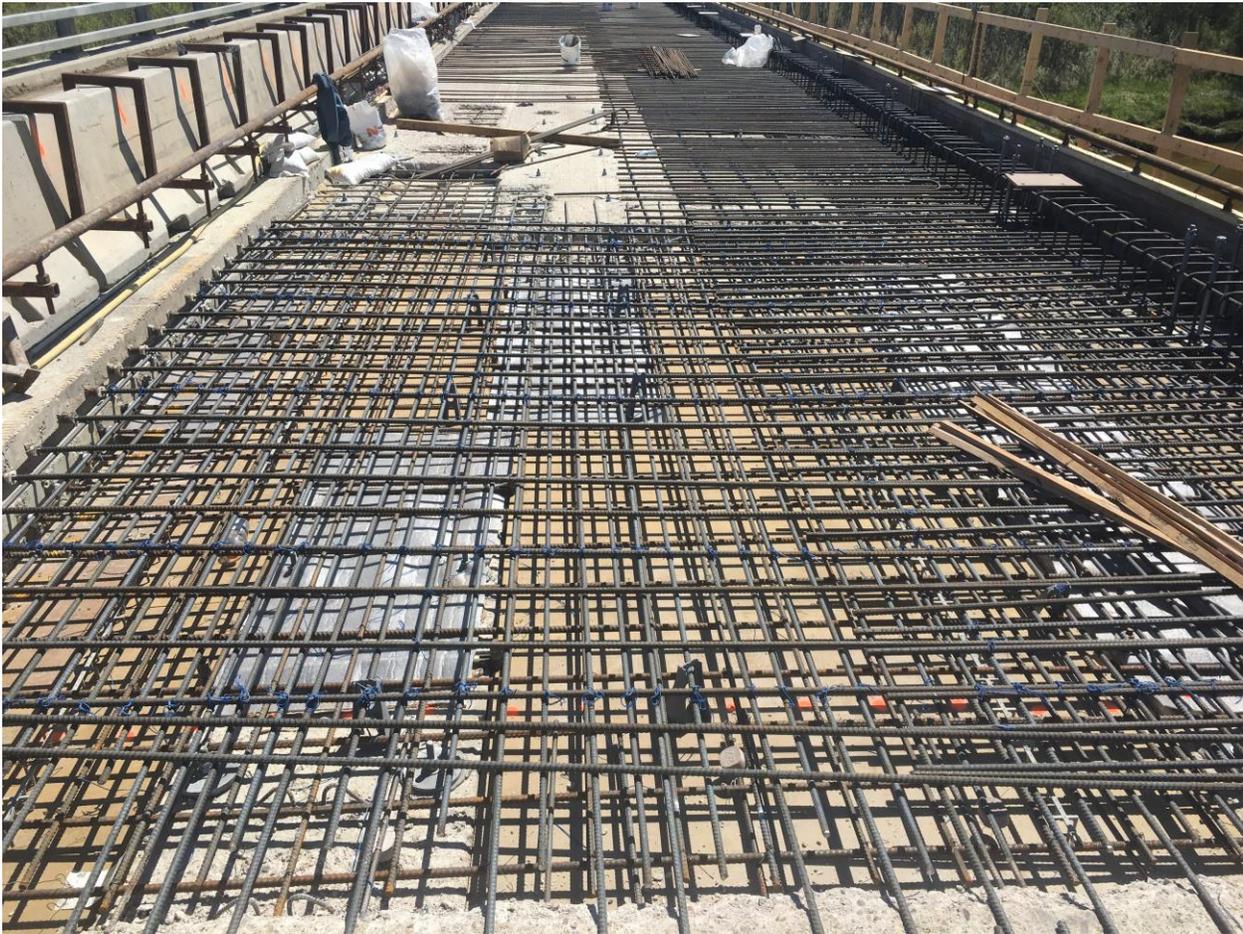
Figure 7 Link Slab Reinforcing

It is hard to see in this photo, but the grey area which appear to be the girders are the foam placed on top of the girders to create the debonded zone for the link slabs.
