**PERFORMANCE OF AN INNOVATIVE IN-SITU CONCRETE PAVEMENT REPAIR  
PATCH**

Paper prepared for presentation at the **Safety Innovations in Delivery of Summer and Winter  
Maintenance** session at the 2020 TAC Conference & Exhibition, Vancouver, B.C.

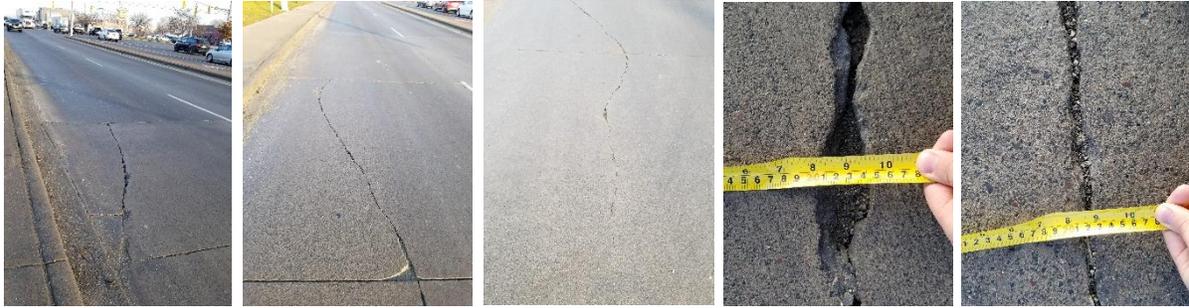
After consulting with officials at the City of Windsor, three concrete road pavement slabs were chosen for patch repair. The cracked pavement slabs are located on Walker Rd in Windsor, Ontario as shown in Figure 2. This road is known for its high traffic volume with an estimated Average Daily Traffic (ADT) count of 40,000 vehicles per day (10,000 vehicles/lane/day). Figure 3 shows the original condition of these concrete pavement slabs with their crack widths.

Figure 3 – Original condition of the concrete pavement

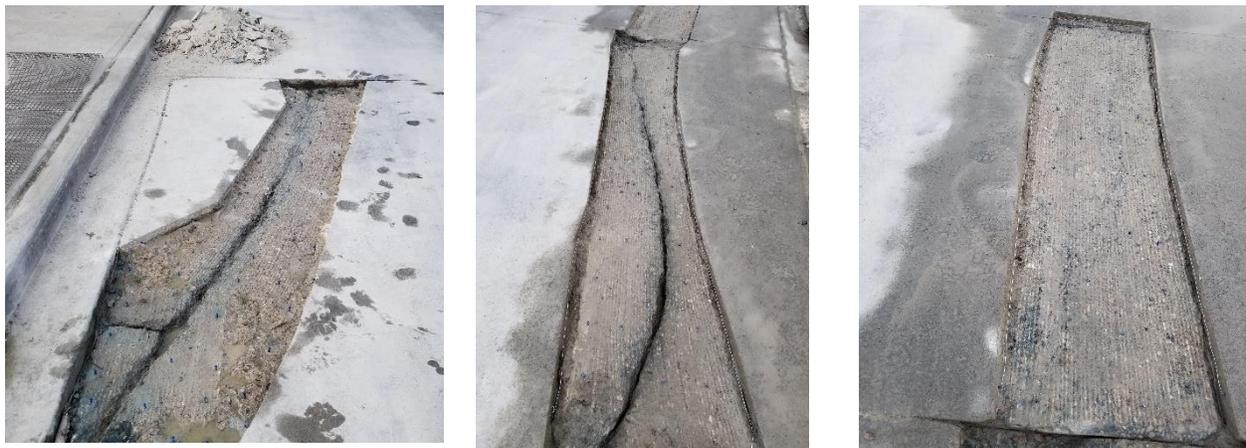
Figure 4 – Concrete pavement condition after milling and surface preparations

The repair operations started by traffic control and lane closure activities on a weekday morning (In November 2019). After, the surface was milled and grinded using a concrete milling machine as can be seen in Figure 4. Each repaired slab had a different milling dimension and shape than the other. However, the milling was positioned over the cracks with an average width of 600 mm and a depth of 45 mm (Figure 4). The length for each slab was between 3 and 4 meters. After milling, the saw cut was used to square the milled concrete edges.

ACI RAP Bulletin 7 recommendations were followed for surface preparations. High-pressure air was used to blow the dust and debris from the surfaces. These surfaces were then soaked with water for about an hour and excess water removed as can be seen in Figure 4.

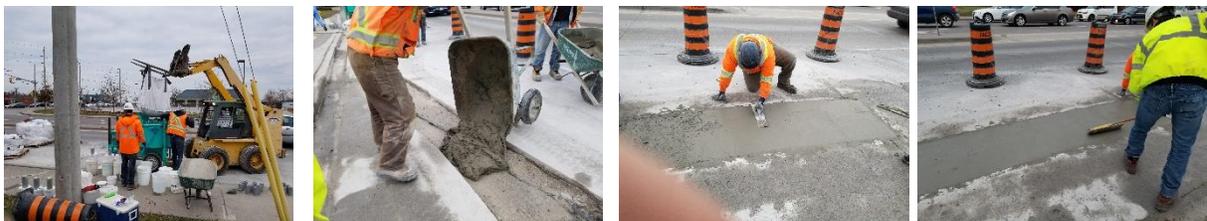
Figure 5 – Production and pouring of the patching repair materials

A mobile pan mixer unit with skilled crew individuals from Dura Concrete Canada Inc. (Figure 5) started producing the two proprietary repair materials on-site (HPFRC and UHPFRC). The produced materials were sequenced in multiple batches of 130 litres each.

The produced materials were poured directly on to the concrete surface that was in a saturated surface dry (SSD) condition (Figure 5). Afterward, the material was levelled and surfaced with a trowel and a spiked roller. Testing cylinders were sampled from both materials to verify the compressive strength of the designed materials. Few cylinders were put beside the repaired patches and few others were sent to the laboratory for testing at a moist curing condition.

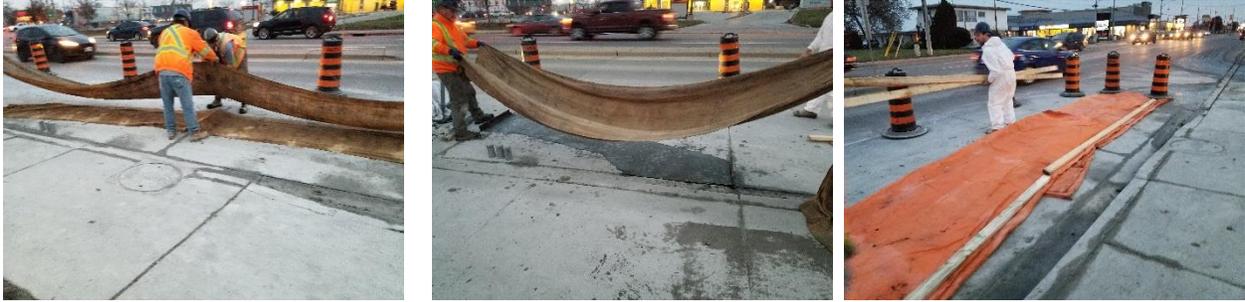
Figure 6 – Curing and protection procedure

Winter curing protection was followed by the pouring and placement activities as can be seen in Figure 6. Hence, the surfaced materials were covered with wet burlaps and thick

heat insulating tarps. Due to the sudden decrease in temperature after about 12 hours from the placement, it was recommended that radiant heating pipes be used. This ensured that the repair materials are exposed to an average temperature of  $22^{\circ}\text{C} \pm 3^{\circ}\text{C}$ . After verifying the compressive strength of the field cured specimens, the lane was reopened to traffic (after about 48 hours from materials placement). The field cured cylinder specimens had a strength comparable to the ones tested at the laboratory.

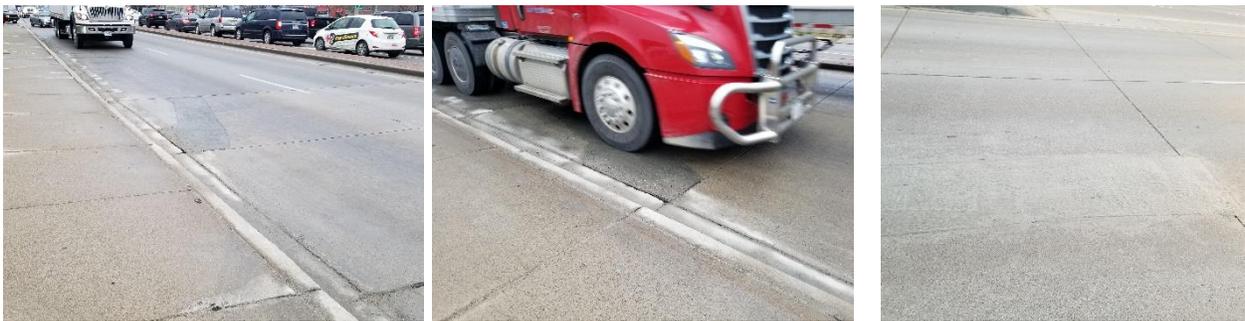
The visual observations and inspections after more than five months revealed that there were no signs or indications of deterioration to the repaired patches (Figure 7). The repaired patches were subjected to heavy traffic volume at about 48 hours after placement and exhibited several freeze-thaw cycles and dry-wet cycles. Figure 8 shows the minimum and maximum temperature profiles in Windsor, Ontario for the months of

Figure 7 – Heavy traffic load and volume on the repaired concrete pavement
