**Discussion of a Selection of Construction Issues Associated with the
Waverley Underpass and other Manitoba Infrastructure**

T.A. Epp, Structural E.I.T., Dillon Consulting Limited

Paper prepared for presentation at the Structures Session
of the 2019 TAC-ITS Canada Joint Conference, Halifax, NS

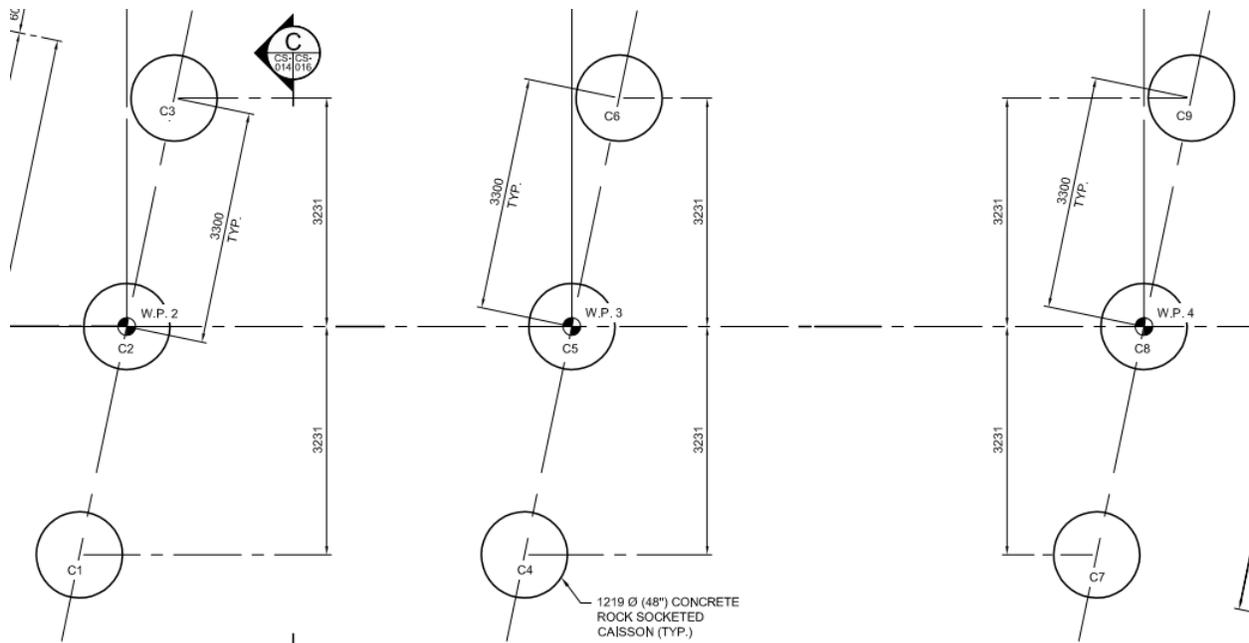
While a test caisson had been installed during the detailed design phase to further determine the subsurface conditions in the area and to verify the constructability of the design – previously discussed in Section 4.2 – Manitoba, like many geographic areas, is known to have formations of bedrock that are not uniform. Typical soil stratigraphy in the Winnipeg area consists of silts and various clays in the near-surface strata with an underlying layer of lacustrine clay of ten or more meters before till and limestone bedrock are encountered. All caissons except caisson C4 and C5 (the southern two caissons at the central pier as shown in **Figure 6**) had final tip elevations of the rock-socket generally similar to the anticipated elevation of 210.0 m. Caisson C4 and C5, however, ended up being in the location of a karst system in which groundwater had eroded the limestone bedrock causing a collection of limestone fragments. As such, sound bedrock was not encountered as expected.

Figure 6: Plan of Caissons (Three Caissons per Pier) – Not to Scale

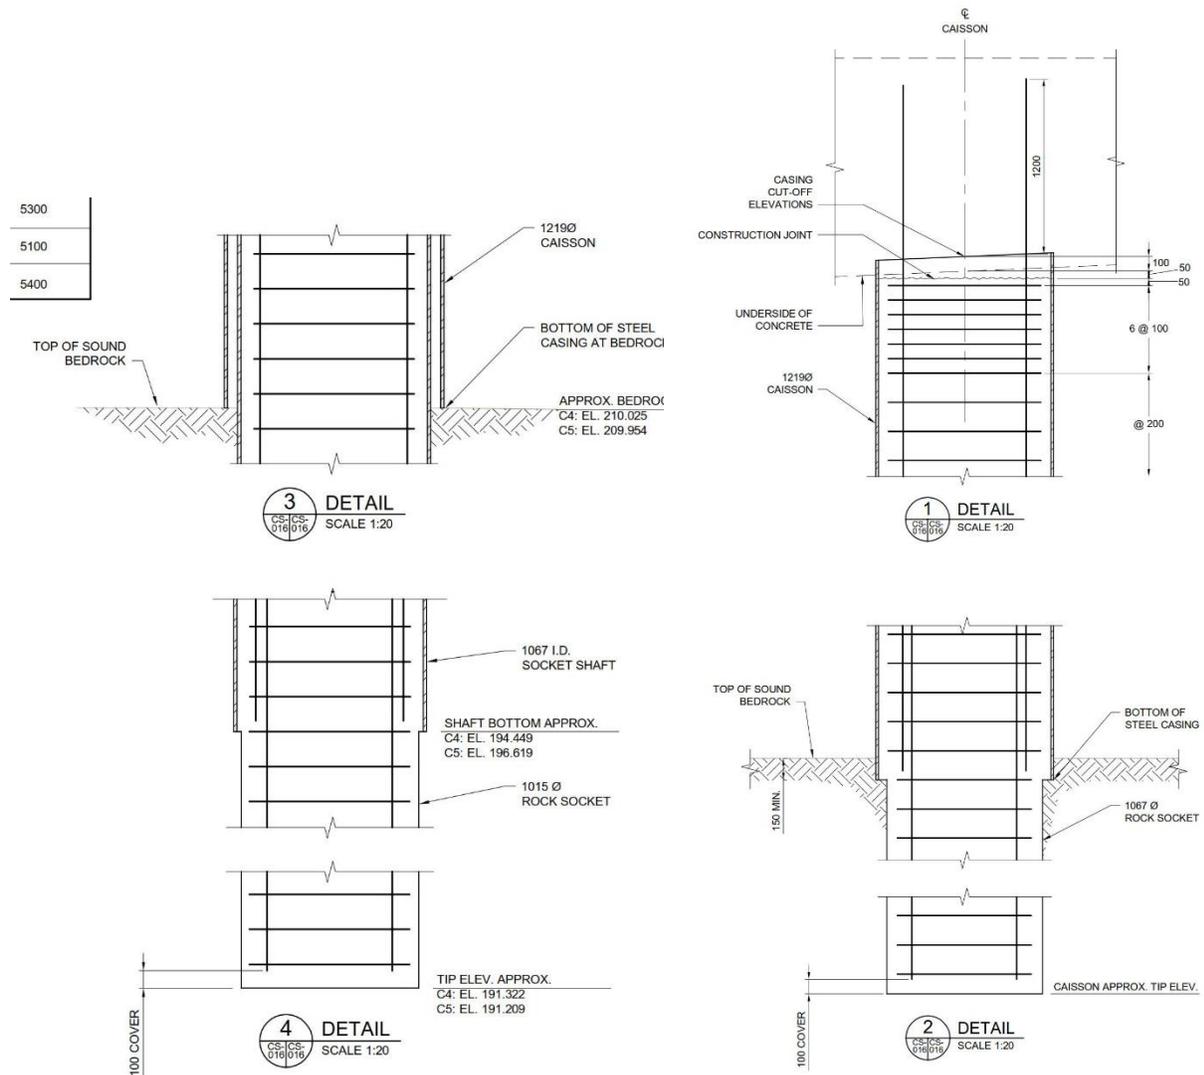
The two test borehole investigations determined that the elevation needed for competent bedrock was close to the elevation that had been reached when works on site had ceased. The depth needed, however, necessitated redesigning the two caissons as the current 1.2m sleeve in the ground was not long enough to advance deeper to allow for the rock-socket to be installed. To

reach the necessary elevation the 1067mm sleeve was telescoped with an additional 1015mm sleeve to complete the rock socket. The rock socket diameter was reduced to 1016 mm (from 1067mm) and the length of the 1067mm sleeve was extended when competent bedrock was found at approximately 196.5m, 13.5m below the anticipated elevation. The redesigned caisson configuration is shown in **Figure 7**.

Figure 7: Caisson C4 and C5 Redesign (Left) and Initial Caisson Design (Right)

In order to avoid safety and stability concerns around caisson construction it is recommended that on future projects test boreholes, similar to those carried out once the problem was identified, are conducted ahead of construction at each caisson location so that a more certain estimate can be made with respect to the amount of effort. The designs can also be further optimized in terms of the lengths of various sleeves. It is expected that had the karst system been identified ahead of

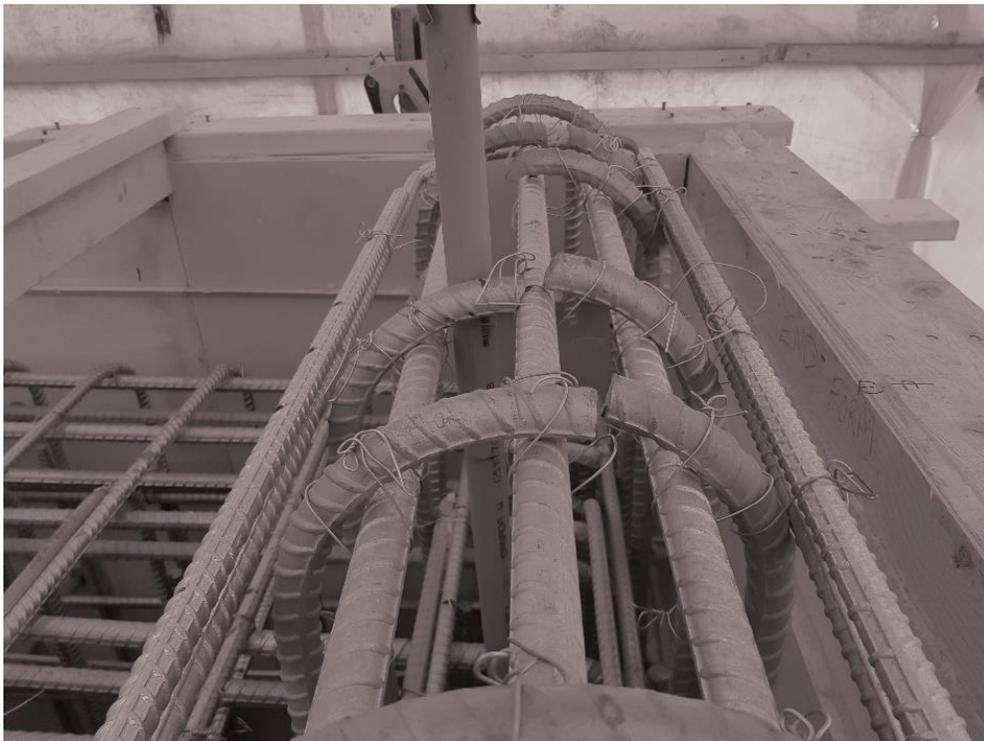
The City of Winnipeg has long been a proponent of the use of hot-dip galvanized (HDG) reinforcing steel in its bridge structures. Although HDG reinforcing steel is fairly commonplace in the industry, the use of HDG reinforcing steel in the Waverley Underpass and other projects being managed simultaneously by the Project Team identified challenges and possible improvements associated with the *ASTM A767/A767M-16 Standard Specification for Zinc-Coated (Galvanized) Steel Bars for Concrete Reinforcement* – particularly with respect to the manner in which hydrogen embrittlement is tested for. Based on the Project Team’s experience on the matter, concerns were raised regarding the HDG reinforcing as there were a number of recent galvanized rebar failures identified on sites during routine inspections of other projects. A typical failure is shown in **Figure 8**. The failure behaviour was noted to be brittle, resembling the deleterious effects of hydrogen embrittlement.

Figure 8: Typical Failure of HDG Rebar (Note bent bars are fractured in two)

For the purposes of this project designed for a service life of 75 years, embrittlement of reinforcement poses significant long-term durability concerns for the composite deck superstructure. As defined by *ASTM A143/A143M-07 Standard Practice for Safeguarding Against Embrittlement of Hot-Dip Galvanized Structural Steel Products and Procedure for Detecting Embrittlement*, embrittlement is “the loss or partial loss of ductility in a steel where an embrittled product characteristically fails by fracture without appreciable deformation”. Any reduction in the ductility and load-bearing capacity can lead to sudden failure below the material’s yield stress.

Common ways in which hydrogen embrittlement is typically derived in reinforcing steel includes aging phenomena, cold working of reinforcing, and specifically for the case in question, absorption of hydrogen. Signs of hydrogen embrittlement may also appear after pickling reinforcement with an excessive immersion time.

In the future, additional language is recommended to be included in project specifications modifying the bend test methodology outlined in ASTM A143M-07: Particularly, the 2003 methodology of reverse-bending a previously bent and galvanized reinforcing steel bar would be considered prudent. Above all, good quality control during the fabrication process – such as strict monitoring of pickling immersion time – is the best way to minimize the occurrence of embrittlement issues. Additionally, the use of “bendable” galvanized reinforcing steel, in which the bending occurs *after* the galvanizing process, could be explored.

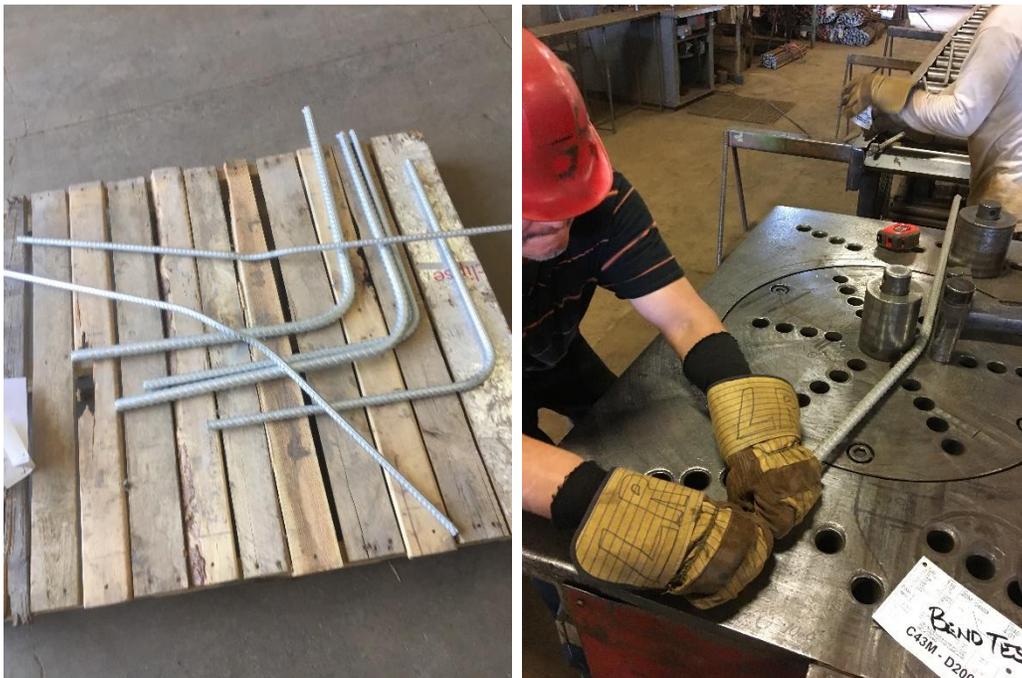
Figure 10: Waverley Underpass 15M and 20M Bend Test Specimens (Left); ASTM A143M-07 Bend Test in Progress (Right)

Additionally, and most importantly, bending of a straight HDG reinforcing steel bar is not equivalent to the reverse-bending of a previously bent and then galvanized reinforcing steel bar. The embrittlement failure tends to occurs particularly at the bends in reinforcement galvanized *after* bending. Although the recommendations outlined by the ASTM Standards have been adhered to in their entirety, the testing completed is not truly indicative of the actual reinforcing steel conditions which complicates the problem resolution process when a fractured bar is discovered in the field.

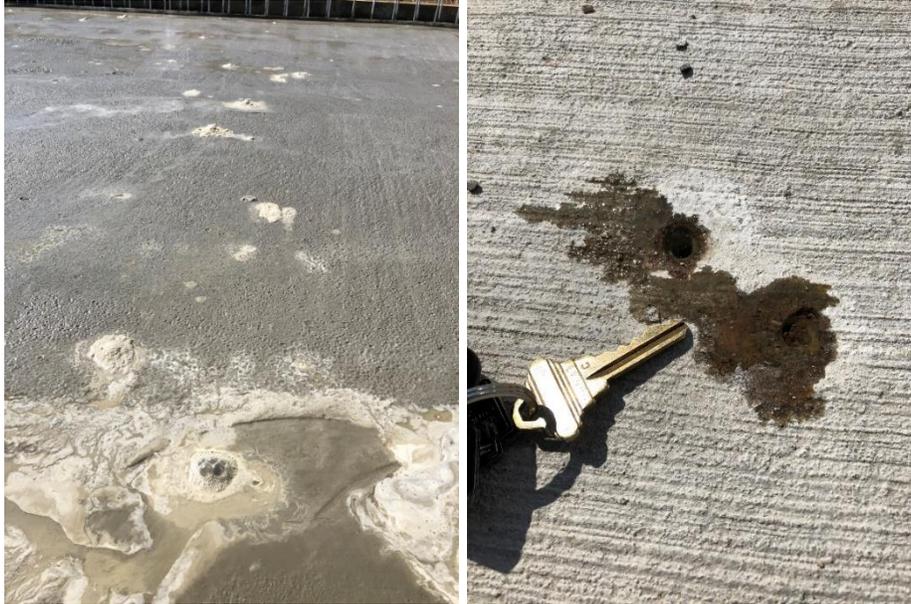
During the superstructure concrete pours for the Waverley Underpass specifically, surface boils appeared at all of the deck and trainman’s walkway pours as shown in **Figure 10 (Left)**. It is important to note that the Waverley Underpass reinforcing steel was chromate quenched in accordance with ASTM A767M and confirmation from the fabricator was obtained confirming so. Upon further investigation into other projects with similar issues, it was hypothesized that the boils were the result of the fresh concrete reacting with the zinc-rich paint that was used to touch up small defects (knicks, holidays, etc.) of the galvanized reinforcing steel or potentially fresh concrete reacting with the areas where the protective chromate layer provided by the chromate quenching of the reinforcement had been compromised or otherwise no longer present. Additionally, literature suggests that the chromating film is typically consumed within six weeks; therefore, if a chromate quenched bar is not cast into concrete within six weeks, the benefit of the chromating may be nullified.

Upon further investigation, the project team did not find any significant research study into the long-term durability concerns associated with these hydrogen gas boils; it is not clear whether these boils result in a direct pathway from the reinforcing steel to the concrete surface allowing for ingress of deleterious substances resulting in accelerated corrosion. In light of this, all boils on concrete components not scheduled to be covered with a waterproofing membrane were repaired by drilling 50mm into each boil and injecting the holes with high-strength two-part epoxy; a completed repair is shown in **Figure 11 (Right)**

Figure 11: Hydrogen Gas Boils on Concrete Deck Surface Immediately After Pouring (Left); Epoxied Repair of Boils (Right)

Interestingly, the off-gassing issues were not encountered during the substructure construction which also utilized HDG reinforcing steel; that is, the formation of boils was limited only to the superstructure concrete pours. It is currently not understood why this is the case, but this may be associated with the fact that the substructure concrete and superstructure concrete were two different mix designs. Seeing as the chemical reaction resulting in hydrogen evolution is strongest the higher the fresh concrete pH, variations in concrete mixes may play a role in the hydrogen formation. Additionally, it is interesting to note that in our experience, these boils have been generally limited to components cast using the redi-mix concrete of a specific local supplier which may further suggest the issue lies with the concrete mix and not necessarily the HDG reinforcing itself.

While the exact cause of the hydrogen gas boils on the Waverley Underpass is not conclusively known, following chromating and material care management best practices should be emphasized in project specifications to mitigate potential issues. Additionally, the Contractor's responsibility to repair hydrogen gas boils should also be explicitly written in the project specifications. Otherwise, as in the case of the Waverley Underpass, the contractor may argue that if the boils are due to a chemical reaction between the HDG reinforcing steel and fresh plastic concrete – both specified in detail by the Engineer – then the Contractor should not be responsible for repairing the gas boils.
