Sid Buckwold Bridge Rehabilitation

Udara Heendeniya, Civil Engineer-in-Training, Stantec Consulting Ltd.

Paper prepared for presentation at the Structures session of the
2021 TAC Conference & Exhibition

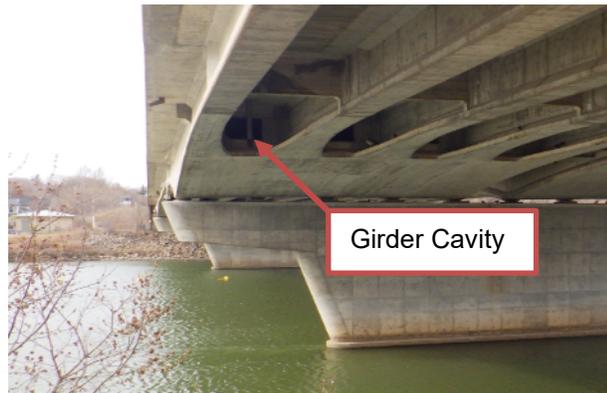
Figure 4 - Girder Cavities

- The concrete surfaces within the box section of the girders, or girder cavities, over the piers, were not inspected due to a substantial build-up of pigeon feces and active pigeon nests. Therefore, to properly inspect these areas, the pigeon flock had to be removed and droppings had to be cleaned. However, since the box sections were formed using 2x4 planks, the inspector was able to count the marks left by the planks to estimate the volume of feces in these cavities without having to enter these areas. The volume of feces per girder cavity was estimated at approximately ~25m³ for a total of ~900m³ in all 36 girder cavities.

- It was recommended to trap and euthanize the pigeon flock. The girder cavities to be then cleaned of pigeon feces and permanent pigeon exclusions to be installed to prevent future habitations. Approximately 800m³ of pigeon feces from girder cavities and other structural members were estimated to be removed.

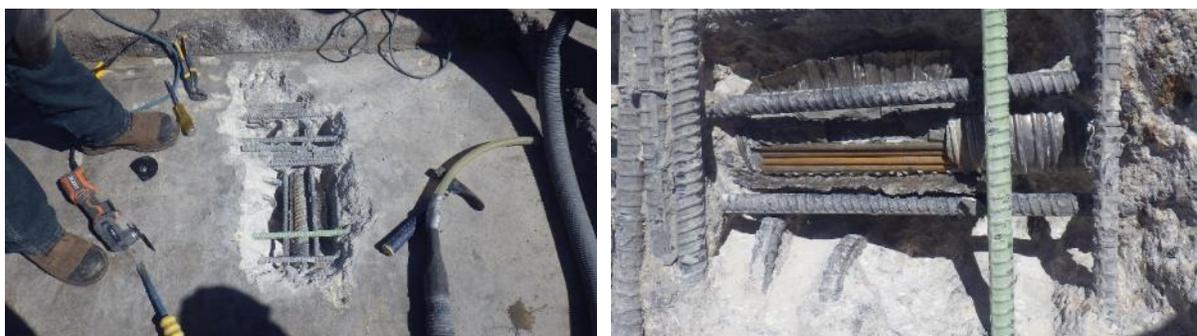
Figure 5 - Exposing Post-Tension Cable Duct

Due to the proximity of PT cables to the deck surface and the indication of chloride-induced corrosion of deck reinforcing, samples were tested at the PT cable ducts to confirm the corrosion status of the PT cables. Test locations were carefully selected to reduce the disruption to traffic and keep the testing as least invasive as possible while considering the representability of the data to the entire bridge deck. Therefore, the selection process considered the severity of chloride exposures and the severity of the members (i.e., primary versus secondary). The inspection areas were in the CIP concrete portions, near the piers, where the ducts are nearest to the deck surface. The cables consist of bundled steel 7mm diameter wires and ≈75mm diameter corrugated steel ducts filled with grout.

- The membrane was well-adhered to the concrete deck and appeared to be providing some level of protection; 92mm to 95mm of concrete cover existed above the PT cable ducts.
- No cracking or deterioration of the concrete was observed over the PT cables. The ducts and grout had no observed material defects and the ducts were fully grouted.
- The impact echo testing did not identify areas with suspected voided or soft grout; the high ratio of girder thickness to PT duct diameter made void detection difficult.
- The bundled cables/wires had light superficial corrosion.
- Low concentrations of chlorides were identified in the grout, which was most likely to be attributed to background chlorides.
- No carbonation was identified on the grout (pH >11). The petrographic analysis determined the grout to be of high quality and in good condition.

Based on the findings from test data, no repairs were warranted.

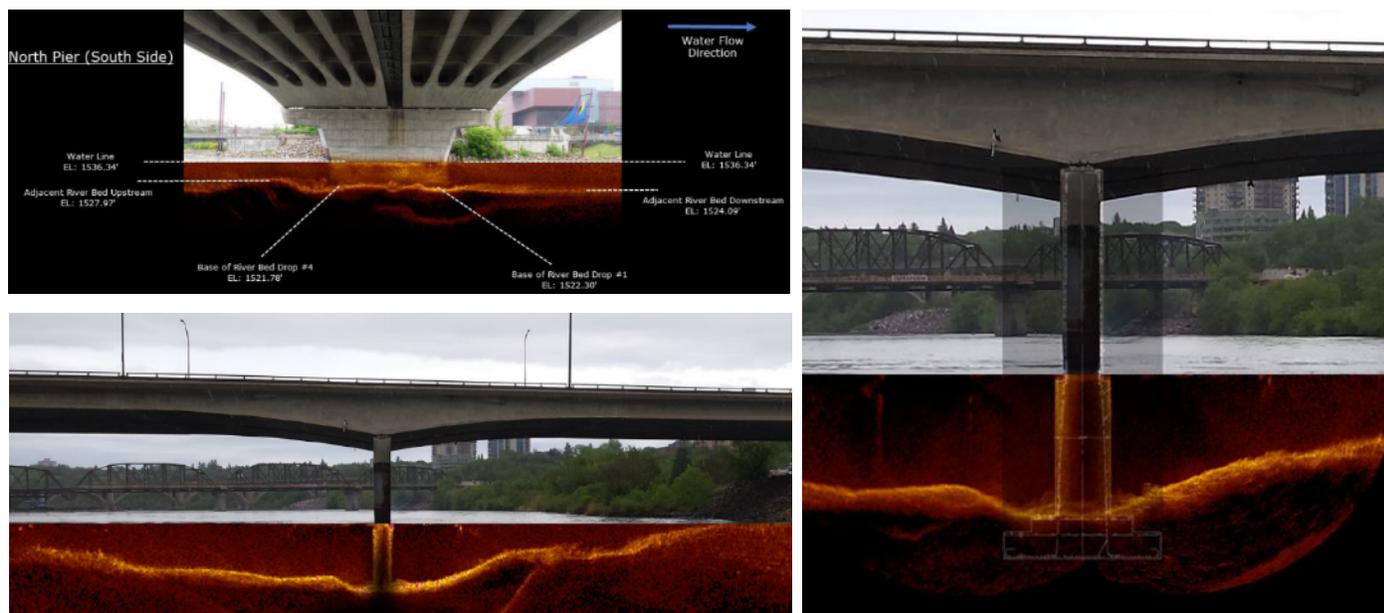
Figure 6 - Imagery From Bathymetric Survey

- No suspected concrete deterioration of piers below water level.
- No suspected movement of the pier footings.
- Substantial loss of rip rap around piers in comparison to as-built drawings.
- Scour was found at the upstream ends of both footings to a depth of ~1.2 metres, leaving approximately 2.0m of streambed material above the bottom of the footings.
- No undermining of footing was observed at the time of the investigation.
- Remains of an abandoned bridge pier (1890 CNR Bridge) have daylighted near the south side of the north pier. This appears to be contributing to the scour.

Stantec recommended restoring the lost riprap at the pier footings but this was not selected for the scope of this rehabilitation by the City. It was recommended to the City to continue underwater assessments at reasonable time intervals to ensure the footings are continuing to perform as intended. It should be noted that currently there are no Canadian specifications for such investigations, though there are a vast number of major structures that are supported on shallow foundations. For this investigation, Federal Highway Administration (FHWA) specifications were utilized as a guide.

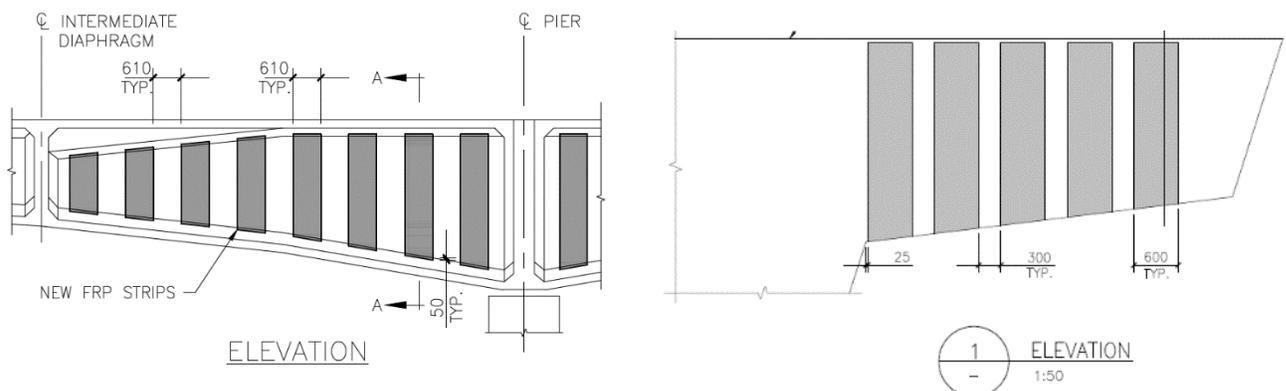
Figure 8 - Proposed FRP Strengthening Options

The capacity at ULS of each element was assessed by calculating the live load capacity factor (F-factors) at critical locations of section change or regions of high stress in accordance with CHBDC. It was found that the girders near the pier in the east structure had an F-factor of 0.52 and the west structure had a factor of 0.6. This was highly concerning as it was well below the serviceable rating of 1. Pier caps, however, were found to have an F value above 5 for both east and west structures. This did not match what was observed during the detailed visual inspections. Girders near the piers did not show any signs of shear cracks, while the piers showed a considerable amount of shear cracking. Hence the recommendations were made to do strengthen both the piers and girder within the predesign report.

- Girder and Pier strengthening, where the option comparison considered the cost of construction, aesthetics, and constructability:
 - Two practical options, Fibre-reinforced Polymer (FRP), and external post-tensioned stirrups with FRP strips on exterior girders were considered. The FRP option was found to be the most effective as it was comparably less expensive and was not visible as the strips. This was due to the fact that the FRP would be installed inside the cavities between the girders adjacent to the piers. The preliminary estimated cost for the FRP system was \$1.6M.

- For the pier strengthening, the two options considered were FRP and a CIP concrete overbuild. The FRP option was chosen as the cost was comparatively lower while the aesthetics were also comparable. Bundling the FRP repairs with the girder repairs resulted in a saving of \$60k over performing the repairs separately.

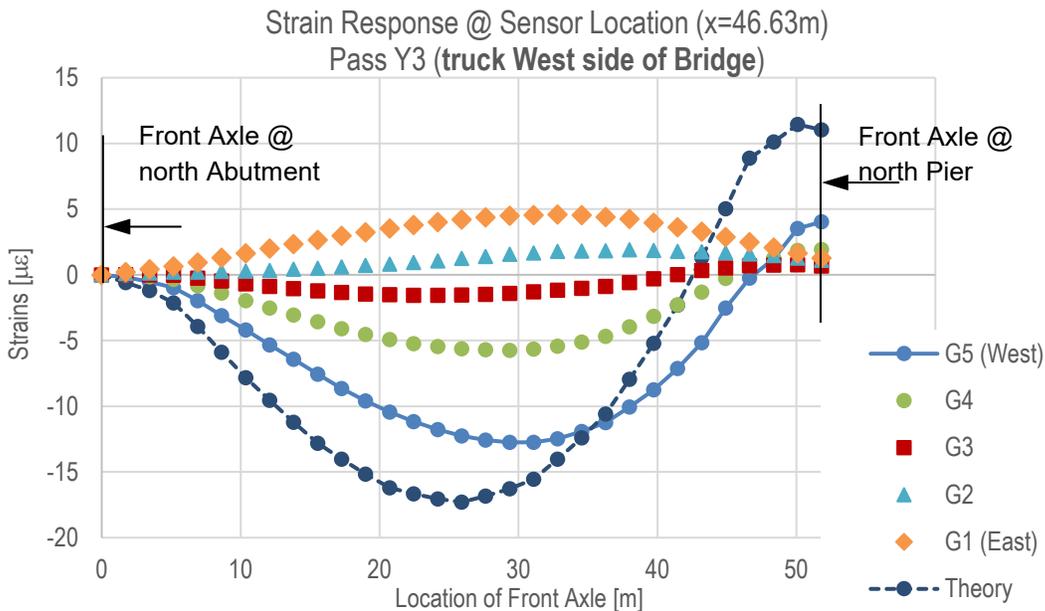
Figure 9 - Strain Response Measured vs Theoretical

As the west-most girder of the east structure is the critical girder, it was used for the analysis. Upon completion of the test, the theoretical live load distribution was compared with the real-time measured distribution. A comparison sample is shown in Figure 9. As such, actual measured Live Load Distribution Factors (LLDFs) were used in the calculations instead of the CHBDC factors. During predesign analysis using CHBDC factors, the LLDF was determined at 0.919, whereas the test results found that the actual distribution was only 0.366. Therefore, the designer was able to reduce the load acting on this exterior girder by close to 60%. As such, the F factor was revised from 0.52 to 1.306. This suggested that no shear strengthening work was required for the girders, eventually saving ~\$1.6M of strengthening cost.

In addition, since the FRP system was not required for the girders, it was decided to go ahead with CIP concrete overbuild for the piers. To complete FRP strengthening only for the piers would increase the cost to be above the estimate for the CIP overbuild. The CIP option was approximately \$20K less than the FRP option when it's not bundled with the girder strengthening work. In addition, CIP overbuild could be done by most competent contractors with minimal supervision.
