**Forensic Evaluation - Southwest Anthony Henday Drive's Portland Cement Concrete Pavement**

Paper prepared for presentation  
at the Innovations in Pavement Management, Engineering and Technologies Session  
of the 2019 Conference of the  
Transportation Association of Canada  
Halifax, NS

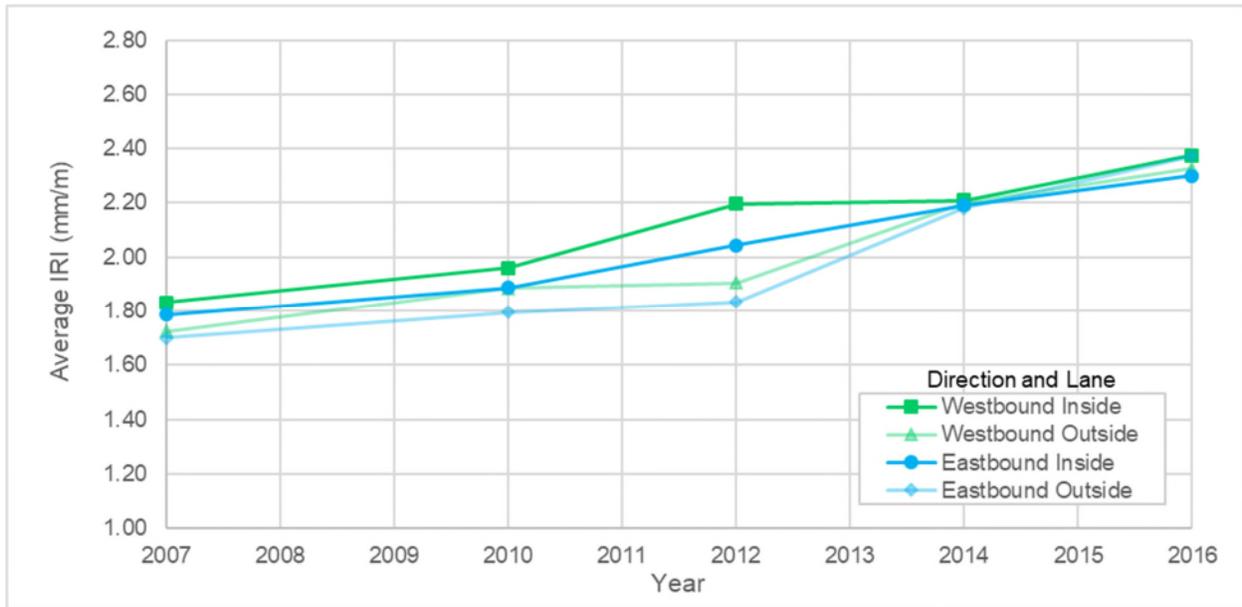
**Figure 2: IRI Progression (Segments without Rehabilitation)**

For the roadway segments observed to have received no rehabilitation treatments, the progression of IRI over time appears to be approximately linear, as illustrated in Figure 2 for each lane of the roadways. Table 2 presents the average IRI values for each year as well as the calculated average annual increase in IRI.

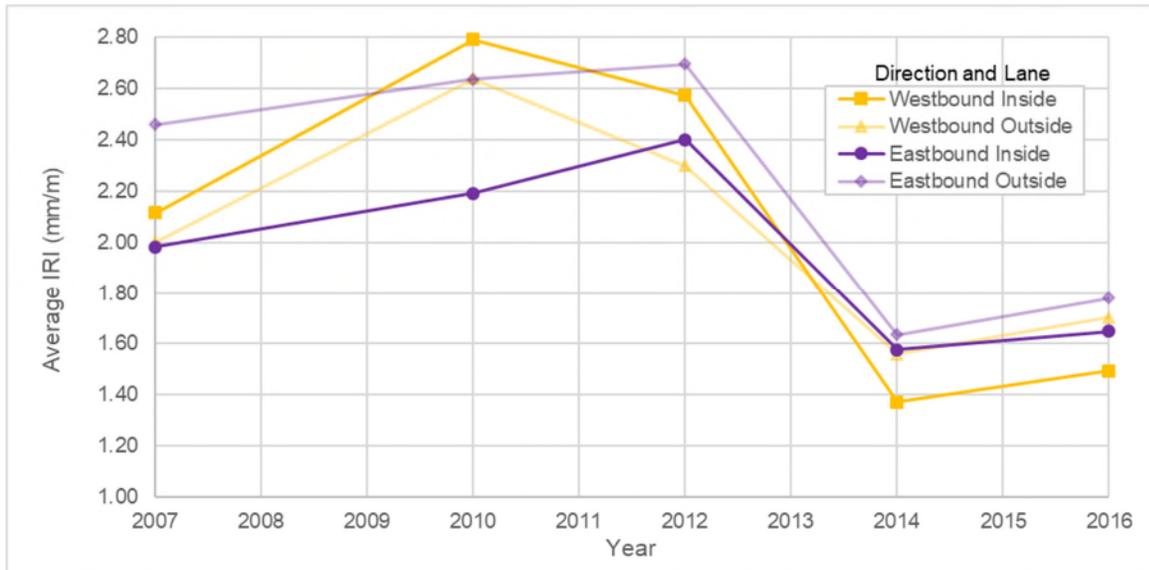
**Figure 3: IRI Progression and Improvement (Segments with Diamond Grinding)**

For the roadway segments that received diamond grinding in 2013, the progression of IRI is illustrated in Figure 3. Table 3 presents the average IRI values for each year; the average annual increase in IRI from year 2007 to 2012; the decrease in IRI from year 2012 to 2014 (i.e. the decrease in IRI associated with the diamond grinding rehabilitation); and the average annual increase in IRI from year 2014 to 2016.

Diamond grinding treatments, on average, provided between a 0.5 and 1.2 mm/m decrease in IRI. The rate of IRI increase before and after diamond grinding are approximately the same. Therefore, following diamond grinding, roughness would expect to return at approximately the same rate as an untreated segment of roadway, i.e. approximately 0.06 mm/m increase in IRI per year. Generally, roughness is consistent between the inner lanes and outer lanes throughout the project. In areas without rehabilitation to improve smoothness, the average annual increase in IRI has been approximately 0.07 mm/m (per year) since 2007.

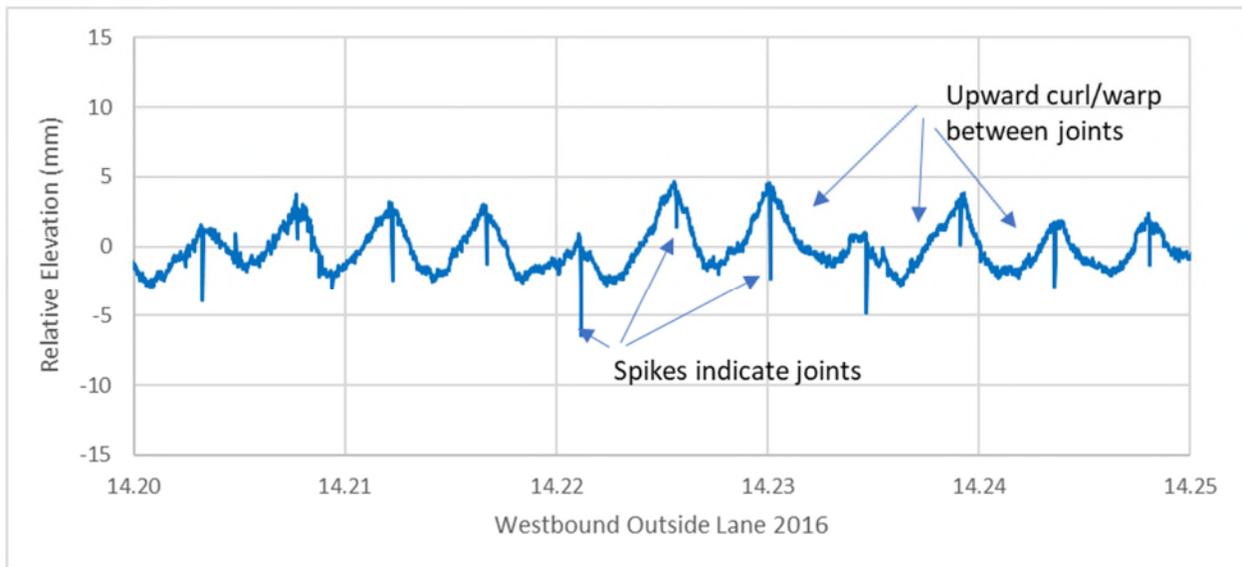
**Figure 5: Example Filtered Profile Showing Upward Curl / Warp**

This averaged profile was then subtracted from the original profile to show surface features with wavelength generally shorter than 7.62 m. This difference between the original profile and smoothed profile is known as the ‘anti-smoothed’ profile. An example is shown in Figure 5. In this figure, downward spikes indicate the location of transverse joints where a laser entered the joint. The presence of upward curl/warp can clearly be seen in this example.

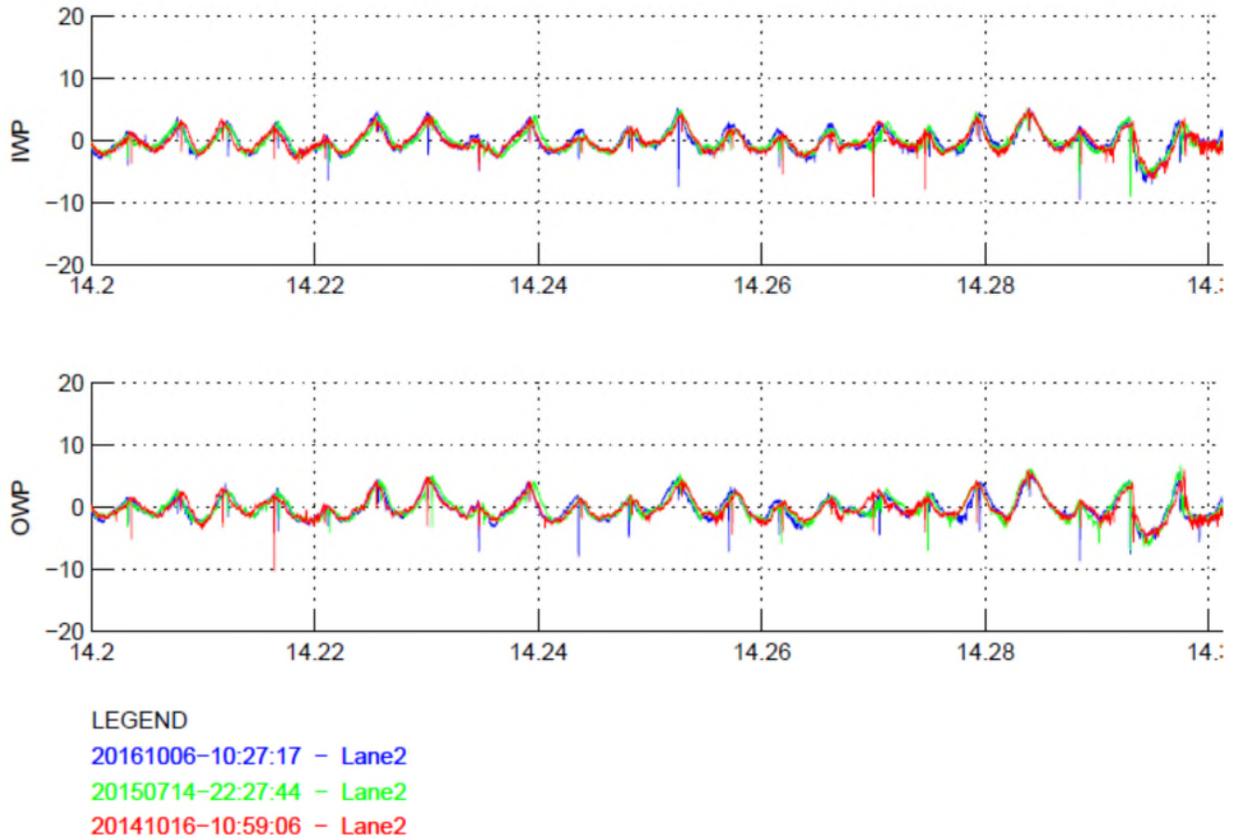
**Figure 6: Example of Multi-Year Filtered Profiles (section without diamond grinding)**

This moving average filtering procedure was applied to the inertial profile data from 2014 to 2016. The surveys took place in mid-October, mid-July, and early October for the three years. Surveys also varied from late evening to mid-morning. The resultant plots, an example of which is shown in Figure 6, showed that the upward curl/warp was present nearly throughout the project limits and relatively stable from year-to-year. This stability is also prevalent throughout the project limits regardless of date or time of day.

This stability leads to the conclusion that the upward curvature is primarily due to moisture, rather than temperature, and is therefore primarily warping, rather than curling.

The portion of the westbound outside lane as shown in Figure 6, from km 14.20 to km 14.25, exhibits warping in the range of 3 mm to 7 mm. The shape of warping resembles a parabola centered on each panel with rounding of the parabola edges between panels. A simulation was conducted on a theoretical profile with 4 mm of curl / warp to develop an understanding of the roughness associated with curl / warp. The example profile, and simulated profile with 4 mm of repetitive parabolic curl / warp, rounded at the joints is also shown in Figure 8.

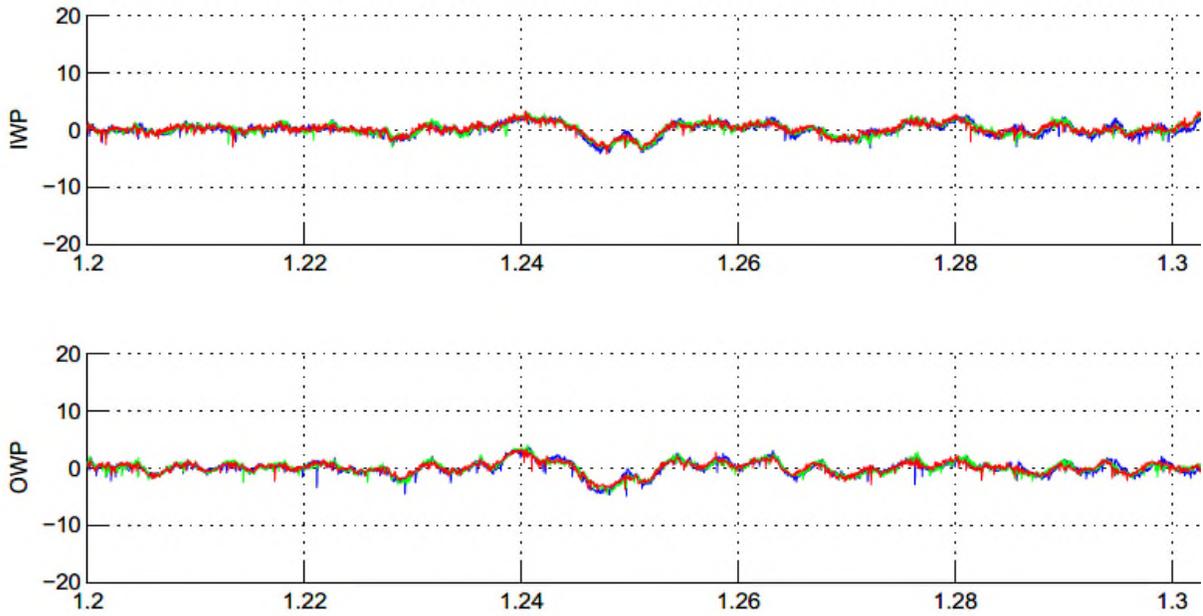
**Figure 7: Example of Multi-Year Filtered Profiles (section with diamond grinding)**

The stability in warping was also evident in sections that had diamond grinding completed in 2013. The diamond grinding was effective in removing the warping and the curvature appeared to be negligible in 2016. An example of longitudinal profile in an area that had diamond grinding in 2013 is shown in Figure 7.

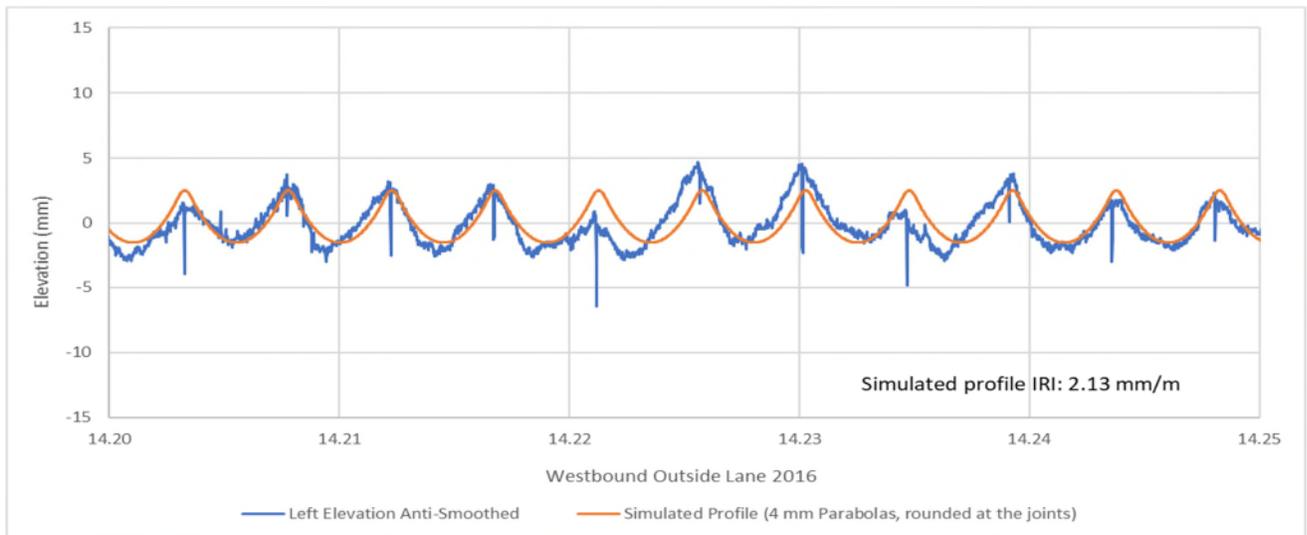
**Figure 8: Example Profile and Simulated Warping**

The level of curling / warping observed in the multi-year analysis from 2014 to 2016 would result in a poor ride, even in the absence of other defects. Therefore, warping was considered to be a primary cause of the poor ride quality offered by the pavement.

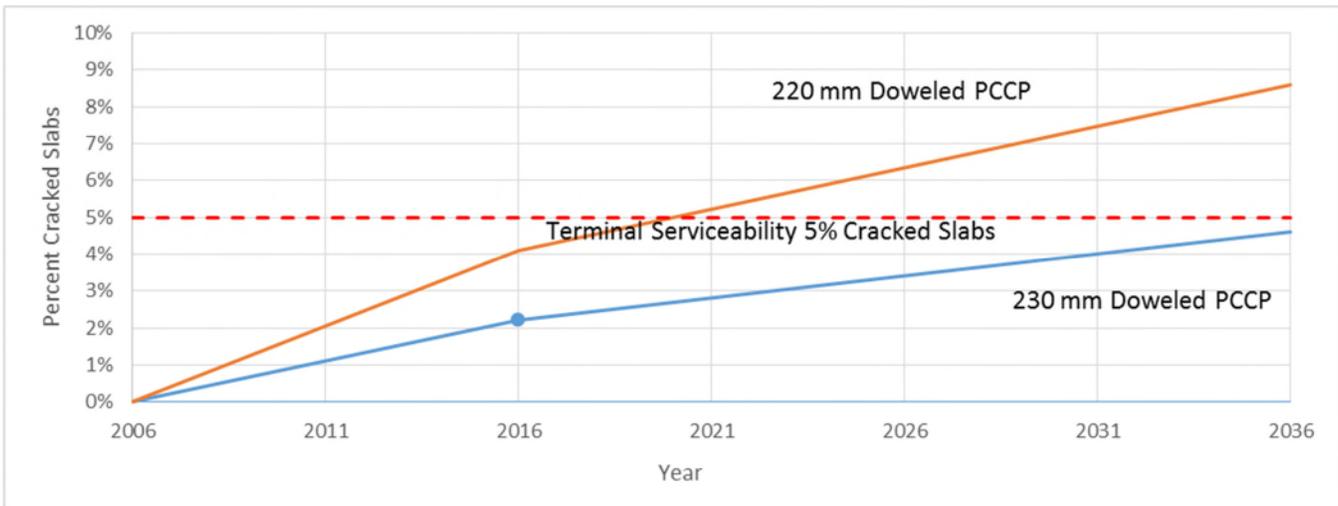
**Figure 9: Calibrated cracking Models Based on 83% Reliability and 4.5 MPa Modulus of Rupture**

To determine the expected service life after grinding, the calibrated cracking model was used with a thickness of 220 mm (following removal of approximately 10 mm of PCC thickness resulting from diamond grinding). The cracking models for both 230 mm and 220 mm thick concrete are shown in Figures 9 and 10.

Without grinding, a 230 mm thick doweled PCCP would be expected to reach terminal serviceability after 2036. Similarly, a pavement with a thickness of 220 mm (for its entire life) would be expected to reach terminal serviceability in 2019, after 28 million ESALs. In the case of Highway 216:06, the concrete thickness would change during the structural service life, an input option not available in StreetPave12. It is hypothesized that grinding would result in gradual transition from the cracked slabs curve for 230 mm thick concrete to the curve for 220 mm thick concrete. This transition is shown in Figure 10.

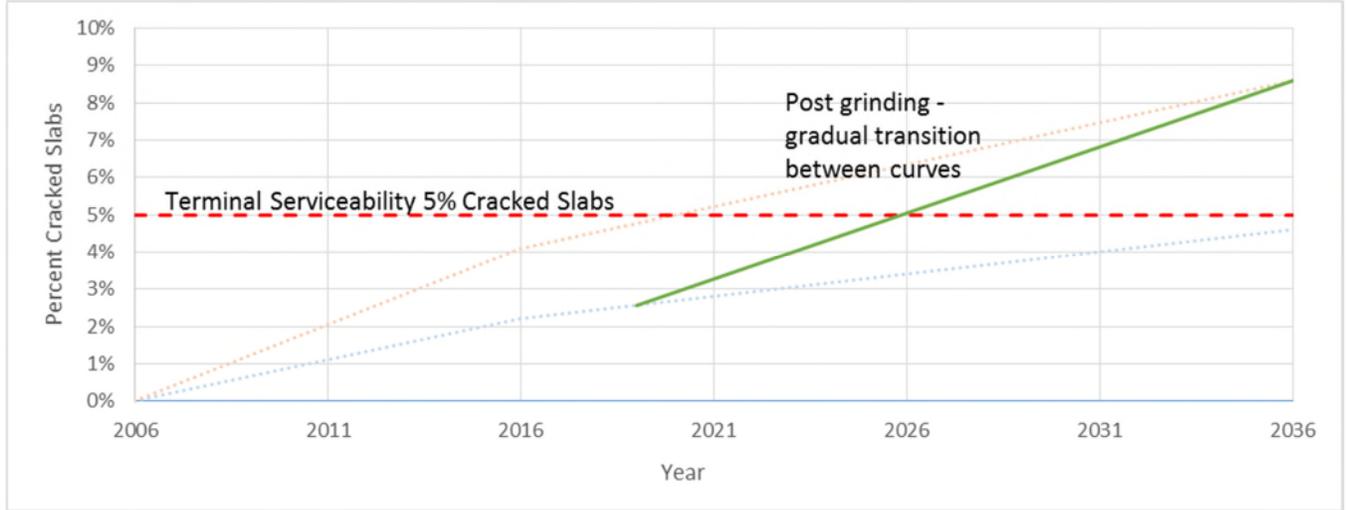
**Figure 10: Hypothesized transition of cracking from 230 mm thick curve to 220 mm thick curve**

Based on the transition from the lower to the higher percentage cracked slabs curve, the PCC would reach terminal serviceability in 2026, after 47 million ESALs. However, any future rehabilitation project with diamond grinding would include the repair of existing cracking; this would reset the cracked slabs to zero. This reset curve, is shown in Figure 11.

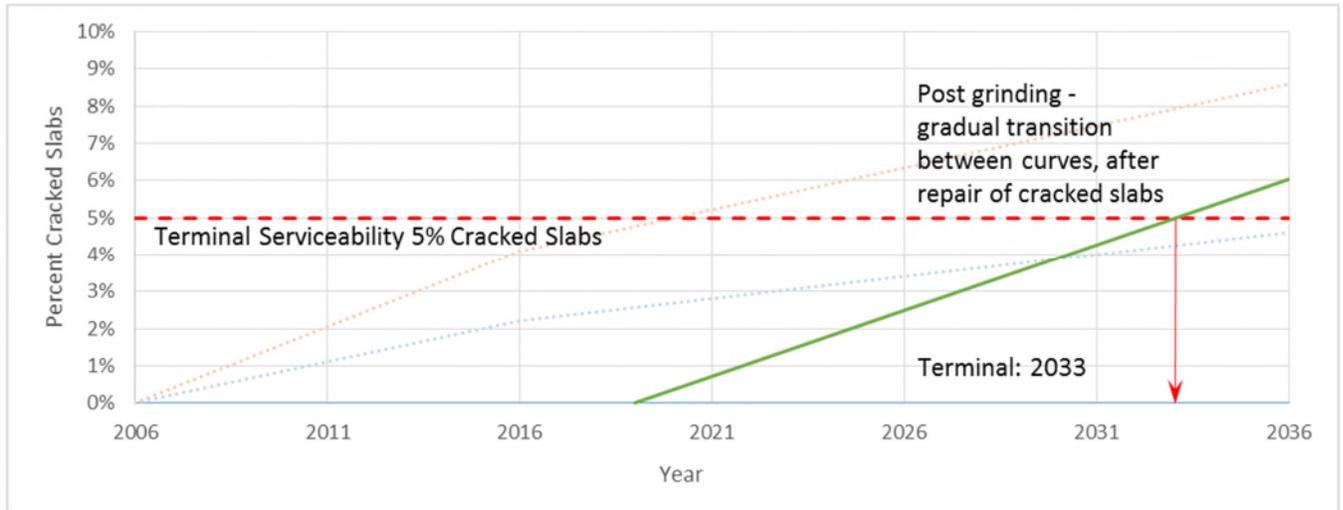
**Figure 11: Post-repair transition of cracking from 230 mm thick curve to 220 mm thick curve**

The cracked slabs of this reset curve will reach terminal serviceability in 2033, after 76 million ESALs. PCC thinner than 220 mm would be expected to have progressively higher risk of cracking and therefore grinding this PCC more than once is not advisable.
