**Field Trial of Spray-Applied Geopolymer Mortar Used to Repair Large Diameter Corrugated Steel
Culverts, New Brunswick Department of Transportation and Infrastructure**

Prepared for presentation at the Transportation Structures Session of the 2022 TAC Conference &
Exhibition, Edmonton, Alberta

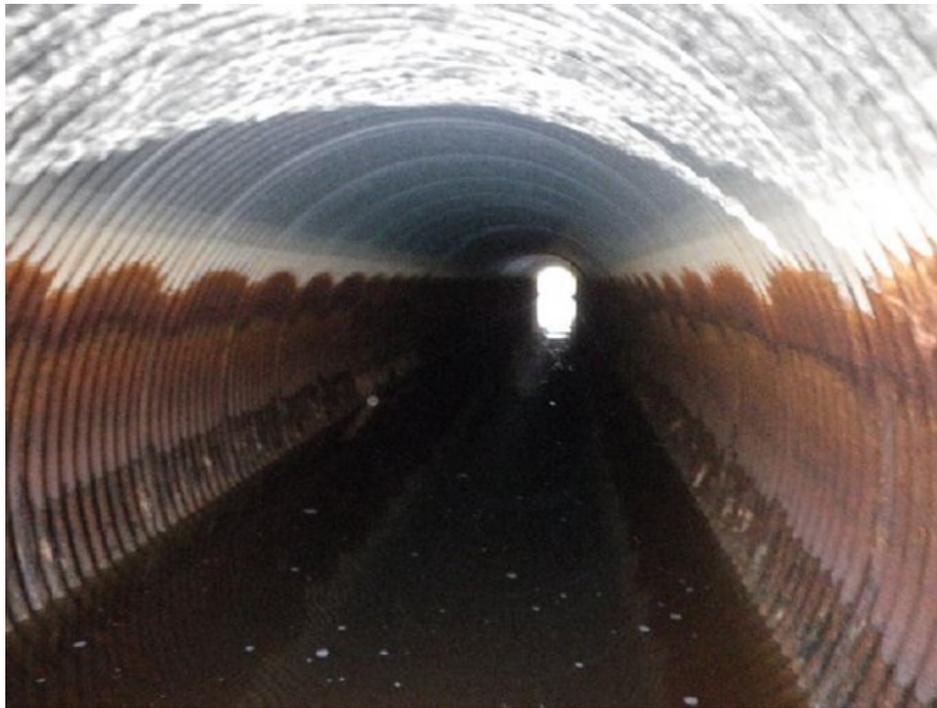
Figure I: Culvert Rehab Candidate, fully backwatered

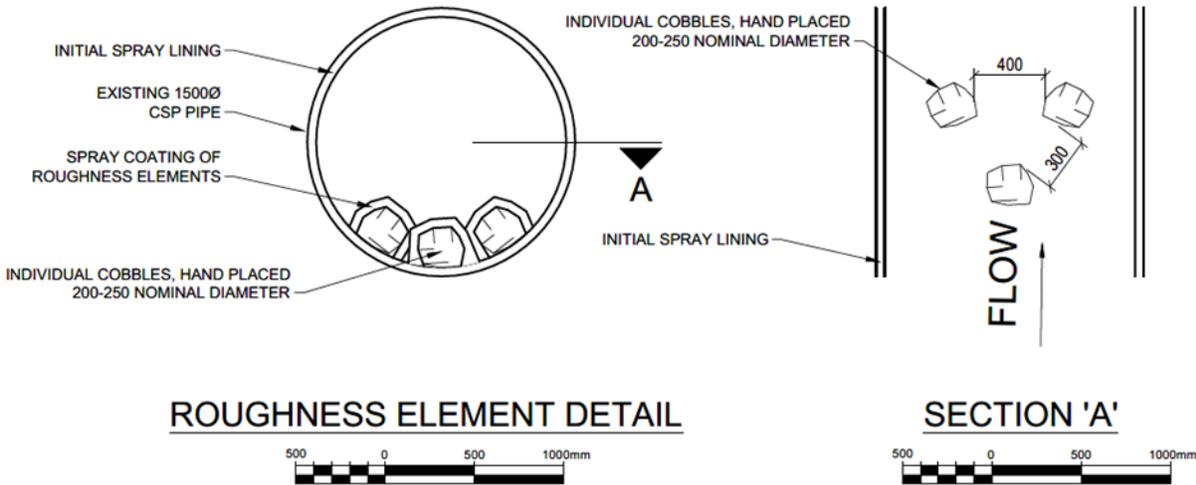
future sites which may have otherwise not been considered. **Figure II** shows the roughness elements design that was eventually agreed-upon with DFO.

Figure II – Roughness Elements Detail at Site DE03

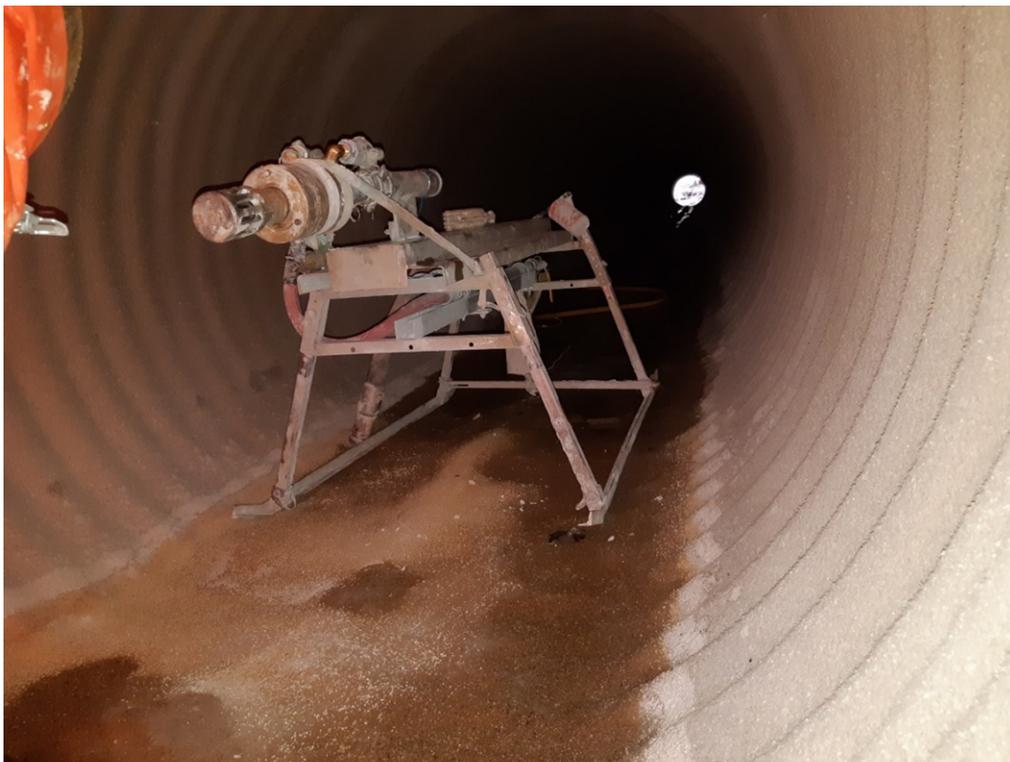
Figure VI – Spin Caster at Site NE12

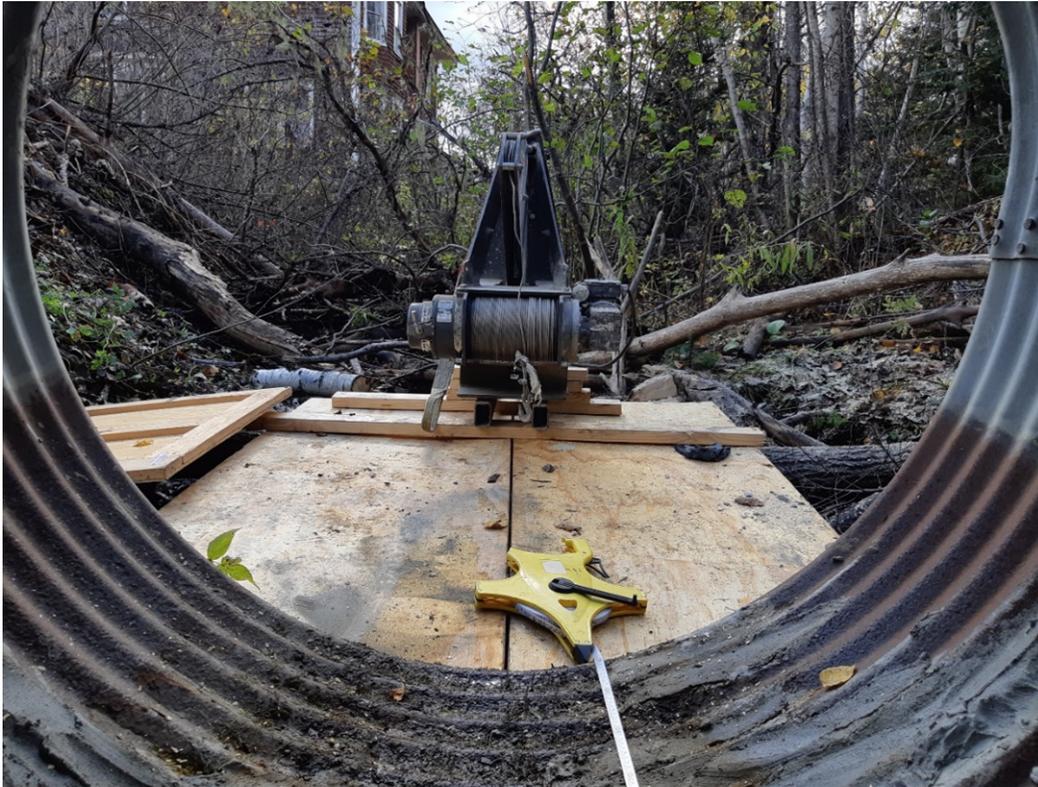
Figure VII – Winch at Site NE12

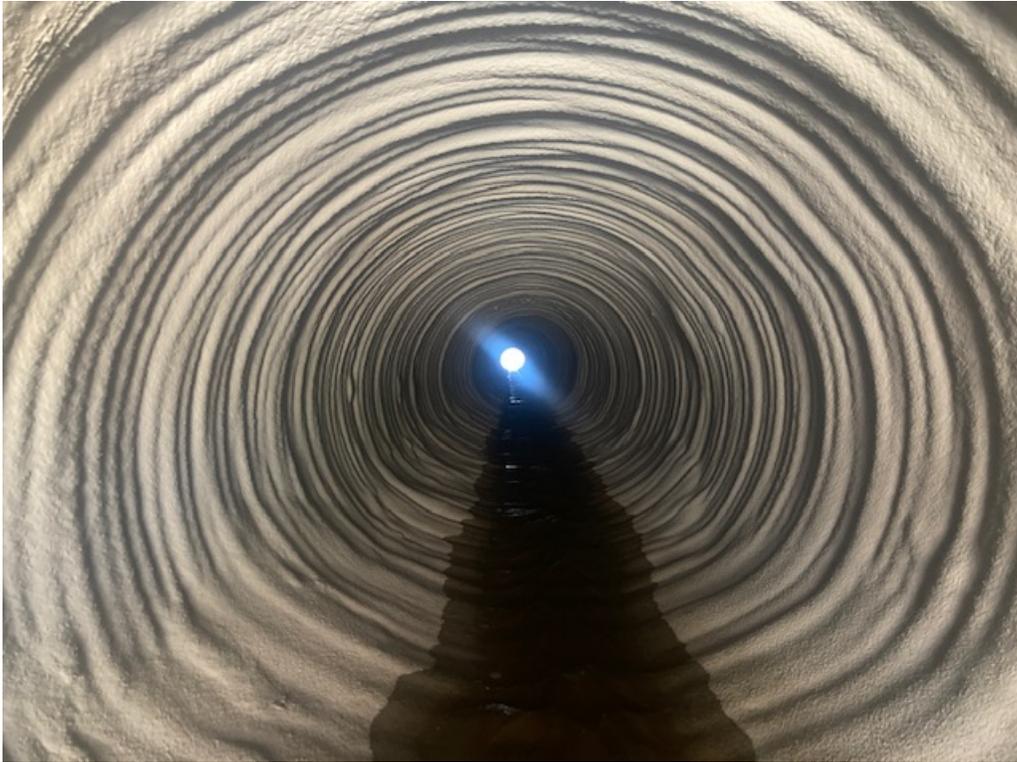
Figure VIII – Photo of Site ND07 After Final Application

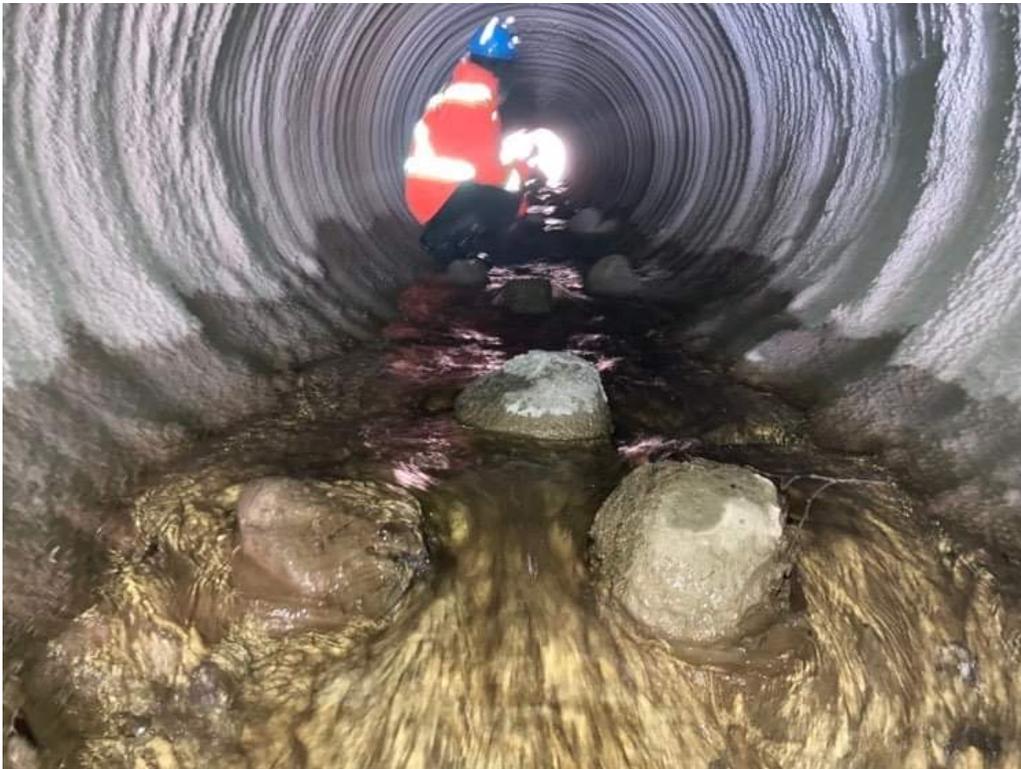
Figure IX – Photo of Site DE03 After Final Application

Later that morning – after stream flow was returned to the culvert - Design Branch staff visited the site. They entered from the inlet end and walked through the entire pipe. When they arrived near the outlet, they observed that the final application had not cured sufficiently prior to being exposed to the stream flow. This was evident by the presence of rippled bedforms near the outlet of the culvert.

It must be verified that the product has cured sufficiently throughout the *entire* culvert prior to redirecting stream flow through the culvert. The contract stated that “The material must be allowed to cure a minimum of 6 hours or until the material has reached a final set condition - whichever is longer - prior to the release of flow through the pipe.”

The Contractor agrees to ensure the entire application is cured prior to redirecting the stream flow through the culvert and that demobilization will not occur until design thicknesses are verified to have been achieved.

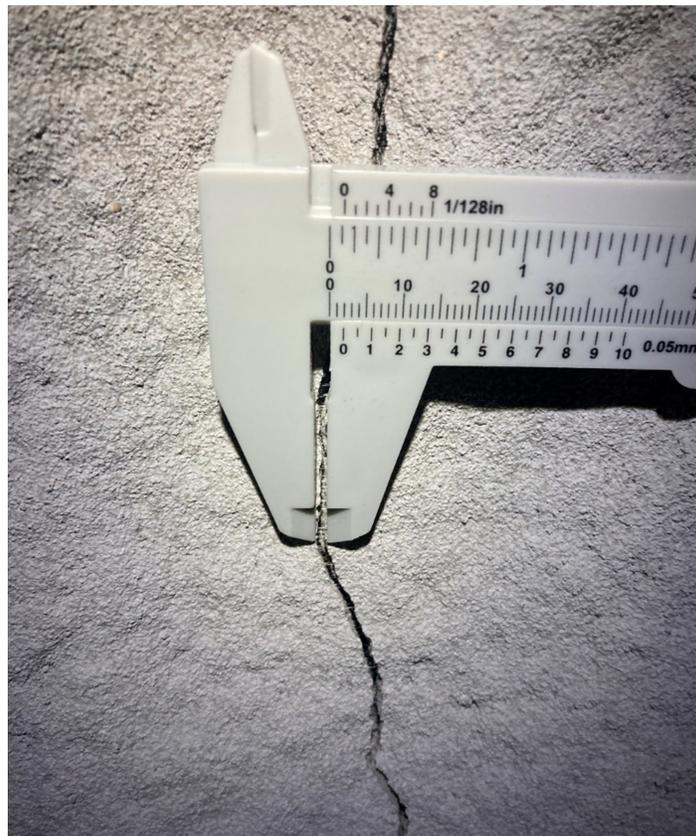
During NBDTI's thickness testing, it was observed that there was repeated circumferential cracking in all culverts. These cracks all had similar characteristics in that they were 2mm or less in width, and that they extended approximately from the 7:30 to the 4:30 clock positions of the culvert (ie. the invert displayed no cracking). **Figure X** below shows one of the widest observed cracks.

Figure X: Circumferential Cracking Observed at Site ND07
