Interesting Solutions for a Culvert Rehabilitation Project in a Sensitive Urban Watershed

Jason Stahl, P. Eng., Project Engineer, Amec Foster Wheeler

Paper and Presentation for the Emerging Environmental Technologies Session

of the 2017 Conference of the  
Transportation Association of Canada  
St John's, Newfoundland

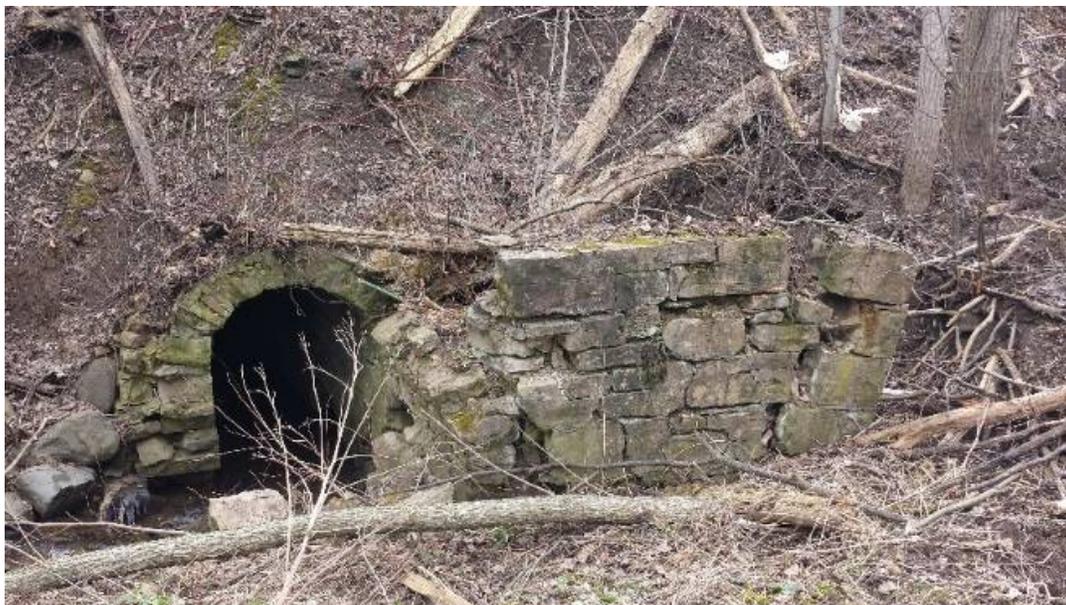
The existing culvert consists of a 14m +/- deep structure with three distinct segments. The first segment (length = 20m) consisted of a 75 year +/- old masonry structure which crosses under an old road platform just north of Bovaird Drive (known as old Highway 7). The second segment (length = 20m) consisted of a cast-in-place concrete box culvert. Finally, the third segment (length = 60m) is a larger cast-in-place concrete box culvert. Both the first and second segments were found to be structurally deficient and required removal and replacement. In addition, a 2m drop within the culvert between the segments was impeding fish passage.

*Figure 3 - Culvert inlet pre-construction*

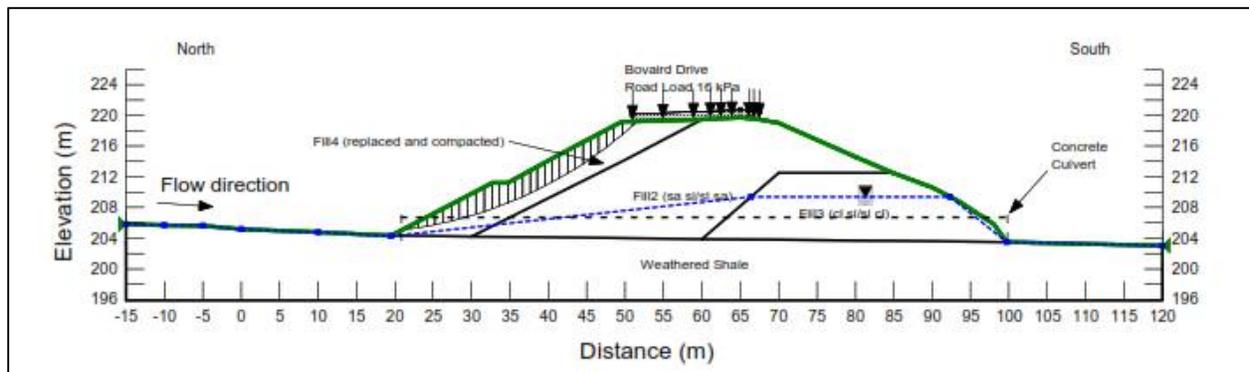
The removal of the culvert was proposed to be completed by open-cut excavation, along with the removal of the old Highway 7 embankment. Slope stability calculations using GeoStudio SLOPE/W (Version 7.17) were completed to analyze and determine the factors of safety considering deep-seated slip surfaces. Based on in-situ soil conditions, a channel cut through the existing embankment within the length of the existing culvert to be removed would be stable at slopes of 2:1.

Figure 4 - Output from slope stability analysis

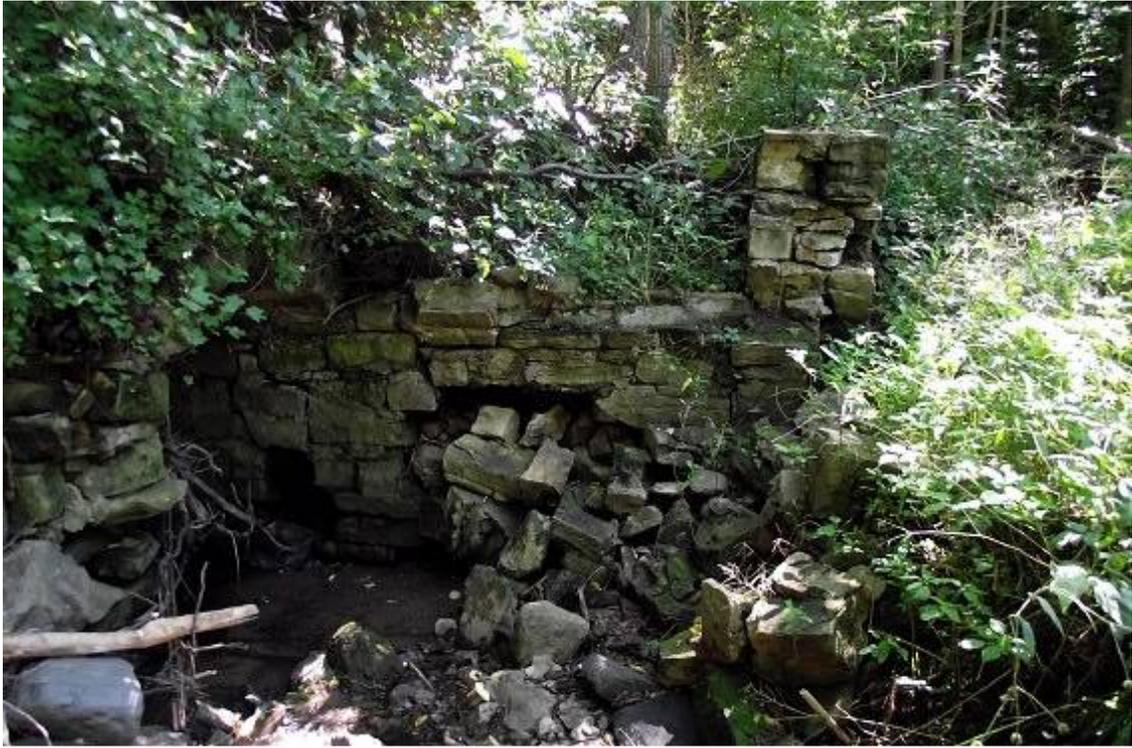
- i) The north return wall and northwest retaining wall were found to be in poor condition (see Figure 5);
- ii) Loose stones at the northeast end of the culvert wall were observed, but no loss had occurred;
- iii) The surrounding conditions included the collapse of the north embankment slope protection and the erosion of the fill on top, and
- iv) Stones within the culvert barrel were not held together by mortar, and some stones at the base of the barrel had either shifted or were missing (see Figure 6).

*Figure 5 – North return wall and northwest retaining wall*

Based on the review of the various criteria considered, Alternative 4, 'Remove a portion of the existing culvert and partially replace with a cast-in-place structure with the same cross-section as the remaining portion of the culvert' was selected as the preferred alternative. The alternative was found to balance both the need to complete the repairs to the existing culvert with the need to minimize impacts to the natural environment. In addition, this alternative would provide the opportunity to improve hydraulics, fluvial geomorphology, and fish passage.

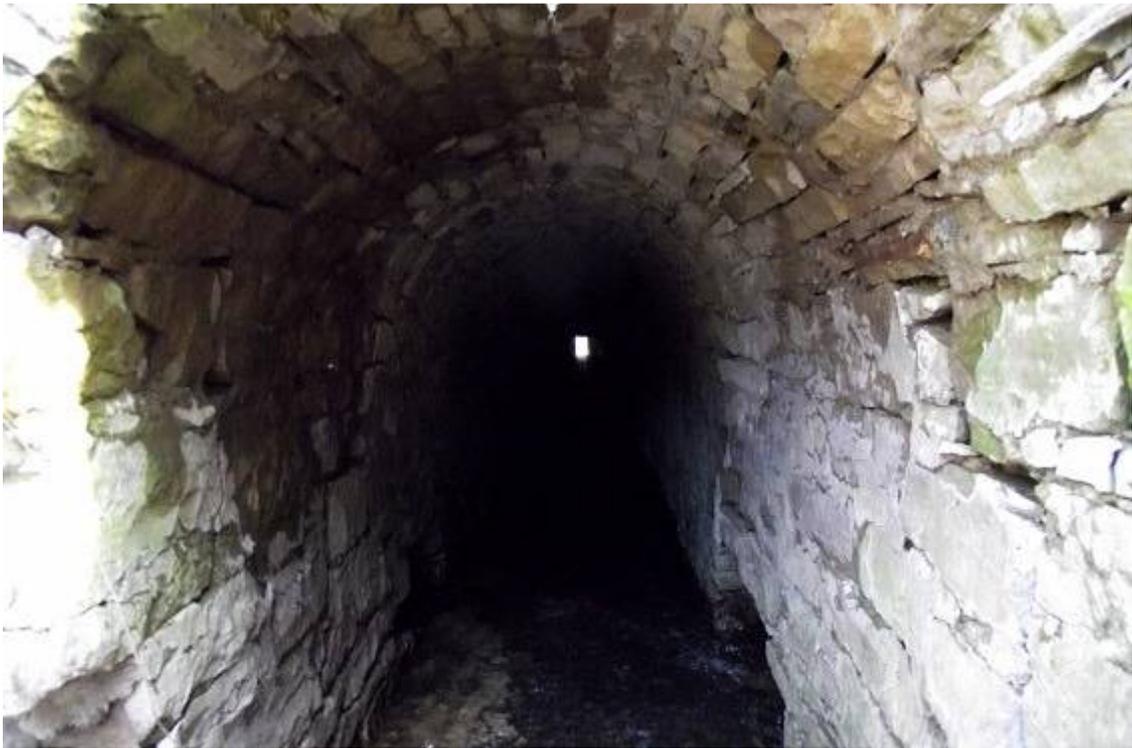
*Figure 6 - Culvert Barrel*

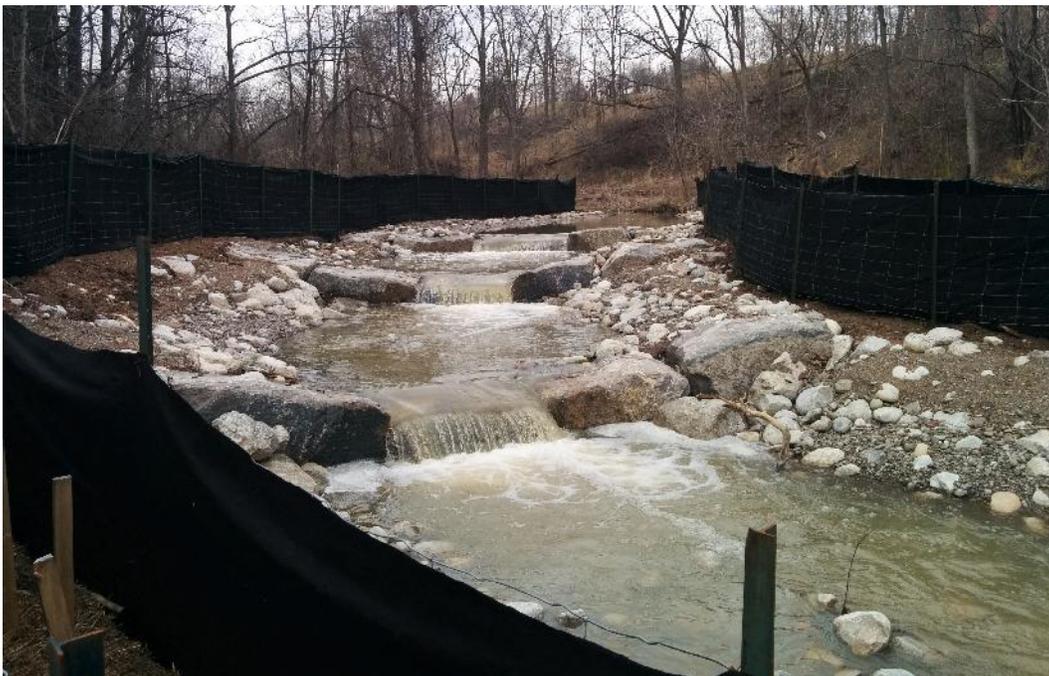
*Figure 7 – Completed pool-step transition*

As previously noted, the work identified to remediate the existing culvert created a 4m difference between the existing tributary and the new culvert invert. To address this issue, a pool-step transition was designed and constructed which allowed the upstream channel to connect to the new culvert in the shortest distance possible. By minimizing the distance, the team reduced the construction footprint, thus minimizing environmental impacts to the surrounding valley. In addition, the reduced footprint allowed the limits of the erosion and sediment controls during construction to be minimized.

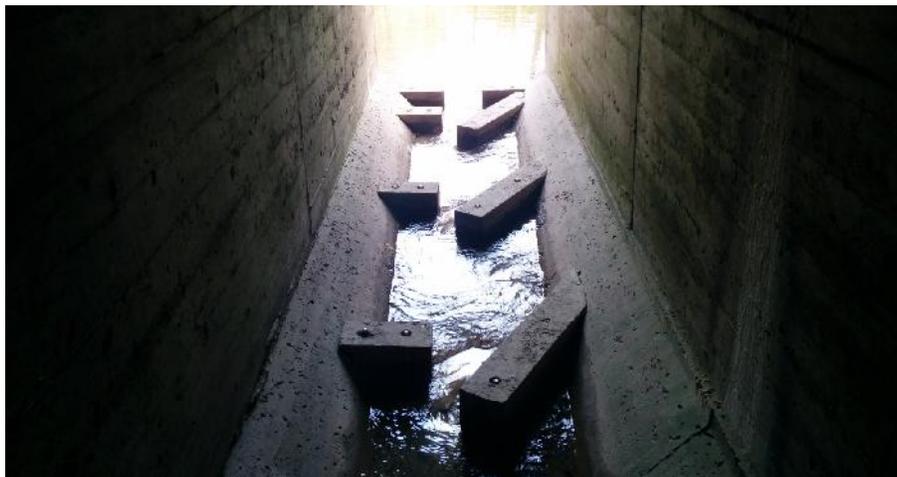
Figure 9 - Fish baffles after installation

Secondly, the downstream watercourse provided habitat for many fish species. There were no species-at-risk identified, however, CVC and MNRF expressed a need to improve fish passage through the culvert and into the upstream reaches. As noted above, most of the fish present downstream were large-bodied fish. The design team, in consultation with MNRF concluded that fish movement upstream would be improved by constructing fish baffles within the existing culvert. The fish baffles, constructed out of marine grade timber, would provide 'rest points' at regular intervals (see Figure 8). In addition, the pool - channel transition upstream of the culvert was designed to accommodate fish passage by constructing pools with a depth equivalent to or greater than the height of the step. This has been found to allow the fish to develop sufficient momentum in the pool to clear the step. During low flow periods, the pool depth and equivalent step was designed to be 0.4m +/- . During more significant flow periods, the pool depth increases and the step height decreases, improving the ability for fish movement to be successful.

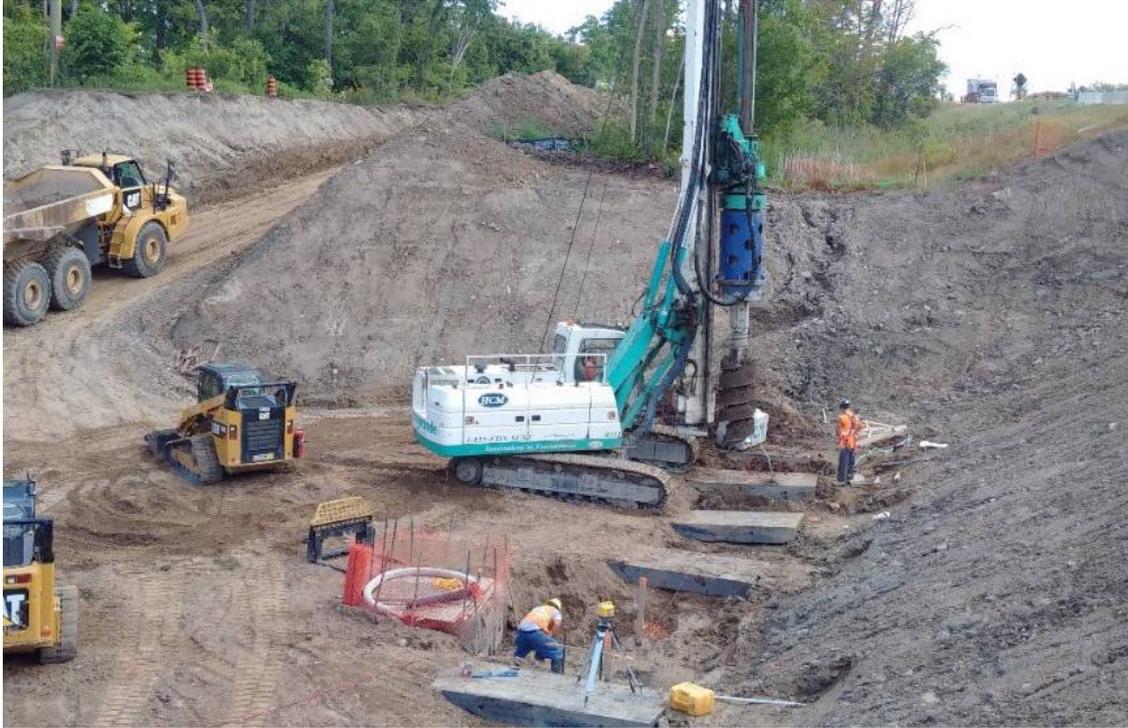
*Figure 10 – Construction of roadway shoring with access to valley completed*

Excavation of over 20,000 m<sup>3</sup> of earth was completed to expose the deficient portion of the existing culvert. Access to the culvert and creek reconstruction area was challenging given the 14m +/- deep valley system that the culvert was contained within. To access the valley floor with the necessary equipment, an access with an approximate 20% slope was constructed. Articulating dump trucks and track equipped excavators were used to haul the excavated material up the access to a nearby stockpile. Once the culvert was in place, the required fill material was hauled from the stockpile, placed and compacted. Some surplus material was reused on site for construction of small landscaping berms, with the remainder of the material hauled off-site.

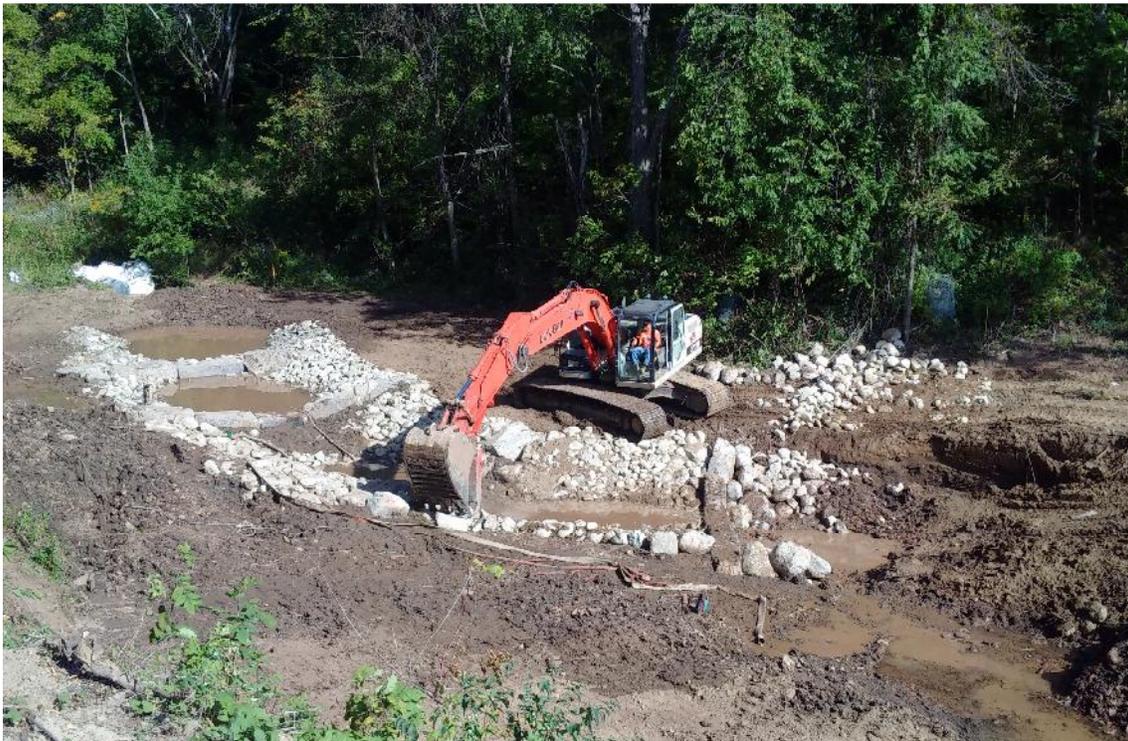
*Figure 11 - Construction of pool-step transition*
