Challenge of Permafrost Degradation Impact on Airport and Road Pavements

Ludomir Uzarowski, Ph.D., P.Eng., Golder Associates Ltd.

Paper prepared for presentation
at the Innovation in Geotechnical and Materials Engineering Session

Of the 2018 Conference of the
Transportation Association of Canada
Saskatoon, SK

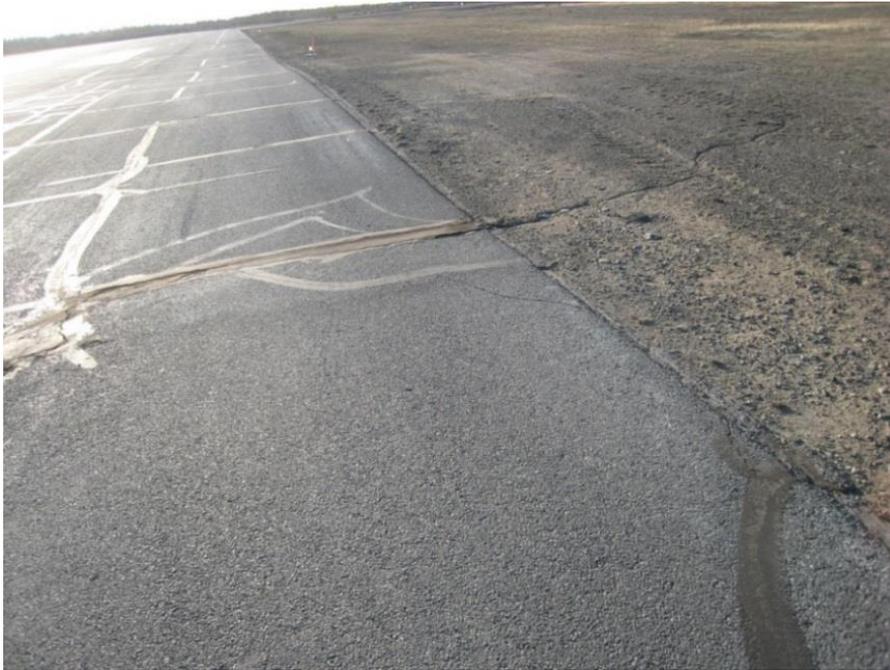
Figure 1 shows an example of high severity settlement that was observed on a runway pavement at Yellowknife Airport. Also, shown in Figure 1 is the cracking that may be observed in the granular shoulders. This type of cracking is typically observed in areas with ice rich soils due to degrading permafrost layers. Figure 2 shows an example of high severity cracking that can typically be observed in pavements that were constructed on permafrost layers that have since degraded or are degrading. Figure 3 shows a large area of ponding water that was observed on the runway pavement at Yellowknife Airport, and Figure 4 shows a large area of ponding water and severe depression that was observed on the apron pavement at Thompson Airport. Figure 5 shown severe tilting of one of maintenance building at the same airport due to permafrost degradation.

Figure 1. Severe settlements in the non-keel zone of runway pavement at Yellowknife Airport and cracking in granular shoulder.

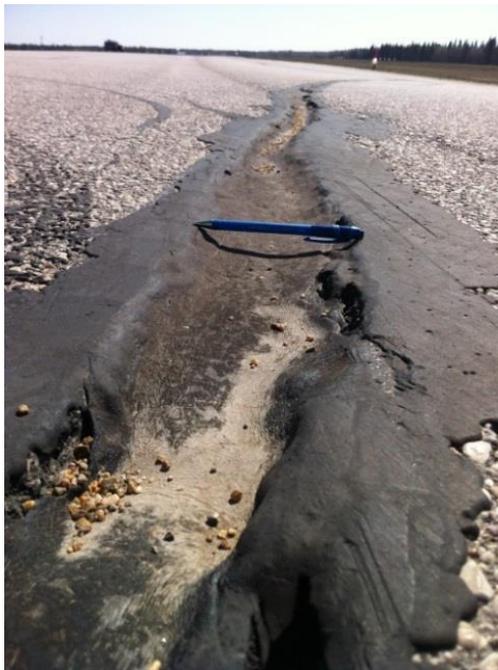
Figure 2. Severe transverse crack on runway at Hay River Airport.

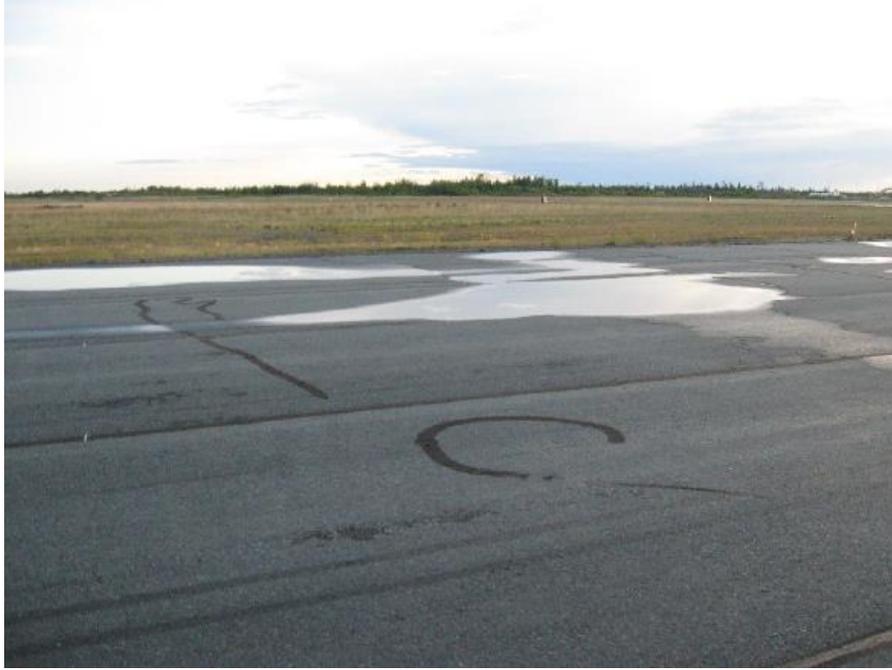
Figure 3. Water ponding in a deep depression on runway pavement at Yellowknife Airport.

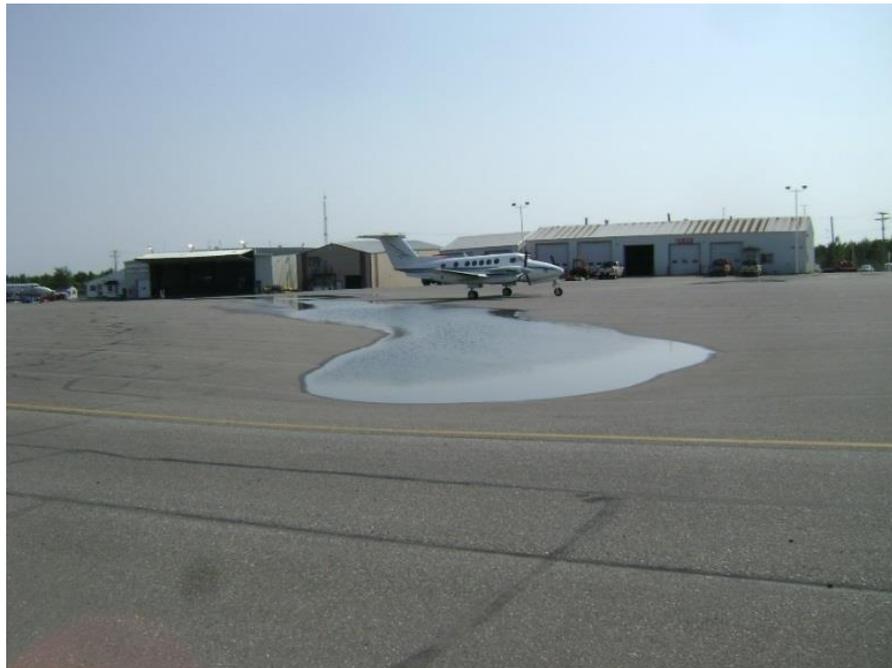
Figure 4. Water ponding in a deep depression on apron pavement at Thompson Airport.

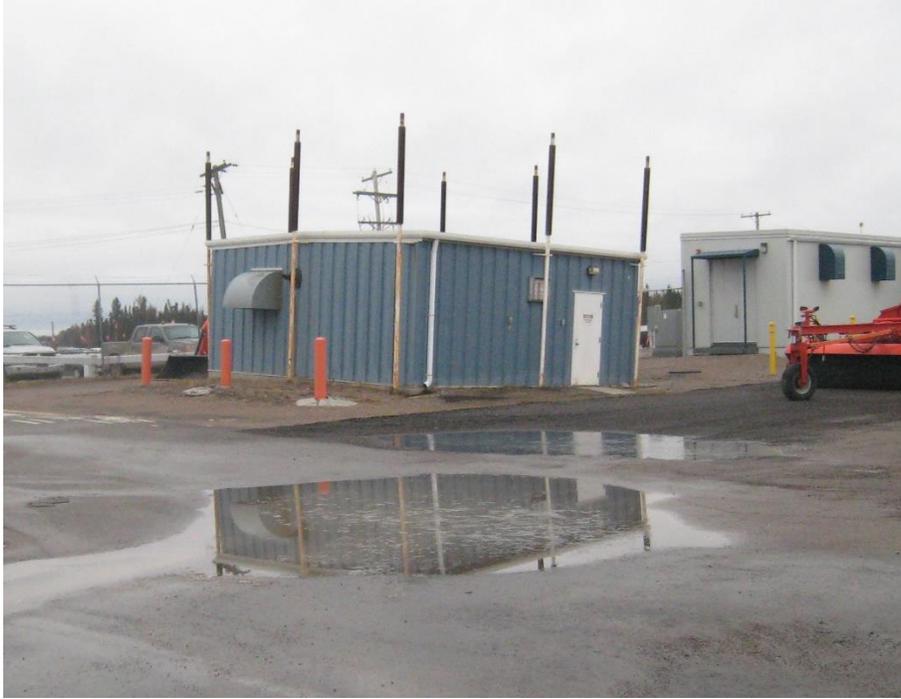
Figure 5. Severe tilting of a maintenance building due to permafrost degradation.

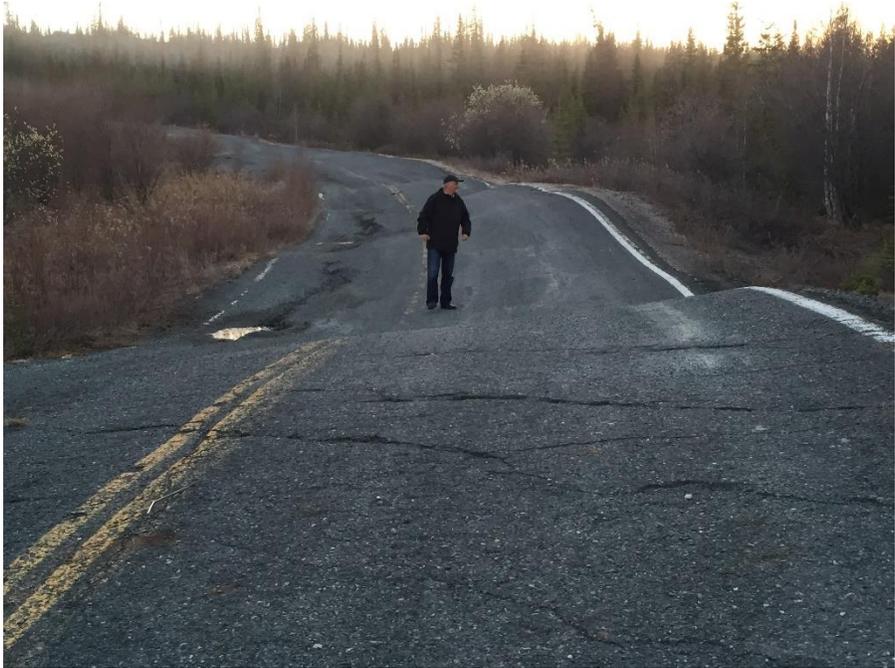
The examples above are for airport pavements; however, similar issues are observed on road pavements in these areas as well. Figure 6 shows an example of a road pavement in the Yellowknife area, exhibiting extreme deformations due to permafrost degradation. The section has shown in the photograph been closed and a new road section had to be constructed.

Figure 6. High severity pavement deformations on a road in the Yellowknife Area.

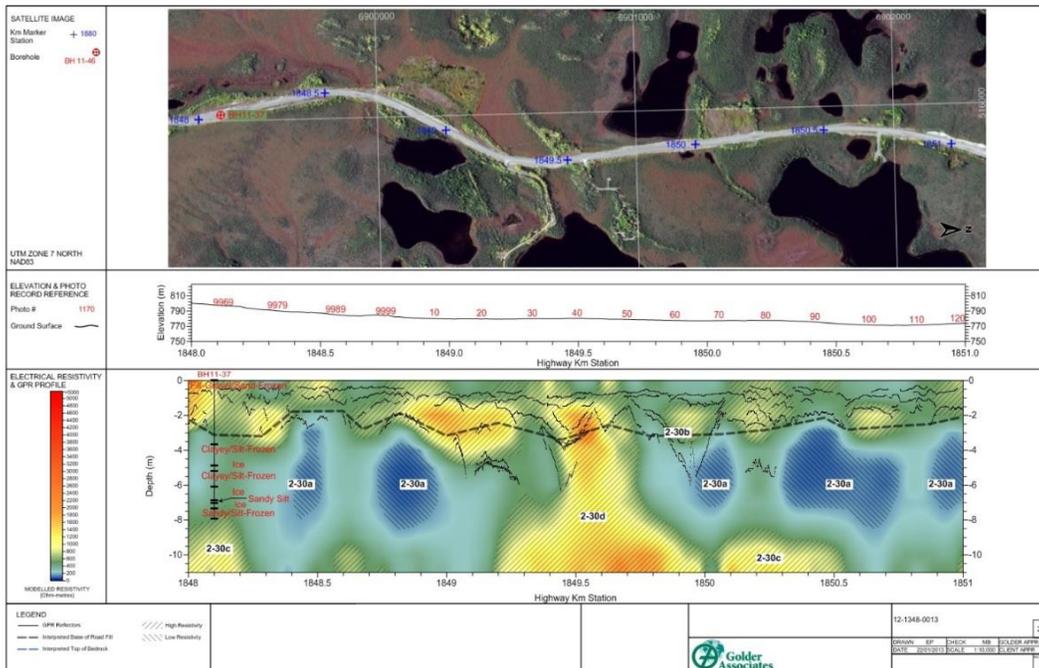
Figure 7 below presents an example of C-CERI data collected along a highway in a region of discontinuous permafrost during winter in northern Canada. The cross-section presents a colour contour map of resistivity in terms of lateral distance and depth, where cool colours represent lower resistivity and warm colours represent higher resistivity. The upper 3 m of the subsurface consists of higher resistivity seasonally frozen road fill materials. Between 3 to 8 meters below ground surface, there are zones of lower and higher resistivity observed. The higher resistivity zones are attributed to increased ice content (permafrost) while the lower resistivity zones are attributed to increased water content (melted permafrost).

Figure 7. Example of Interpreted C-CERI Resistivity Survey Data to Delineate Permafrost

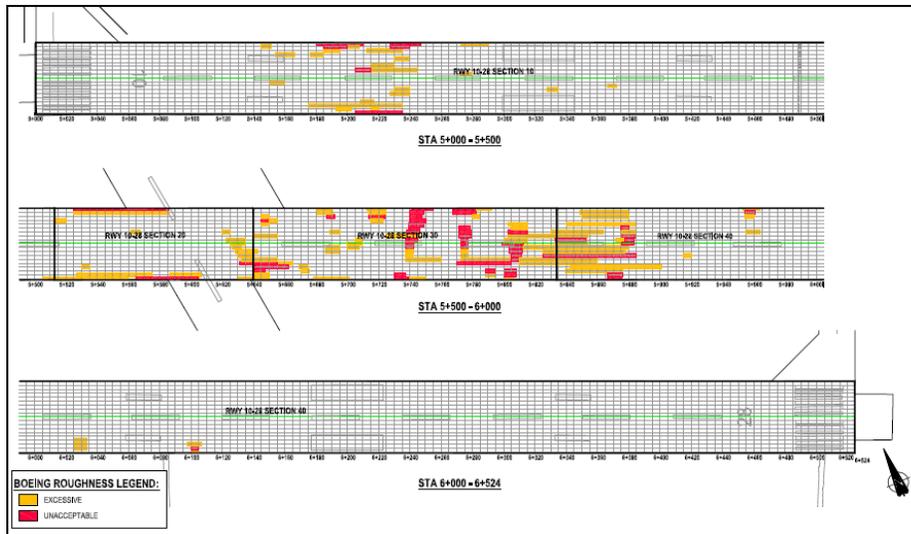
Case 1 – Yellowknife Airport. The surveyed pavement roughness is shown in Figure 9. The analysis indicated two locations on Runway 10-28 where the survey roughness was in the excessive and unacceptable zones. The thermistor measurements clearly indicated that the permafrost is either melting or melted. Examples of the readings are shown in Figures 10 and 11. It was recommended to carry out an emergency repair be carried out at both locations and a pavement rehabilitation be carried out in the near future. This should include pavement subsurface drainage system installation.

Figure 9. Roughness analysis results on Runway 10-28.

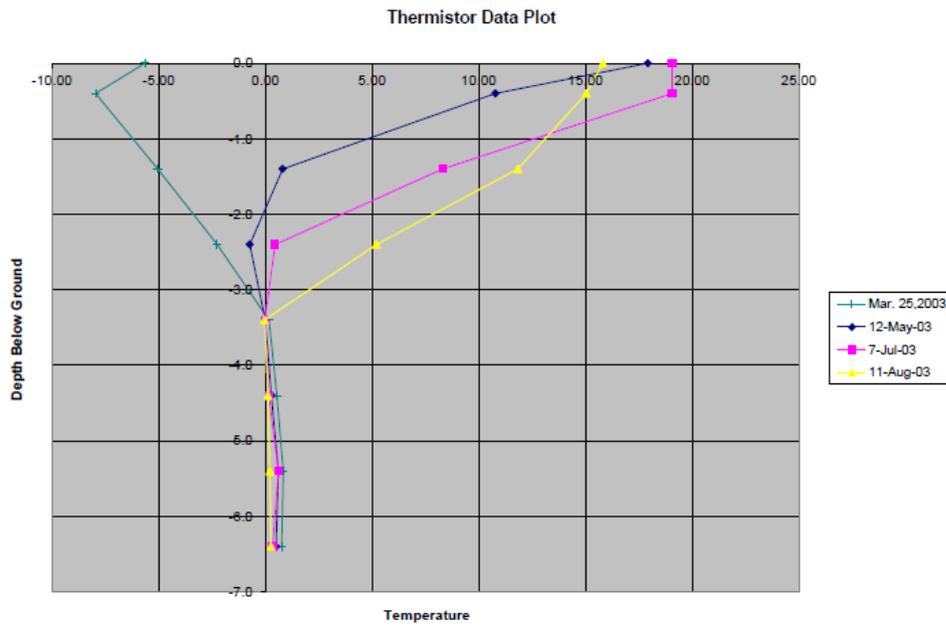
Figure 10. Example of thermistor readings on Runway 10-28.

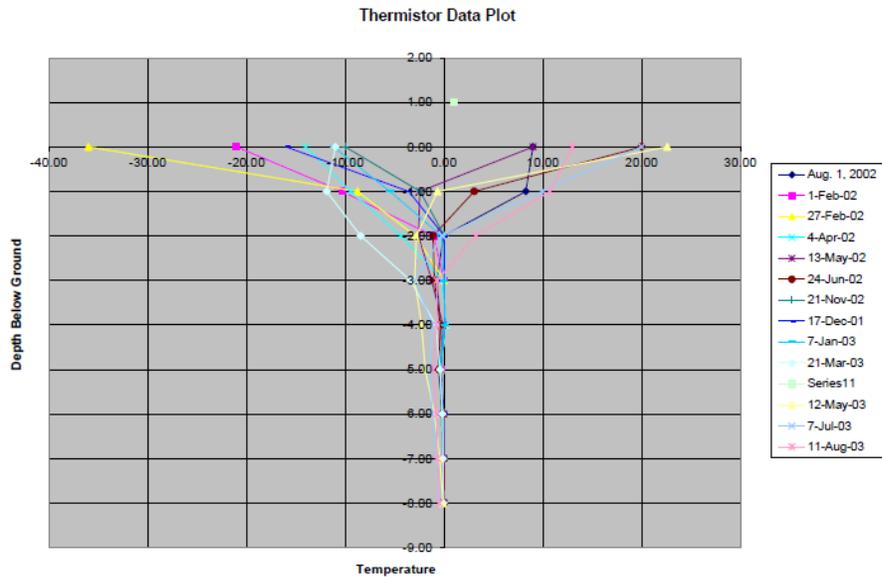
Figure 11. Example of thermistor readings on Runway 10-28.
