## Corrosion Evaluation of Bonded Post Tensioning

Paper prepared for the session Transportation Structures  
2025 Transportation Association of Canada (TAC) Conference & Exhibition  
Québec City, Québec

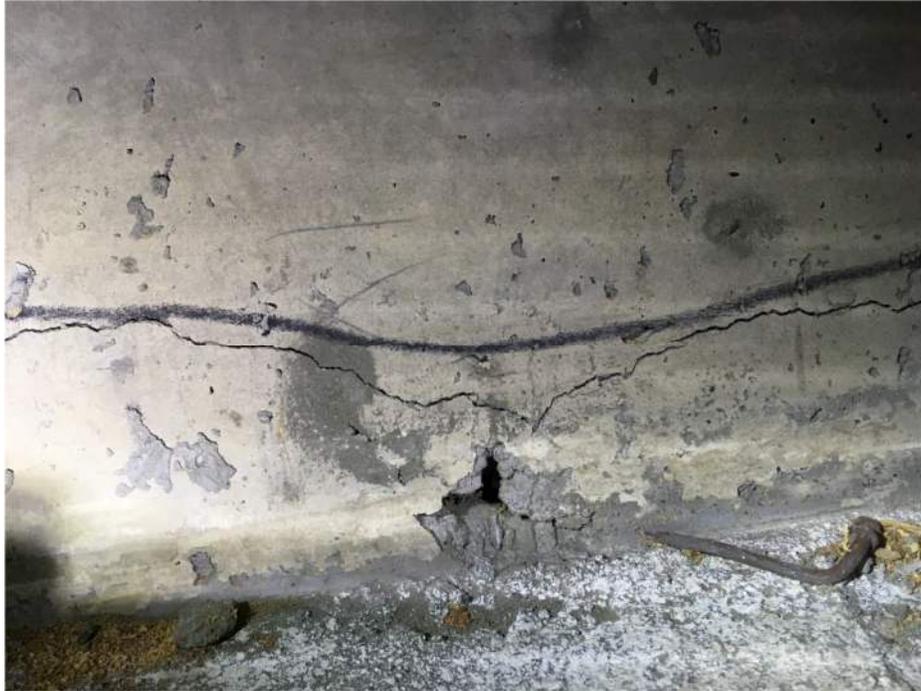
In the pedestrian bridge, voids and soft grout were identified in 1 tendon. No soft grout was identified in the vehicular bridges, but voids exposing the strands were found in both bridges with the largest void measuring 14.5 m. Overall, grouting defects were identified in 14% of the 1,319 m tested tendon length. Despite the presence of the voids, strands were generally in good condition with corrosion ranging from surface to moderate corrosion (Figure 13).

Figure 11. Cracking Following the PT Tendon Profile above a Void, Minnesota Bridges

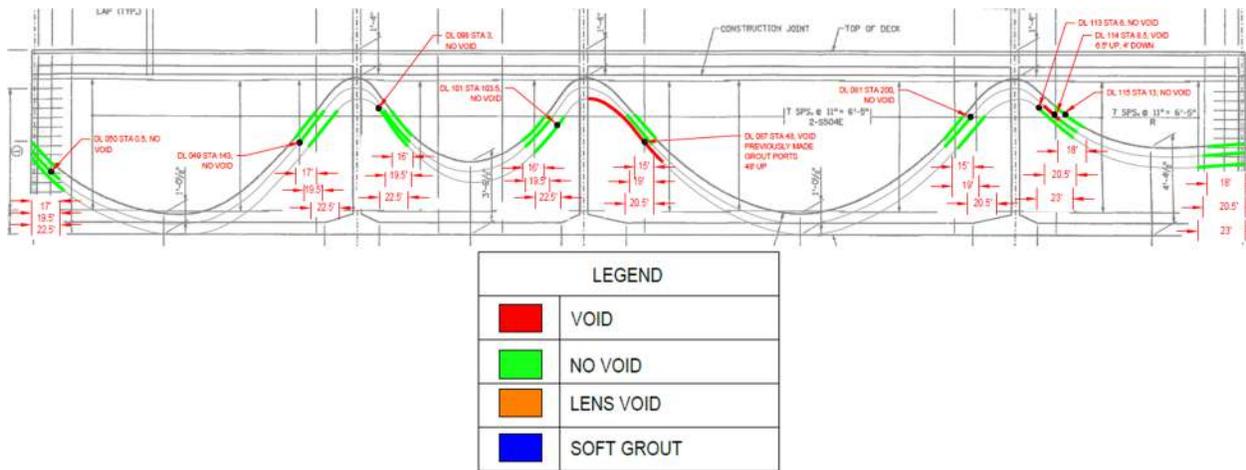
Figure 12. Typical IE/PV Testing Results, Vehicular Bridge in Minnesota

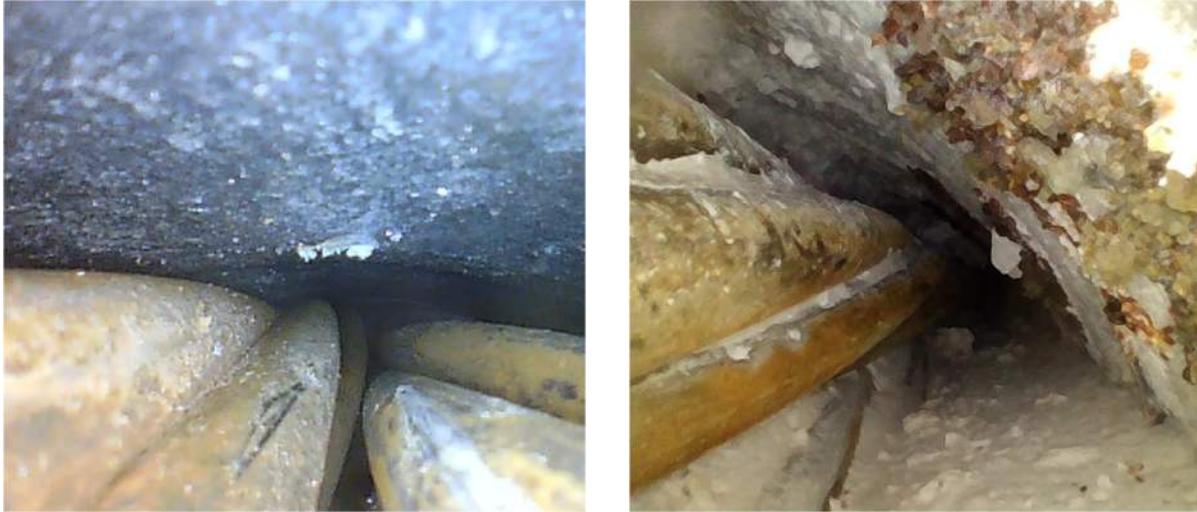
Figure 13. Typical Borescope Photos from the Minnesota Bridges

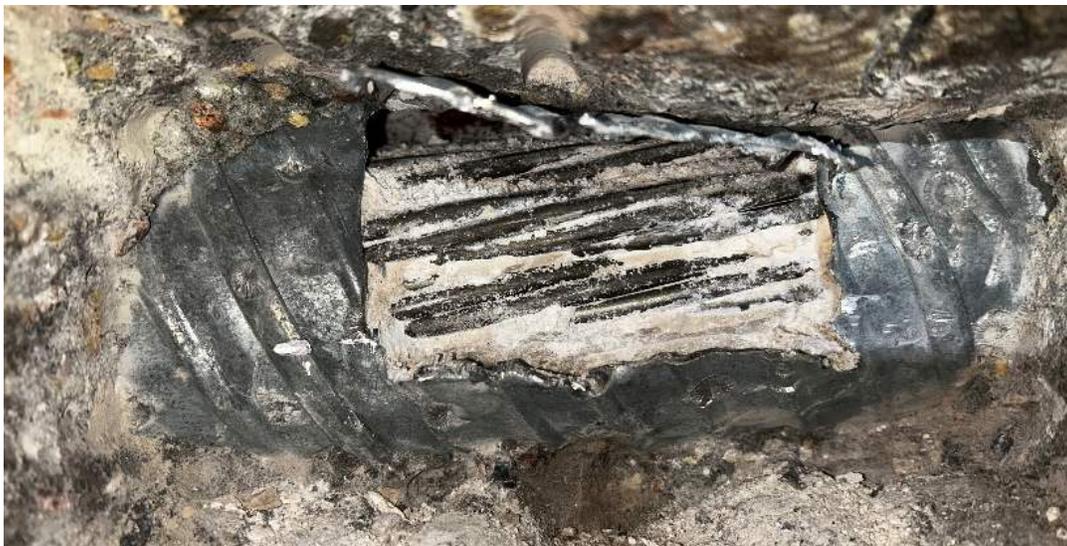
Large window openings were made for grout sampling (Figure 14). A value of 0.2% chloride by mass of cement is typically used as the corrosion initiation threshold for grout. This is based on a grout comprised of only portland cement and a water/cement ratio of 0.5. Chloride concentration testing performed in accordance with ASTM C1152<sup>2</sup> showed that chloride concentration in all the grout samples was well below the threshold and even below the 0.08% by mass of cement, which is the ACI 222<sup>4</sup> limit for prestressed (pretensioned or post-tensioned) construction.

Figure 14. Typical Window opening for Grout Sampling, Minnesota Bridges

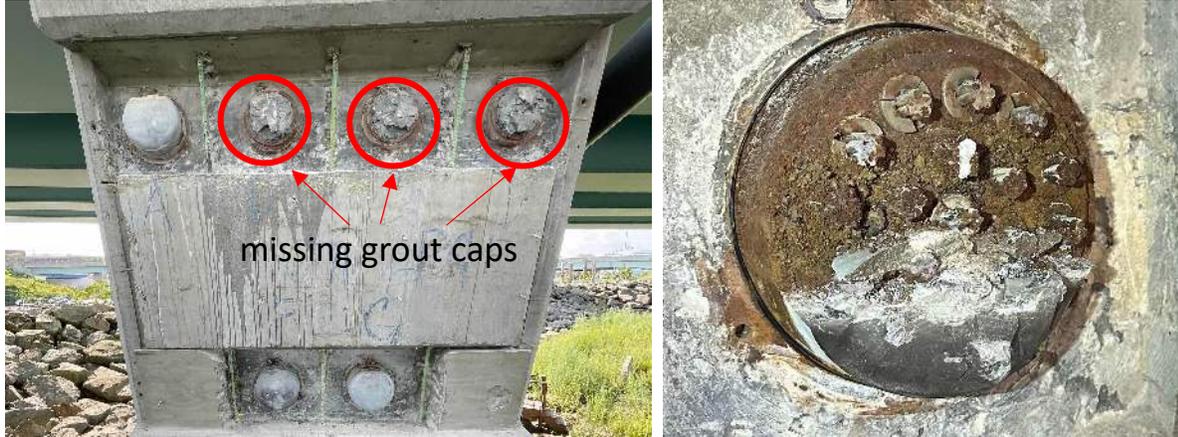
Missing grout caps and voids inside grout caps were observed on several tendons (Figure 15). At voided locations, corrosion of the anchor plates and strand tails was observed. Although majority of the grout ports were full, borescope inspection showed that 6% of all the ports had lens voids that did not expose the strands, while 13% were voids that exposed the strands putting them at risk for corrosion. Figure 16 shows borescope images from some of the voided tendons showing corrosion of the strands. Moisture testing results showed that all the tendons were either in the “dry/wet” or “wet” classification, which puts them at a moderate and high risk for corrosion, respectively (Figure 17). Grout chloride concentration testing showed that only 1 sample was above the corrosion initiation threshold. An exposed grout port that was not enclosed by the pour back was observed at that location, most like allowing chloride-contaminated water leaking from the deck to enter the tendon (Figure 18).

Figure 15. Missing Grout Caps and Voids inside Grout Caps

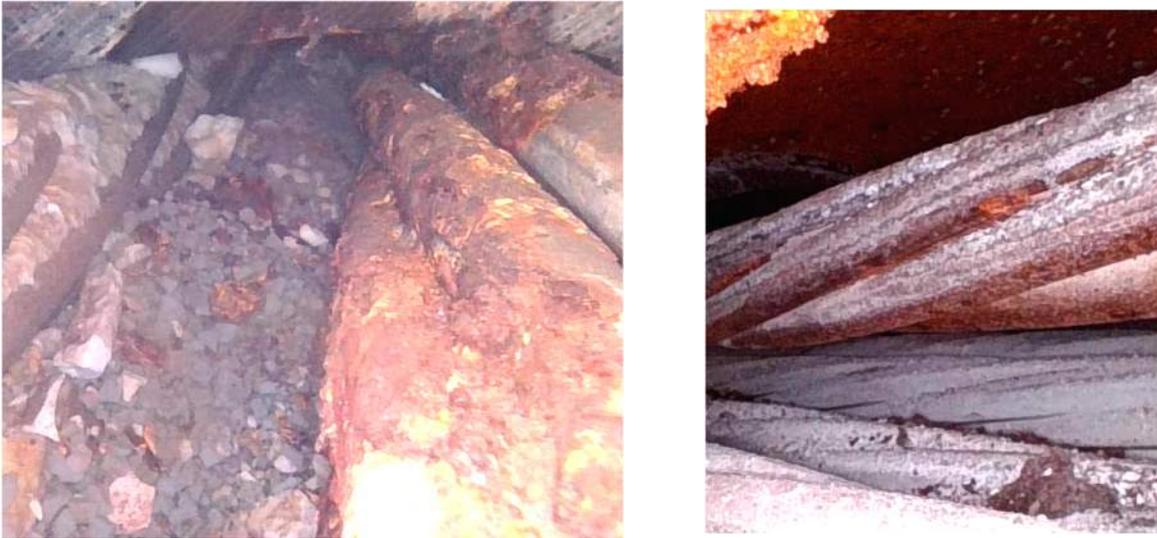
Figure 16. Borescope Images of Voided Tendons in the Pier Caps

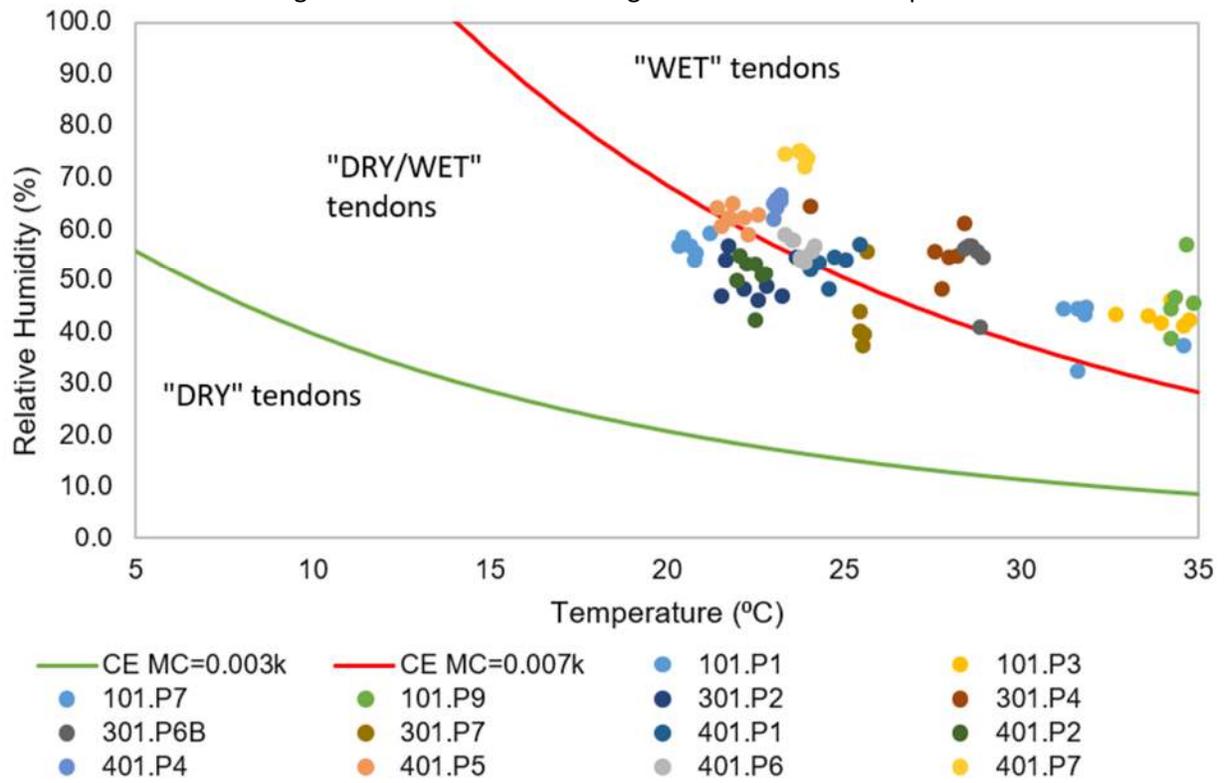
Figure 17. PT Moisture Testing Results for the Pier Caps

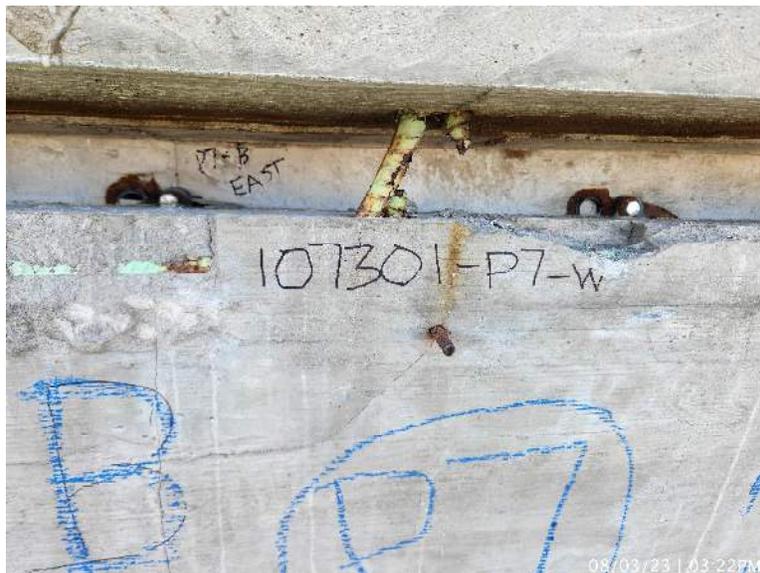
Figure 18. Exposed Grout Port in One of the Pier Caps

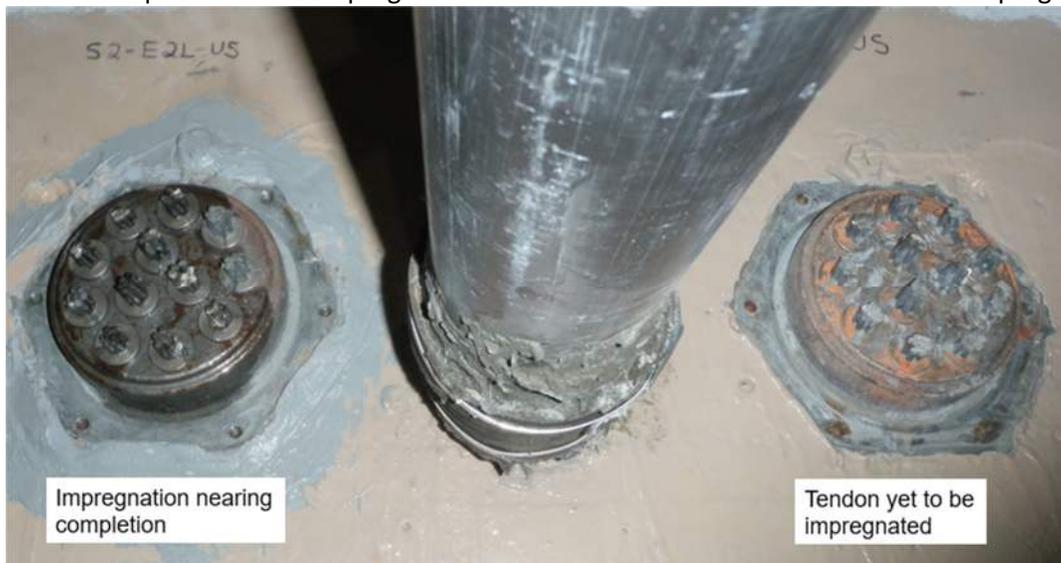
Figure 22. Comparison of the Impregnated Tendon vs the Tendon that Has not Been Impregnated

The PT impregnation with a corrosion inhibitor is a rehabilitation method that is highly effective at mitigating the corrosion of PT tendons. Defects in PT tendons due to soft grout or voids can result in severe corrosion damage to the strands. The impregnation process coats the steel reinforcement and impregnates the surrounding grout thus protecting the strands from corrosion. The corrosion inhibitor used in the impregnation process is a specially developed low-viscosity material that travels along the interstitial spaces between the wires in a tendon and coats the steel strands (Figure 19). Due to the difficulty in accessing the full length of a PT tendon, the corrosion inhibitor can be applied either from the anchorage or from any point along the tendon length (Figure 20 and Figure 21). Very little pressure is required to push the corrosion inhibitor through the tendon since its primary transportation mechanism is the capillary effect along the strand. Occasionally vacuum is used to assist or control movement of the corrosion inhibitor. This method can be implemented on individual tendons or simultaneously on multiple tendons as necessary. The material creates a film on the strand's surface, protecting the steel from moisture and deleterious ions thus protecting the strands from corrosion activity (Figure 22).
