Gardiner Expressway Strategic Sustainable Substructure Rehabilitation Using Galvanic Protection

Paper prepared for the Structural Session
2025 Transportation Association of Canada (TAC) Conference & Exhibition
Québec City, Québec

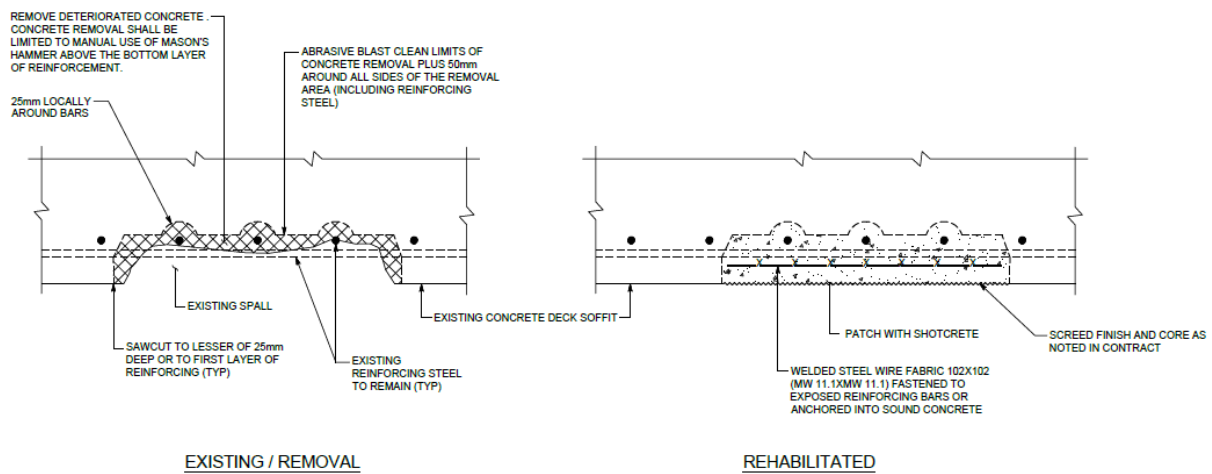
Figure 6. Typical soffit repairs

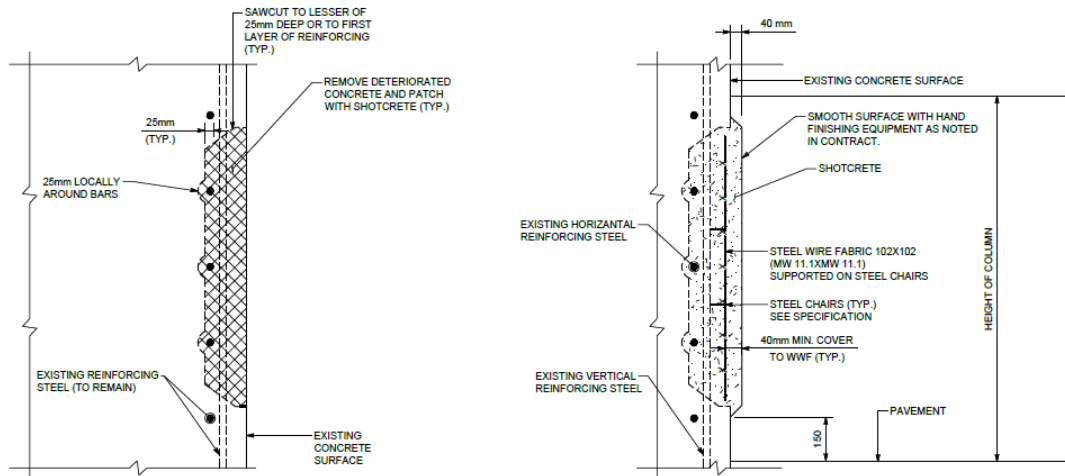
Figure 6. Typical vertical repairs

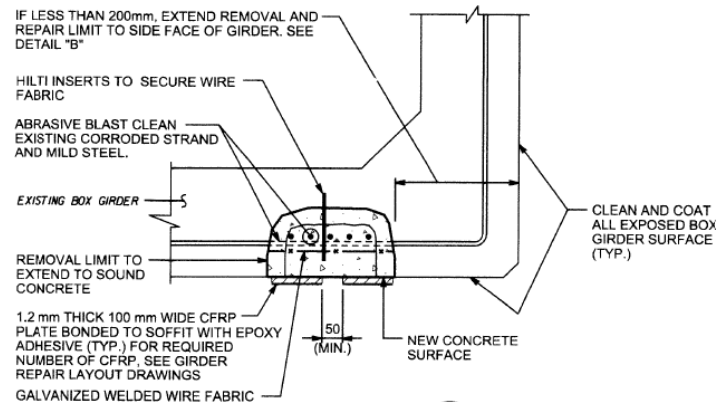
Figure 7. Carbon Fibre strengthening required for girders with corroded strands

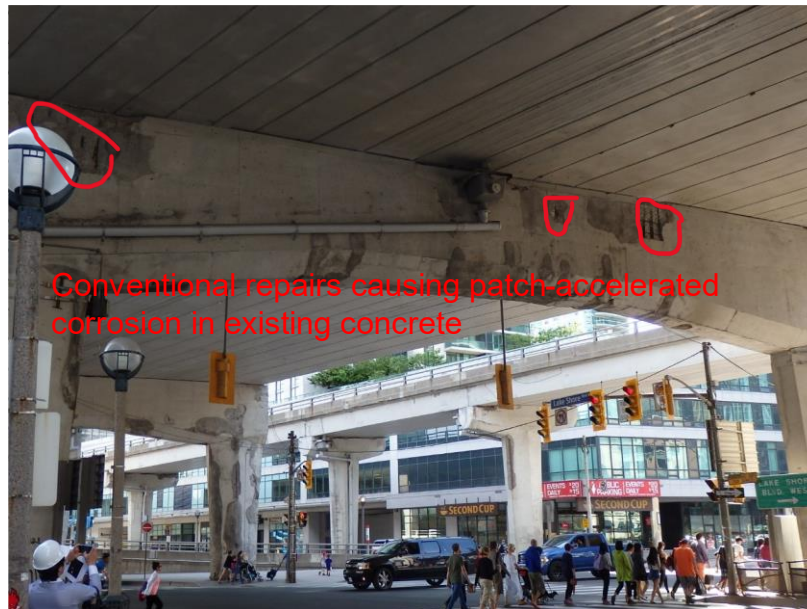
Figure 8. Patch-accelerated corrosion

Similar to Figure 2 and 3, conventional concrete repair in Figure 8 can cause patch-accelerated corrosion in existing concrete.

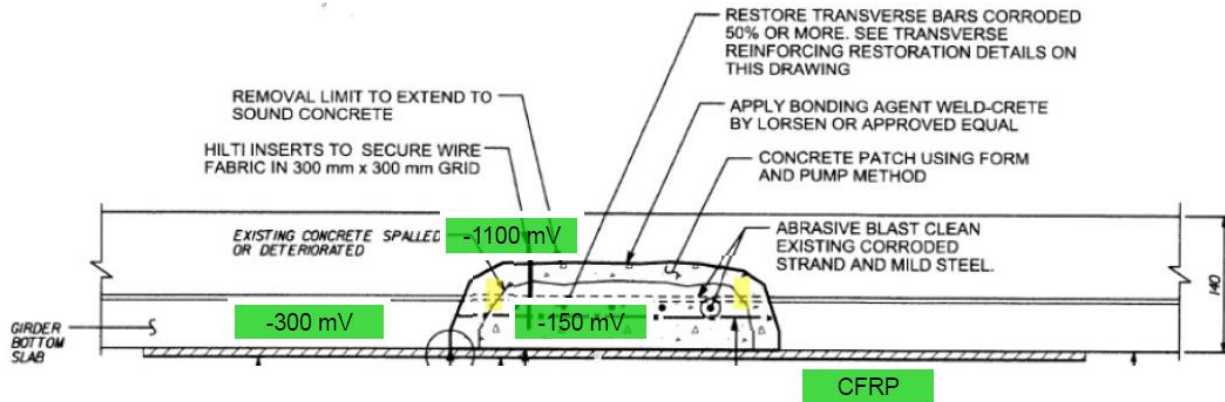
Figure 9. Galvashield Anodes added to control the corrosion prior to CFRP strengthening

According to ACI 440 and CSA 806, FRP are not recommended for corroding substrate, unless the corrosion is stabilized.

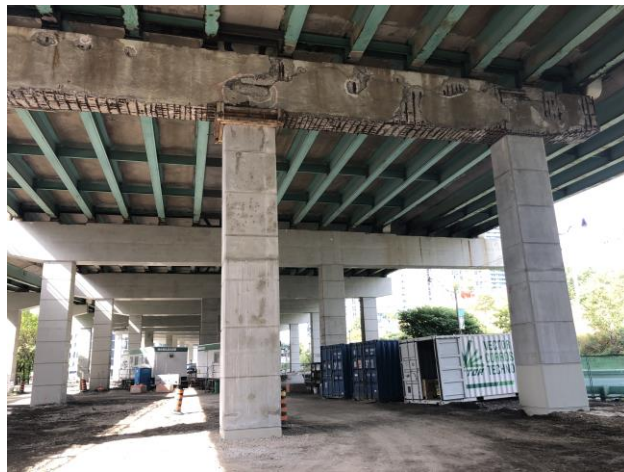
Figure 14. Completed Piers in the Background with a Partially Completed Pier in the Foreground

In piers receiving concrete jacketing, Galvashield DAS anodes were provided corrosion protection to the deteriorated substructure components (columns and pier caps). Specifications required the galvanic cathodic protection supplier to design and install a system based on long-term field performance data for galvanic anodes in a similar environment. Anode size and spacing were designed to protect all reinforcing steel in each pier for the specified 30-year service life requirements.

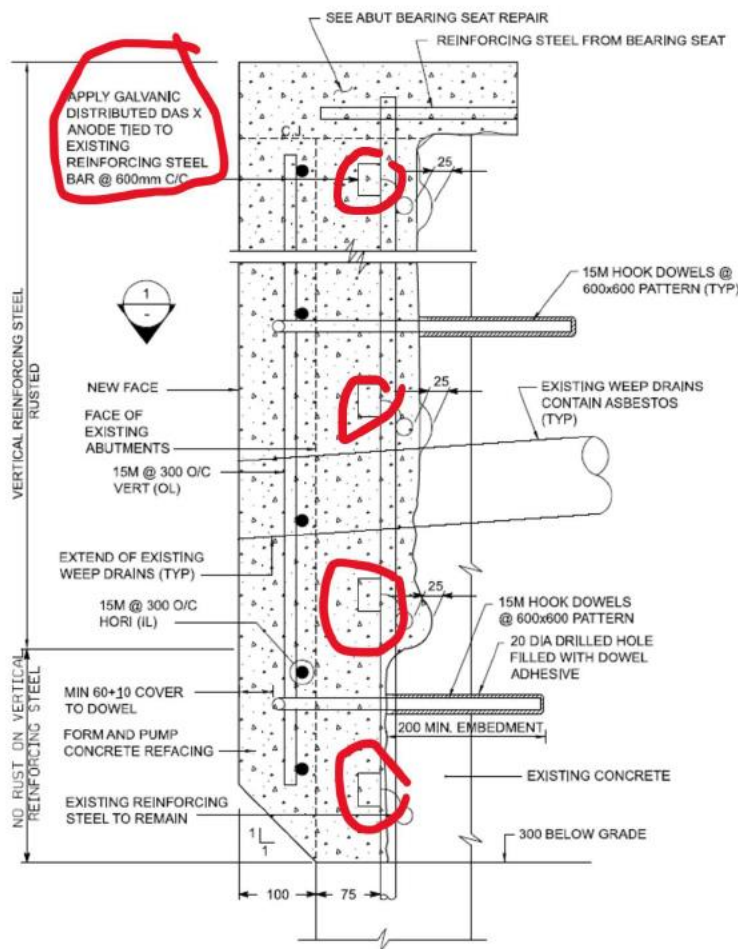
Figure 15. Corrosion protection for abutment refacing

In the abutment refacing at Mimico Creek Bridge, Mimico Creek Ramp and Park Lawn Bridge, Galvashield DASX anodes have been designed to provide 30+ years of protection. The design current density requirements of the existing steel were selected according to the risk levels of the abutments.

site	Chloride contents by weight of concrete	Risk category of existing steel	Current density requirements at year 30
Gardiner Expressway over Mimico Creek DASX at 700mm	0.331%	Extremely high	2.4mA/m ²
Gardiner Expressway over Park Lawn	0.101%	Low to moderate	0.6mA/m ²
Gardiner Ramp over Mimico Creek	0.5%	Extremely high	2.4mA/m ²

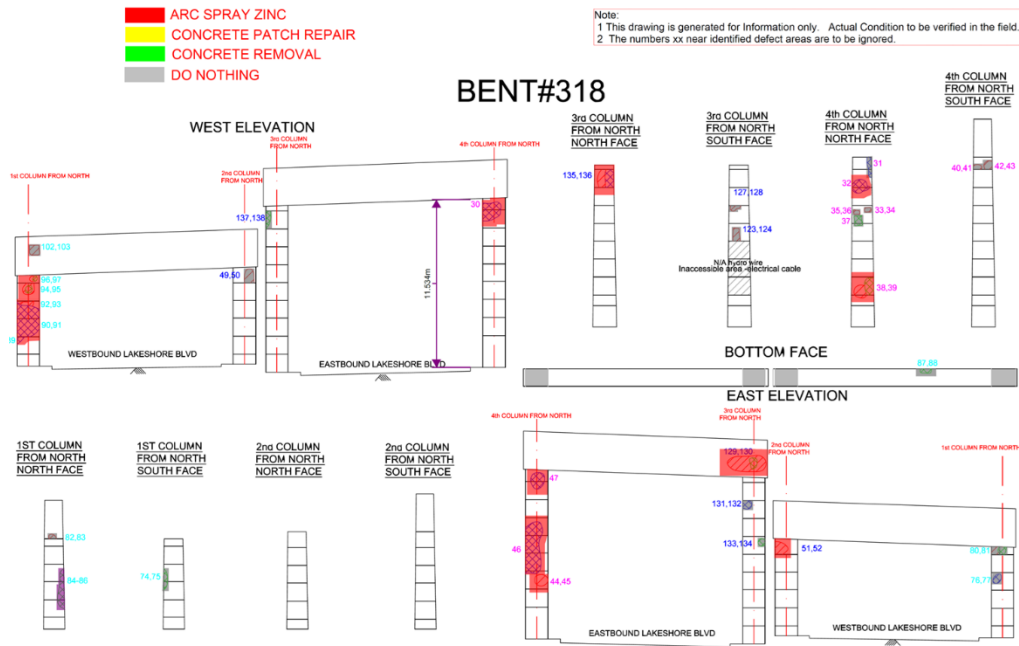
Figure 16. Holding strategy for a typical pier

Before section 5 is re-aligned and completely rebuilt, the existing piers need temporary protection for 5-10 years. After loose concrete were removed, ASZ+ anode were installed in the spalled area and surrounding concrete to prevent further deterioration. With the ASZ+ process, a thin coating of metallic

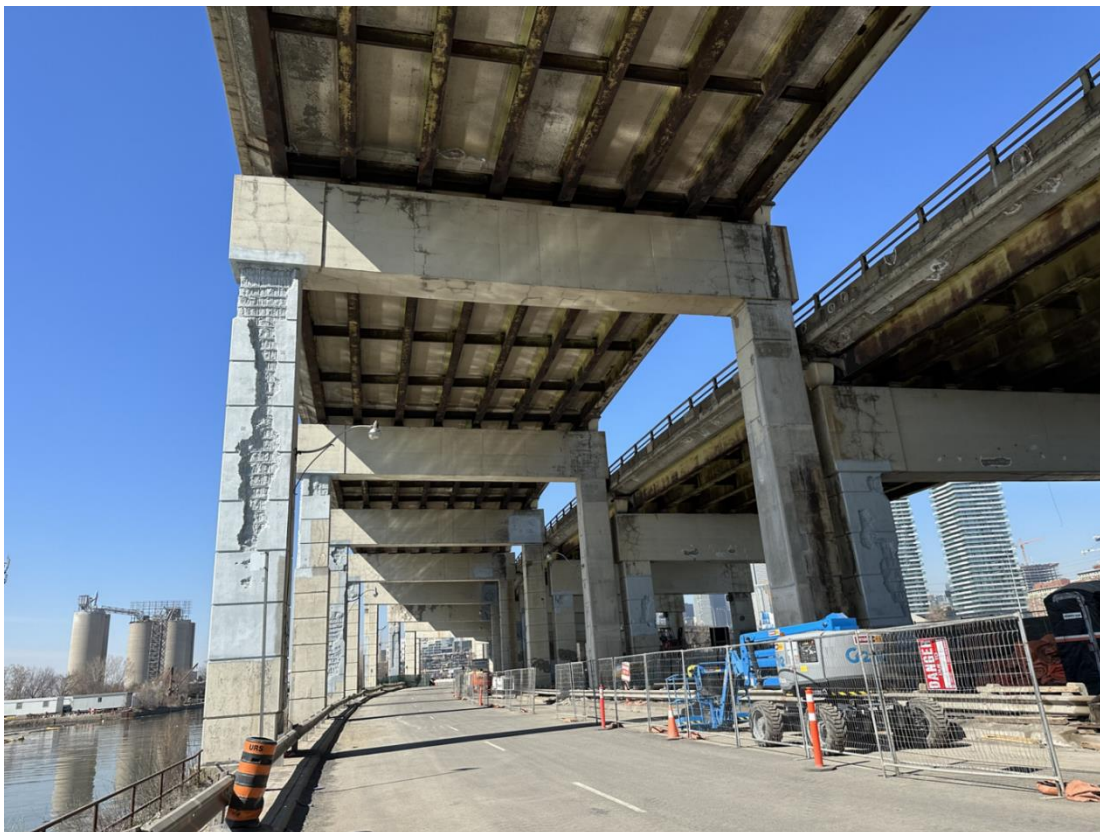
Figure 17. Spalled and surrounding areas protected with ASZ+ anodes

zinc is sprayed onto the surface of the concrete and electrically connected to the embedded reinforcing steel. After installation of the metalized zinc coating, Humectant activator solution is applied to the surface of the zinc to achieve a higher level of current output and protection over time.
