Rehabilitation Opportunities
For
NBDOT Steel Culvert Type Bridges

Phillip L. Hansen, P.Eng.
Design Branch
New Brunswick Department of Transportation

Paper prepared for presentation
at the Cost-effective Assessment/Rehabilitation of the Condition of Materials Session
of the 2007 Annual Conference of the
Transportation Association of Canada
Saskatoon, Saskatchewan

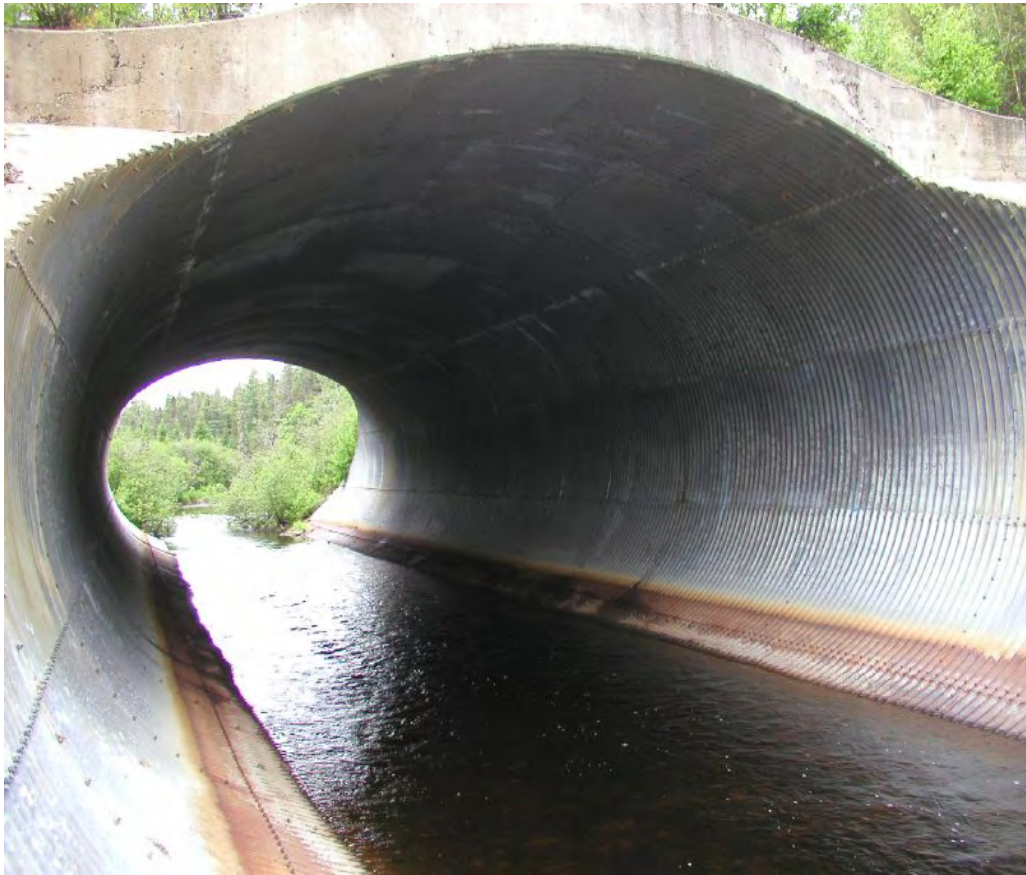
Beginning in 1996, NBDOT started detailed evaluation of the performance of galvanized steel culverts that were “bridge” size, i.e. having a total span of 3 m or more. This work was prompted by maintenance requirements at some of these structures and concerns over the apparent deterioration of the bottom plates, as observed at most sites (Figure 1).

Figure 1: Typical SPCSP Bridge Showing Rust in Lower Quadrant

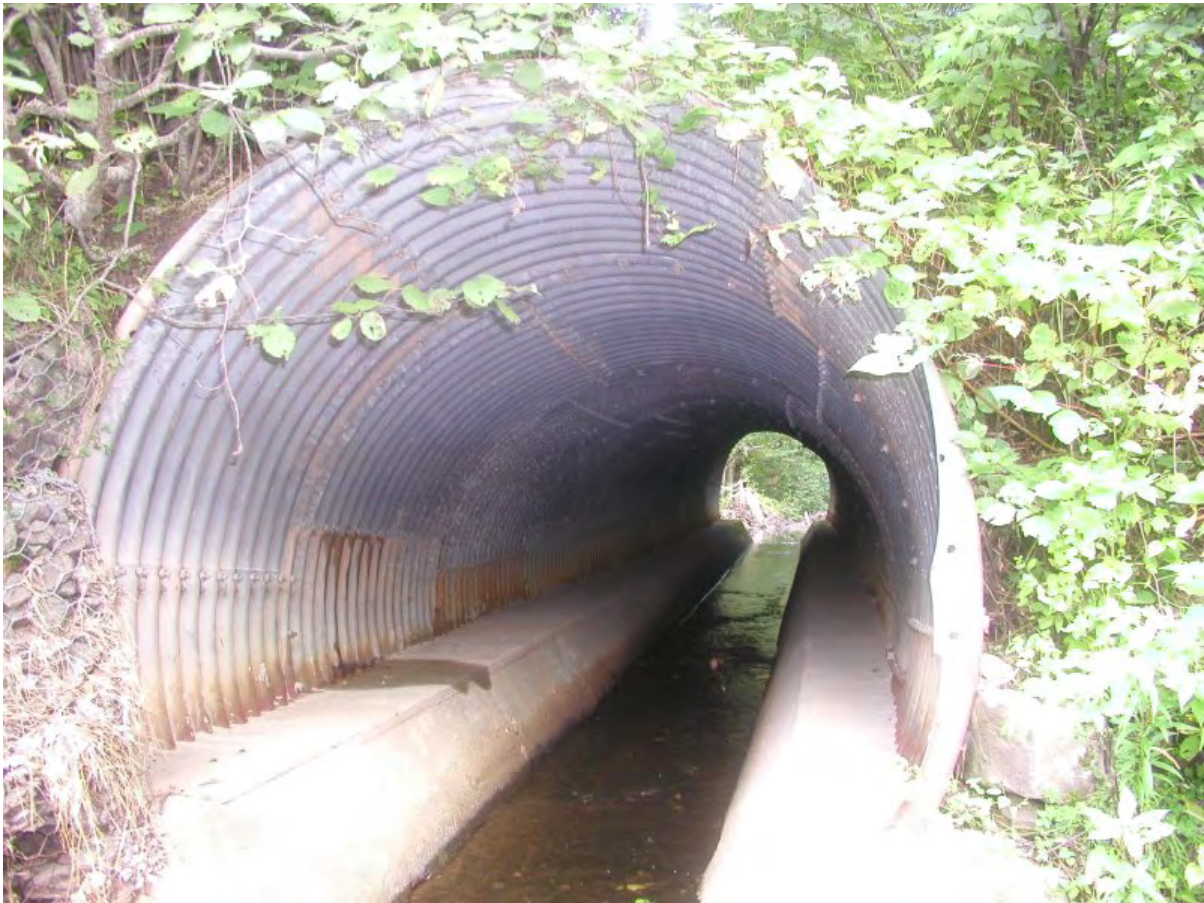
It is important to note that NBDOT had begun rehabilitating structures of this type at least ten years earlier, as needed (Figure 2). Methods and means described in transportation literature were followed during 1987 to 1997. However, the extent of the galvanized steel culvert durability problem in New Brunswick, and its causal factors, were not well understood.

Figure 2: SPCSP Bridge Rehabilitated in 1987

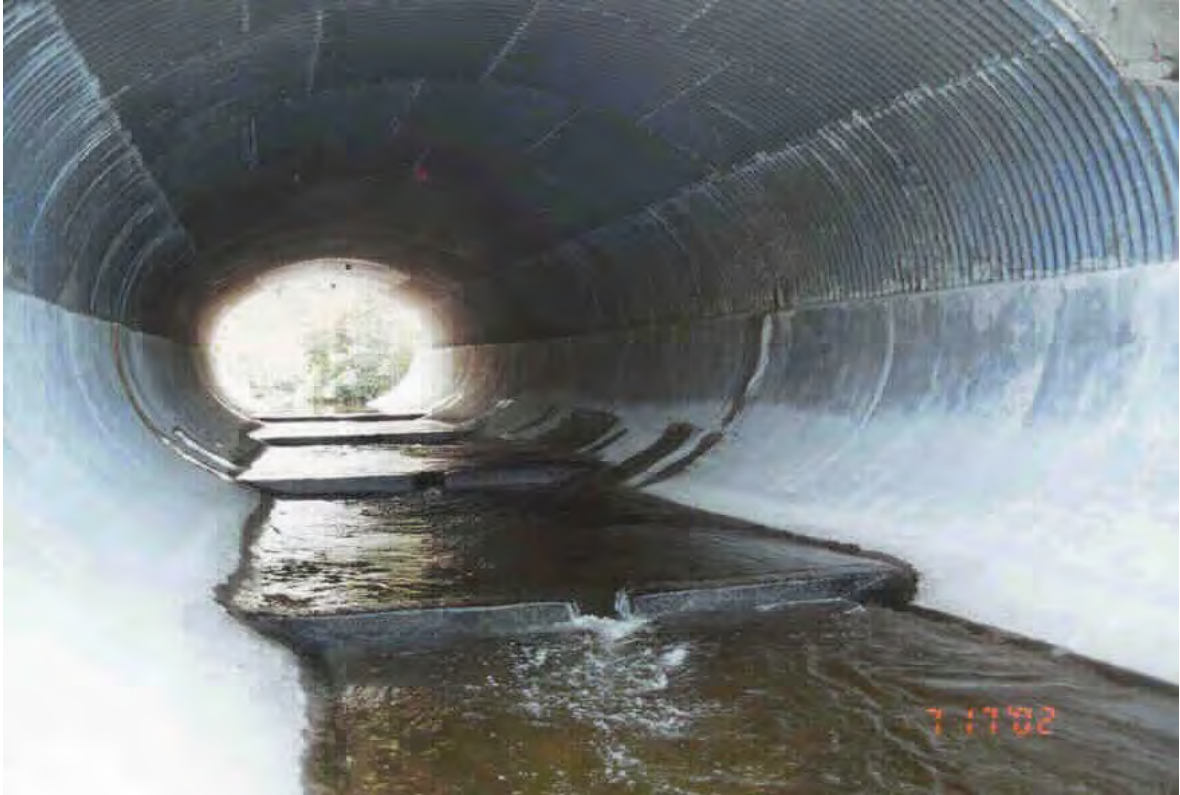
Figure 4 – Completion of Typical Rehabilitation
