2014 Manitoba Southwest Region Bridge Flood Response and Recovery

Paper Prepared for Presentation
at the Structures Session

of the 2015 Conference of the
Transportation Association of Canada
Charlottetown, PEI

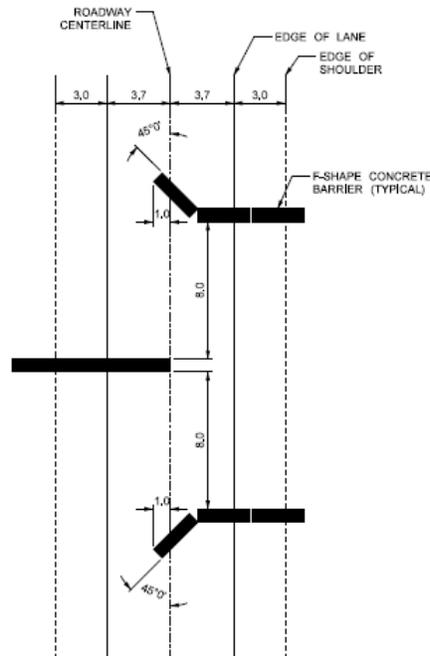
ZIG-ZAG BRIDGE BARRICADE
(N.T.S.)

Figure 5: Precast Concrete Barrier “Zig Zag” Barricade Traffic Control Plan, Used to Prevent Overweight Vehicles from Crossing Restricted Structures During Flood Response and Recovery

- a. To permit only passenger and emergency vehicles to cross sites, concrete barriers were placed in a zig zag arrangement to prevent non-permitted loads from crossing load restricted bridges; this was accomplished by forcing traffic entering the sites to make tight radius turns around the barrier arrangements, preventing vehicles with long wheel bases and hauling trailers from crossing damaged structures.

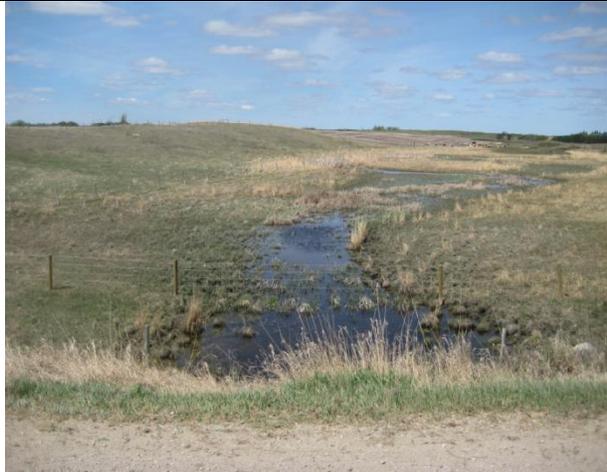
May 22, 2008: PR 542 over Drain near Kirkella looking Upstream at Water Level During a Typical Year

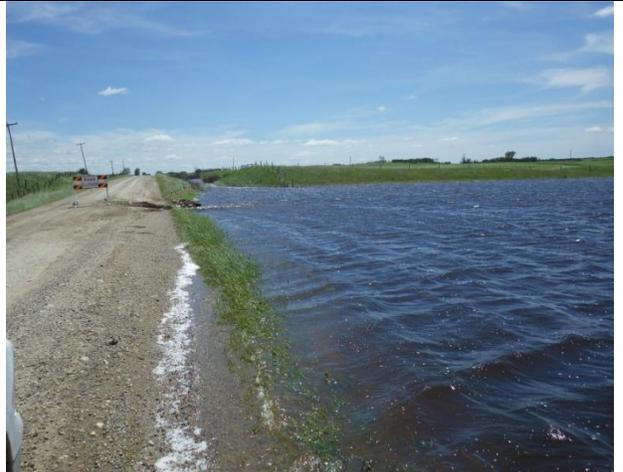
On July 1st, 2014, a culvert uplift failure at PR 542 over a Drain, near Kirkella, MB, caused a channel back up approximately 3 km in length and a head differential of approximately 4.0 m between the culvert inlet and outlet. This failure required MIT personnel to plan a contingency controlled embankment release as rapid failure of the embankment would have exacerbated the flooding in the vicinity of Elkhorn, MB, downstream of the release site and aggravated issues already encountered at other critical crossings downstream that, if destroyed, may have required evacuation of residents. MIT determined the most prudent approach was monitoring integrity of the embankment at the culvert failure site until water levels receded. The risks of implementing the contingency controlled release were determined to outweigh the benefits as artificially increasing downstream flows and risk of losing control at release point could have significant detrimental effects.

July 1, 2014: PR 542 over Drain near Kirkella looking Upstream During Flooding, Note Water Level is ~ 4.0 m Higher than 2008 Photo and is Backed up for ~3 km Upstream of Failed Culvert Site

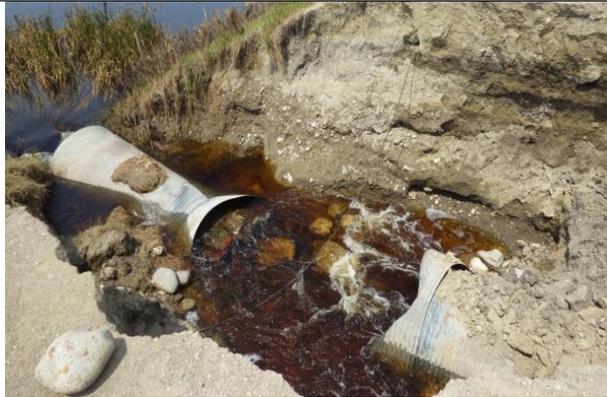
1. Inlet uplift (buoyancy failure)
2. Embankment erosion failure
3. Saturation of the roadway embankments due to a significant head differential from the inlets to outlets
4. Tapered end treatments were not used as performance of straight, projecting culverts ends were adequate prior to the 2014 flooding
5. Insufficient scour protection
6. Composition of the roadway embankment materials

July 16, 2014: PR 542 over Drain near Kirkella, Structural Plate Culvert Inlet De-Coupled due to Uplift and Erosion

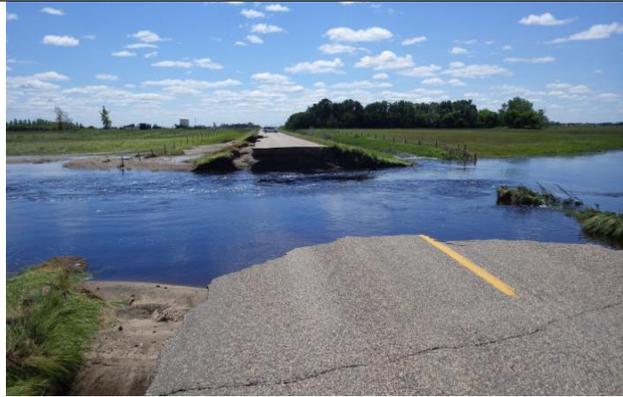
July 2, 2014: PR 256 over Graham Creek, Washed Out Structural Plate Culvert Site, Washout was ~40 metres in Length

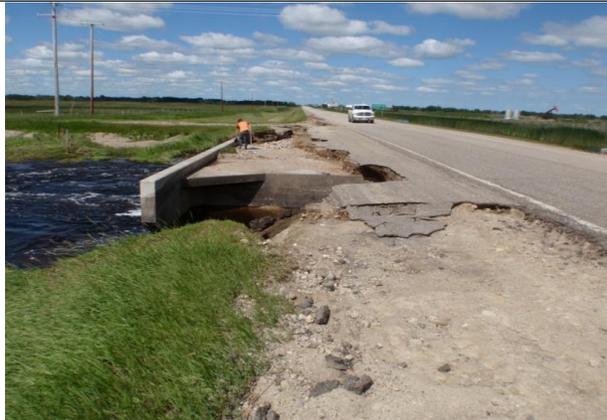
July 2, 2014: PTH 2 over Graham Creek, Erosion Around Wingwalls and Headwall and onto Culvert Barrel at Cast in Place Concrete Box Culvert Site

1. Roadway and embankment erosion damage at PTH 2 over Graham Creek (cast in place concrete box culvert) and PTH 2 over Jackson Creek (precast concrete pipes) occurred when the culverts and roadway were overtopped and inundated during peak flows (see photos in Figure 6). However, these sites were able to be repaired in under 5 days, from the time the damage was caused to repairing the embankments with granular backfilling to reopen the road and re-establishing scour protection. A granular wearing surface was utilized on a temporary basis until final repaving could be completed.

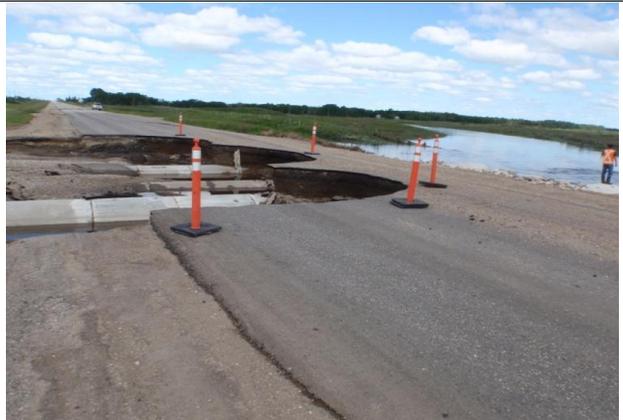
July 2, 2014: PTH 2 over Jackson Creek, Embankment and Roadway Erosion Damage at Precast Culvert Site

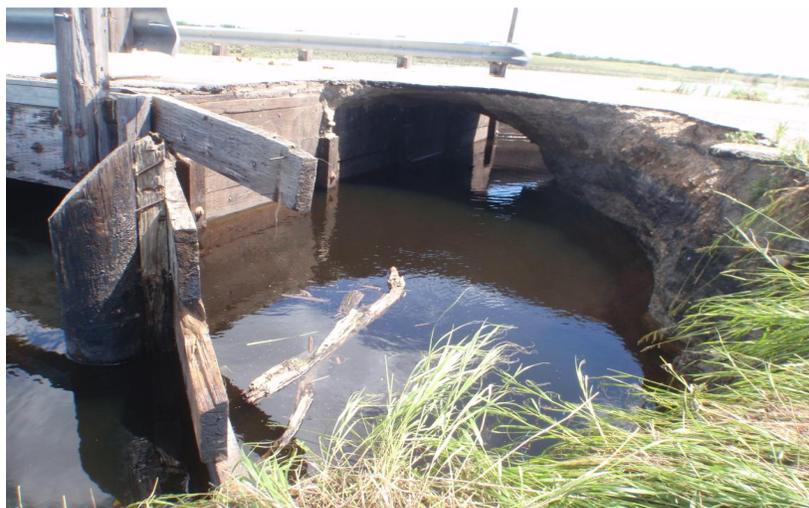
5. MIT's timber bridges do not have approach slabs included in their construction that would bridge over voids formed behind the abutment backwalls which increased the risk caused by voids at abutments due to embankment erosion. In several cases, it was found by MIT Bridge Inspection personnel that flows had eroded around the wingwalls and undermined the approach roadway causing voids through the embankment that were bridged by asphalt and granular materials. These voids were only able to be seen after flows receded.

Figure 7: 2014 Southwest Flooding Timber Bridges, Example of Voids Forming Under Approach Roadways

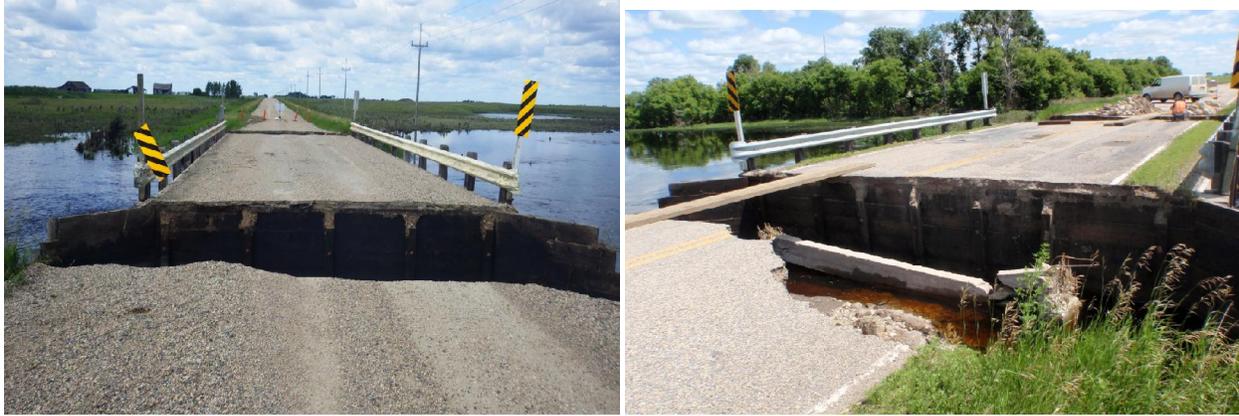
3. The timber bridges in the flood affected area had insufficient scour protection (stone armouring) around the abutments, permitting peak flows to cause extensive erosion damage to the embankment backfill.

Figure 8: 2014 Southwest Flooding Timber Bridge Photos; Examples of Approach Embankment Wash Outs Observed at Several Sites.

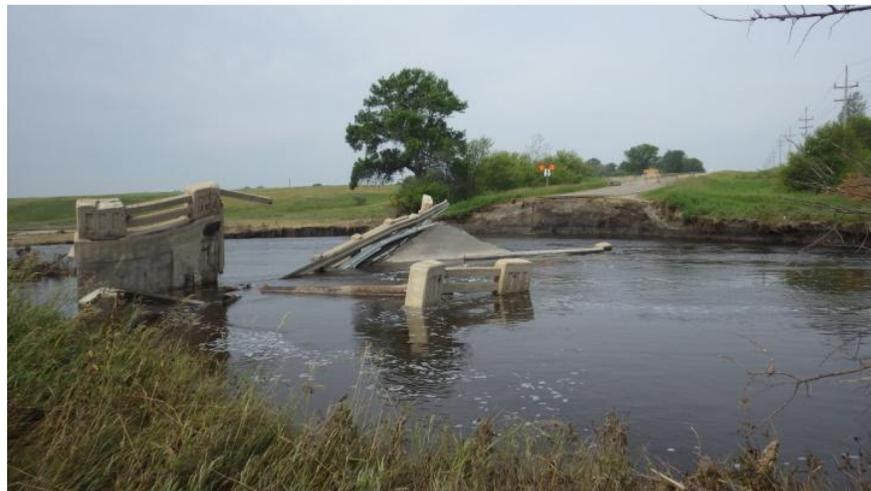
Two, Reinforced Cast in Place Concrete Arch Structures on Spread Footings, both on PR 445 and crossing the Graham Creek, were constructed in the 1920s and were both inundated during the peak flood flows. Extensive foundation undermining was the cause of failure of both of these structures. In addition to high flows, meandering / migration of the river channel at these sites also increased embankment erosion and contributed to scour damage.

Figure 9: July 10, 2014, PR 445 over Graham Creek, One of Two Concrete Arch Structures on Spread Footings that Failed due to Scour
