**CPR TECHNIQUES IN ONTARIO
- 15 YEARS EXPERIENCE**

Thomas J. Kazmierowski, P.Eng.
Manager, Pavements and Foundations Section
Tom.Kazmierowski@mto.gov.on.ca

Very Long-Term Life-Cycle Analysis of Pavements –
Determining the True Value of Our Investment (B)

of the 2005 Annual Conference of the
Transportation Association of Canada
Calgary, Alberta

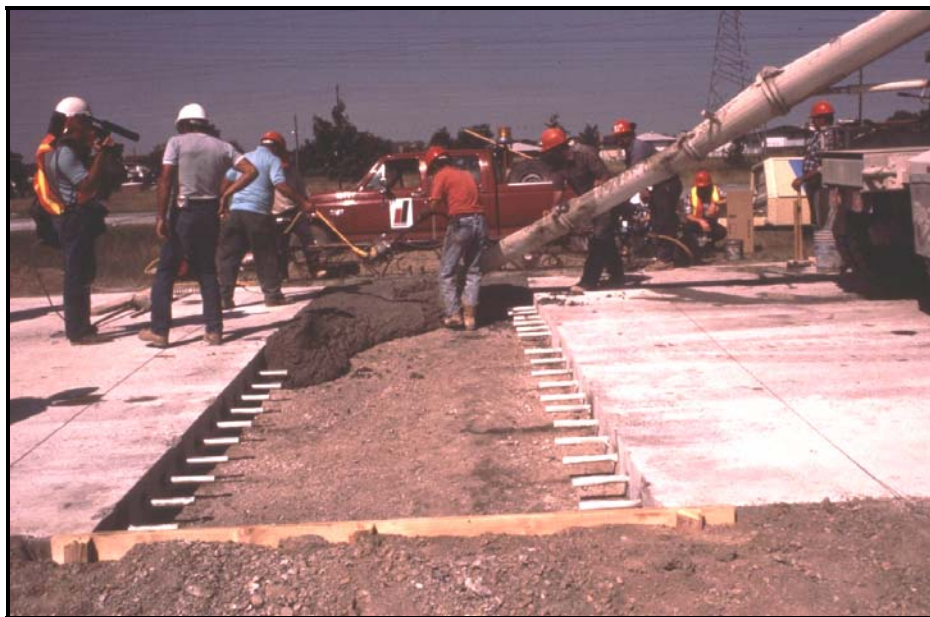
Figure 1. Typical Full Depth Repair in NBL

The PCC rehabilitation techniques utilized on the northbound lanes incorporated the latest designs and construction procedures. The design of the full depth repairs included a minimum repair width of 2.0 m with epoxy coated dowel bars epoxied into drilled holes spaced at 300 mm on both transverse faces. Also, the existing concrete had to be removed in such a manner as not to disturb the underlying granular base. See Figure 1 below for the full depth repair operation.

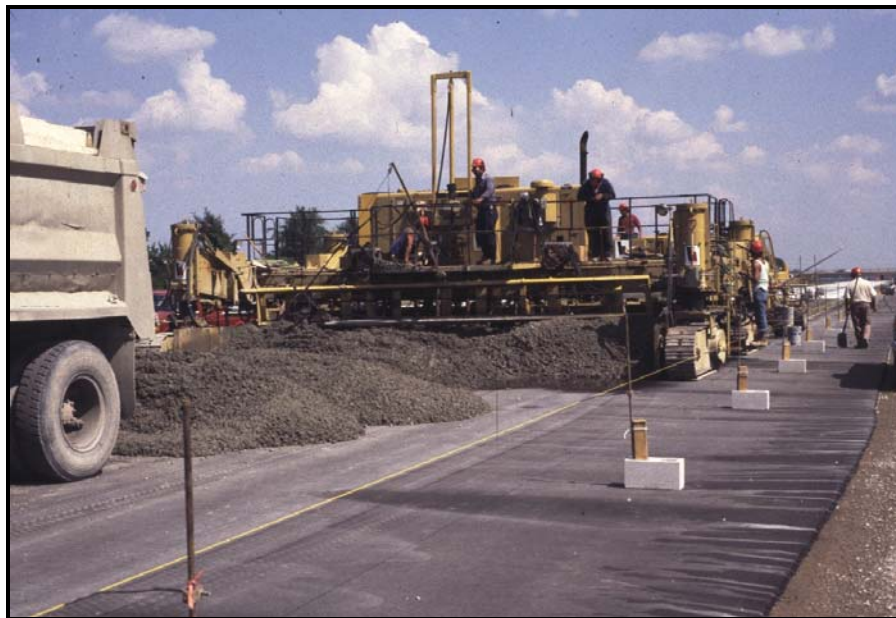
Figure 2. Slipforming Unbonded Concrete Overlay in SBL

The design of the unbonded concrete overlay on the southbound lanes included the placement of a 20 mm asphaltic sand hot mix bondbreaker over the existing pavement surface. Then overlain by a 180 mm thick unreinforced plain jointed concrete pavement. Slipforming of the concrete overlay used revised specifications based on experience gained on an earlier MTO demonstration project on Highway 3N, which placed and monitored four types of experimental concrete pavements [2, 3]. Skewed randomized joints were utilized with no effort made to avoid matching the underlying joints. See Figure 2 below for the slipform paving of the unbonded concrete overlay.

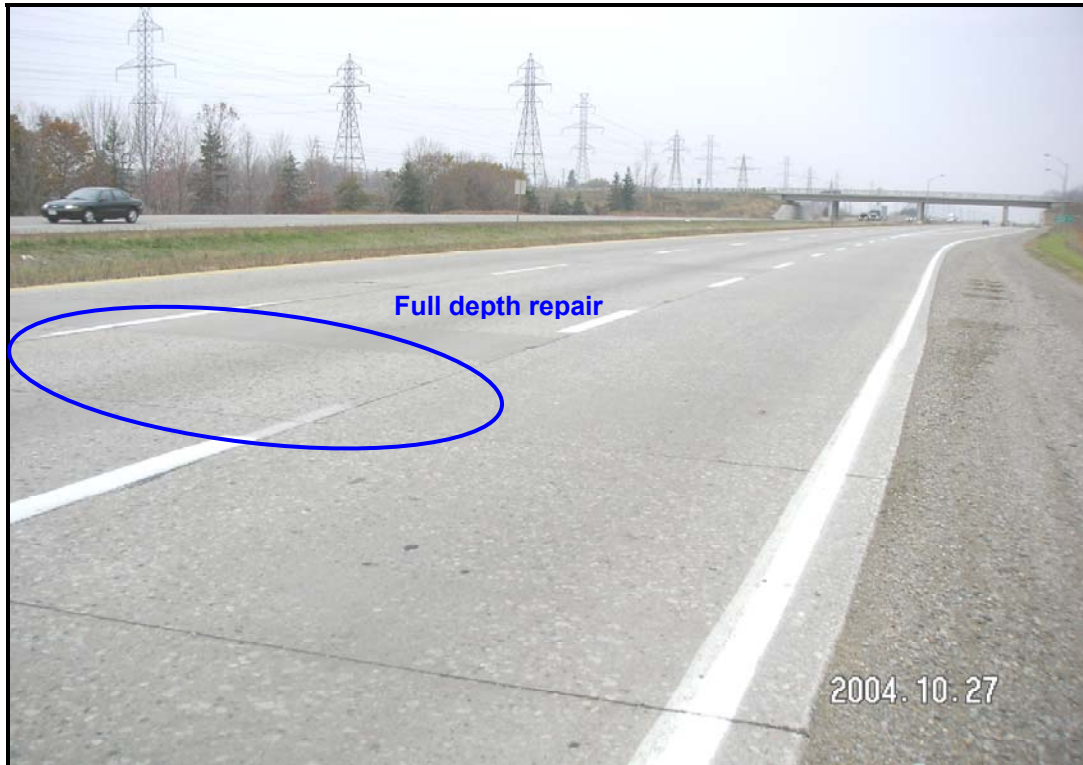
Figure 3. Typical NBL Pavement Condition

A recent survey of the northbound lanes in Fall 2004 indicates the pavement is in fair to good condition, with a Pavement Condition Rating (PCR) of 63 in the driving lane, and 70 in the passing lane. MTO's Pavement Condition Rating (PCR) is a composite pavement serviceability index ranging from 0 to 100; with the higher rating indicating a better pavement condition. Routing and sealing of cracks and joints, plus additional full depth and partial depth concrete repairs was carried out in early 2000. Most of the

joints and cracks are performing well. There were a few moderate faulted joints and intermittent moderate joint and crack spalls. In addition, extensive severe pavement edge drop off was identified. See Figure 3 below showing the typical northbound lanes performance in 2004 adjacent to full depth repair.

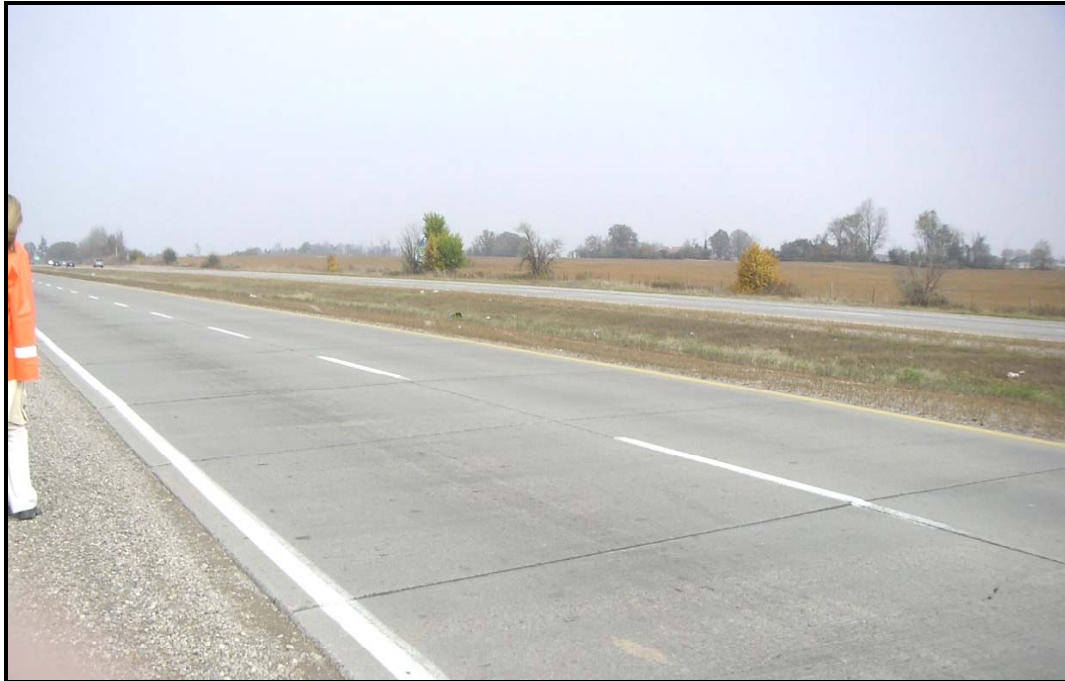
Figure 4. Typical Condition of Unbonded Concrete Overlay, SBL

A recent survey of the southbound lanes in Fall 2004 indicates the pavement is in good condition with Pavement Condition Rating (PCR) of 70 in the driving lane, and 78 in the passing lane. In 1997, southbound lanes maintenance activities included routing and sealing of cracks and joints, as well as a few full depth and partial depth concrete repairs. There were a few moderate joint and crack spalls, localized slight faulting at the joints, and intermittent very severe pavement edge drop off. The longitudinal cracks

identified in 1999 are now of moderate severity. In addition, a few severe reflection diagonal cracking and occasional moderate transverse cracking were identified. See Figure 4 below for the typical southbound lanes condition showing localized slight faulting at the joint.

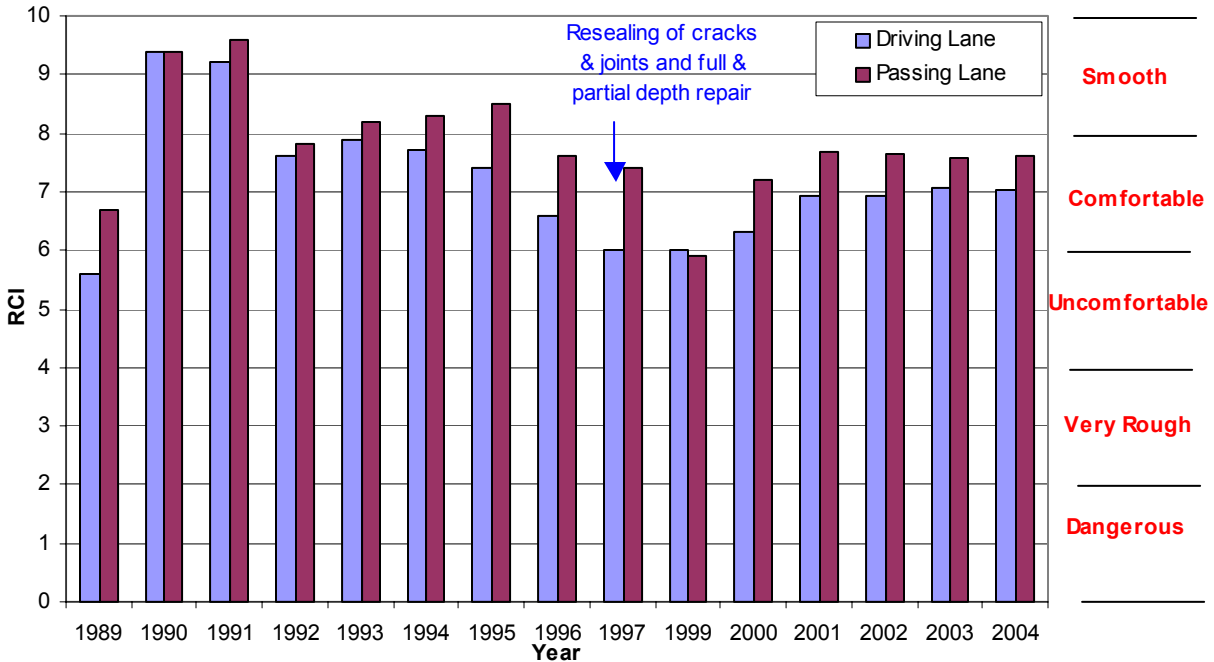
Figure 5. Summary of Roughness (RCI) in NBL

The roughness improved significantly after the concrete pavement surface was diamond ground in 1989, with an improvement in RCI from initially 5.6 to 9.4 and 6.7 to 9.4 in the driving and passing lanes respectively. The ride quality levels (smooth, comfortable, uncomfortable) indicated on the graph are converted based on the established RCI. The ride data for the diamond ground surface indicates that the initial roughness value deteriorated to an approximate value of 7.7 after two years and has remained fairly constant over the next three years. These RCI values are in the comfortable range of the ride categories.

The maintenance history indicated the northbound lanes were rehabilitated in 1995 and 2000 with resealing of cracks and joints, as well as some full depth and partial depth concrete repair. Due to an incorrectly correlated transfer function used to convert PURD measurement to RCI coupled with several additional cycles of remedial work, roughness results from 1996 to 2000 are out of trend, see Figure 5.

The ARAN surveys from 2001 to 2004 indicates the roughness remained constant over these years, with an average RCI of 7.0 and 7.6 for the driving and passing lane respectively. Overall, the northbound lanes rehabilitated using full CPR techniques are still performing within the comfortable range, after 15 years of service.

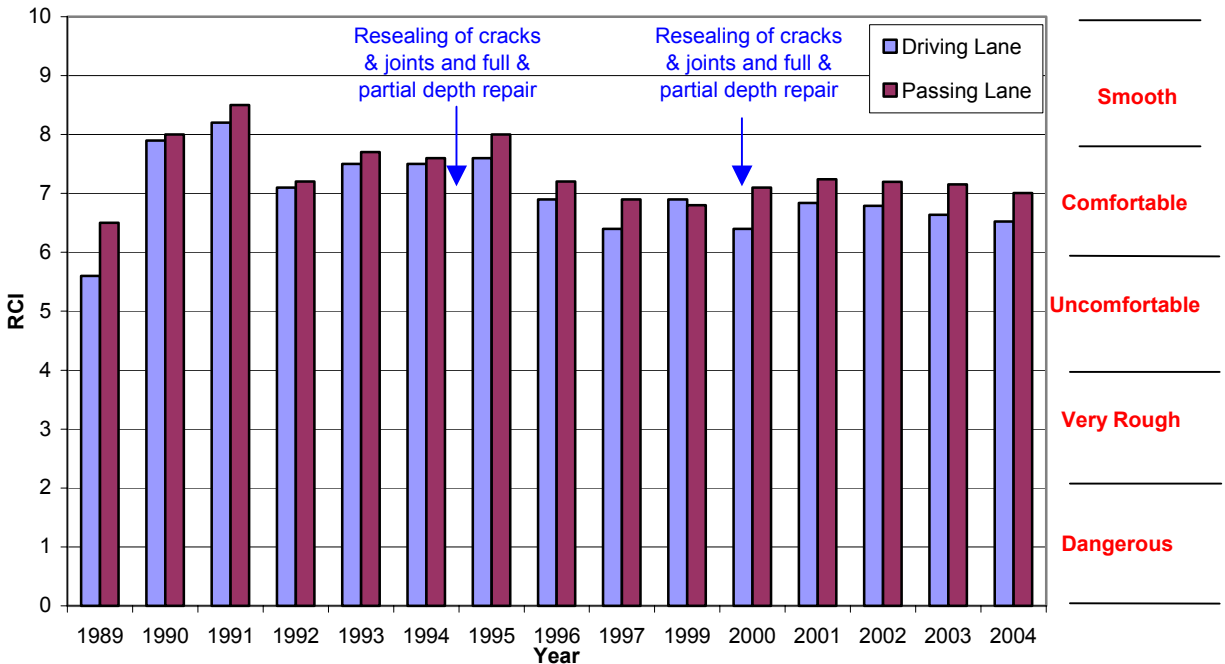
Figure 6. Summary of Roughness (RCI) in SBL

The unbonded overlay on the southbound lanes resulted in an improvement in roughness in RCI from 5.6 to 7.9 and 6.5 to 8.0 in the driving and passing lanes respectively; see Figure 6. The newly tined surface texture on the unbonded overlay was very aggressive and may have contributed to some of the initial roughness. The roughness in both the passing and driving lanes in the southbound direction have had fairly constant RCI values from 1990 to 1995, with an average RCI of 7.6 and 7.8 in the driving and passing lane respectively.

The RCI roughness values between 1996 to 2000 appear elevated as a result of an erroneous transfer function used in converting PURD measurements into RCI values. The conversion was based on limited correlation data.

The survey from 2001 to 2004 indicates the roughness remained fairly constant over these years, with an average RCI of 6.7 and 7.2 for the driving and passing lane respectively. Overall, the southbound lanes are in the comfortable category, indicating that after 15 years service, the unbonded concrete overlay treatment is performing well within anticipated life cycle parameters.

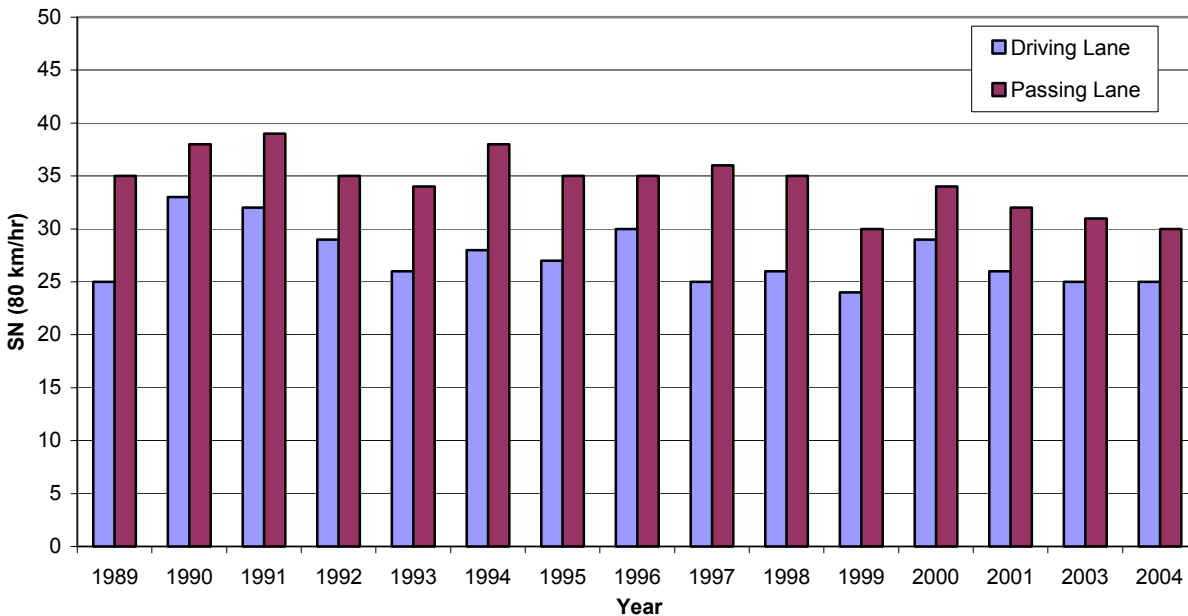
Figure 7. Summary of Average SN₈₀ in NBL

On the diamond ground surface, the skid numbers improved just after construction in 1989, from an average of 25 and 35 to 48 and 49 for the driving and passing lanes respectively. Skid numbers of this magnitude indicate a good friction factor and are similar to numbers obtained on premium hot mix surface courses in Ontario [8]. Over the last fifteen years, the skid resistance appears to be consistent in the range of 24 to 33 (average of 27) for driving lane, range of 30 to 39 (average of 35) for the passing lane, see Figure 7.

These values are approximately 7 units lower than the results of the burlap dragged and tined texture on the southbound lanes. The fractured ridges in the diamond ground surface have worn away fairly quickly under high traffic and heavy winter maintenance activities. The micro-texture created with diamond grinding may not be as durable as

that created by the burlap drag/tined texture resulting in an earlier reduction in measured frictional properties.

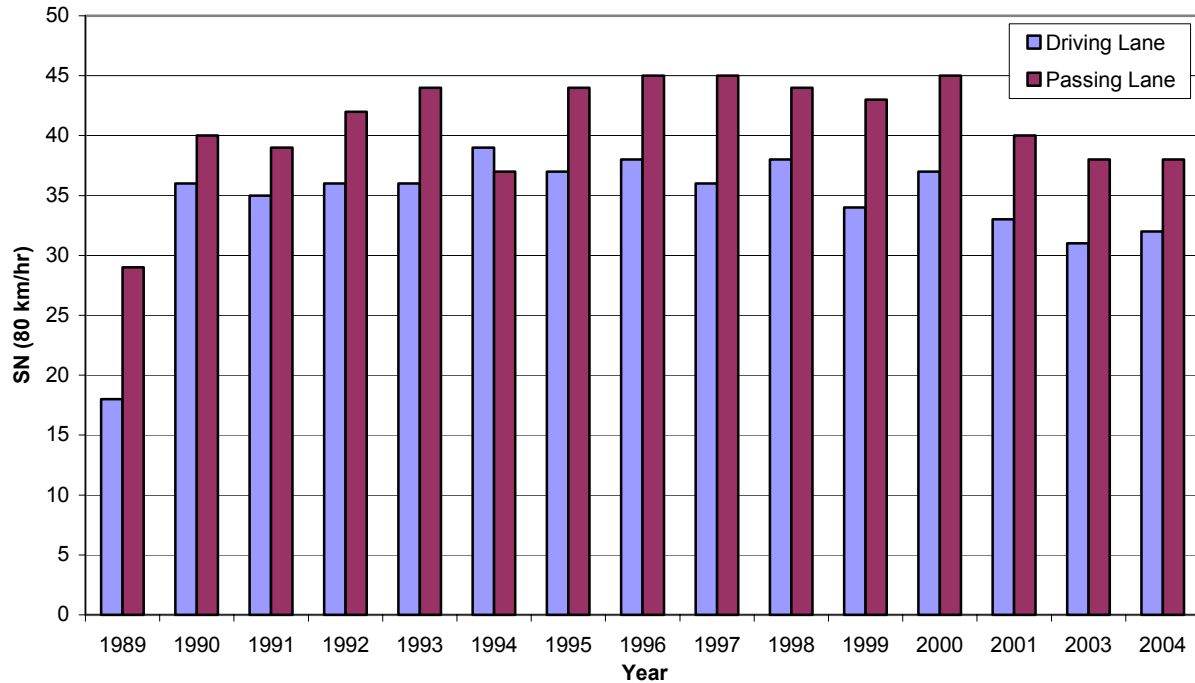
Figure 8. Summary of Average SN₈₀ in Southbound Lanes

The skid numbers in the southbound lanes increased to an average SN₈₀ of 55 for both lanes after the overlay in 1989, from an SN₈₀ of 18 and 29 in the driving and passing lanes respectively. The skid resistance has stayed fairly constant since construction with the driving lanes ranging from 31 to 39 (average of 34) and the passing lanes ranging from 37 to 45 (average of 41). See Figure 8 for a summary of the skid resistance in the southbound lanes.

As anticipated, in the first year the initial sharp projections of the burlap drag/tined surface have been worn, polished and sheared off by traffic and snow removal operations.
