Assessment of Aged Bridge Bearings: Use of Automated Monitoring Equipment to Complement Traditional Inspection Techniques

Paper prepared for the session Transportation Structures 2024 Transportation Association of Canada (TAC) Conference & Exhibition Vancouver, British Columbia

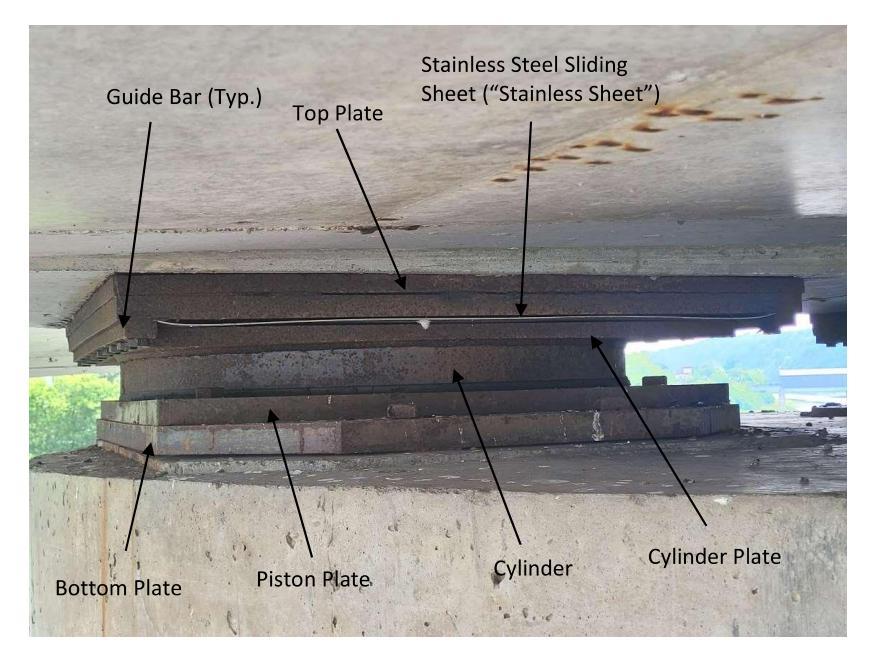
Figure 4: Existing (original) Main Span Bearing at Pier 12; Photo Taken August 12, 2021 (EXP, 2021b)

Two pot bearings support the main span box girder at each pier. Pot bearings at the central pier 11 are fixed, and bearings at the remaining main span piers (piers 8, 9, 10, 12, 13 and 14) are unidirectional/guided and permit longitudinal movement. As defined in the original construction drawings, main span bearings are "Rotaflon Structure Bearings" by Andre Rubber Co Ltd. These are guided pot-bearings with a polytetrafluoroethylene (PTFE) sliding surface and stainless-steel mating surface. Andre Rubber reports a coefficient of friction of the sliding surface in the range of 0.018 to 0.026. Figure 4 is a photo of an existing (original) bearing at pier 12 with component terminology noted.

Replacement of the remaining main span bearings (piers 9-13) was deemed likely, and the timeline for such replacement is dependent on the performance of the bearings. Recall that piers 9-13 are located within the Saint John River watercourse; bearing replacement at these piers is therefore more involved compared to the land piers and is considerably more costly. Visual inspection of these bearings generally

revealed corrosion of steel surfaces with little to no section loss, a cracked and brittle rubber seal between the cylinder and piston, and delamination of the stainless-steel sheet at exterior edges. Displacement of the stainless-steel sheet was observed at 3 of the 8 guided bearings ranging in magnitude from 15-35mm (EXP, 2021b).

Results of this instrumentation and monitoring program suggested that the original main span bearings were operating within reasonable parameters. Based on these experimental observations and results of visual inspections, the bridge consultant and NBDTI determined that replacement of main span bearings was not warranted at this time (EXP, 2023). It was concluded in 2023 that the need for replacement would be re-evaluated on an on-going basis as the bearings continue to age. Monitoring of bearing deformations as a function of temperature would continue at the Florenceville Bridge to further assess the performance of these bearing. With the data collected in year 1 acting as a baseline, future deviations from this baseline could be used as a trigger to prompt remedial actions if/when required. It was concluded that the condition of main span bearings would be re-evaluated in 5 years with a follow up visual inspection.

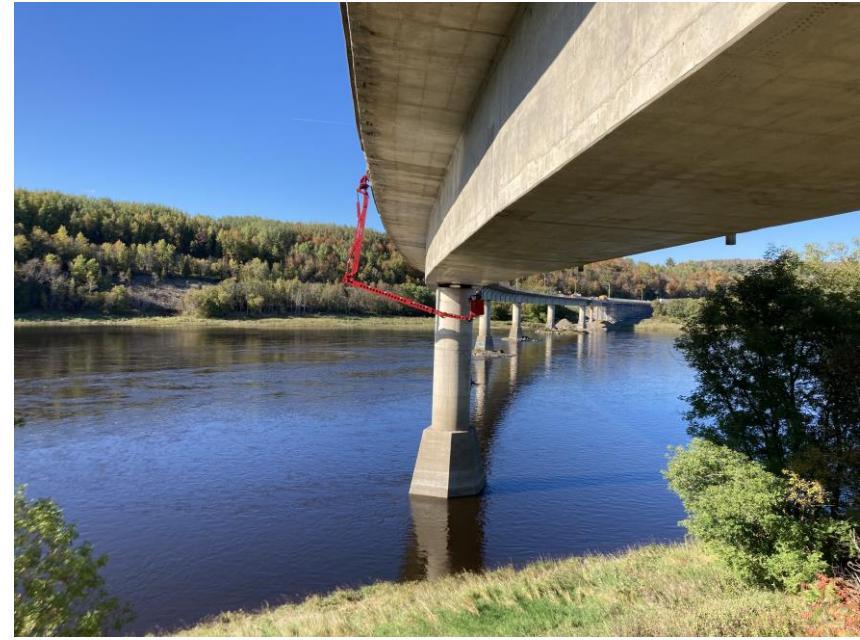
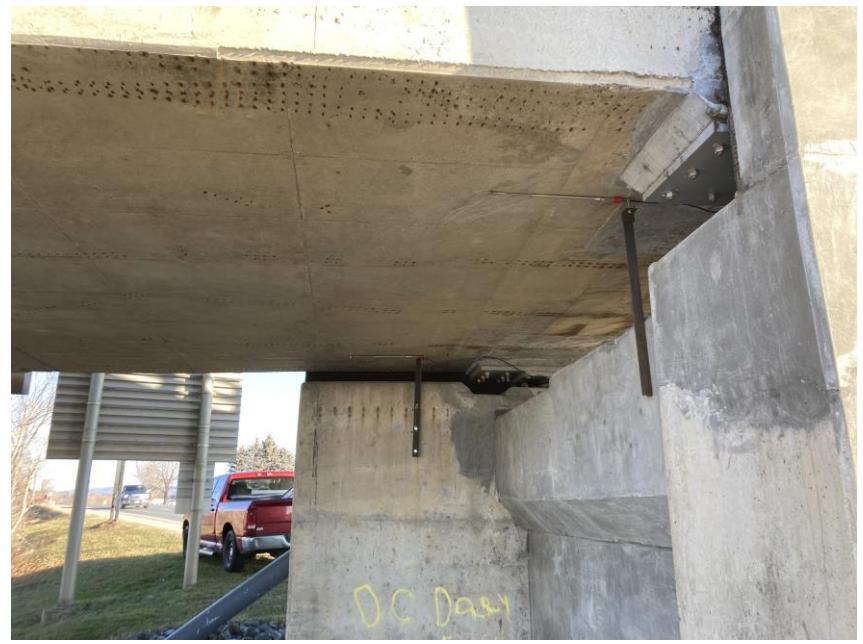
Figure 5: Photos Taken During Installation Showing a) the Installation Process at Pier 13, and b) the Completed Installation at Pier 14 (EXP, 2023).

to within 0.1% of the operating range (Geokon, 2020). The ambient temperature at the time of installation was approximately 10°C; deformation gauges were therefore installed near the mid-range of their operating range to allow adequate capacity during future expansion and contraction events. Figure 5a is a photo displaying the installation process of deformation gauges at pier 13, and Figure 5b is a photo showing the completed installation of sensors at pier 14.

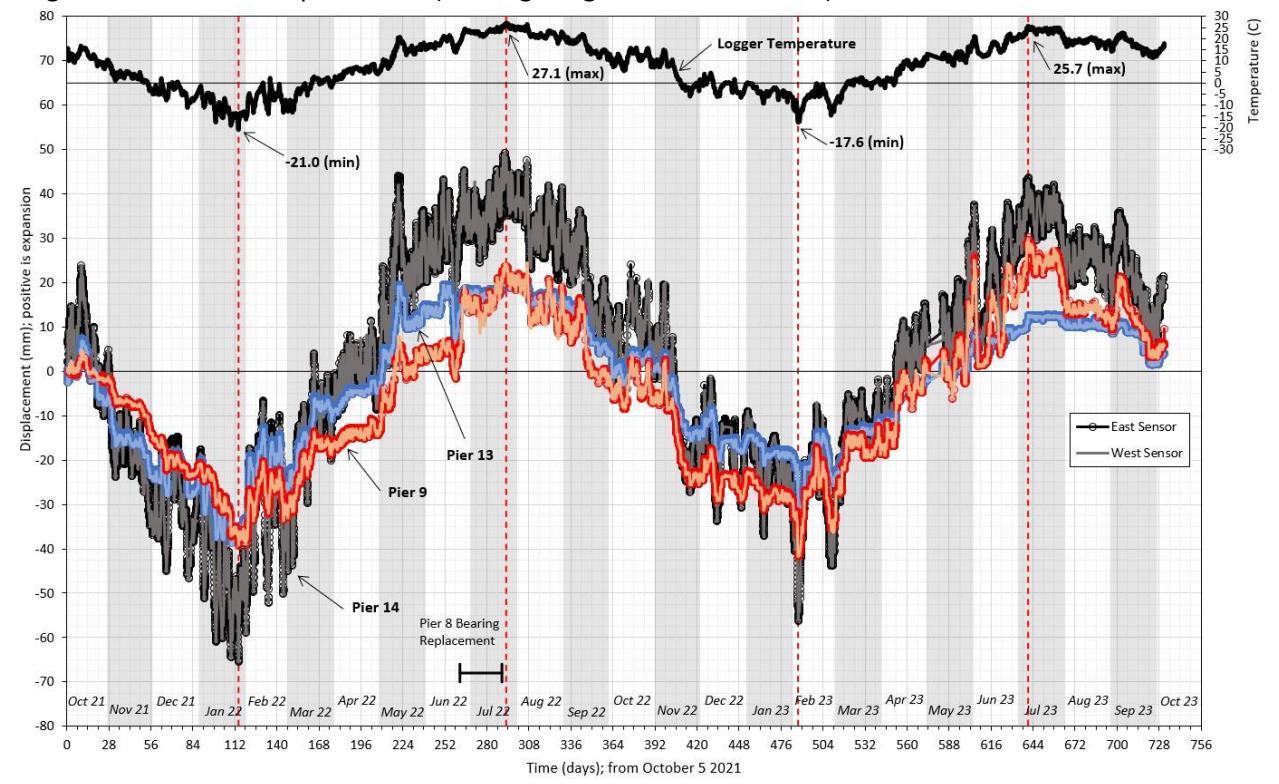
Figure 6: Measured Displacement (Bearing Longitudinal Movement) as a Function of Time

The results contained in Figure 6 display bearing deformations over 731 days (two full years) and therefore includes two complete thermal cycles. Daily expansion-contraction events are evident throughout. The displacements at pier 14 are greater than those observed at pier 9 and pier 13. This is expected, since the greatest thermal movement is experienced at the terminal piers. The general deformation trends observed over each of the two 12-month periods are observed to be similar and are summarized below:

- Year 1: Oct 5 2021 to Oct 7 2022
 - The general trend of deformation was longitudinal contraction from October 5 2021 to January 27 2022, longitudinal expansion from January 27 2022 to July 24 2022, and longitudinal contraction from July 24 2022 to October 7 2022.

- With respect to the 'zero' position at the time of sensor installation, the measured contraction at pier 9, 13, and 14 was observed to peak near January 27 2022 at -39.2mm, -38.9mm, and -65.4mm, respectively. The measured expansion at pier 9, 13, and 14 was observed to peak near July 24 2022 at 23.7mm, 20.5mm, and 49.3mm, respectively.

- At completion of this 12-month period, the structure had experienced one complete thermal cycle and the data shows that all three instrumented bearings returned to near their initial position.

- Year 2: Oct 7 2022 to Oct 6 2023
 - The general trend of deformation was longitudinal contraction from October 7 2022 to February 4 2023, longitudinal expansion from February 4 2023 to July 7 2023, and longitudinal contraction from July 7 2023 to October 6 2023.

- With respect to the 'zero' position at the time of sensor installation, the measured contraction at pier 9, 13, and 14 was observed to peak near February 4 2023 at -41.7mm, -31.3mm, and -56.1mm, respectively. The measured expansion at pier 9, 13, and 14 was observed to peak near July 7 2023 at 30.0mm, 12.8mm, and 43.3mm, respectively.

- The data recorded over the second one-year cycle shows that all three instrumented bearings have once-again returned to near their initial position.

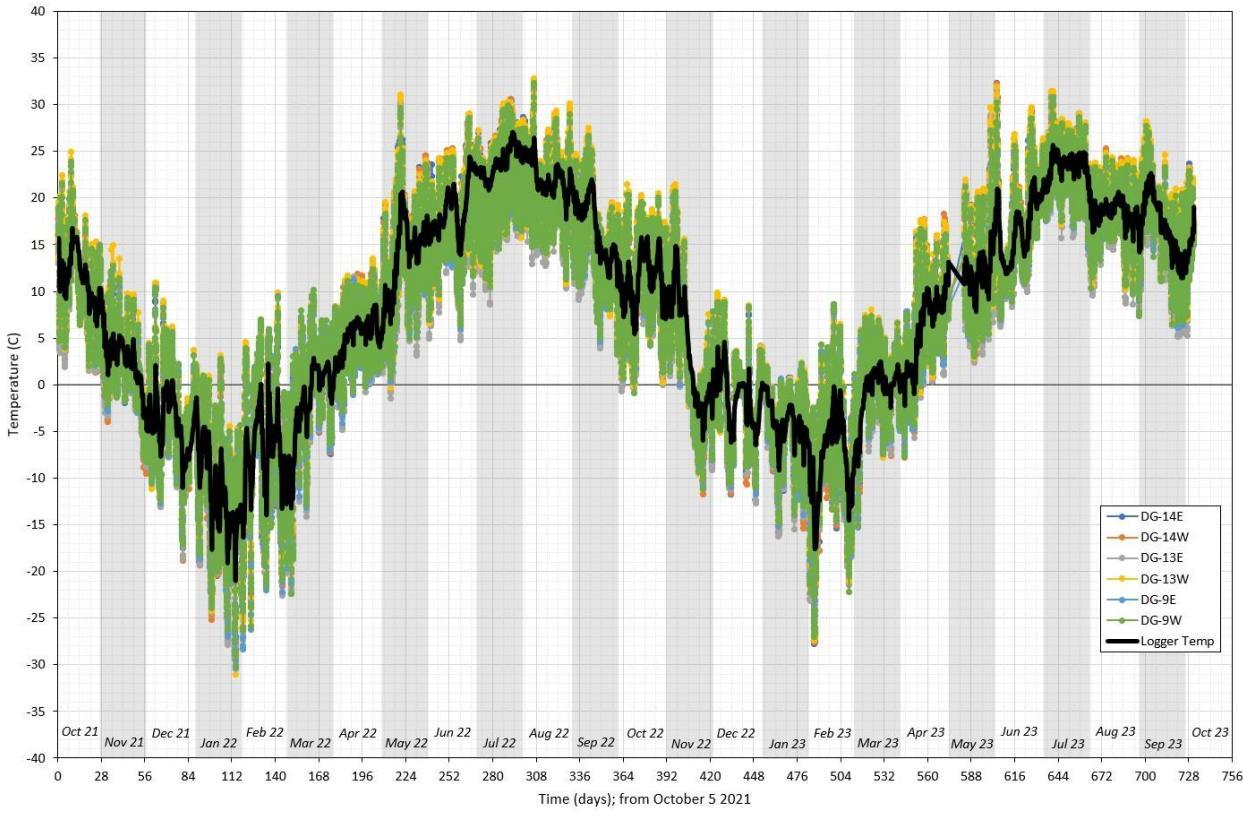
Figure 7. Temperature Recorded by Deformation Gauges and Datalogger as a Function of Time

Longitudinal expansion and contraction of the Florenceville bridge superstructure is a result of thermal strain. During this monitoring period, temperatures were also recorded at the time of each bearing deformation observation. The temperatures recorded by all six sensors and by the datalogger are plotted as a function of time in Figure 7. It is found that there is a considerable difference in temperature between the ambient conditions outside of the box (i.e., at the sensor locations) and conditions inside the box (i.e., at the datalogger location). Temperature differences inside the box structure vs. outside the box structure are observed to differ by up to 10°C during the two-year monitoring period. It is worth noting that all sensors were installed on the underside of the box girder near the bearings and are therefore not exposed to direct sunlight. The general temperature trends observed over each of the two 12-month periods are observed to be similar and are summarized below:

- Year 1: Oct 5 2021 to Oct 7 2022
 - The minimum and maximum temperature recorded by sensors outside the box during the monitoring period was -31.0°C and 32.8°C, respectively.
 - The minimum and maximum temperature recorded by the datalogger inside the box was 21.0°C and 27.1°C, respectively.

- Year 2: Oct 7 2022 to Oct 6 2023
 - The minimum and maximum temperature recorded by sensors outside the box during the monitoring period was -27.8°C and 32.3°C, respectively.
 - The minimum and maximum temperature recorded by the datalogger inside the box was 17.6°C and 25.7°C, respectively.

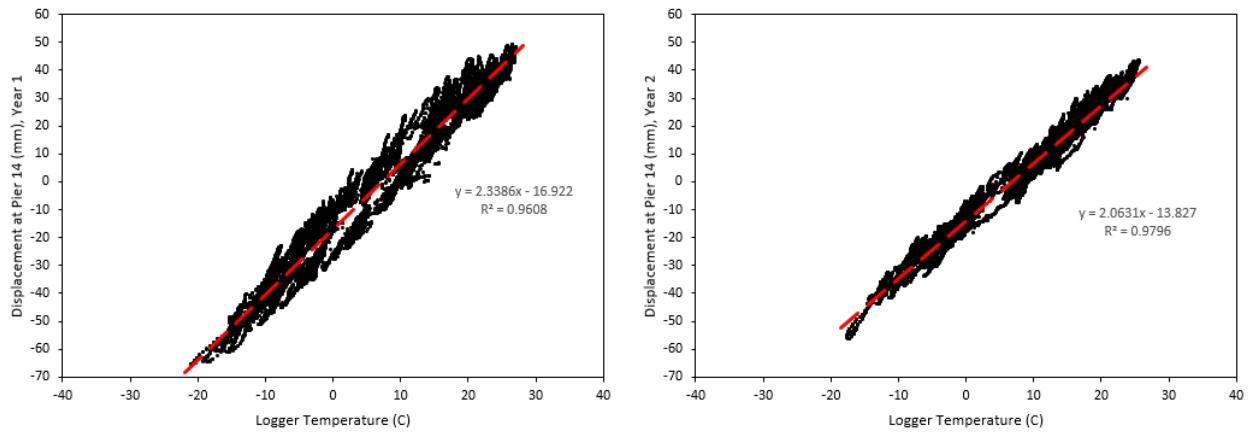
As shown in Figure 8, the deformation data is well correlated with box internal temperature for data collected over both years. The slope of the best fit line through the deformation/logger-temperature data is 2.3386 mm/°C in year 1 and 2.0631 mm/°C in year 2. This suggests that, on average, bearings at pier 14 experienced longitudinal displacement at a rate of 2.3 mm per degree temperature change (box internal temperature) in year 1, and at a rate of 2.1 mm per degree temperature change in year 2.

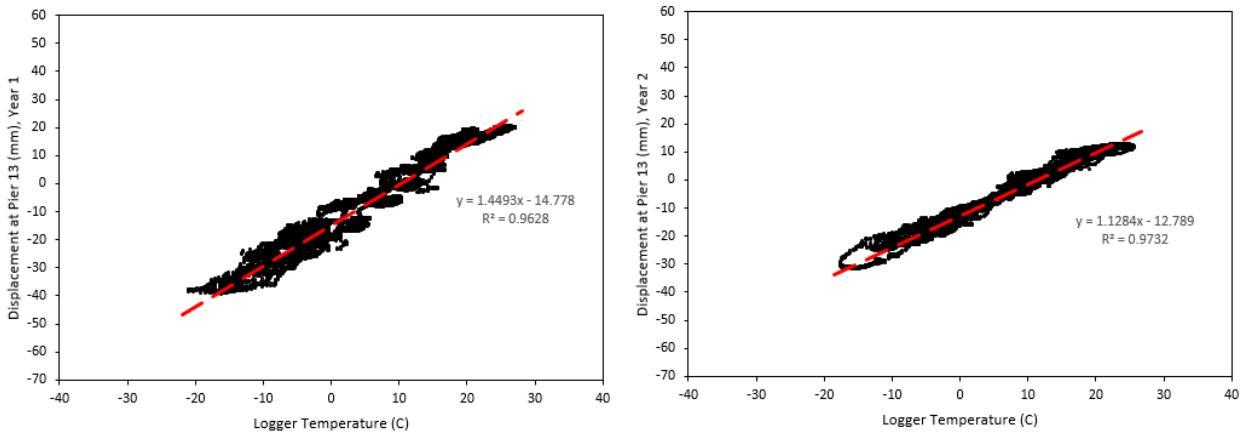
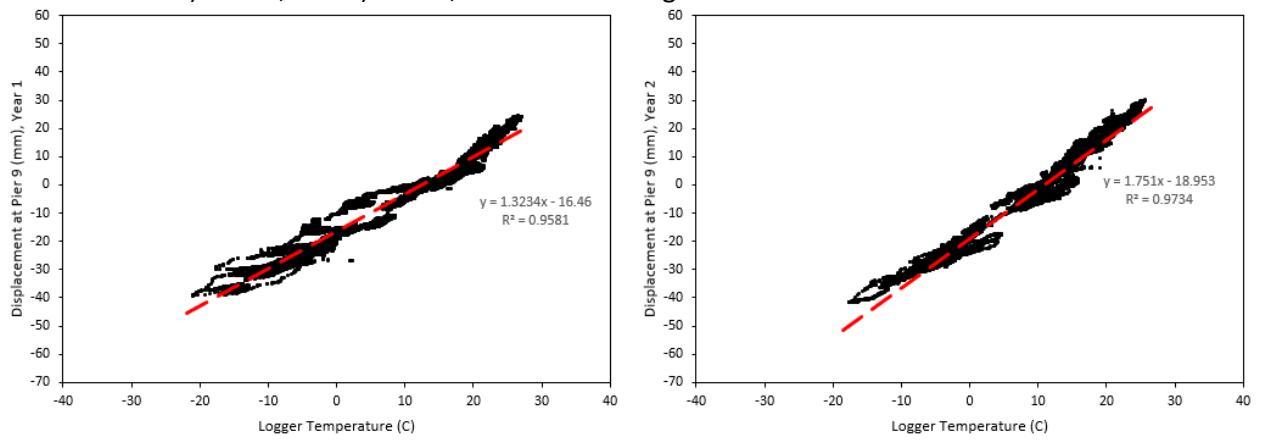
Figure 10. Pier 9 Displacement Readings Plotted as a Function of Box Internal (datalogger) Temperature for: a) Year 1, and b) Year 2, of the Monitoring Period.

The deformation data recorded at pier 13 and pier 9 are also shown to be well correlated with box internal temperature for both years of data collection. The slope of the best fit line through the pier 13 deformation/logger-temperature data in year 1 is 1.4493 mm/°C, while the slope of the best fit line through the pier 13 data in year 2 is 1.1284 mm/°C. These results suggests that, on average, bearings at pier 13 experience longitudinal displacement at a rate of 1.4 mm per degree temperature change in year 1 and 1.1 mm per degree temperature data in year 1 is 1.3234 mm/°C, while the slope of the best fit line through the pier 9 deformation/logger-temperature data in year 1 is 1.3234 mm/°C, while the slope of the best fit line through the pier 9 and 1.1 mm per degree temperature data in year 1 is 1.3234 mm/°C, while the slope of the best fit line through the pier 9 and 1.1 mm per degree temperature data in year 1 is 1.3234 mm/°C, while the slope of the best fit line through the pier 9 and 1.1 mm per degree temperature data in year 1 is 1.3234 mm/°C, while the slope of the best fit line through the pier 9 and 1.7 mm per degree temperature change in year 2.

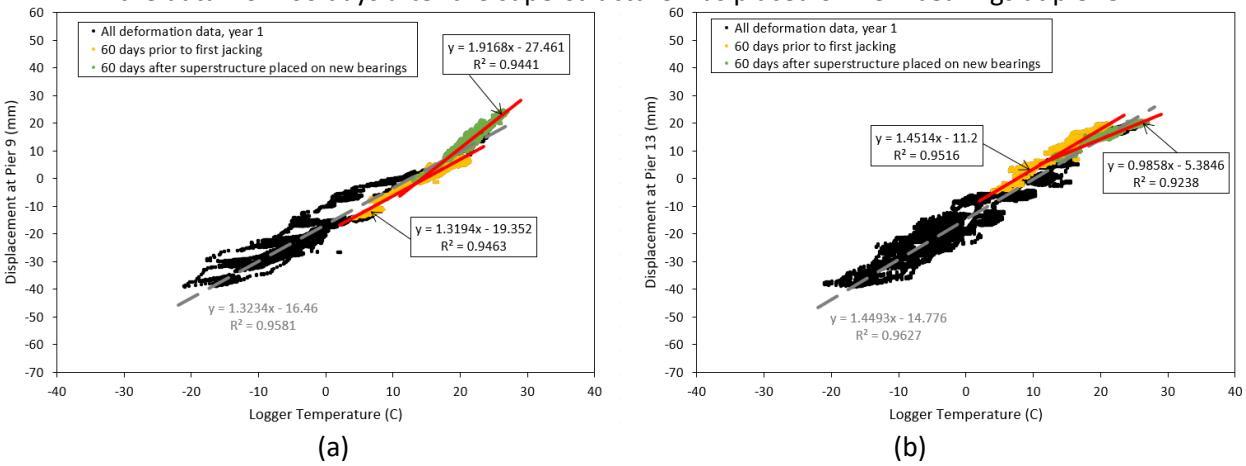
Figure 11. a) Pier 9 and b) Pier 13 Displacement Readings Plotted Against Box Internal (datalogger) Temperature highlighting 1) the data from 60 days prior to the first jacking operation, and 2) the data from 60 days after the superstructure was placed on new bearings at pier 8.

As shown in Figure 11a, the slope of the best fit line through the deformation/temperature data is considerably steeper during the 60-day period after pier 8 bearing replacement compared to the 60-day period before the bearing replacement. Similar observations are evident at pier 13 as shown in Figure 11b; the slope of the best fit line through the deformation/temperature data is considerably less steep during the 60-day period after pier 8 bearing replacement compared to the 60-day period before the bearing replacement. These results suggest that replacement of the pier 8 bearings may have relieved some restraint at this end of the structure and therefore allowed more thermal expansion at pier 9 in the period immediately following the pier 8 bearing replacement.

- The original bearings at pier 8 were replaced during 2022 rehabilitation work, which took place during the monitoring period. Interpretation of the deformation data suggests that replacement of the pier 8 bearings may have relieved some restraint at this end of the structure and therefore allowed more thermal expansion at pier 9 in the period following the pier 8 bearing replacement. However, additional observations are required.
