A NOVEL FORENSIC STUDY OF DOWEL BAR ALIGNMENT USING NON-DESTRUCTIVE METHODS

Aleks K. Kivi, MASc, P.Eng. Senior Pavement Engineer Applied Research Associates, Inc. 2904 South Sheridan Way, Suite 103 Oakville, ON L6J 7L7 <u>akivi@ara.com</u>

Paper prepared for the session "Innovations in Pavement Management, Engineering and Technologies" 2024 Transportation Association of Canada (TAC) Conference & Exhibition Vancouver, British Columbia

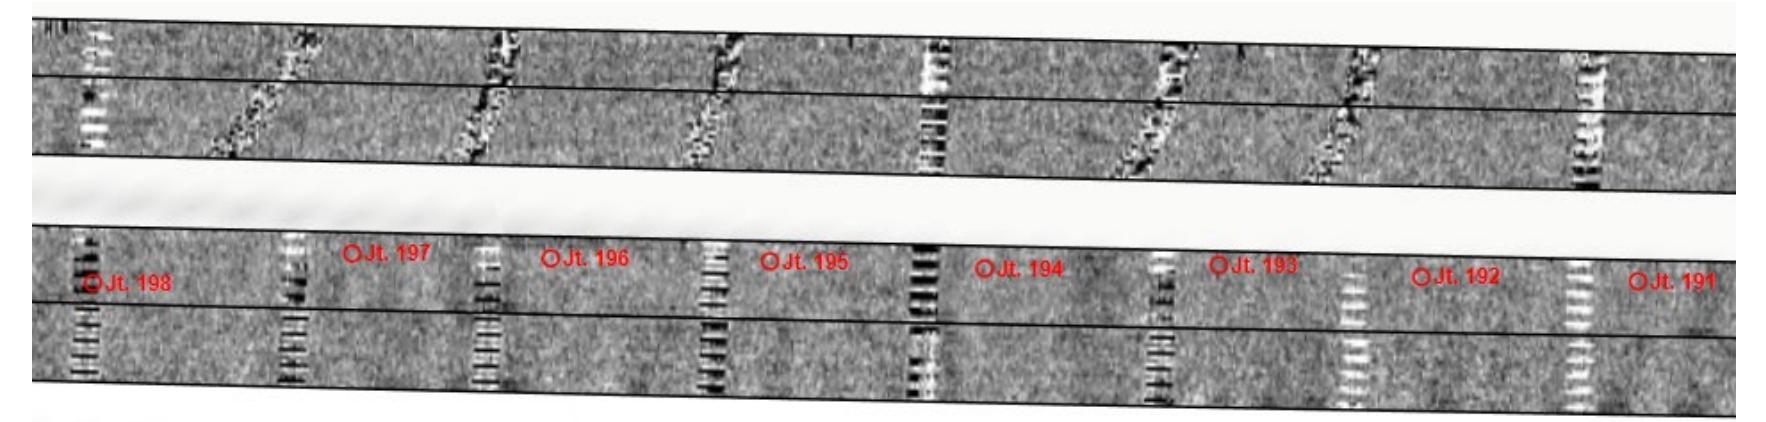
Figure 10: GPR Survey Plan View – Eight Consecutive Joints

An example comparison of the results from the two non-destructive testing equipment are shown in Figure 10 and Figure 11. Figure 10 shows the characteristics of the dowel bars in eight consecutive transverse joints, collected using the 3D GPR system. Figure 11 shows the same eight joints as evaluated using the MIT-SCAN device. Each transverse joint comprises two 3.75 m wide lanes and one concrete shoulder 3.0 m wide. Both sets of results show a large degree of rotation/displacement of the dowel basket in the outside driving lane (near the top of the images).

A thorough review of all the pairwise MIT-SCAN data and GPR data was performed. In general, the GPR plan view scans were found to be consistent with the MIT-SCAN heat maps in identifying areas of gross misalignment of the embedded dowel baskets. This was sufficient to convince the agency and the contractor that the bar misalignments reported by the MIT-SCAN results were accurate. Subsequently, the data was used to develop a remediation plan.

Using the non-destructive testing results, the contractor's engineers developed a remediation plan. The recommended activities included in the plan comprised full depth repairs, dowel bar retrofits, sawcutting of dowel bars, and sawcutting of tie bars. In the most severe cases, where the dowel baskets had been considerably displaced, full depth repairs were specified. In areas where the joints in question only had one or two bars out of alignment, or where the tie bar was overlapping the dowels, sawcutting was recommended. Where dowel bars were locally missing out of alignment, dowel bar retrofits were specified.
