Strategic Drainage Reconfiguration to Remediate a Landslide Affecting Saskatchewan's Highway 914

Paper prepared for the session SO - Testing, Modelling and Innovation for Roadway/Embankment Materials and Geotechnical Engineering 2024 Transportation Association of Canada (TAC) Conference & Exhibition Vancouver, British Columbia

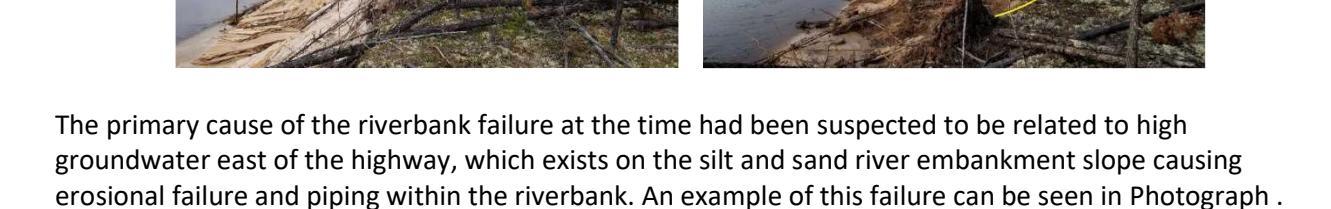
Photograph 1: Haultain riverbank - Sept 27, 2019
 Photograph 2: Haultain riverbank - Oct 18, 2019

- > 20 September 2019 to 27 September 2019 riverbank eroded 8 m in a week (over 1 m per day) and the riverbank top of slope was 50.0 m from the highway. This can be seen in Photograph 1.
- > 27 September 2019 to 1 October 2019 riverbank eroded less than 1 m per day and the riverbank top of slope was 46.5 m from the highway, and;
- > 1 October 2019 to 15 October 2019 riverbank eroded 3 m in two weeks (0.2 m per day) and the riverbank top of slope was 43.5 m from the highway. 5.0 m offset stakes were installed on 18 October 2019 along the crest of the riverbank to monitor movement and can be seen in Photograph 2.

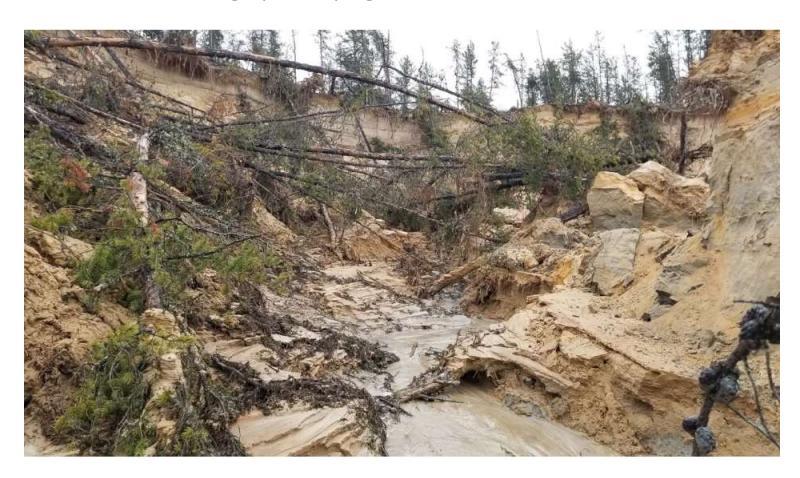
Photograph 3: Piping within Haultain riverbank

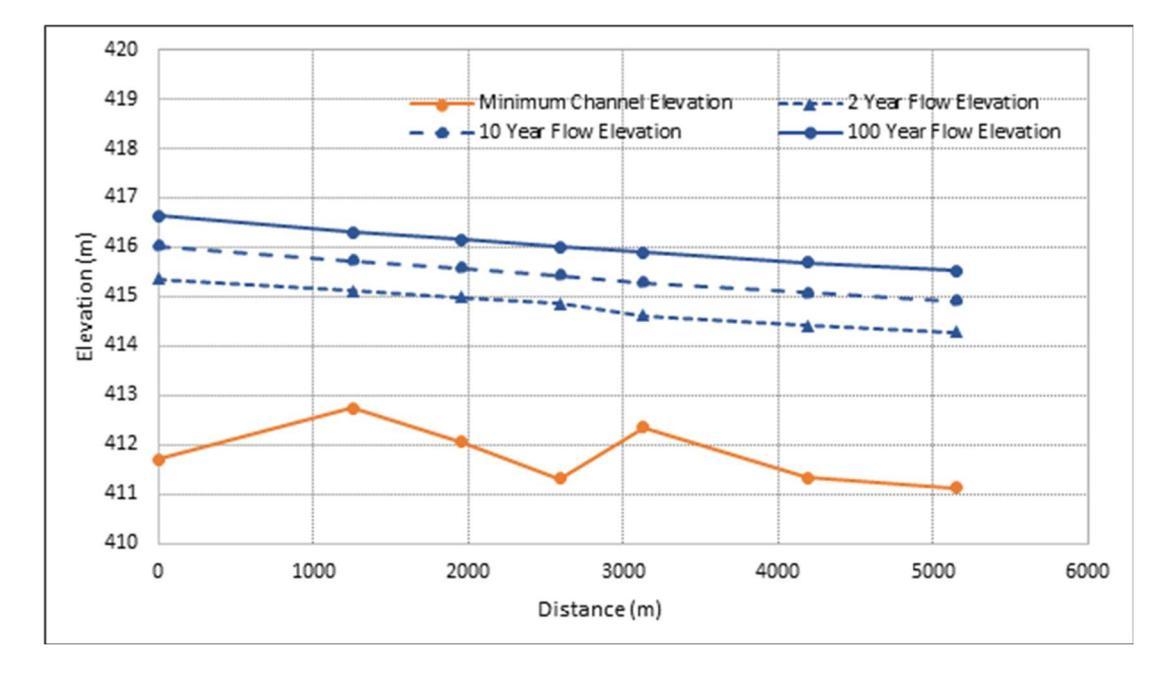
Figure 4 display the simulated water surface profiles of the Haultain River at the Site, while Figure 5 and Table 4 displays the simulation result at the river bend cross-section closest to the highway.

Figure 4: HEC-RAS simulation plot profile:

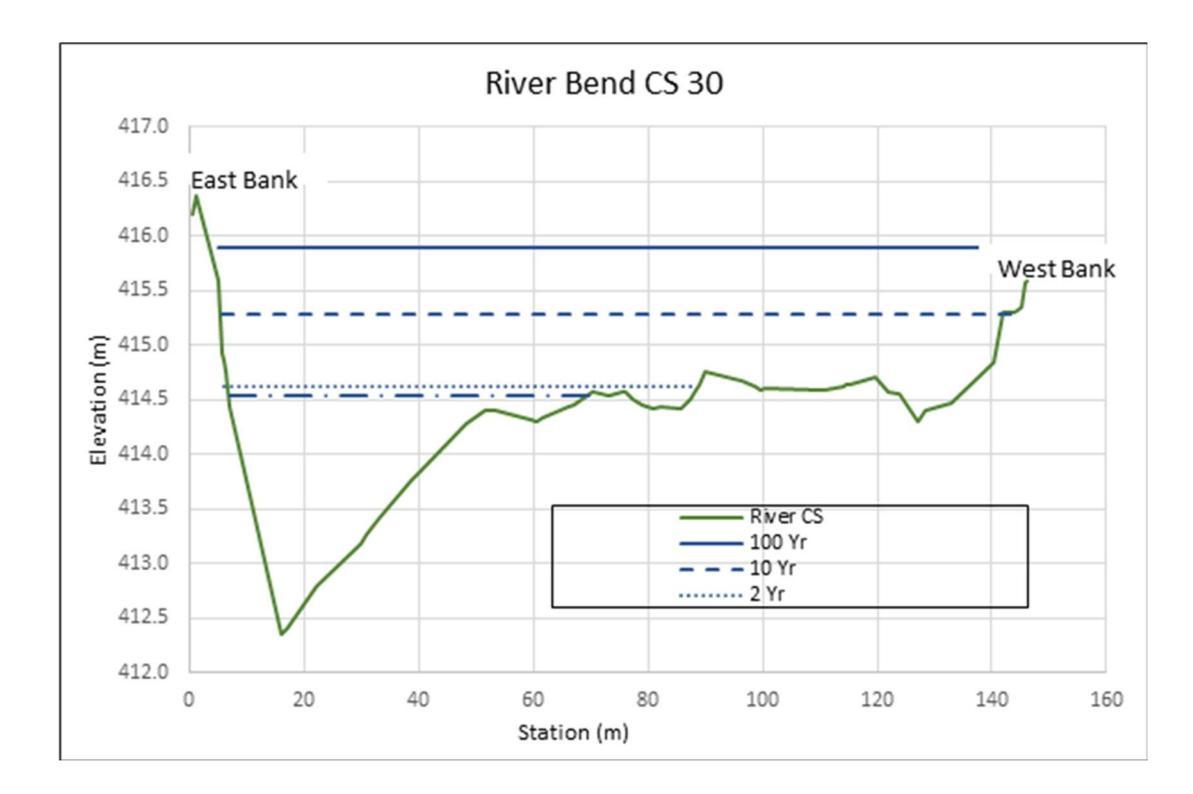
The maximum mean velocity obtained at the river bend from the simulation, was 1.0 m/s, which typically does not warrant protection. However, due to the severe river bend, the fine sand and silty sand soil, and the saturation of the embankment, the river bend is eroding and riprap could be used for

Figure 5: HEC-RAS simulation result at river bend cross-section:

mitigation. A nominal thickness of 300 mm thick riprap (D_{50} = 175 mm) was proposed with a 200 mm bedding material to control seepage and minimize piping of the underlying fine silt and sand through the voids.

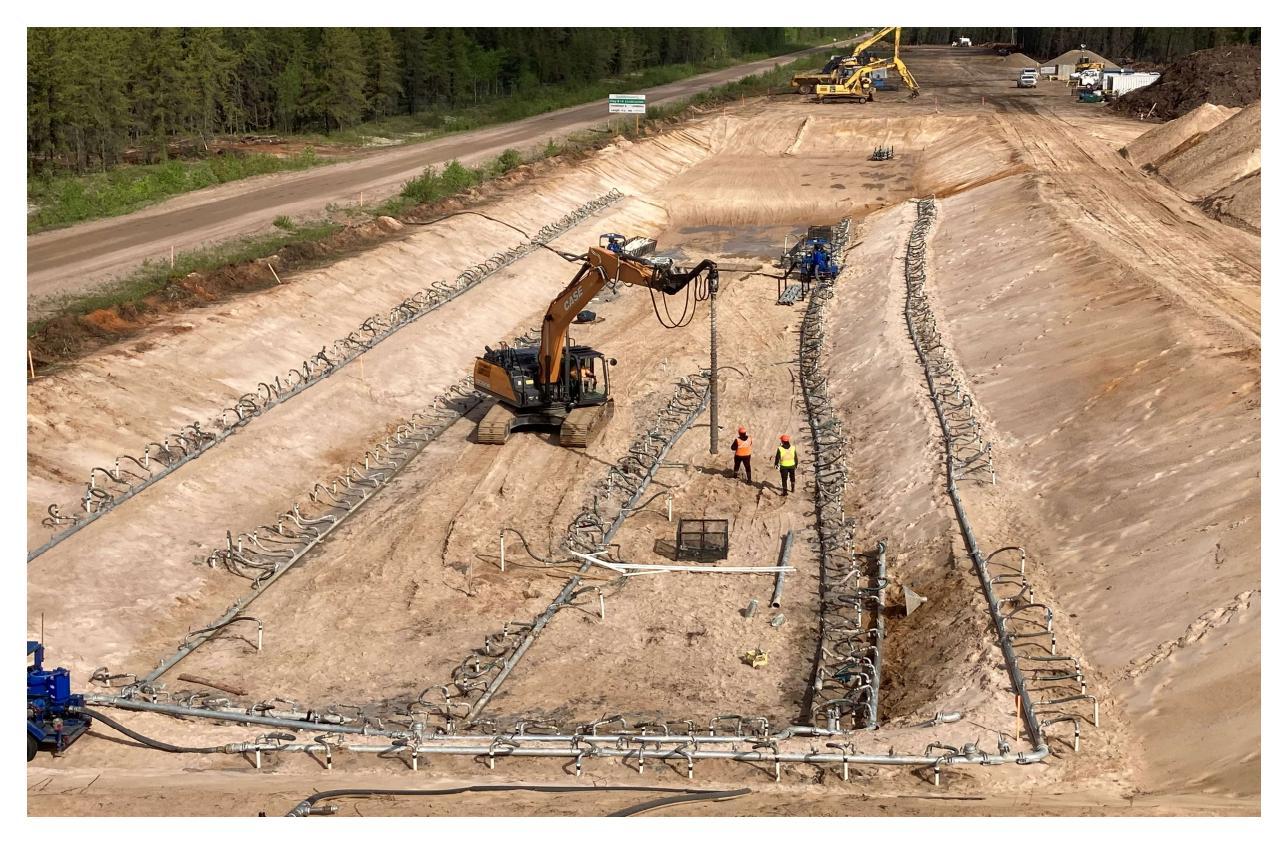
The formal well point system was implemented to facilitate construction. The well point system consisted of 2-inch PVC dewatering wells connected through a main line header pipe to Thompson rotary wet prime pumps. Dewatering well drilling and removal throughout the project was completed in segments as the subsurface drainage pipe installation progressed. Before the wells were installed an initial excavation was completed to the approximate groundwater table elevation in order to maximize the pumping production efforts. Throughout the majority of the subsurface pipe installation, two rows of wells points were installed on either side of the main excavation at an approximate 1.0 m spacing. The dewatering well scheme can be seen in Figure 6.

Figure 6: Multiple dewatering well rows

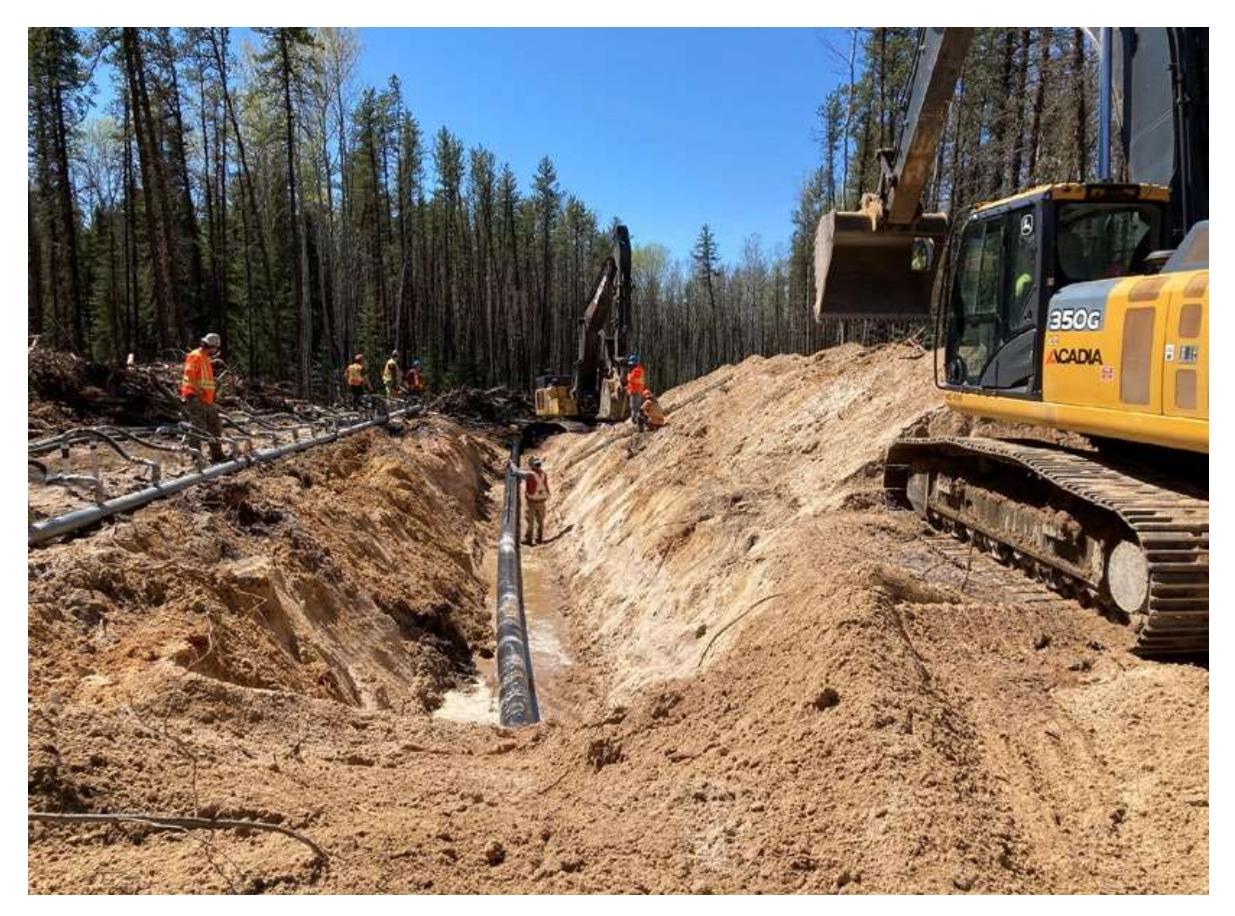
The drainage system installed at the Site consisted of a 300.0 mm diameter HDPE SDR 11 perforated HDPE pipe wrapped in non-woven geotextile, which ran 585.0 m in length, and is comprised of forty 8 mm circular perforations per meter. A granular filter was incorporated into the design and was isolated from the in-situ deposits by a non-woven geosynthetic fabric. A manhole access location was constructed to connect the north to south running perforated drainage pipe to the east to west running solid drainage pipe. The perforated subsurface drainage pipe was installed with a grade to flow southeast towards the manhole access location at the south end of the Site. Horizontal drilling was conducted to install the solid subsurface outlet pipe from the manhole location and through the highway to a riprap swale, which diverts water to a natural low-lying location away from the eroding bend along the Haultain River. Installation of the solid subsurface drain pipe can be seen in Figure 7.

Figure 7: Solid subsurface drainage pipe installation
