Rising to the Challenge: From Concept through Construction Repairs of the Existing Taylor Rd. (Callender Hamilton Through Truss Type) Bridge Grand Falls-Windsor, NL

Wade Pottie, P.Eng., ing.

Paper prepared for presentation at the Structures Session

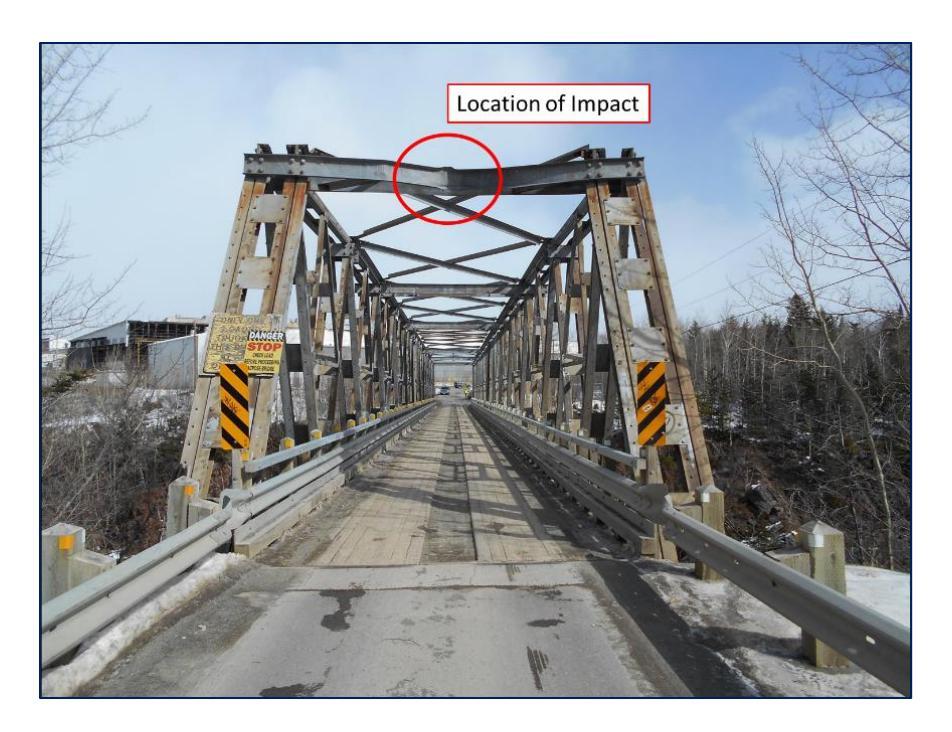
In January 2016, a truck carrying a piece of tree harvesting equipment and travelling at a relatively high speed collided with the south portal strut of the bridge. This collision resulted in severe damage to several superstructure members. The most critical members sustaining damage were the non-redundant truss top chord and diagonal members. The Callender Hamilton Bridge following the collision is shown in Figure 2 and Figure 3 below, with damage to the south portal and truss top chord clearly visible in Figures 2 and 3, respectively.

Figure 2: Damaged south portal of Callender Hamilton Bridge

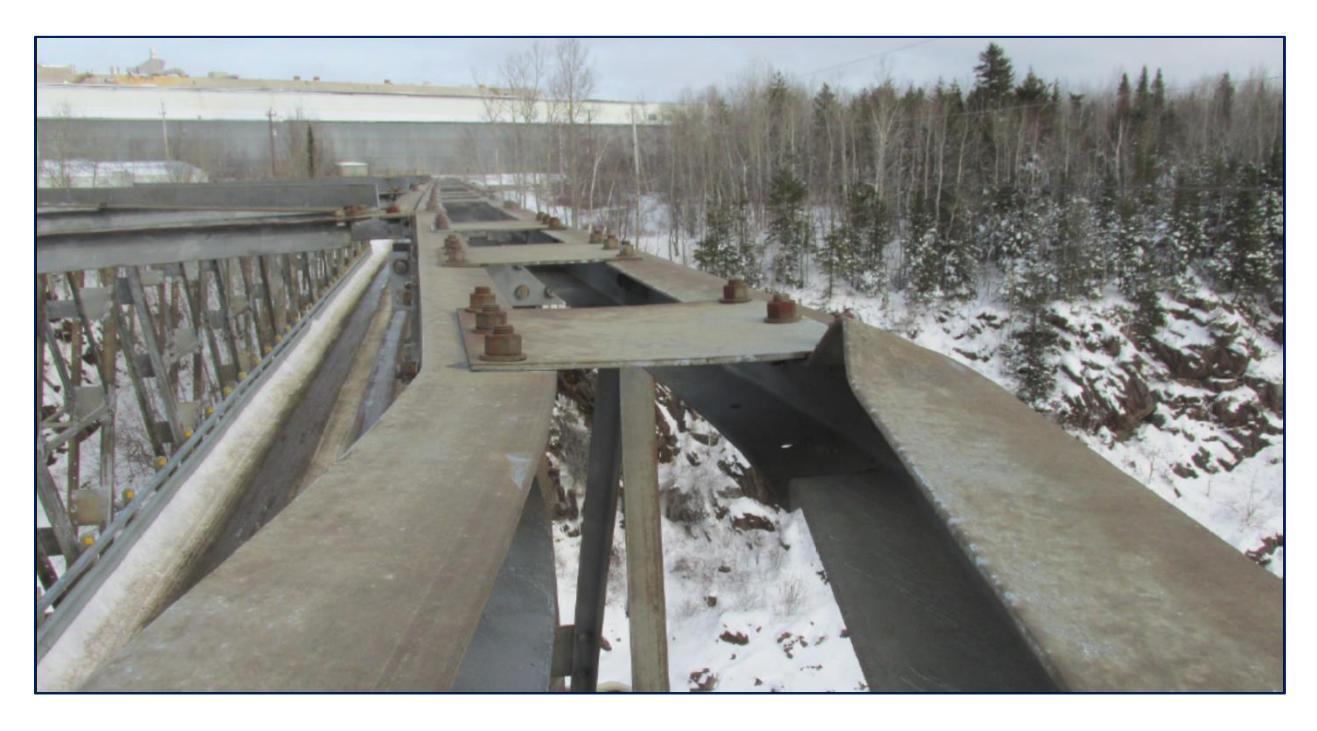
Figure 3: Buckled truss top chord of Callender Hamilton Bridge

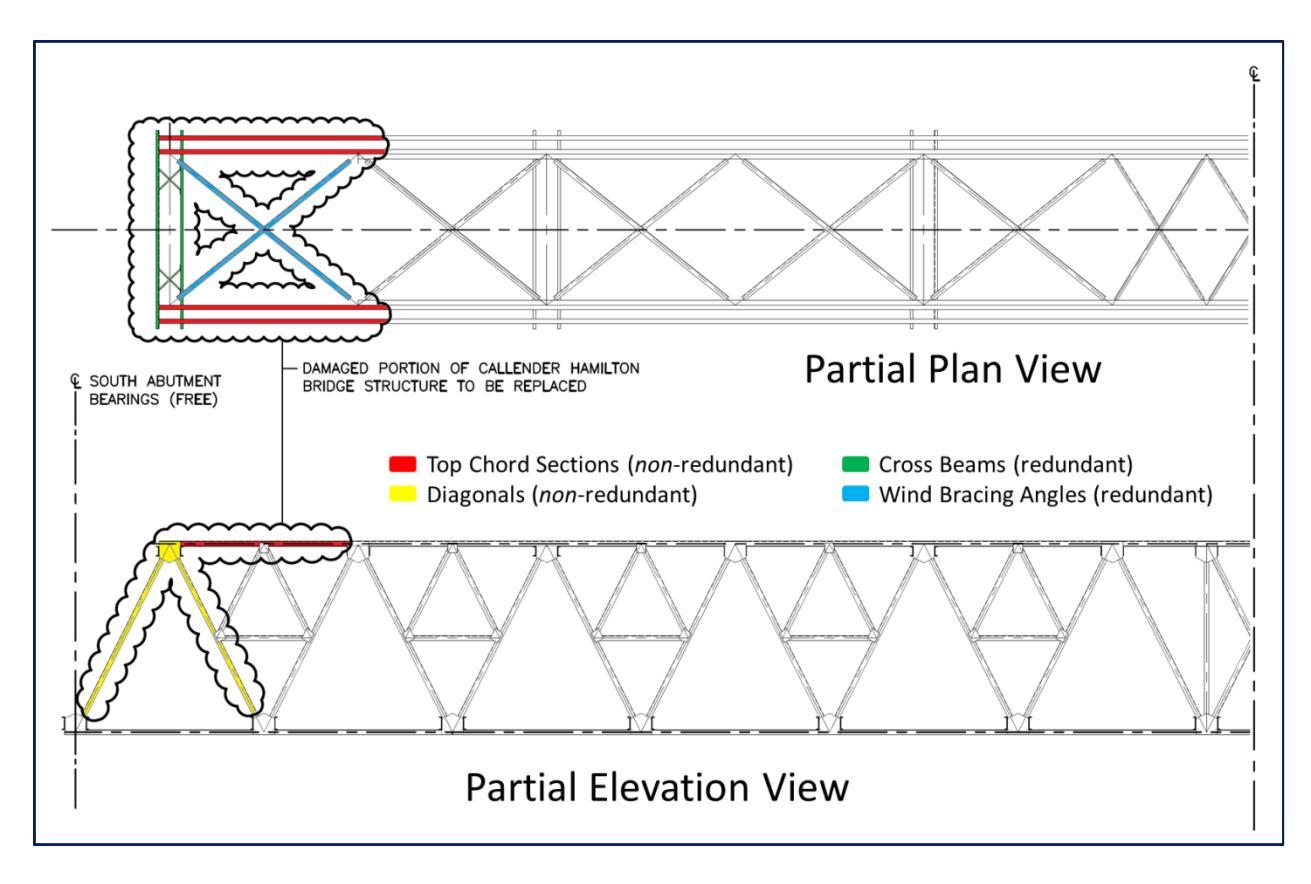
The structural members damaged during the collision included two truss top chord sections, four truss diagonals, two end portal cross beams including bracing and two top-chord transverse wind bracing members, all of which were damaged beyond practical repair and required replacement. The extents of the damage to the bridge and the members that required replacement are indicated in Figure 4 below. The truss top chord sections and truss diagonals are non-redundant members, meaning that there are no other members (i.e. no alternate load paths) to share / support the non-redundant member tributary loads. The failure of a non-redundant member would lead to structure collapse. For this reason, the repair methodology needed to provide an alternate load path to the structure to temporarily support the loads currently supported by the damaged truss members to enable their replacement. As can be seen in Figure 4, without any one of the aforementioned damaged truss top chord sections or truss diagonals in place, the structure becomes unstable and there is no path for the vertical loads to be transferred to the south abutment.

Figure 4: Extents of Callender Hamilton Bridge requiring replacement: partial plan view (top) and partial elevation view (bottom); only south half of bridge shown, north half similar

With all damaged truss members completely relieved of load following the torch cutting of the D2 diagonals, the contractor was able to proceed with the damaged member replacement. All damaged members, as indicated in Figure 4 above, were removed and replaced in-kind. Man lifts, specifically a scissor lift and a telescopic boom, along with two mobile cranes were used by the Contractor during site works as shown in Figure 12 below. The contractor also had a crane supported man basket to perform work outboard of the trusses. All newly installed members were inspected by HEC personnel, ensuring all components and connection plates had been installed and all bolts were fully pre-tensioned using the turn-of-nut method.

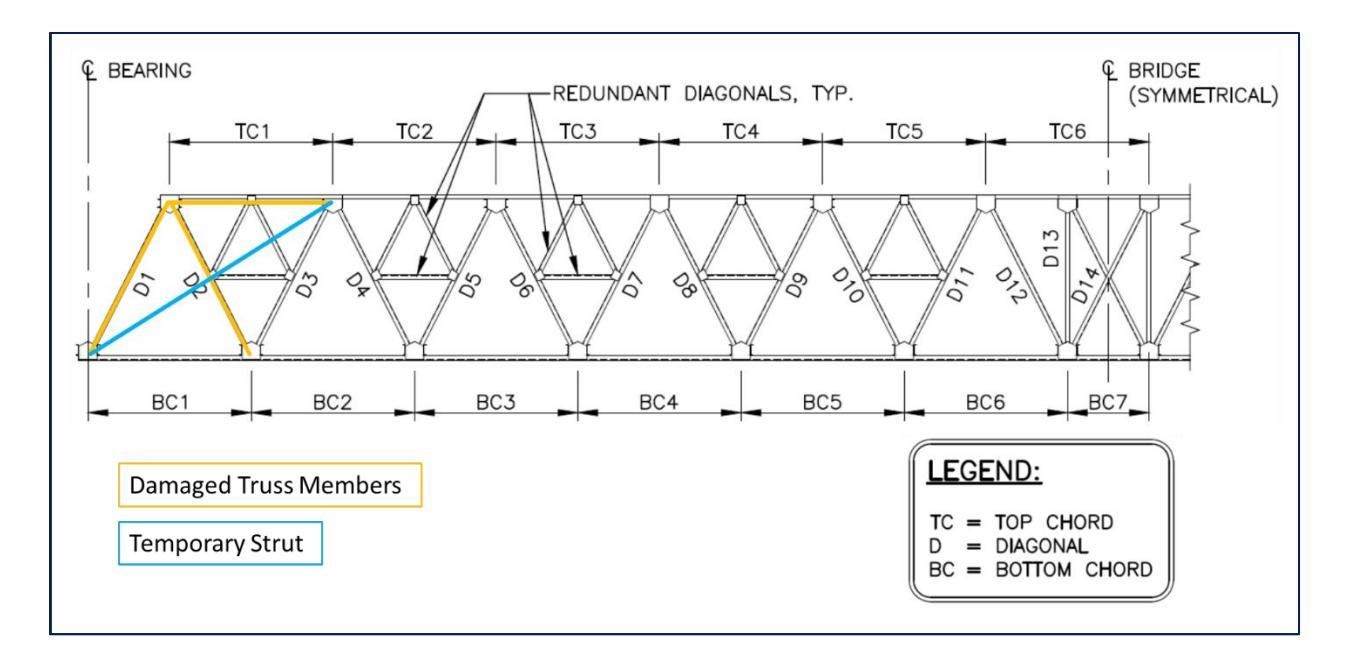
Figure 6: Temporary support concept, in which a temporary strut provides an alternate load path to allow the replacement of the damaged truss members

Following development of the above noted concepts, an alternative method that would accommodate the challenging site geometry while still adhering to the budget and schedule limitations was needed. At the conceptual stage, the ultimate solution that met all key project considerations was a temporary diagonal strut solution in which the struts would be located in the plane of the existing trusses connecting the south abutment bearing node to the second to last truss top chord node. This created an alternate load path that effectively bypasses the damaged truss members. The concept is demonstrated in Figure 6 below.

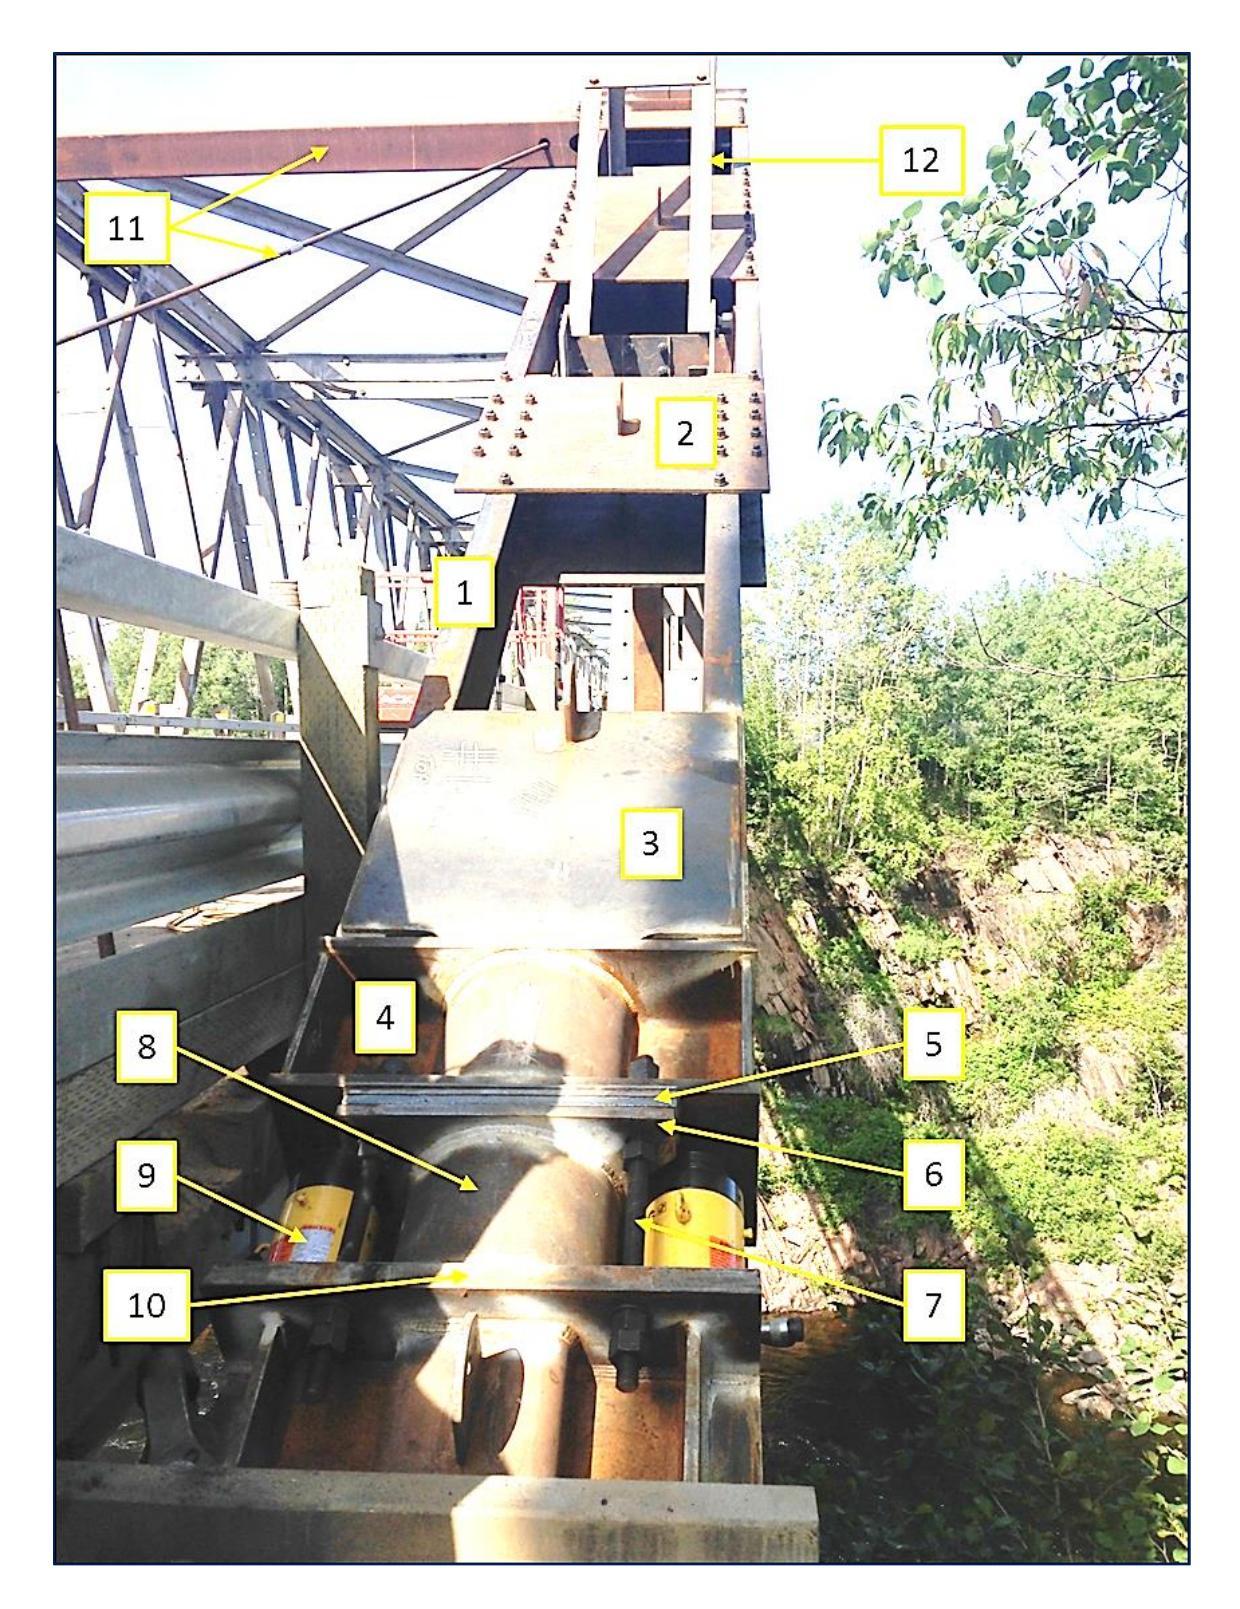
Figure 11: Assembled and loaded jacking strut and jacking system [1. MC310, 2. bolted batten plate, 3. welded batten plate, 4. strengthened W360, 5. shim plates, 6. collar plate, 7. threaded bar, 8. HSS sleeve, 9. jack, 10. jacking plate, 11. wind strut and wind cross bracing, 12. existing truss diagonal]

Once it had been confirmed that an adequate amount of load had been transferred to the jacking struts, the jacks were locked off, shim plates were installed between the two strut segments (W360 bottom flange and collar plate) to provide longitudinal continuity to the strut, and the threaded bars were snug tightened. The placement of the shim plates and tightening of the threaded bars served to secure the jacking struts in their extended positions. The pressure was then then slowly released from the jacks, gradually transferring the loads from the jacks to the shim pack / internally into the struts. The cross bracing threaded bars were then tightened into a snug, strain-compatible condition to provide a load path for transverse wind loads during member replacement. At this stage, all loads were relieved in the existing truss members, all temporary works assemblies were installed, and the Contractor was ready for member replacement. A fully-constructed and fully-loaded built-up jacking strut / jacking system, with all components labelled, is shown in Figure 11.

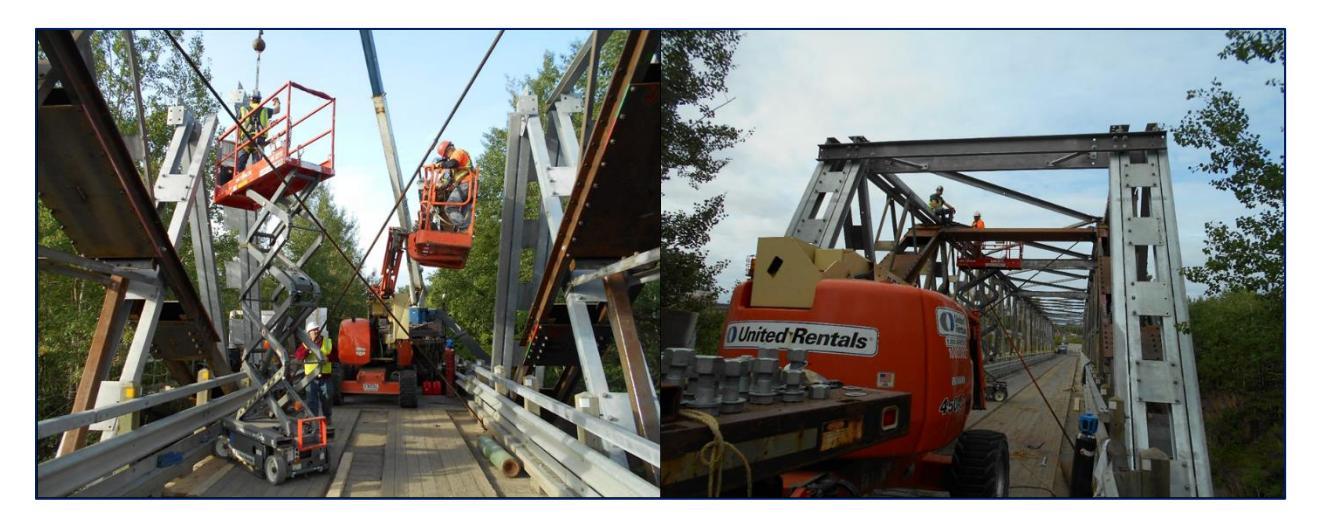
Figure 12: Truss member replacement operations underway (*left*); newly installed truss members (*right*)

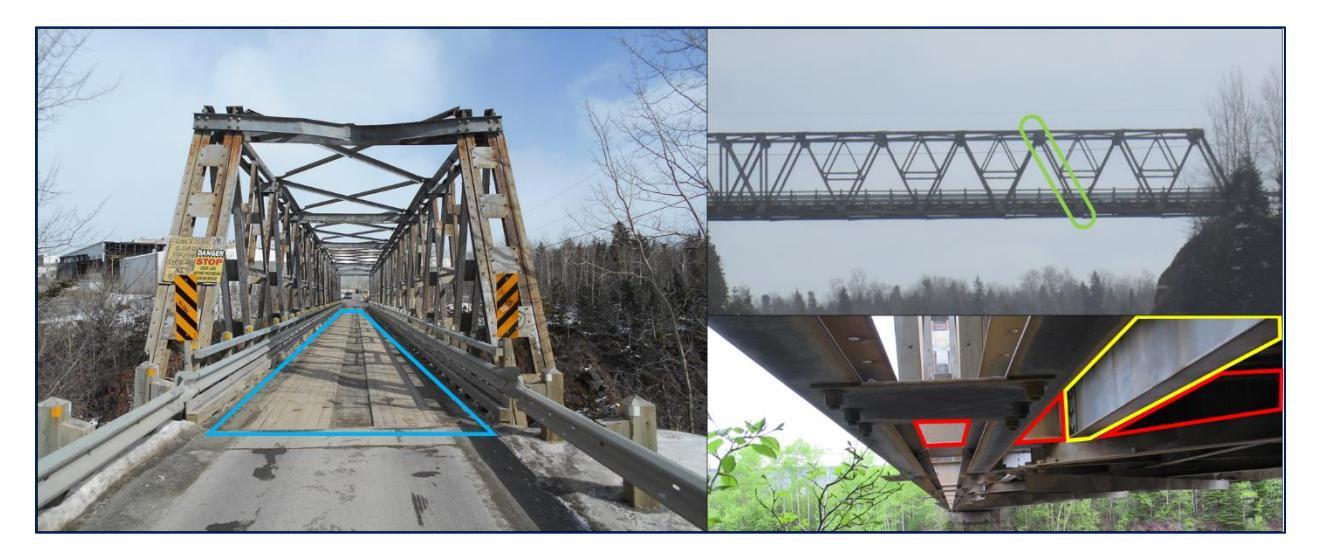
Aside from the collision damage repair design and procedures, HEC conducted a full superstructure evaluation, in accordance with Section 14 of the CHBDC, to determine the live load carrying capacity of the existing bridge. During this evaluation, it was determined that a number of structural elements did not meet the CAN/CSA S6-14 (CHBDC) requirements for the full CL-625 live loading, the current design truck used for the design of highway bridges in Canada. When the bridge was designed and constructed in the early 1960's, a lighter HS20-44 design truck was the standard live loading considered when designing highway bridges in Canada. It should be noted that the bridge does not appear to have been under-designed, although some of the structural elements were efficiently designed according to the HS20-44 design truck, which as a result of the increased live loading does not meet the current requirements the CHBDC. The structural members that did not meet CHBDC CL-625 loading

requirements included the timber decking, the longitudinal stringers, below deck crossbearers, and four truss diagonals (one diagonal, mirrored at all four truss corners). The aforementioned overstressed members have been highlighted for reference in Figure 13 below. It should be noted that the longitudinal stringers and truss diagonals were only marginally overstressed (i.e. less than 5%), while the timber decking and cross bearers were more significantly overstressed, with the crossbearers governing at 35% overstress. As a comparison to the current CHBDC CL-625 truck, HEC calculated the demands in the crossbearers using the historical HS20-44 design truck and determined that the overstress was only 3% (i.e. in other words a reasonable and efficient design). The main reason for the increase in overstress in the crossbearers (which are local components governed by axle loads, rather than governed by full bridge global loads) is the fact that the axle spacing for the CL-625 truck is significantly closer than the axle spacing on the HS20-44 truck and as a result the crossbearers are required to resist nearly two full 125 kN axles of the CL-625 truck at spacing of 1.2 meters vs rather than just the one 142 kN axle of the HS20-44 truck.

Figure 13: Structural members not meeting CAN/CSA S6-14 requirements to carry full CL-625 loads: timber deck (blue), truss diagonals (green – fifth member from each end, both trusses), longitudinal stringers (yellow, below deck), and crossbearers (red, below deck)

Strengthening and/or replacement of the crossbearers not meeting CHBDC requirements was deemed impractical due to the number of overstressed crossbearers (26 in total) and the challenges associated with difficult access for site works below the bridge deck, which would lead to significant costs. Based on HEC's additional analysis, where the crossbearer capacities were compared to the NL legal axle weight limits, HEC recommended posting an axle limit sign based on the actual capacity of the crossbearers (as shown in Table 1 above). This recommendation results in no weight restrictions when compared with NL legal load limits for single and tandem axles and only an 8% maximum restriction on tridem axles.

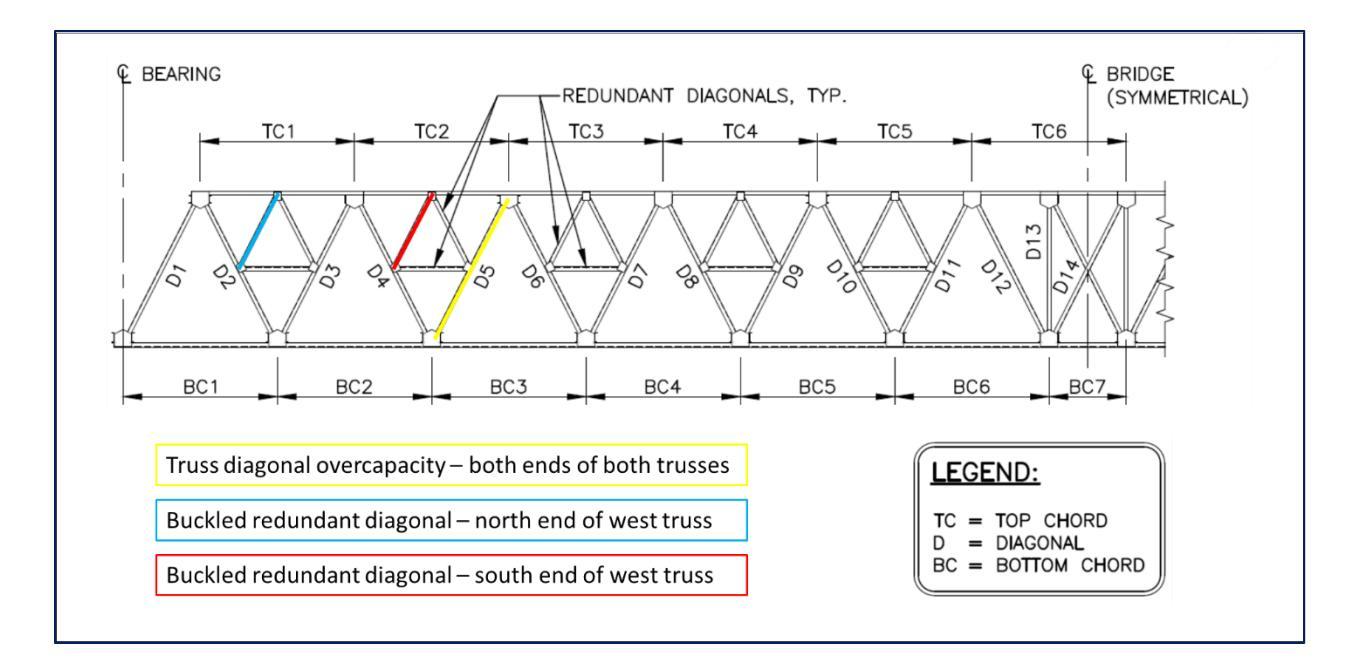
Figure 14: Locations of overcapacity and buckled diagonal truss members (one side of one truss shown)

Additionally, it was observed during HEC's site visit that two redundant diagonals were buckled (likely due to previous vehicular collisions). The redundant diagonals in the structure do not carry any load, but play an important role in the stability of the structure as they serve as braces for the non-redundant diagonals and top chord members to reduce their effective bucking lengths. The locations of the buckled diagonal truss members are indicated in Figure 14 above.

Due to the importance of the redundant diagonals for the overall stability of the trusses, NLDTW proceeded with the replacement of the two buckled redundant diagonals as recommended. The replacement procedure, which was designed by HEC and included the installation of a temporary brace to stabilize the truss members during the redundant diagonal replacement, was completed by the Contractor immediately following the vehicle collision repairs.
