Development of a Mortar Abrasion Test for Fine Aggregates and Wear Resistance of Concrete Pavements

Paper prepared for presentation at the
Innovation in Pavement Management, Engineering and Technologies- Design Application Session
of the 2016 Conference of the
Transportation Association of Canada,
Toronto, ON

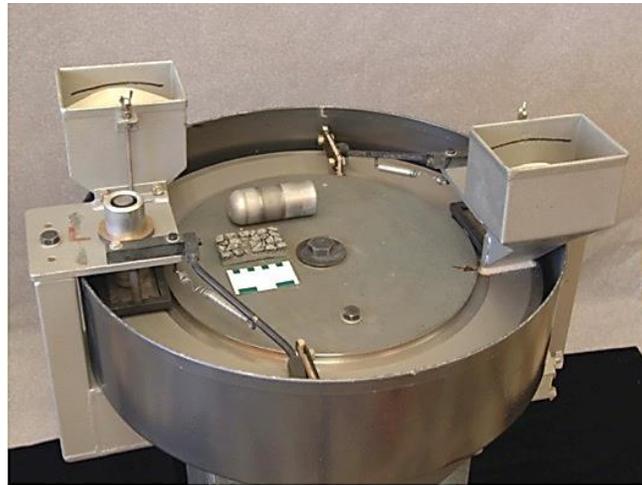
Figure 2. Aggregate Abrasion Value Test Apparatus

The AAV test exposes aggregates to grinding by direct shear on a large mechanical lap wheel with abrasive sand (Figure 2). The lap rotates at 30 revolutions per minute for a total of 500 revolutions while the dry abrasive charge is fed onto the lap in front of each specimen. The index used to evaluate abrasion, the AAV, is the average mass loss of two specimens in grams, when measured before and after the test, multiplied by the volume of the aggregate and divided by the aggregate's relative density.

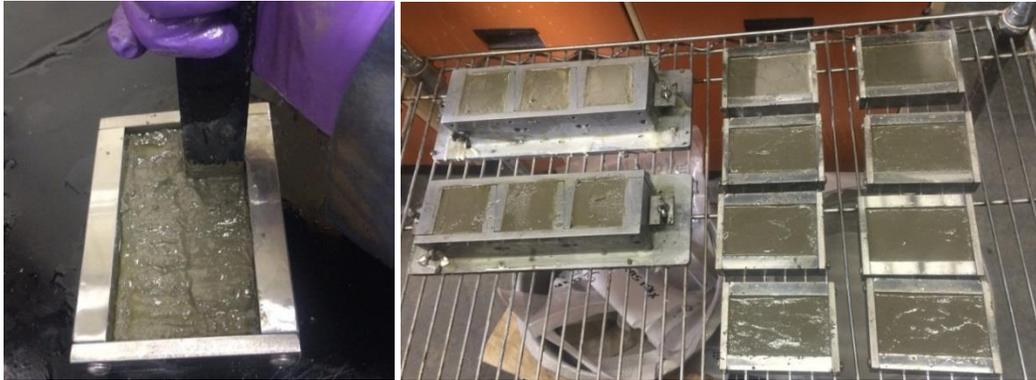
Figure 5. Casting process of a set of mortar coupons and cubes for each aggregate.

The mixing procedure was completed according to ASTM C305 (Standard Practice for Mechanical Mixing of Hydraulic Cement Pastes and Mortars of Plastic Consistency). Each cement mortar coupon and compressive strength cube was cast into its respective mold in two lifts (Figure 5). Each lift was compacted 36 times using a rubber tamping rod. After casting, any excess mortar was cleaned away and the surface was finished using a trowel.
