# Investigating the Freeze-Thaw Damage in Asphalt Concrete Using Imaging Techniques

This paper was prepared for presentation at the Innovations in Pavement Management, Engineering and Technologies (PS) Session at the **2020 TAC** Conference & Exhibition, online conference.

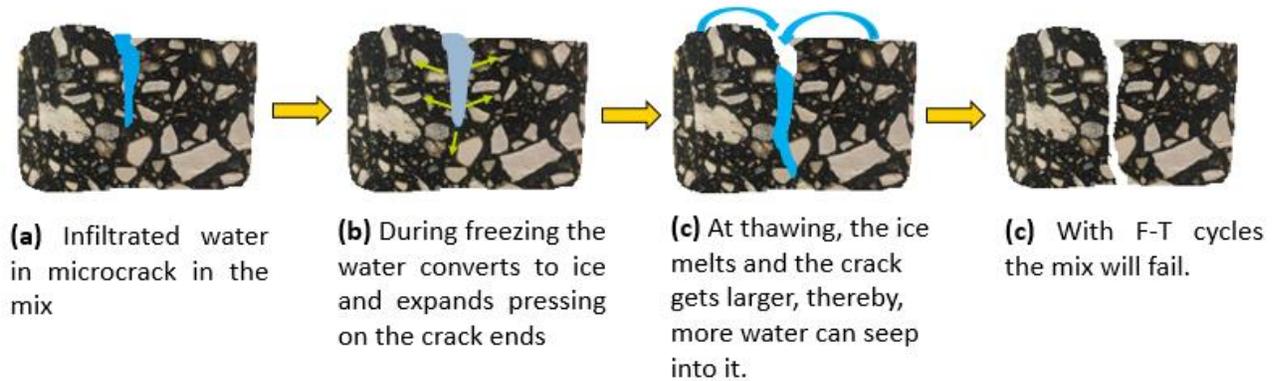
**Figure 1.** F-T response of the infiltrated water inside the AC

Asphalt concrete (AC) or asphalt mixture is the top layer of the flexible pavement. It is a heterogeneous mixture that consists of aggregates in different sizes, asphalt binder, and air voids. The behaviour of the AC mixture depends highly on its internal structure. After exposure to freeze-thaw (F-T) cycling, the loss of adhesion at the asphalt binder-aggregate interfaces and/or the loss of cohesion within the asphalt binder itself deteriorate the integrity of the AC mixture (Si et al. 2014, Goh and You 2012). **Figure 1** shows an example for failure mechanism of water infiltration into the microcracks/pores of the AC mix combined with F-T cycling.

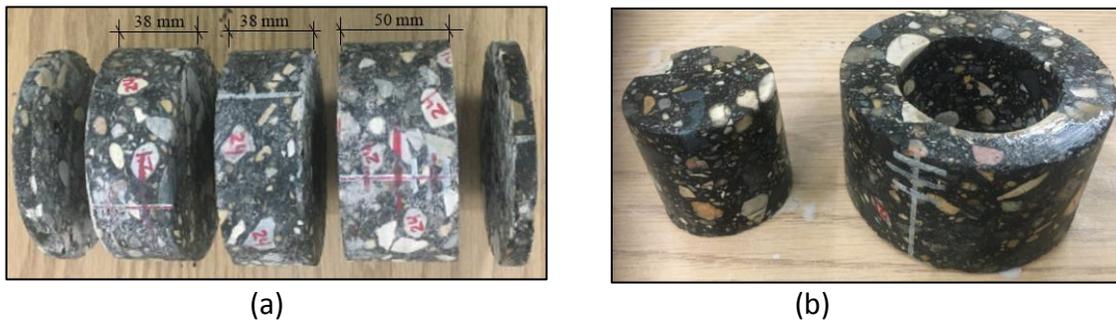
**Figure 2.** AC samples for F-T testing: (a) Cutting samples into slices (b) extracted small core for X-ray CT scan.

AC field cores, 100 mm in diameter and 150 mm in height, were collected from different projects with different types of AC mixtures (0% RAP and 10% RAP). Each sample was cut into two slices (diameter=100 mm and height=38 mm height), and one small core (diameter =50 mm and height =50 mm), as shown in **Figure 2**. Before exposing to F-T cycles, the faces of the slices were mapped using an iPhone XR camera and a Nikon stereomicroscope and the extracted small cores, **Figure 2 (b)**, were scanned at Canadian Light Source (CLS) using x-ray CT system.

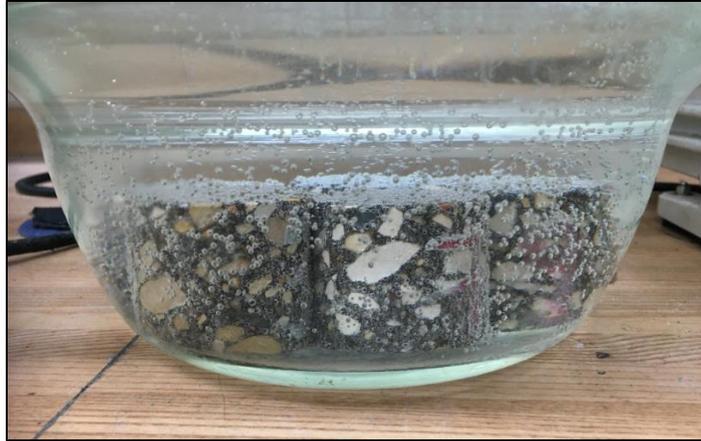
**Figure 3.** Vacuum saturation of AC Samples

Before F-T conditioning, samples were saturated using vacuum saturation to make sure that permeable air voids in the sample are filled with water. A modified method of NCHRP 246 was used in this study. Samples were placed in a desiccator with distilled water covering the samples under pressure ( $P \leq 5 \times 10^{-4}$  torr) for 10 minutes, as shown in **Figure 3**. Then, the vacuum pump was stopped, and the samples were left under a constant low-pressure vacuum. A constant low-pressure vacuum is required to reach a certain percentage of saturation in AC specimens without creating severe micro-damage (Yi et al., 2016). Samples reached full saturation after two weeks.

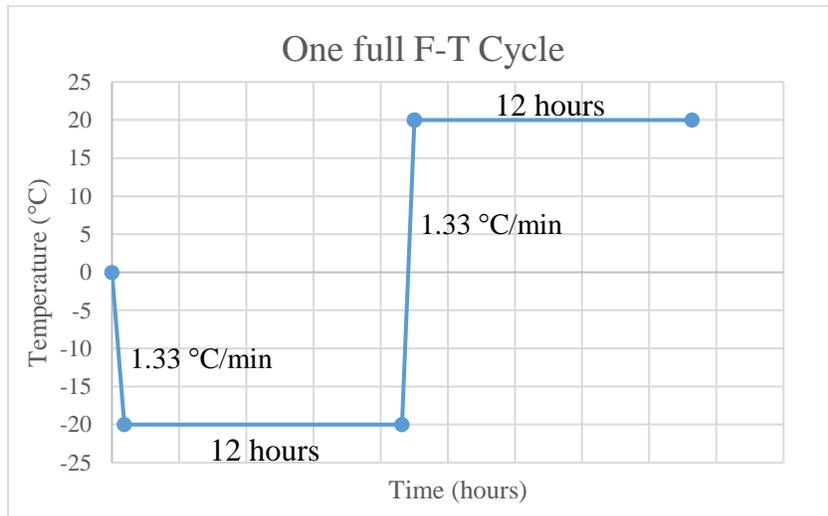
**Figure 4.** One full F-T cycles for 24 hours (one day).

After saturation, samples were subjected to 30 F-T cycles using an environmental chamber. The cooling /heating rate of air inside the chamber was  $1.33\text{ }^{\circ}\text{C}/\text{min}$ . The duration of one F-T cycle was 24 hours with 12 hours of freezing at  $-20\text{ }^{\circ}\text{C}$  and 12 hours of thawing at  $+20\text{ }^{\circ}\text{C}$ , as shown in **Figure 4**. These temperatures are the average temperatures in Saskatoon-Canada during winter and summer, respectively, according to the world weather online website from 2009 to 2020, **Figure 5**.

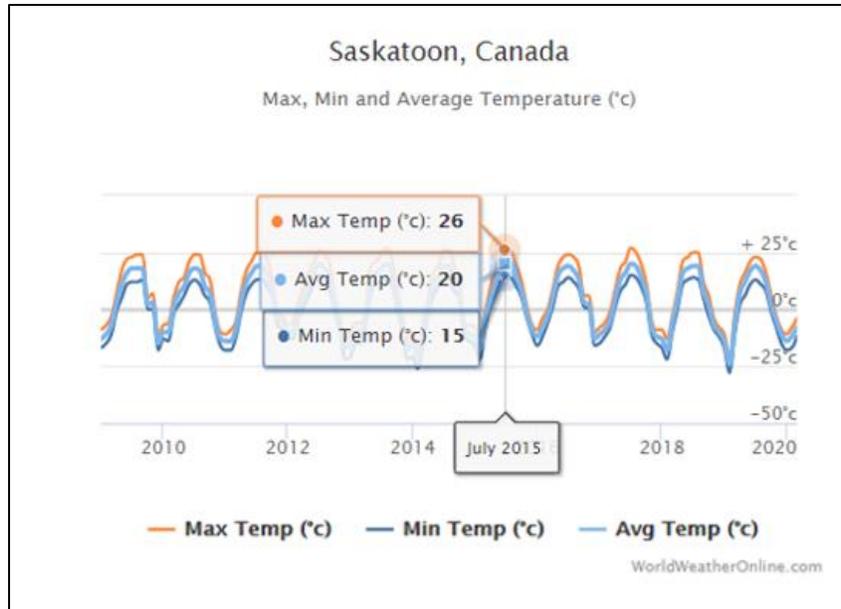
**Figure 5.** Minimum, maximum and average temperatures in Saskatoon-Canada through the years from 2009 to 2019 according to the world weather online website (<https://www.worldweatheronline.com/saskatoon-weather/saskatchewan/ca.aspx>).

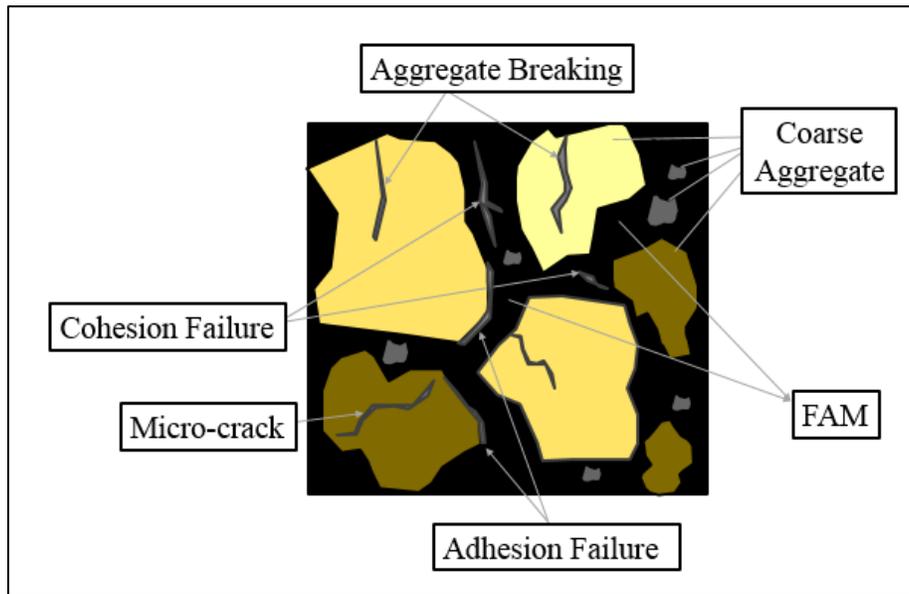
**Figure 6.** Types of F-T damage in AC mixtures

Image analysis of F-T conditioned samples can help in characterizing the failure mechanism of AC samples. **Figure 6** shows the types of F-T damage that can present in the internal structure of AC mixtures. Broken particles of coarse aggregate indicate that the coarse aggregate matrix in the main source of F-T damage in the AC mixture. Adhesion failure indicates that the bond between

coarse aggregate particles and asphalt binder cannot resist F-T cycling. A cohesion failure within the asphalt binder indicates that the asphalt binder cannot resist F-T cycling.

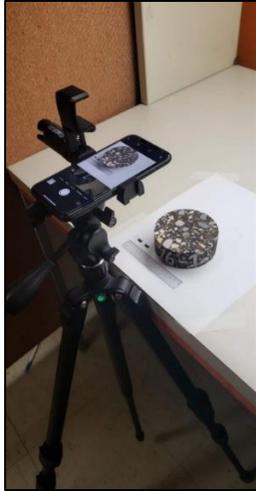
**Figure 7.** Digital camera imaging set-up.

In this technique, an iPhone XR camera with a resolution of 1.4  $\mu\text{m}$  or 326 pixels per inch (ppi) was used to collect a set of top view 2D images for the AC slices. A tripod was used to fix the phone at a height of 20 cm above the samples. The upper and lower surface of each slice were mapped before F-T cycling and after 30 F-T cycles. **Figure 7** shows the iPhone imaging set-up.

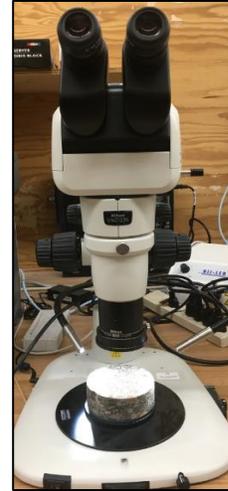
**Figure 8.** Stereomicroscope (SMZ1270i) with AC slice.

The microscopic technique can be employed to provide magnified images that show more details about the internal structure of the AC mixture. Stereomicroscopes are powerful tools in this area as they provide a high level of precision, allowing the micro changes in the AC internal structure to be identified and analyzed under high-resolution. Nikon stereomicroscope (SMZ1270i), **Figure 8**, with high camera resolution (1.32  $\mu\text{m}$ ) and a best-in-class zoom ratio of 12.7x (0.63x-8x), was used to get magnified images for the upper and lower surface of the AC slices. 2D images were collected before F-T cycling for the same surfaces that were mapped using the previous technique. The samples supposed to be evaluated again after 30 F-T cycles, but the test was delayed to the current circumstances related to the coronavirus situation.

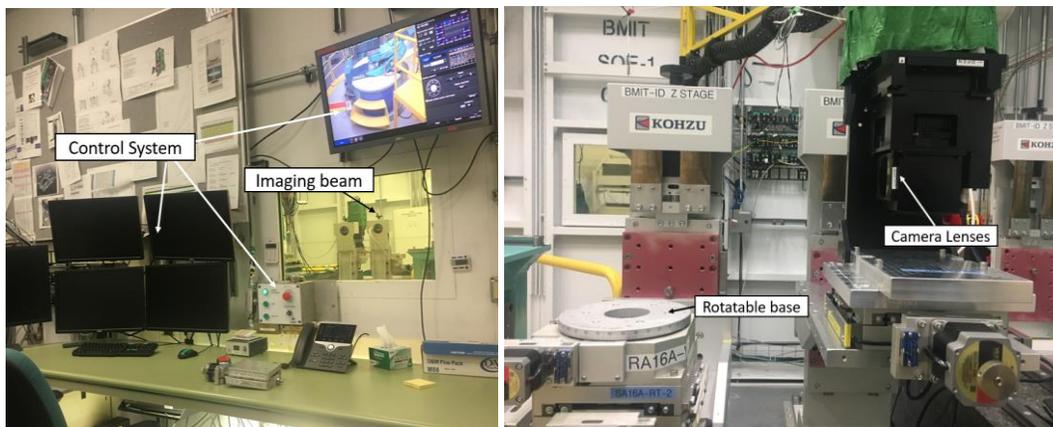
**Figure 9.** BMIT-ID beamline at CLS

The small cores that were extracted from the AC field samples were scanned using the X-ray CT system at the Canadian Light Source (CLS). The small cores, 50 mm in diameter and 50 mm in height, were scanned using the Biomedical Imaging and Therapy Facility (BMIT) - Insertion Device (ID) beamline, **Figure 9**. A core size of 50mm x 50mm is the maximum size that can be scanned at the BMIT-ID beamline in CLS with a high resolution of 13  $\mu\text{m}$ .

The BMIT-ID beamline delivers an X-ray beam with a photon flux density enough to acquire a monochromatic CT scans in a relatively short time. The spectral range extends to 140 keV, which can be used to penetrate through thick and absorbing samples, such as AC cores, and investigate their internal structure. **Table 1** shows a comparison between the imaging techniques used in this study.

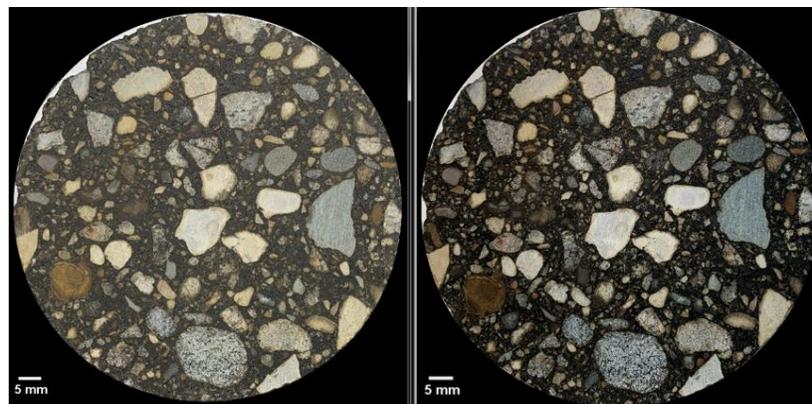
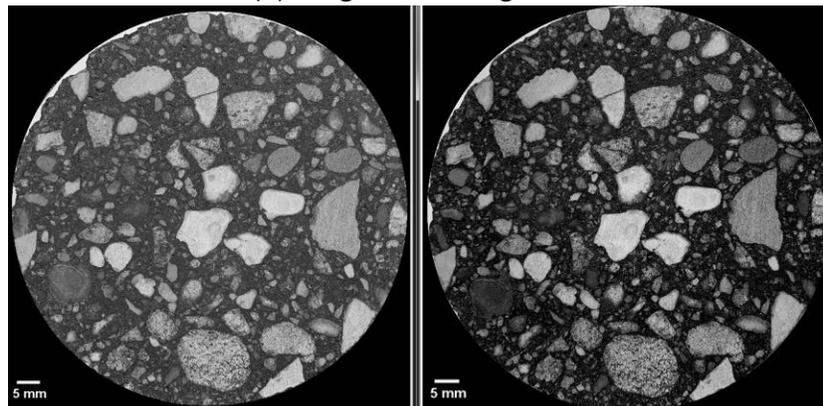
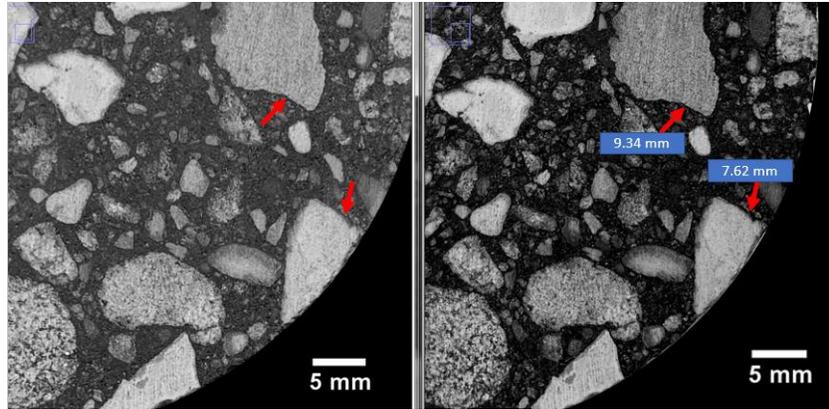
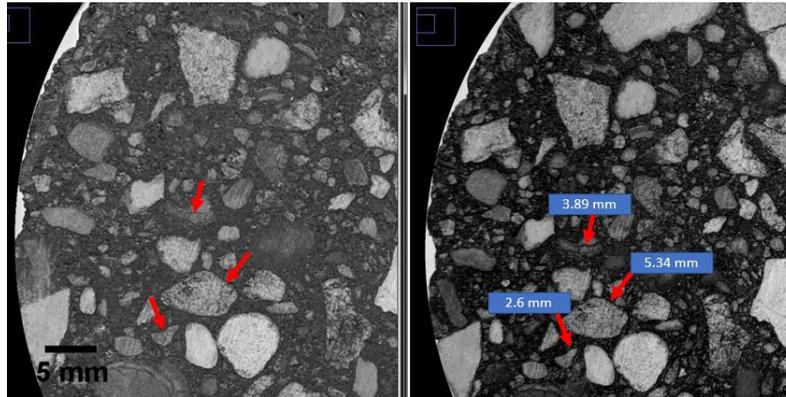
(a) Original 2D images

(b) 8-bit images

(c) Adhesion failures at lower-left part of the sample

(d) Broken aggregate and adhesion failures at the left side of the sample

**Figure 10.** ImageJ analysis for 2D digital camera images of the lower face of sample 2 (0% RAP) at 0 F-T cycles (right) and after 30 F-T cycles (Left)

ImageJ software was used to analyze the collected 2D images and CT scans. ImageJ is a public domain Java image processing program. The software can measure distances, areas, and angles. In addition, ImageJ supports standard image processing functions such as contrast manipulation, sharpening, smoothing, edge detection, and median filtering. All analysis and processing functions are available at any magnification factor. This software is used extensively for biological tasks such as cell detection, but it was used in this study for microanalysis of AC mixtures. **Figure 10(a)** shows the images taken by the digital camera for the lower face of sample 2 (0% RAP) before and after 30 F-T cycles. To be analyzed using ImageJ, the coloured images were converted to 8-bit images, as shown in **Figure 10(b)**. **Figure 10(c)** shows that after 30 F-T cycles, there is a loss of adhesion between the coarse aggregates and the fine aggregate matrix (FAM). **Figure 10(d)** shows a broken coarse aggregate particle and more adhesion loss within the mixture. The total length of the micro-cracks in this cross-section was 28.79 mm.

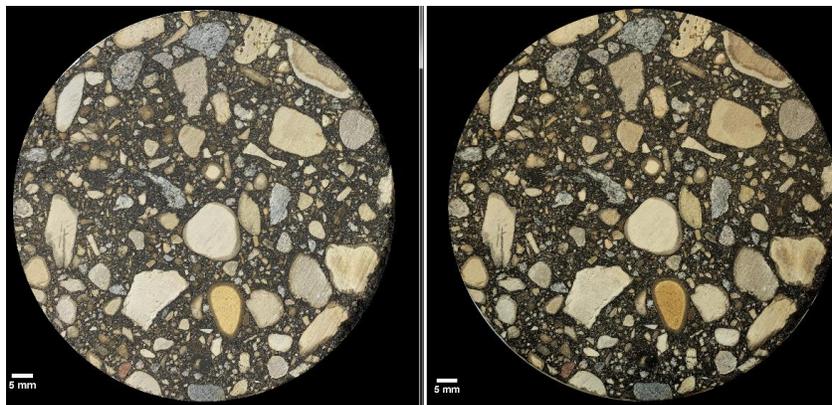
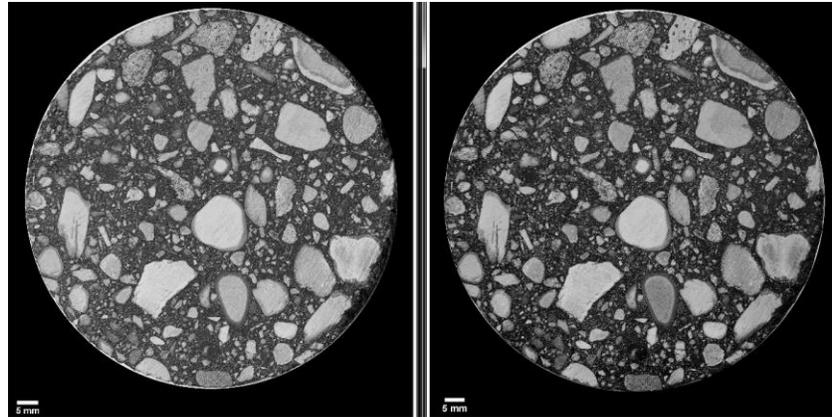
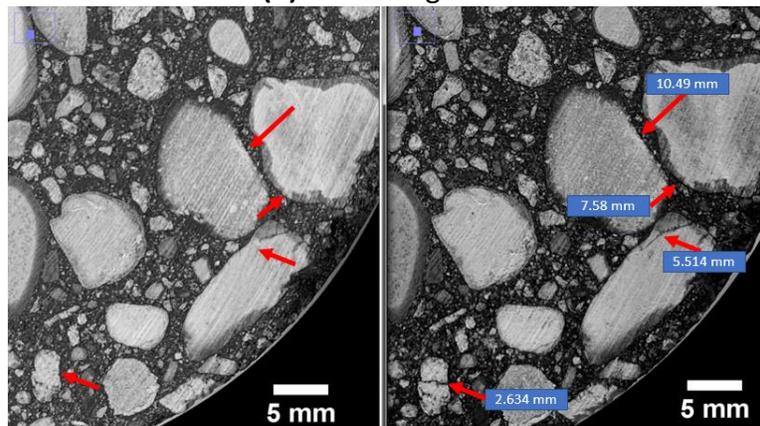
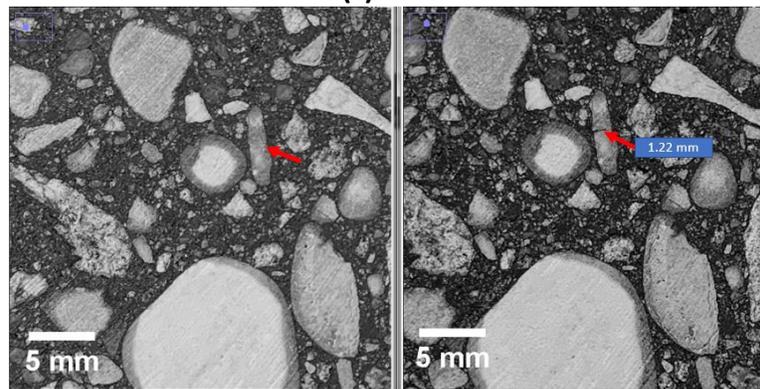
(a) Original 2D images

(b) 8-bit images

**Figure 11.** ImageJ analysis for 2D digital camera images of the lower face of sample RAP-2 (10% RAP) at 0 F-T cycles (right) and after 30 F-T cycles (Left).

**Figure 11(a)** shows the images taken by the digital camera for the lower face of sample RAP-2 (10% RAP) before and after 30 F-T cycles. After 30 F-T cycles, sample 4 experienced length increase of exiting micro-crack in coarse aggregates, breakage of coarse aggregates, and adhesion loss between coarse aggregates and FAM as shown in **Figures 11(c)** and **11(d)**. The total length of the micro-cracks in this cross-section was 27.43 mm.

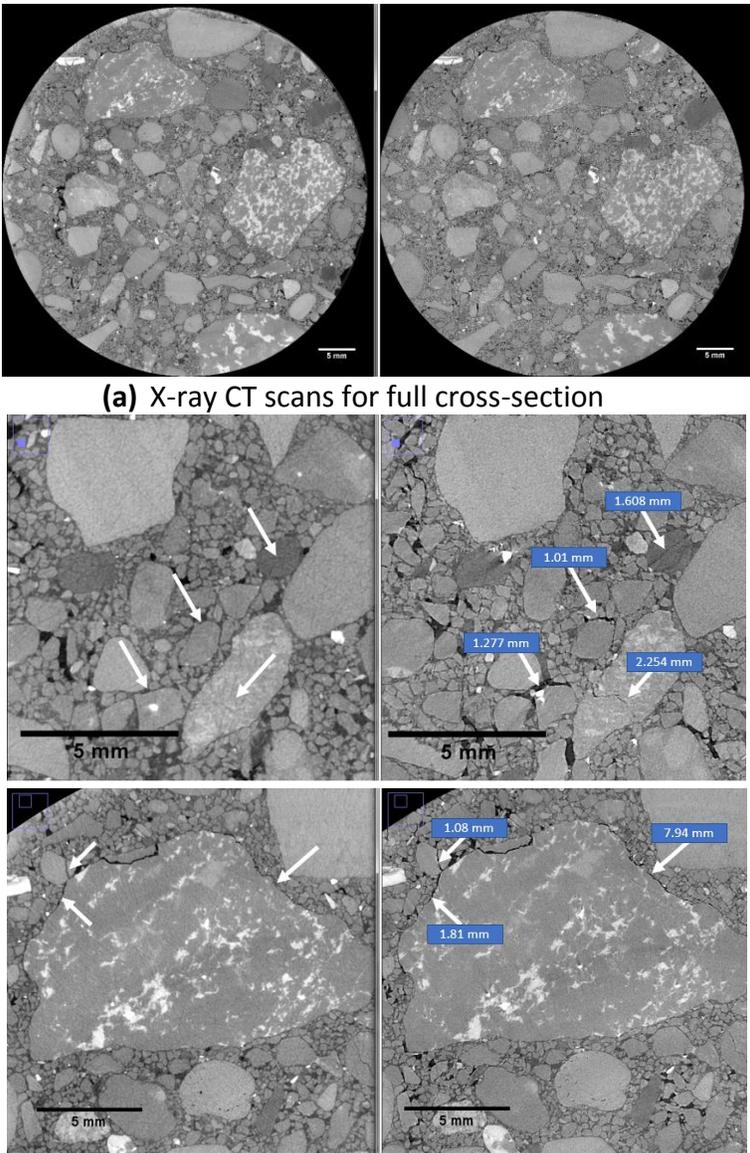
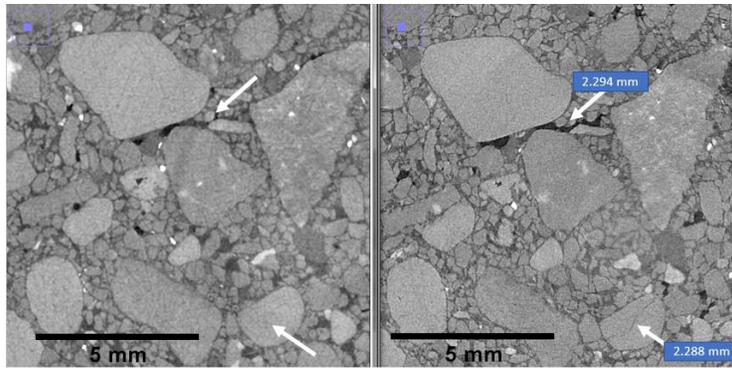
**(b)** Broken coarse aggregates and adhesion failures

**Figure 12.** ImageJ analysis for X-ray CT scans of sample 1 (0% RAP) at 0 F-T cycles (right) and after 30 F-T cycles (Left) – cross-section 1

A cross-section from the X-ray CT scan for sample 1 core (0% RAP) was analyzed using ImageJ software. The X-ray CT scans for the cross-section before and after 30 F-T cycles are shown in **Figure 12(a)**. **Figure 12(b)** shows examples of observed breakage in coarse aggregates and adhesion loss between coarse aggregates and FAM. The total length of micro-cracks in this cross-section was 29.75 mm. **Figures 13(a)** and **13(b)** show X-ray CT scans for the same sample, sample 1, but for a second cross-section at a different height of the sample. From **Figure 13**, the observed damage types in the second cross-section were also breakage of coarse aggregates and adhesion loss between coarse aggregates and FAM. Also, the width of pre-existing cracks in coarse aggregates increased after F-T cycling, as shown in **Figure 13(b)**. The total length of micro-cracks in the second cross-section was 24.94 mm.

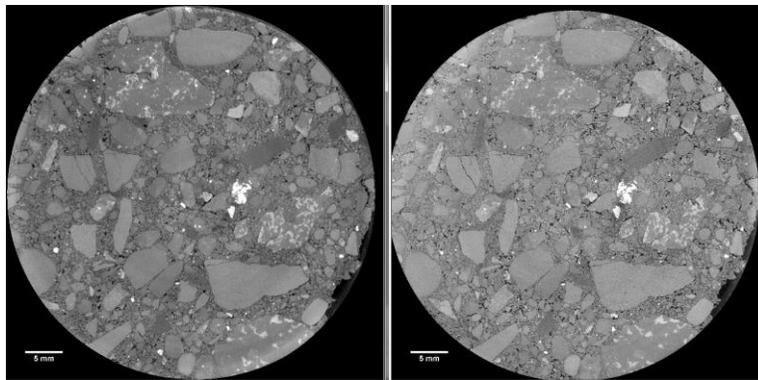
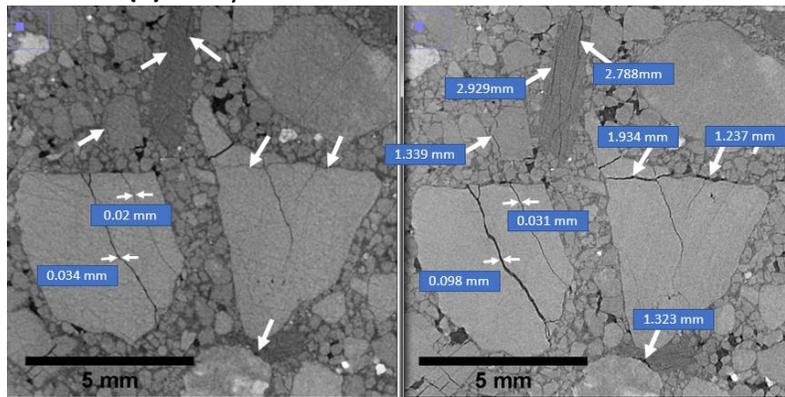
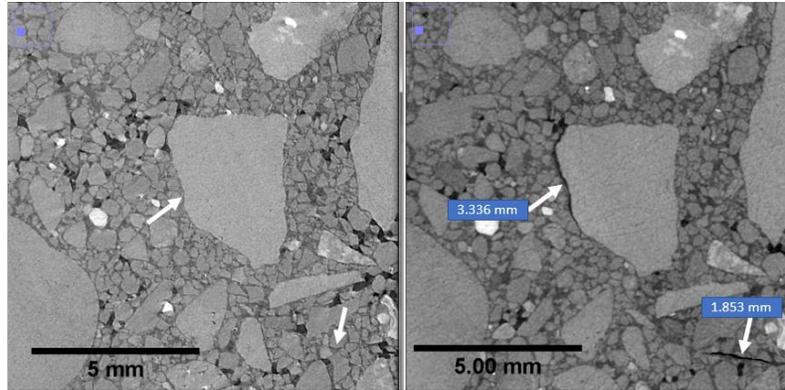
**(a)** X-ray CT scans for full cross-section

**Figure 13.** ImageJ analysis for X-ray CT scans of sample 1 (0% RAP) at 0 F-T cycles (right) and after 30 F-T cycles (Left) – cross-section 2

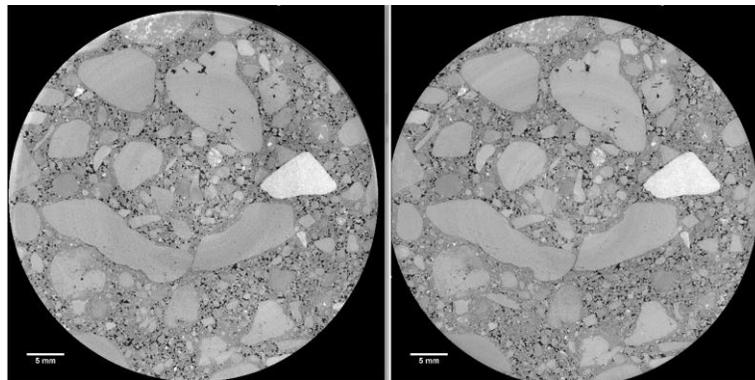
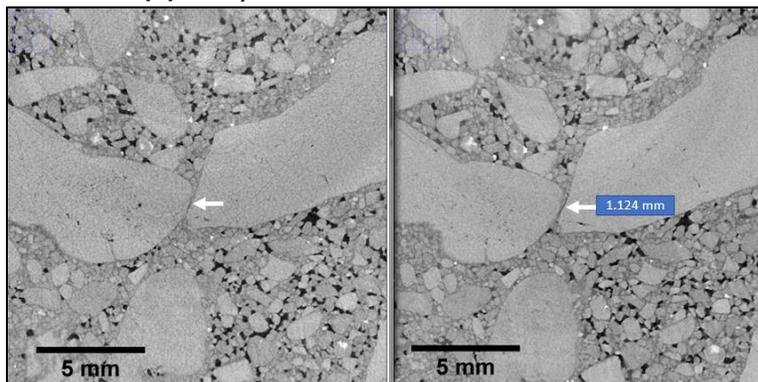
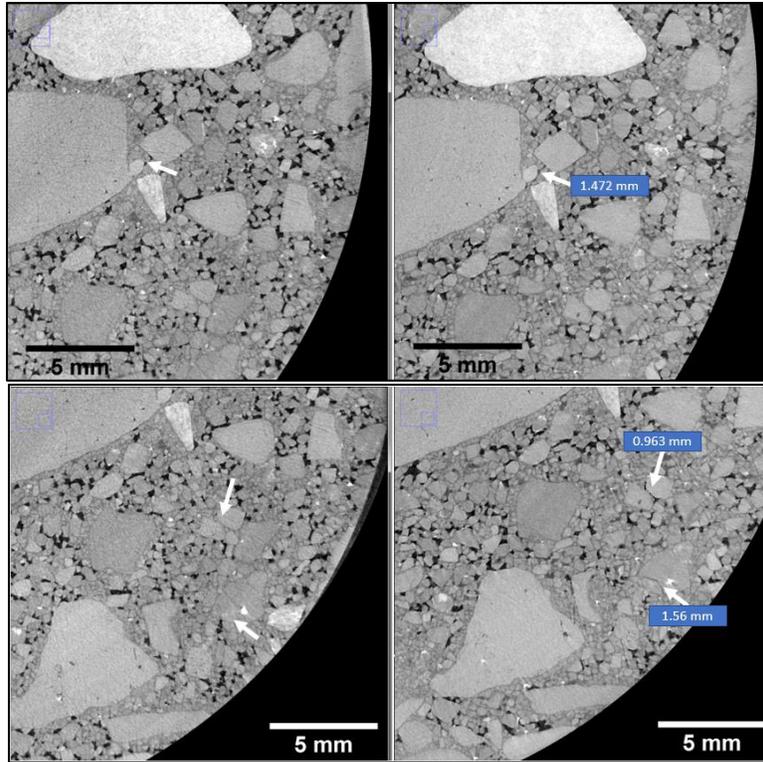
(a) X-ray CT scans for full cross-section

(b) Broken coarse aggregates and adhesion failures

Figure 14. ImageJ analysis for X-ray CT scans of sample RAP-1 (10% RAP) at 0 F-T cycles (right) and after 30 F-T cycles (Left) – cross-section 1

Using the same procedures for sample 1, two X-ray CT scan cross-sections at different depths were analyzed for sample RAP-1 (10% RAP). **Figures 14** and **15** show the X-ray scans for the first and second cross-sections, respectively, before and after 30 F-T cycles. Similar to sample 1, the dominant damage types after F-T cycling were breakage of coarse aggregates, adhesion loss between coarse aggregates and FAM, and increase in width of pre-existing cracks in coarse aggregates. For the first cross-section, the total length of micro-cracks was 5.12 mm. For the second cross-section, the total length of micro-cracks was 5.00 mm.

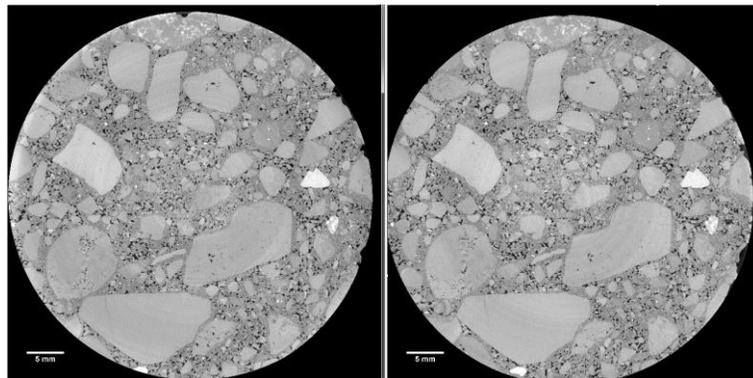
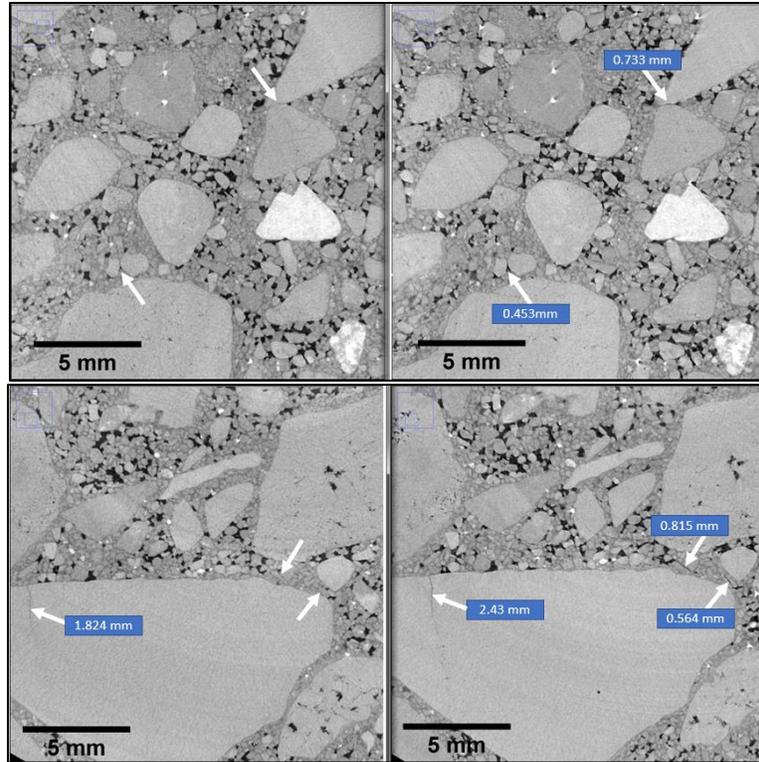
(a) X-ray CT scans for full cross-section

(b) Broken coarse aggregates and adhesion failures

**Figure 15.** ImageJ analysis for X-ray CT scans of sample RAP-1 (10% RAP) at 0 F-T cycles (right) and after 30 F-T cycles (Left) – cross-section 2
