Integrating Laser Crack Measuring System
into the Saskatchewan Pavement Management System

Brandon Williams, Preservation and Operations Intern
Nichole Andre, P.Eng., Sr. Asset Management Engineer Roads,
Kyle Bowey, Preservation and Operations Intern,
Kevin Huynh, Preservation and Operations Intern,
Saskatchewan Ministry of Highways & Infrastructure

Paper prepared for presentation
at the Innovations in Pavement Management, Engineering, and Technologies Session
of the 2017 Conference of the
Transportation Association of Canada
St. John's, NL

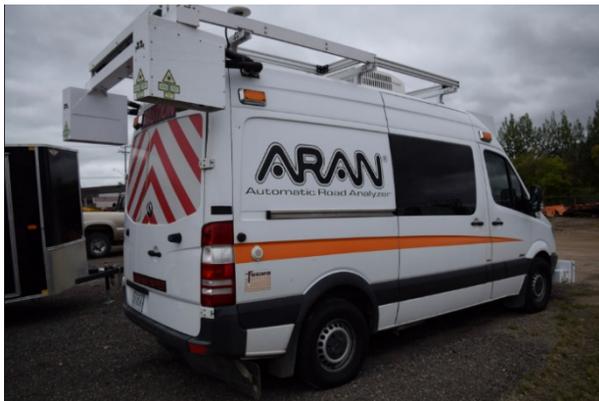
Figure 1: ARAN with LSMS sensors

How LCMS Works: Two sensors are mounted on the back of the data collection vehicle. Each unit contains a spread line laser and a 3D camera mounted off axis to the laser. The lasers cast a 4m long line with 1 mm resolution on the road surface. The 3D cameras capture an image of the laser line gathering two data types:

Range/height – height of the pavement surface

Intensity/reflection-reflectivity of the pavement surface

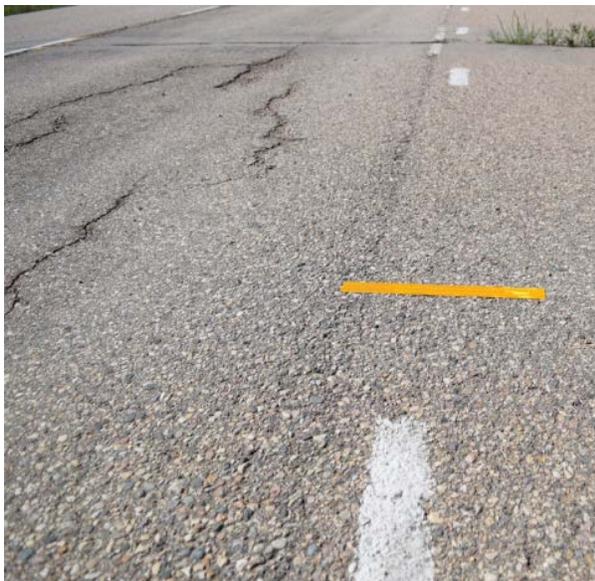
Figure 4: Lane Markings & In situ Cracking

A 150-m long lane was selected at the site to set up the test area for verification testing. An array of cracks were already present at this location including both transverse and longitudinal cracks of varying severity.

Three 50-m cells were marked out using a surveyor's wheel and yellow reflective tape. Next, pavement marking paint was applied to delineate the edges of the lane. Dashed pavement markings were placed at approximately 4 m spacing denoting the edge of the lane. Reflective beads were added to the fresh paint to ensure the markings could be identified by the LCMS.

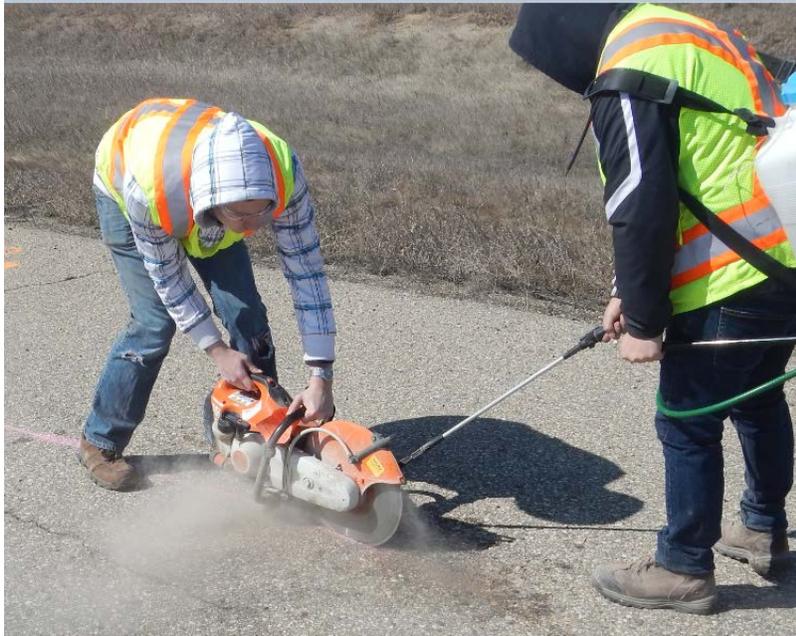
Figure 5: Fabricating Cracks using a Pavement Saw

In some cases the pavement saw was used to augment existing cracks. Five transverse cracks were created to test transverse crack severity. Wide transverse cracks were partially filled back in using cold mix cement to achieve the desired widths. Corrugated plastic strips were used as forms for partially filling in the cracks and letting the cold mix set. Figures 5 and 6 illustrate the method used to fabricate a severe transverse crack and shows what the finished crack looks like.

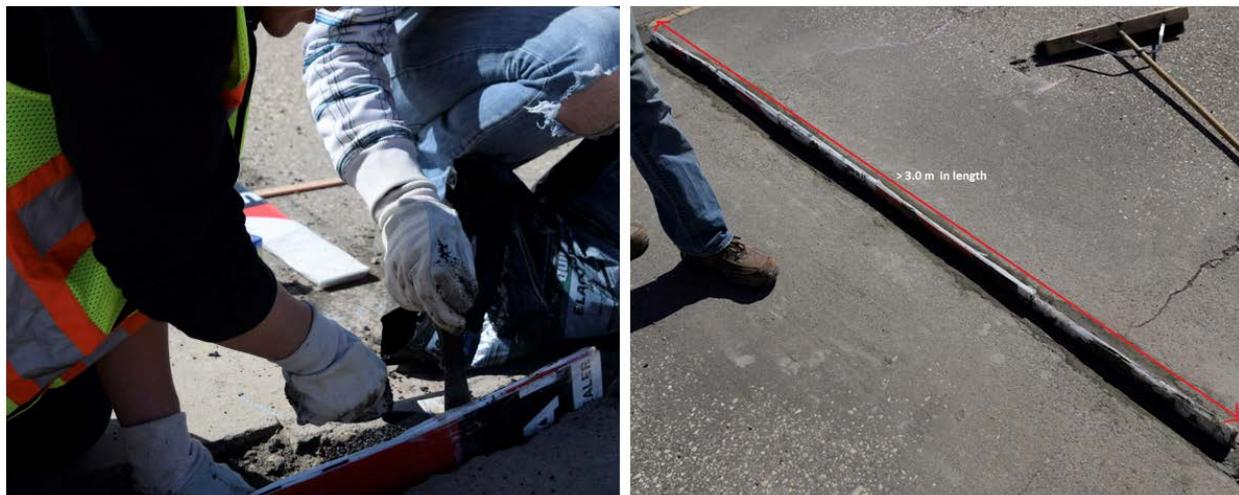
Figure 6: Manually Creating a Severe Transverse Crack (left) & Finished Transverse Crack (right)

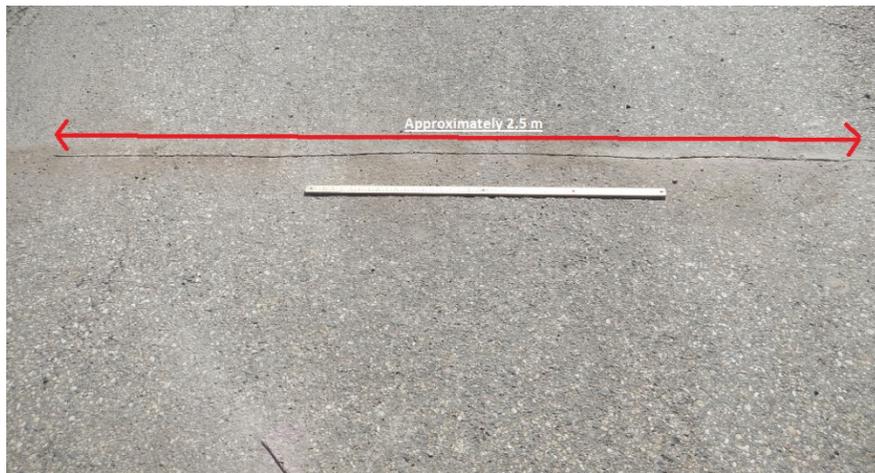
Figure 7: Testing Minimum Transverse Crack Length

Figure 7 illustrates a transverse crack that was cut to test the minimum transverse crack length of 3.0 m. The cut crack is approximately 2.5 m long.

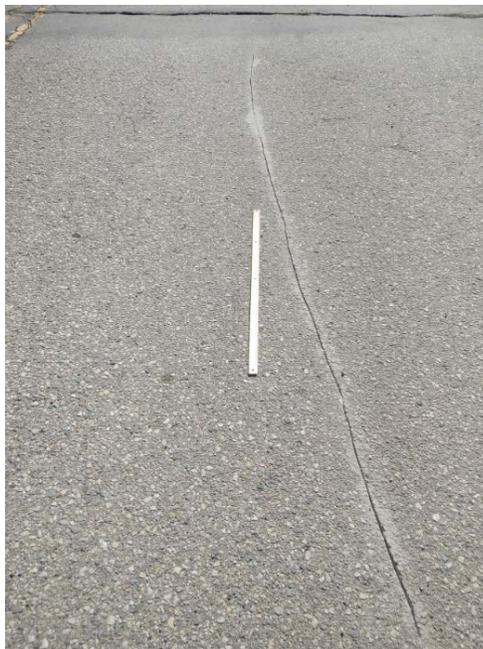
Figure 8: Saw Cut Longitudinal Crack

Several longitudinal and meandering cracks were cut into the test area. Cracks were created at different angles and lengths to test the crack classification definitions. Cracks were located in each wheel path and along the edges of the lane to test whether the LCMS would classify cracks as edge and centerline cracking.

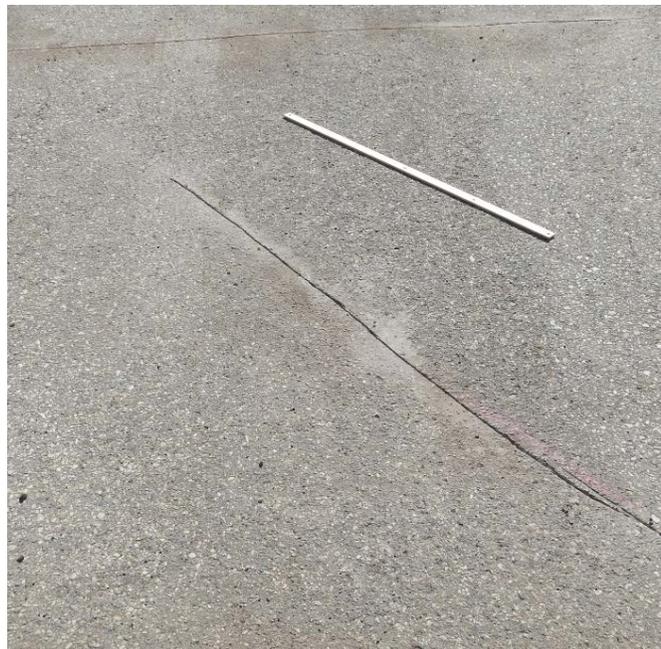
Figure 9: Saw Cut Meandering Crack

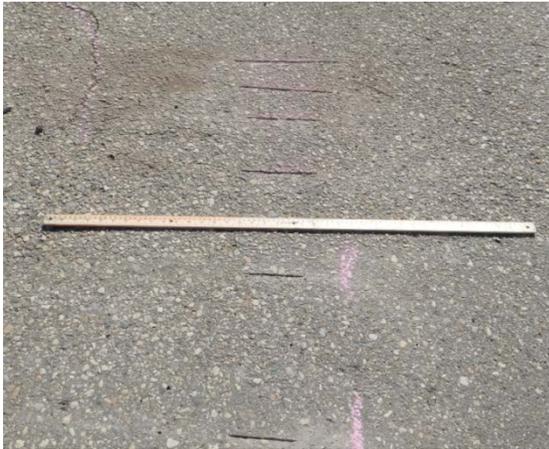
Figure 10: Testing the Minimum Crack Length

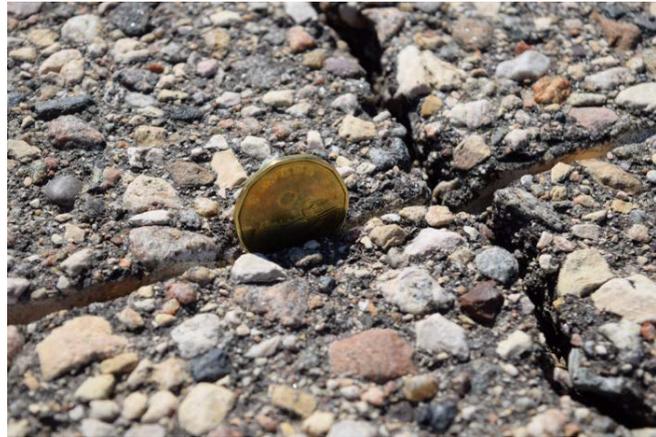
Figure 11: Saw Cut Crack Width

As illustrated in Figure 11, crack width was limited to the width of the pavement saw blade. Slight severity cracks (<4mm) could not be added to the site.

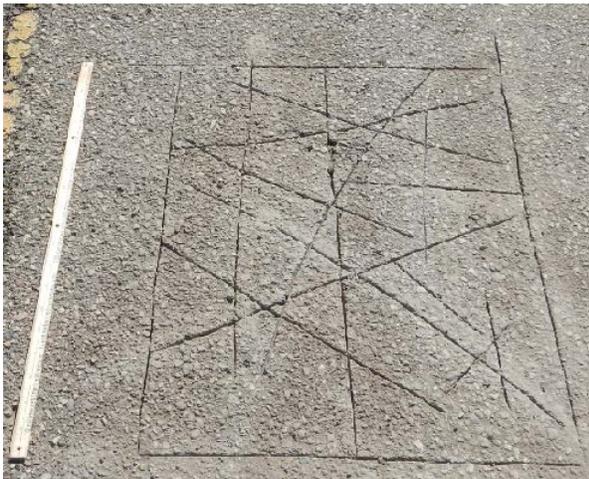
Figure 12: Saw Cut Wheel Path Block Cracking

Block cracking was simulated on site by cutting multiple cracks within close proximity to one another. The simulated block cracking was cut to test severity and how the LCMS sensors located the area of block cracking within the lane.

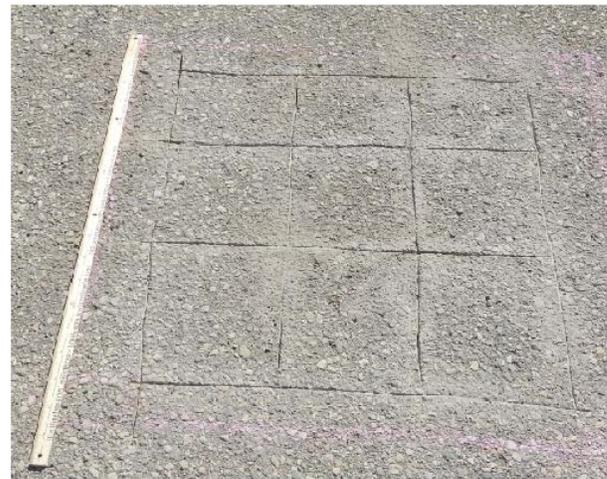
Figure 13: Saw Cut Non-Wheel Path Block Cracking

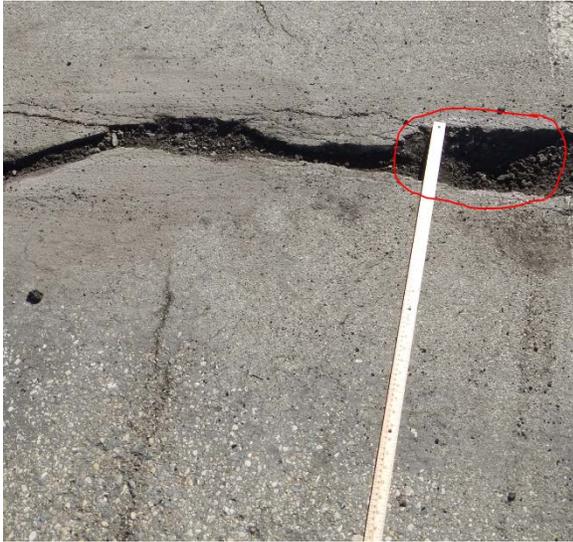
Figure14: Severe Pothole

Moderate and severe potholes were cut into the the pre-survey calibration site by running the pavement saw along the edges of a spalled out transverse crack. Cold mix cement was used to fill in the bottom of the potholes to depths matching moderate and severe pothole criteria.

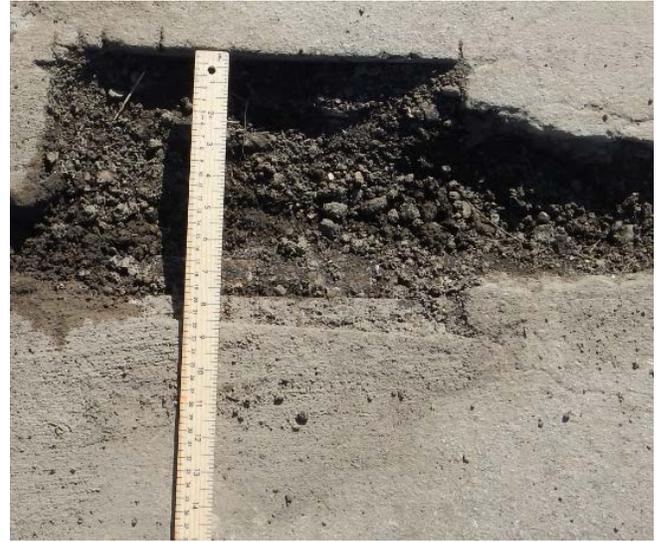
Figure 15: Moderate Pothole

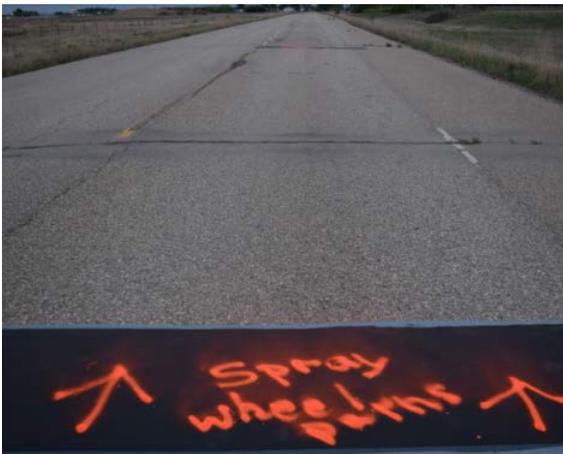
Figure 16: Construction Paper used to mask off Bleeding Area

To replicate bleeding in the test area an asphalt distributor was used to spray asphalt strips 15m in length at the start of the test area. Construction paper was used to mask off the start and end of the wheel paths. Figure 17 shows the bleeding section of the site.

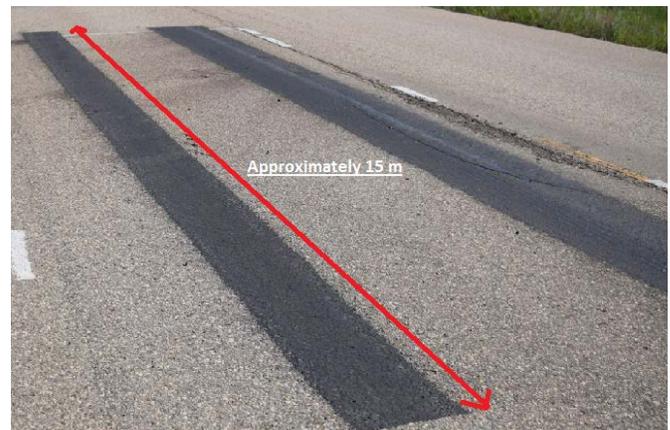
Figure 17: Bleeding added to the Test Area

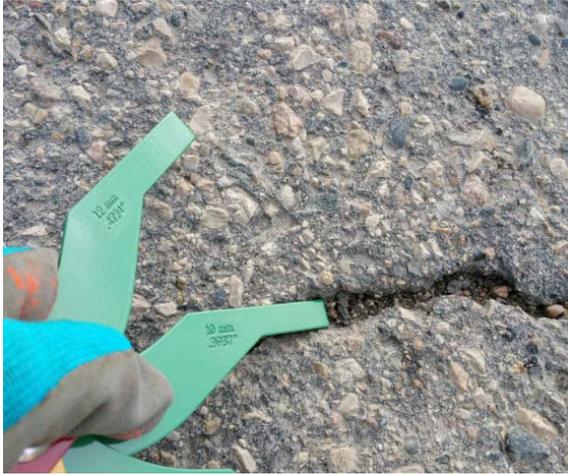
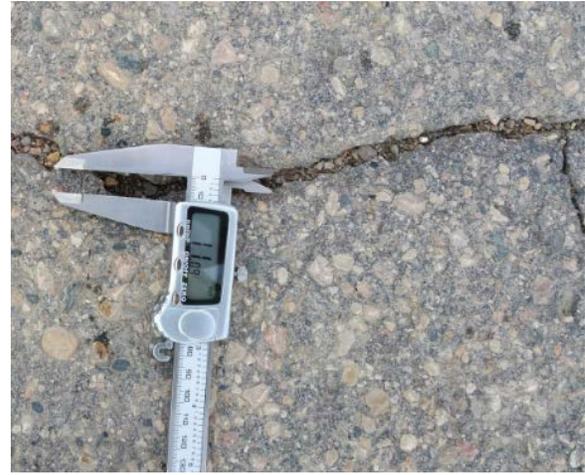
Figure 18 & 19: Crack widths measured using Automotive Brake Gauges (left) and digital calipers (right)

Manual measurements of crack lengths and widths were achieved using measuring tape, calipers, and crack width gauges.
