Protecting the Trans-Canada Highway at Souris with Inter-tidal Reefs

M.H. Davies, Ph.D., P.Eng., Coldwater Consulting Ltd.

Paper prepared for presentation in "Beyond the Storm" - Responding to Extreme Weather and Climate Events Session of the 2019 TAC-ITS Canada Joint Conference, Halifax, NS

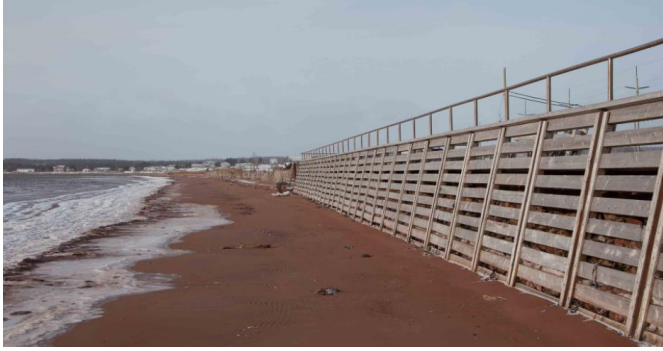
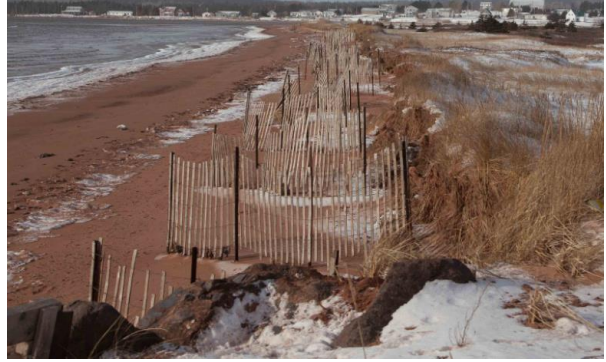
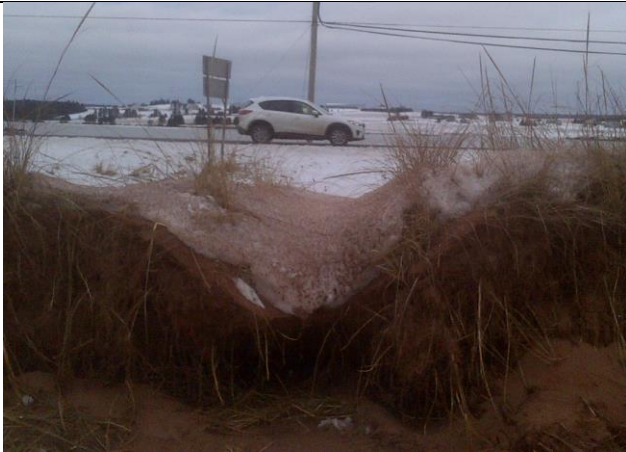
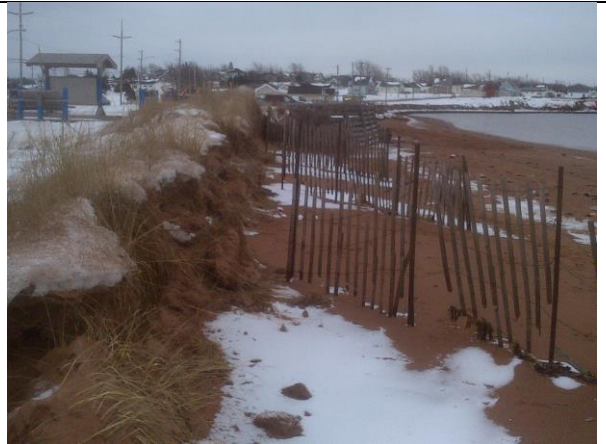
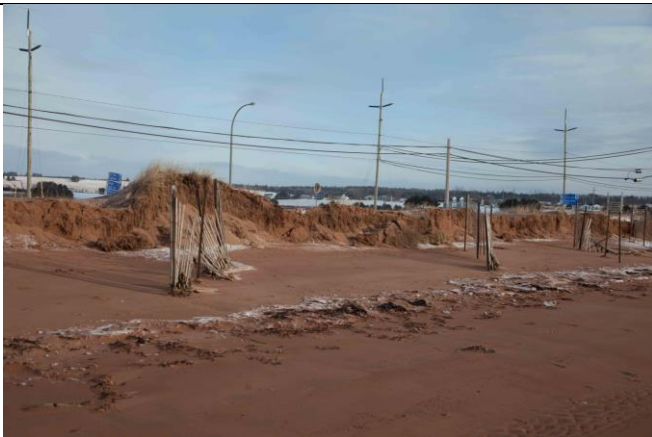
Photos showing beach conditions post-storm.

Sand fencing had previously been almost completely buried by dunes that had grown since construction of the Langley wall in 2012.

January storm removed almost all of the dune, leaving very little remaining dune between the shore and the highway.

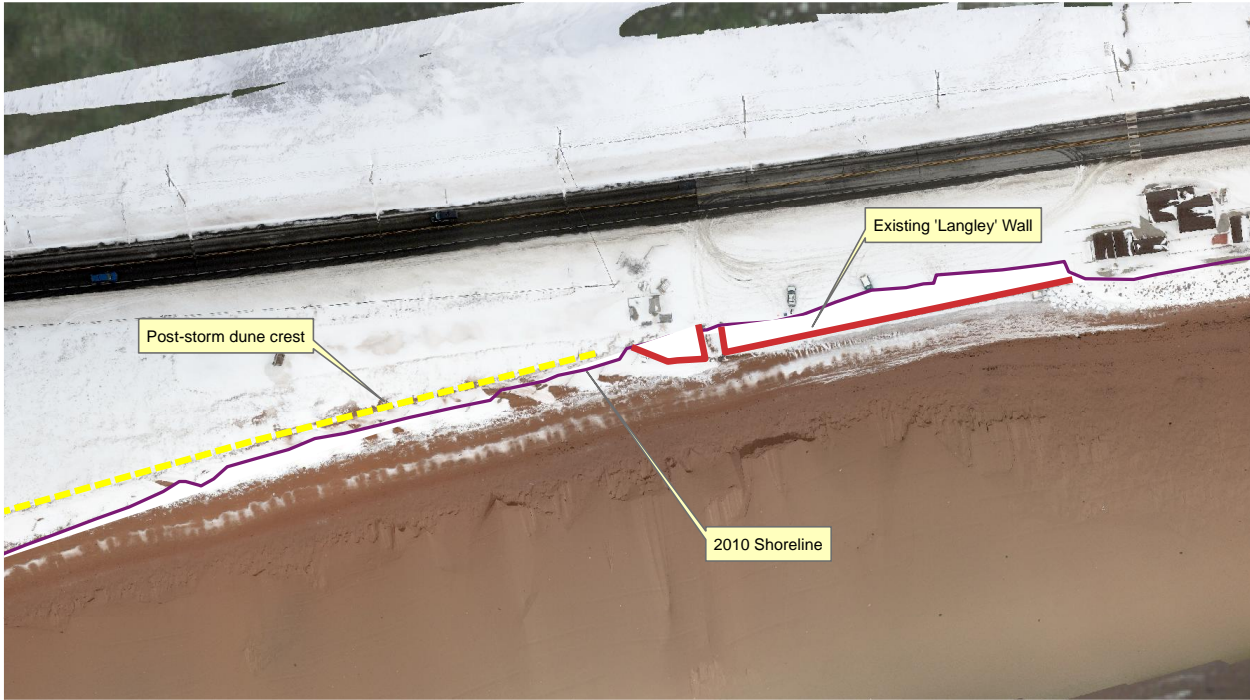
Figure 6 Aerial composite imagery Jan 23 2016

The aerial photo mosaic from the drone survey is shown on the next page, followed by the elevation map produced by the drone survey. The map and images show that the beach dune is quite low and narrow for a distance of approximately 150m.

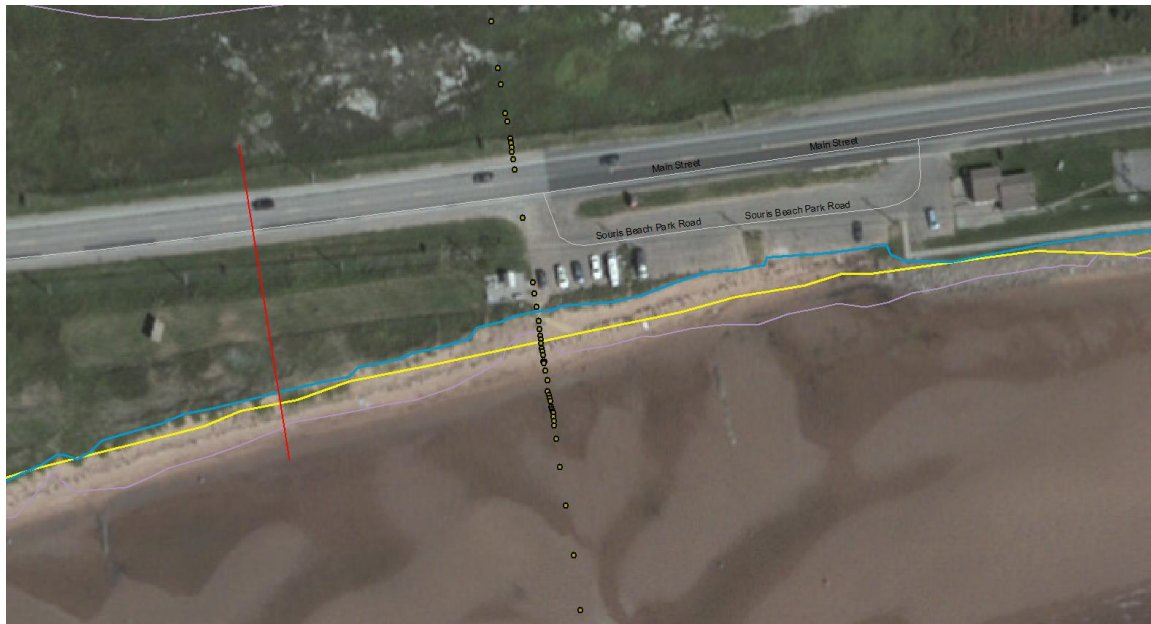
Figure 8 Beach profiles

Profiles taken from this DEM have been compared to previous survey results for this shoreline. The prior surveys (from 1999 and 2010) pre-date the dune restoration works that were undertaken in 2012.

Analysis of beach profiles at several locations from the end of the existing seawall to 200m west show that the beach lost between 4.5 to 6.0 m² of cross-sectional area between 2010 and 2016. The remaining dune (as of January 23rd) had a crest elevation of between 2.1 and 2.5m with some spots as low as 2.1m. With the very small volume of remaining sand, a single storm would now be capable of breaching the dunes, allowing wave action to reach the edge of the highway. Given that the highway is lying at approximately the 25-year return period still water level, this placed the highway at considerable risk of storm damage.

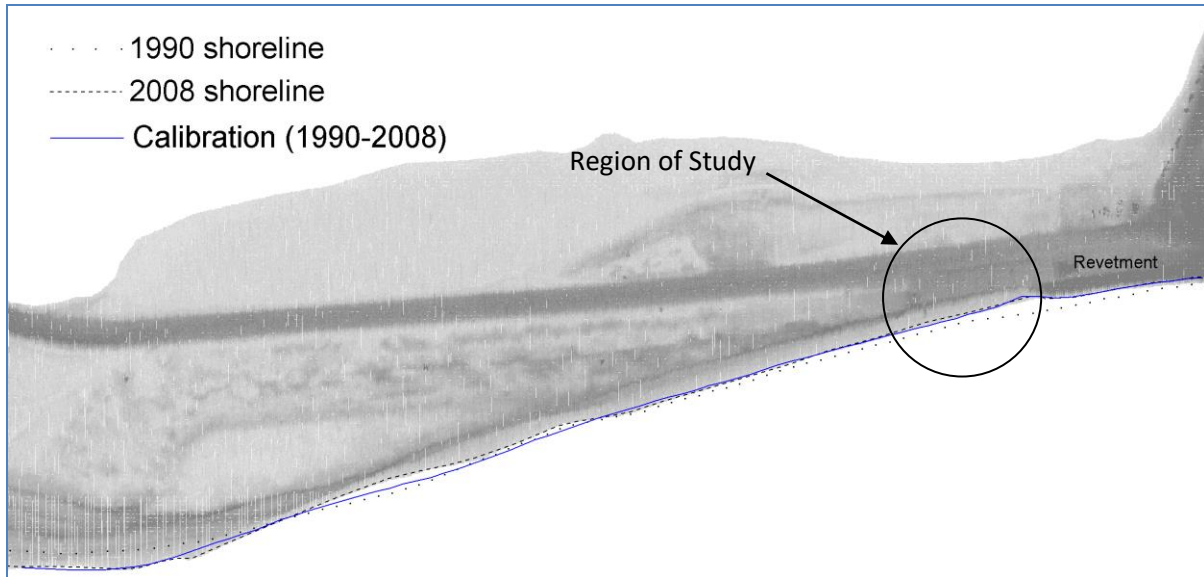
Figure 10 Calibration of the GENESIS model

Calibration of the GENESIS model was based on reproduction of observed historical shoreline changes. The results of the calibration process are shown in Figure 10. The agreement between the GENESIS predictions and the observed beach behaviour is deemed sufficient to allow the GENESIS model to be used as a predictor of future beach response following construction of the proposed reefs.
