Replacement of the City of Saskatoon's Historic Traffic Bridge

Paper prepared for presentation
at the Structures Session

of the 2018 Conference of the
Transportation Association of Canada
Saskatoon, SK

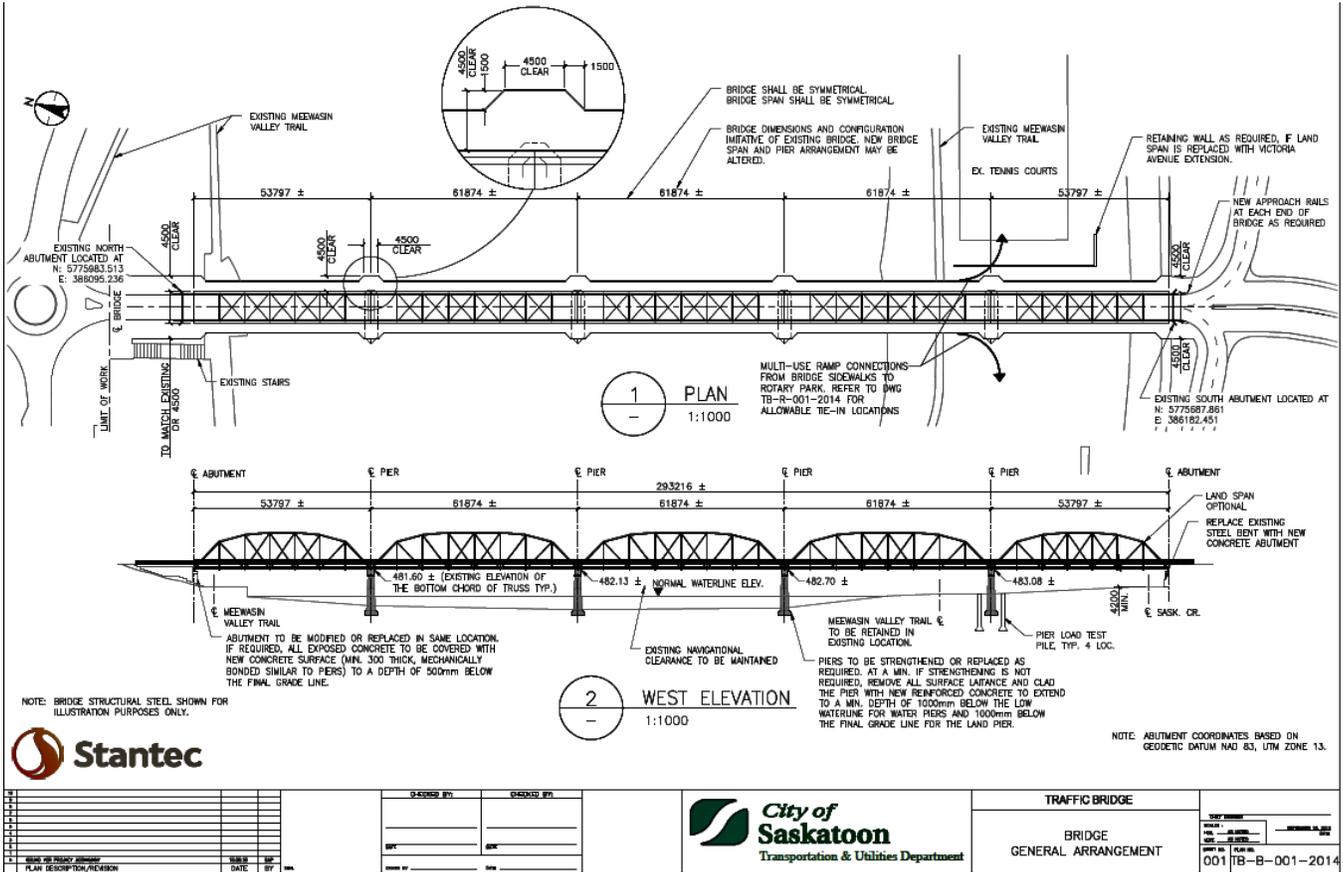
Public meetings were held to describe the various options. Renderings of the various options were presented so that the public could get an idea of what the bridges would look like at the existing bridge location. After public opinion of the options was collected and presentations were made to council at the City of Saskatoon, the heritage value of the existing bridge was found to be an important issue for the citizens of the City of Saskatoon and a new truss similar to the existing truss was selected as the bridge replacement option. In order to keep as much of the original style of the old bridge, a new modern Parker truss matching the shape of the existing bridge was selected. The existing foundation elements, the piers, were to be salvaged. A drawing showing the proposed layout of the replacement bridge is shown on the following page.

After various public engagement events, the City of Saskatoon selected the Modern Steel Truss Bridge as the preferred alternative. The final design consisted of a new 4-span steel truss structure on top of the existing rehabilitated piers. The piers were reinforced with an outer layer of concrete to extend the design life and accommodate the larger bridge deck and truss structure. The new bridge deck allowed for two 3.7m driving lanes and two 3.0m wide cantilevered concrete pedestrian/cyclist walkways with pier lookouts. Extra mass earth fill and rip-rap was added at the South side to eliminate the need for a 5th span. MSE Walls would be used to elevate the approach slab at the South abutment, as well as facilitate a concrete box girder land span over Saskatchewan Crescent.

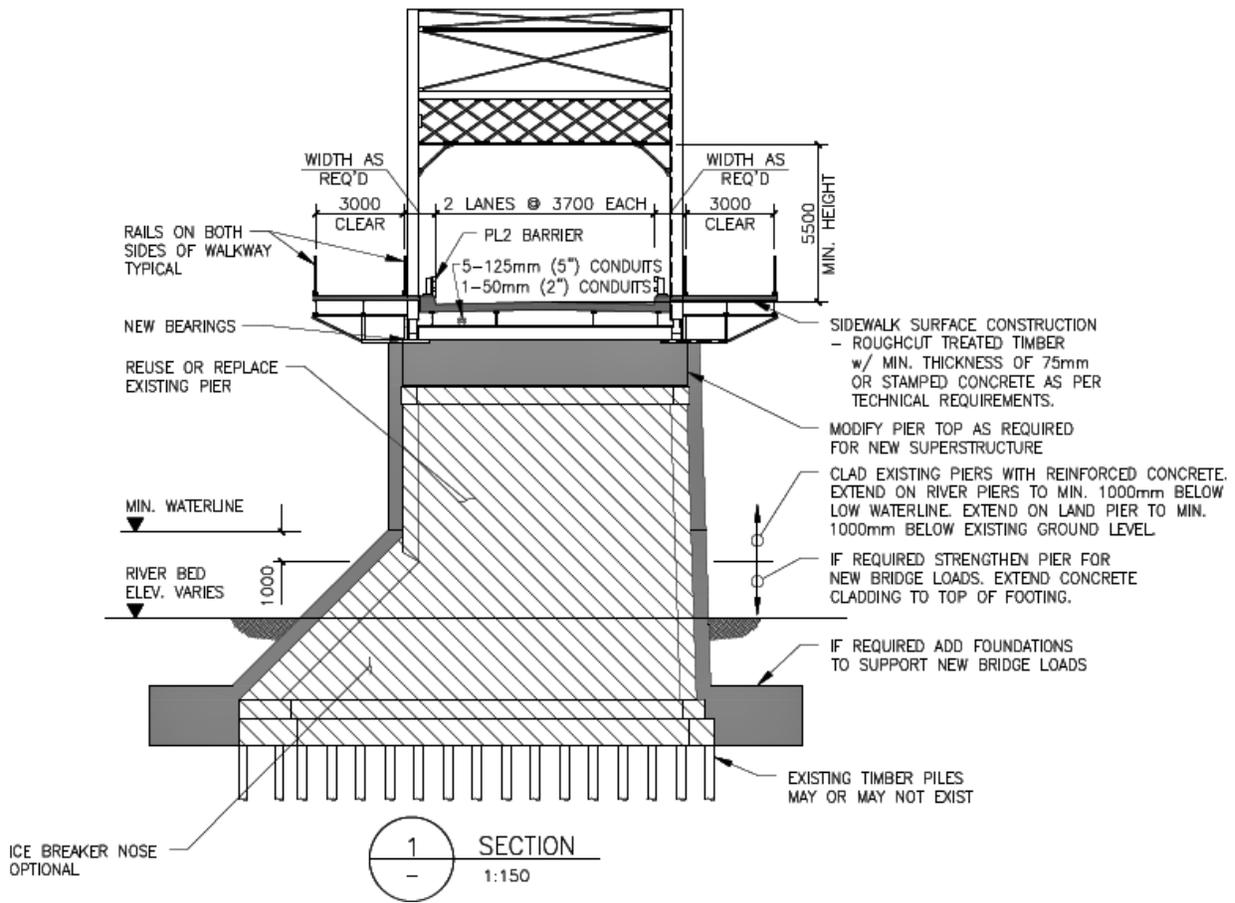
A cross section of the proposed bridge is shown on the following page.

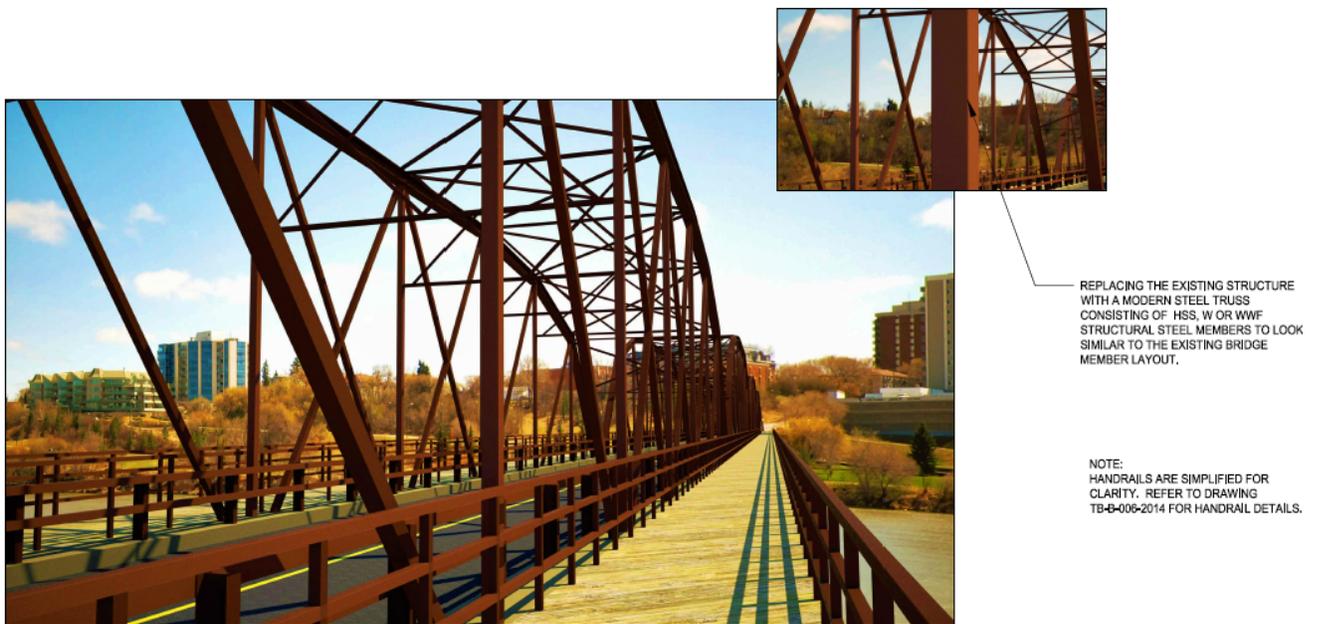
A rendering of the finished truss bridge is shown below.

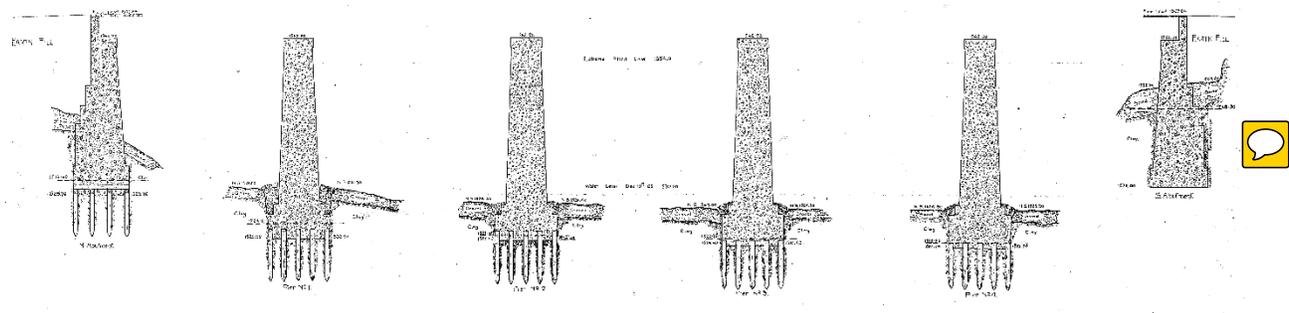
A review of the as-built drawings for the traffic bridge suggested that the existing piers are supported on footings which are supported on driven timber piles. (add figure).

The footings of each of the piers rest on a hard-glacial clay till. Other bridges constructed in the City of Saskatoon are supported on raft footings placed directly on this clay till. This material is a hard material and it was assumed that the timber piles shown on the plans were not installed into this hard material. A raft foundation placed in this hard clay till could potentially have more capacity than the driven timber piles shown on the drawings.

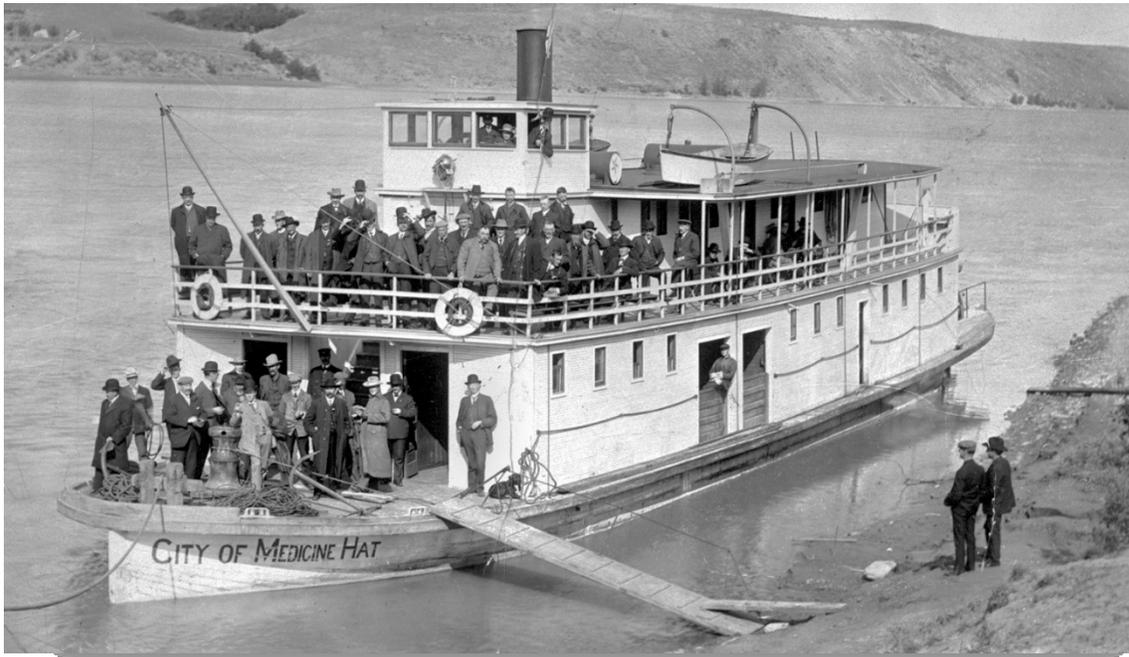
Photo 1 – S.S. City of Medicine Hat ca 1907

On June 7th, 1908, the *S.S. City of Medicine Hat*, a steam powered sternwheeler wrecked against the south-most pier of the traffic Bridge. The *S.S. City of Medicine Hat* was built in 1906-07, was 130 ft (39.6 m) long had a beam of 25 feet (7.6 m) and a draft of only 2 ft (0.3 m). The boat was commissioned by Horatio Hamilton Ross, a Scottish nobleman and remittance man. The *S.S. City of Medicine Hat* is shown in Photo 1.²

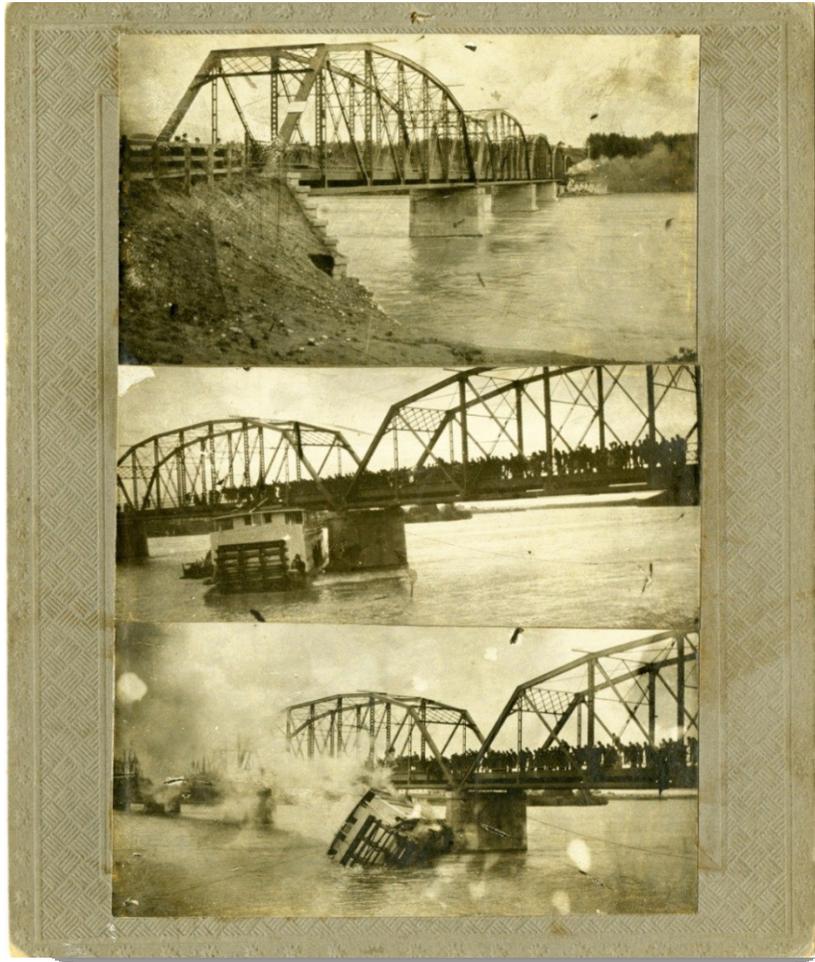
Photo 4 - Time lapse photos of the S.S. City of Medicine Hat

At the Grand Trunk Railway bridge Ross tied the boat just below to order the passengers off, hoping the water levels would drop if they waited. Instead, the water levels rose. Ross calculated that if he removed the smoke stack, the ship would fit under the bridge. Once through, Ross moored the ship near the powerhouse and measured the space between the river and the next bridge – the Canadian National Railway Bridge. The *S.S. City of Medicine Hat* successfully navigated under this bridge, but got caught on the telegraph cable, which was obscured by the high water, spanning the river (Polachic, 1991). The cable disabled the steering gear, making the ship un-navigable. The attempts to tie the ship to a tree and run it aground were unsuccessful. The strong current of the river sent the ship careening into the steel girder and swung around to hit the concrete pier of the Traffic Bridge (Polachic, 1991) (Photo4)³.

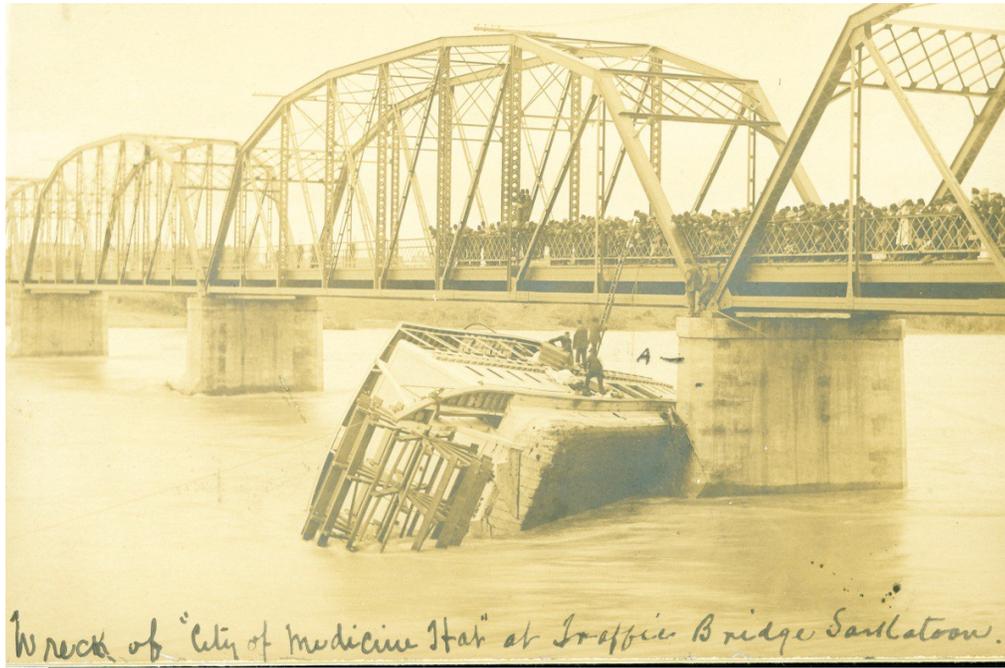
**Photo 5 - S.S. City of Medicine Hat capsized
with crowd gathered on bridge**

The crew safely abandoned ship, but all of the passenger's belongings, the shipment of flour, and the barge carrying 50 tons of coal were all lost in the river. As was Ross' \$28,000 ship that was only insured against fire (Polachic, 1991) (Photo 5).
