Long Term Performance of Utility Trench Repairs in Low Traffic Residential Areas

Luke Gallant, E.I.T, WSP

Paper prepared for presentation at the Innovations in Pavement Management,  
Engineering and Technologies Session

Of the 2019 TAC-ITS Canada Joint Conference, Halifax, NS

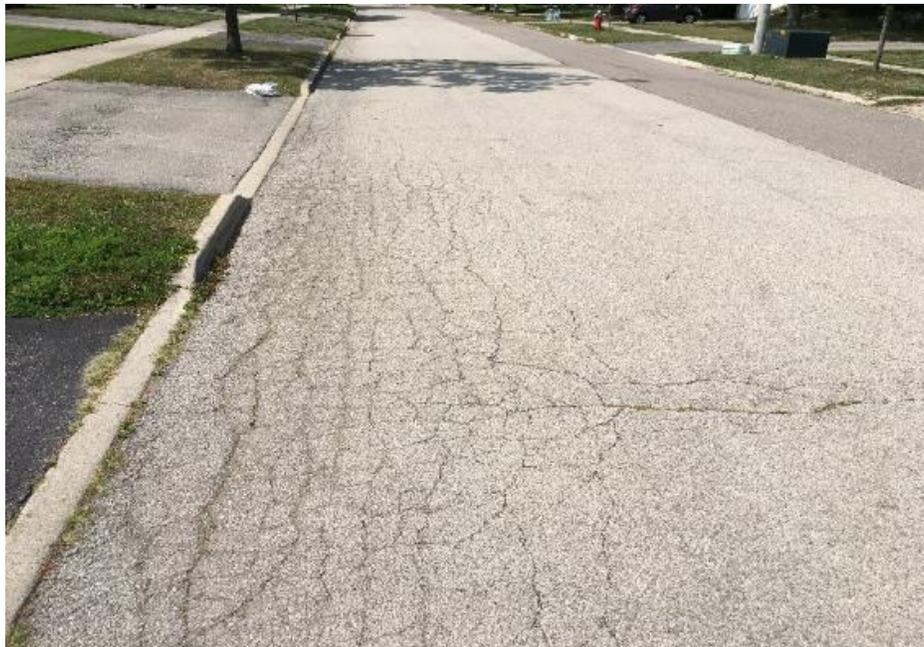
The existing roadways do not include subdrain installations, thus drainage issues and water-related damage was expected and encountered in the pavements during the study. The lack of subdrains are a probable contributing factor to the pavement edge alligator cracking encountered on some of the roads. Photo 1 below shows an example of pavement edge alligator cracking on Frankfield Avenue

Photo 1: Pavement Edge Alligator Cracking – Frankfield Ave

For the most part, the above failures may be avoided by ensuring that paving is taking place in close to optimal conditions (dry, warm) and that the paving process is controlled with strict standards and specifications, as well as quality control measures taken on site during operations. Within the study area, the most common failure mode was pavement edge alligator cracking as reflected in the Photo 1 of this paper.

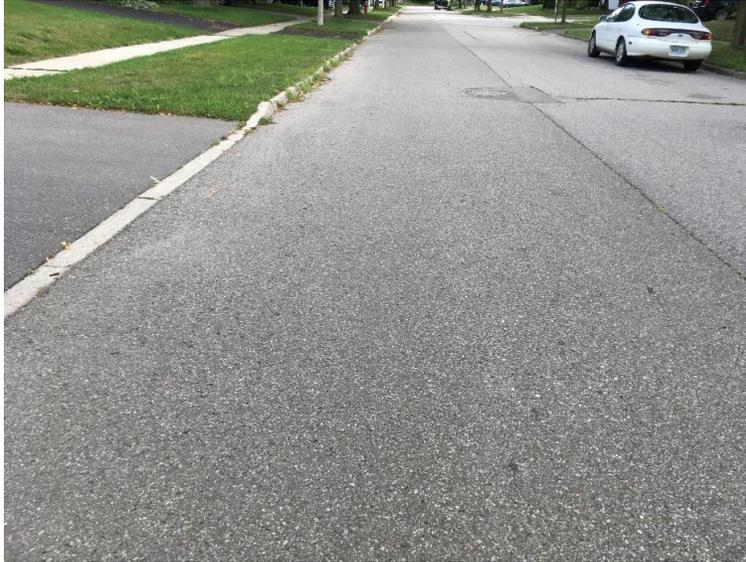
Trench restorations with three (3) meters wide asphalt replacement were the most common (20 roads of 29). These three meter restorations were performed with screed-width in mind, as the asphalt was saw-cut at three meters in width from the curb edge, which enabled the contractor to include the backfilled and compacted trench and approximately 0.3 m on either side while both full width eight (8) meter asphalt replacement and one (1) meter wide of asphalt replacement was isolated to one (1) location (one road) each. Photos of the Typical 3m and 1m trench restoration are presented below:

Photo 2: Typical 3m Trench Restoration, Sheridan Homelands

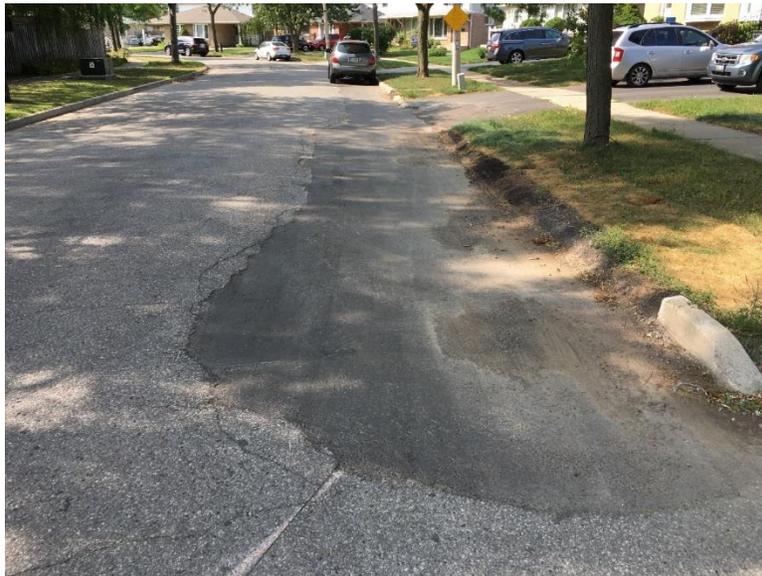
Photo 3: 1m Trench Restoration (Hand Laid), Altadena Court

Pavement restorations of one (1) meter in width encounter some limitations when placed, if properly sized laying and compacting equipment is not used. Hand-laid trenches are prone to break up and premature deformation and are susceptible to freeze-thaw cycles in cold climates. Studies to observe the long-term performance of 1-meter trenches may help to build a clearer picture as to whether, when properly implemented with specific equipment, these smaller trenches can withstand long-term use.
