Performance evaluation of Porous Rubber Pavement (PRP) in the Canadian climate

Paper prepared for presentation at the **Innovations in Pavement Management, Engineering and Technologies** Session at the 2020 TAC Conference & Exhibition, Vancouver, B.C.

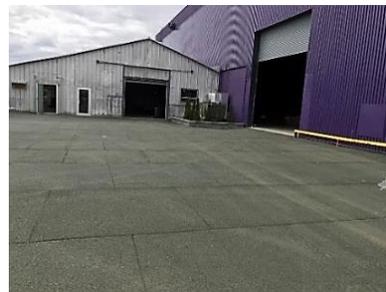
(b) Front view of the site driveway after construction

This parking lot was constructed between July and August of 2017. Within a year of construction, ripples or corrugation was observed on parts of the parking lot. So, the damaged part was cut and replaced by new material using the same construction techniques.

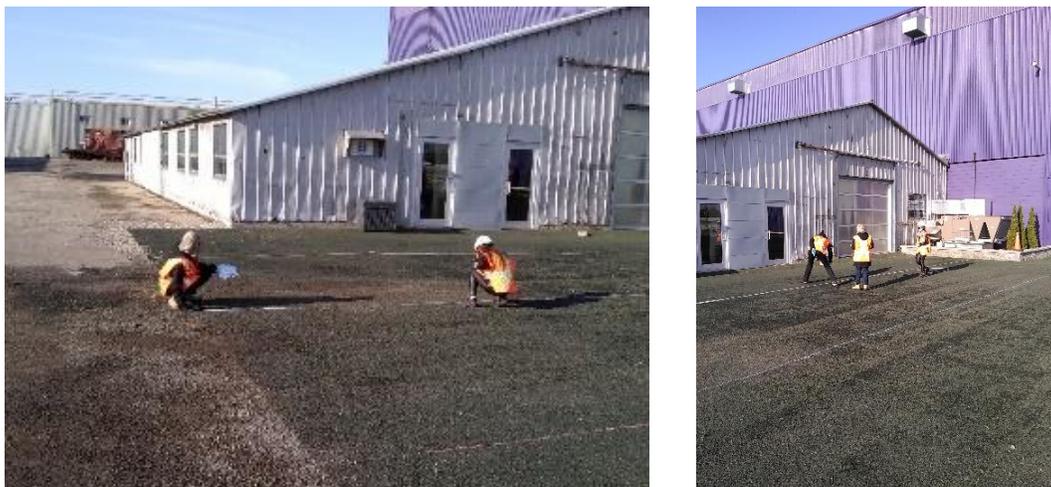
Figure 5: Site preparation for testing according to plan

Figure 5 shows the preparation of the study area for testing according to the plan shown in Figure 4.
