## **Advanced Pavement Technology – A Must for Airport Pavements – Case Studies**

Ludomir Uzarowski, Ph.D., P.Eng., Golder Associates Ltd.

Paper prepared for presentation  
at the Innovation in Geotechnical and Materials Engineering Session

Of the 2019 Conference of the  
Transportation Association of Canada  
Halifax, NS

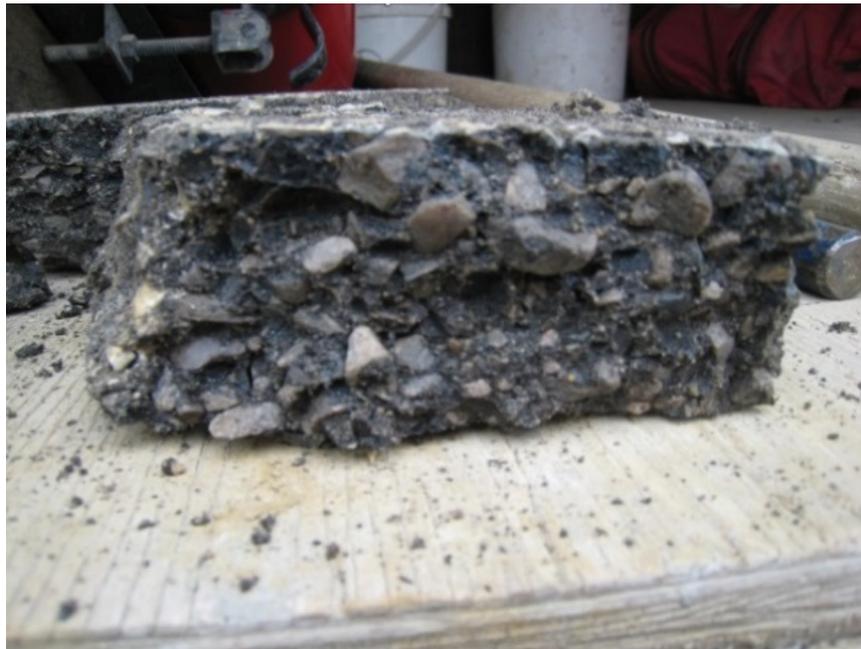
Photograph 1: Asphalt stripping visible in a piece of the asphalt mat obtained from the runway pavement.

distresses present on the runway pavements. EIA is also currently implementing Airport Pavement Management System (APMS). During the condition inspection it was observed that one of the primary deficiencies with some of the pavements was the significant amounts of stripping of the asphalt cement from the aggregates used in the asphalt mix. Photograph 1 shows an example of the stripping that was observed in a piece of the asphalt that was removed from the runway pavement. The figure shows that aggregate particles in the mix are completely stripped of asphalt cement. This is a clear indication that the asphalt mixes placed previously on the airfield facilities were severely susceptible to moisture damage, which successively occurred over the years that the runway pavement was in service. Through consultations with Edmonton Airports and based on Golder's experience with asphalt mixes used in the Edmonton area, it was our understanding the stripping in asphalt mixes was a common problem that had been encountered for a number of years.

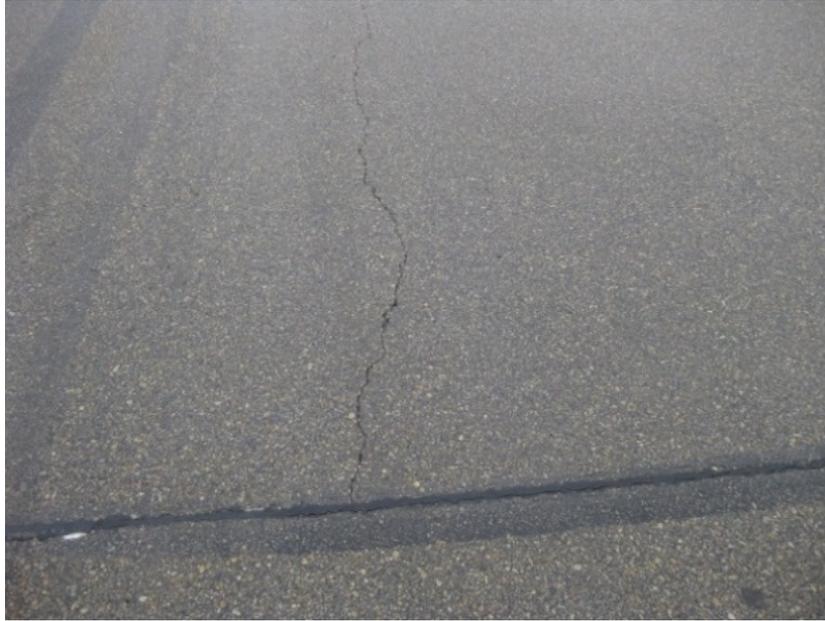
Photograph 2: Typical medium severity reflective cracking on the runway pavement.

In addition to the issue associated with asphalt stripping, it was also observed that the old mixes used exhibited poor durability and resistance to cracking and some exhibited poor resistance to permanent deformation. Very extensive high to medium severity reflective cracking and shoving was observed on the asphalt surface. The reflective cracking was noted to be primarily from the joints and the cracks in the concrete slabs underlying the asphalt layers. At a number of locations, the cracks were significantly deteriorated and spalling of the asphalt mat adjacent to the crack was observed. Photographs 2 and 3 show examples of the typical medium and high severity cracking that was observed on the runway pavement.

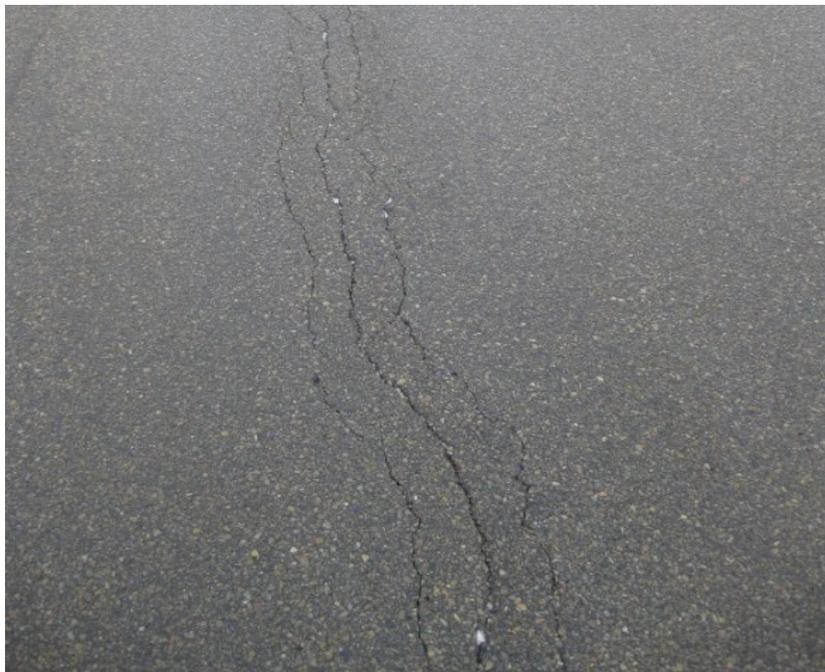
Photograph 3: High severity reflective cracking on the runway pavement.

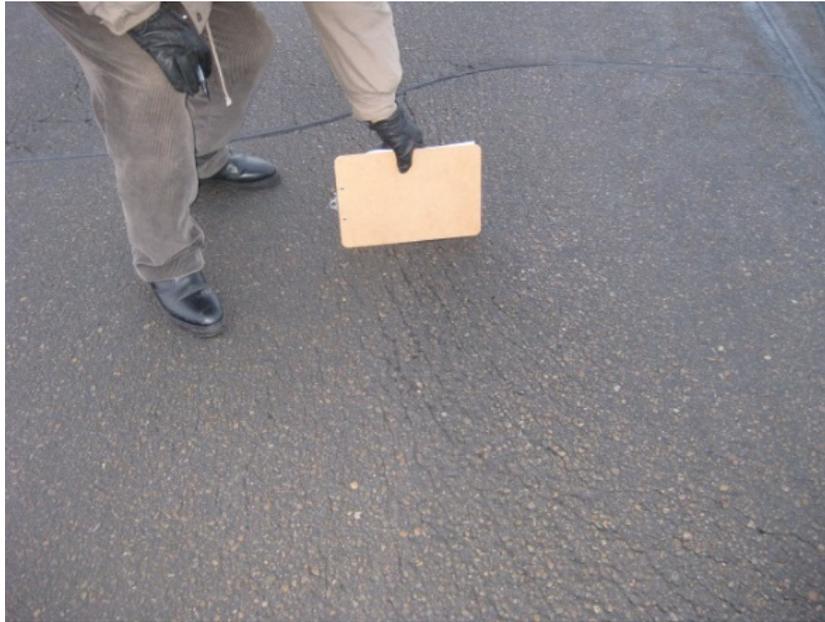
Photograph 4: Shear cracking and shoving of the asphalt surface at a threshold of Runway 12-30.

cracking was observed. Photograph 4 shows an example of the shear cracking and shoving observed at the threshold of one of the runways.

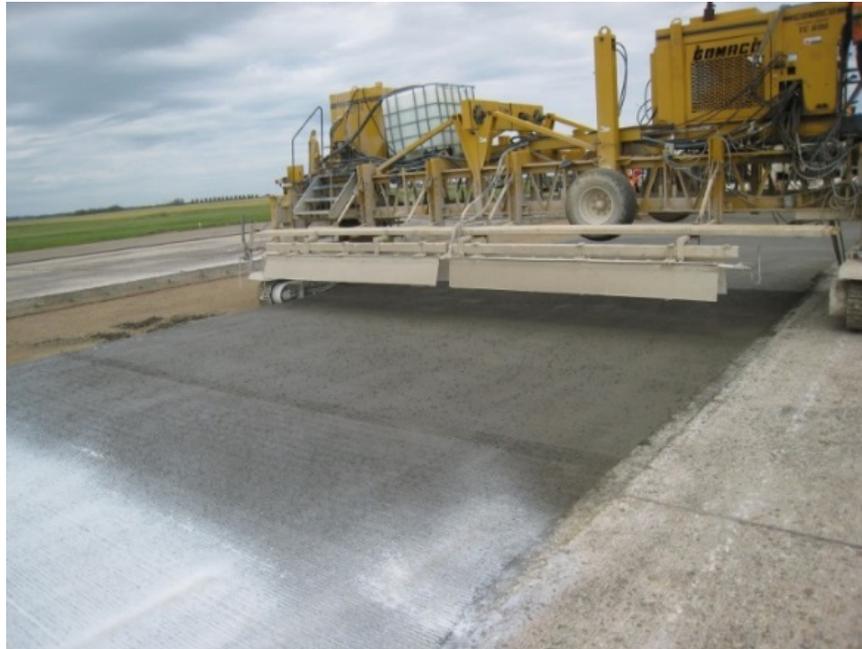
Photograph 5: Construction of new slabs on Runway 02-20.

The pavement rehabilitation on the runways at EIA typically includes the milling of the existing asphalt and placing new asphalt on the centre 14 m of the runway. Photograph 5 shows construction of new slabs on Runway 02-20 and Photograph 6 shows a cross stitched crack. The pavement rehabilitation on Runway 02-20 included concrete slab removal in Row 1 on both sides of the centerline and localized slabs in other rows.

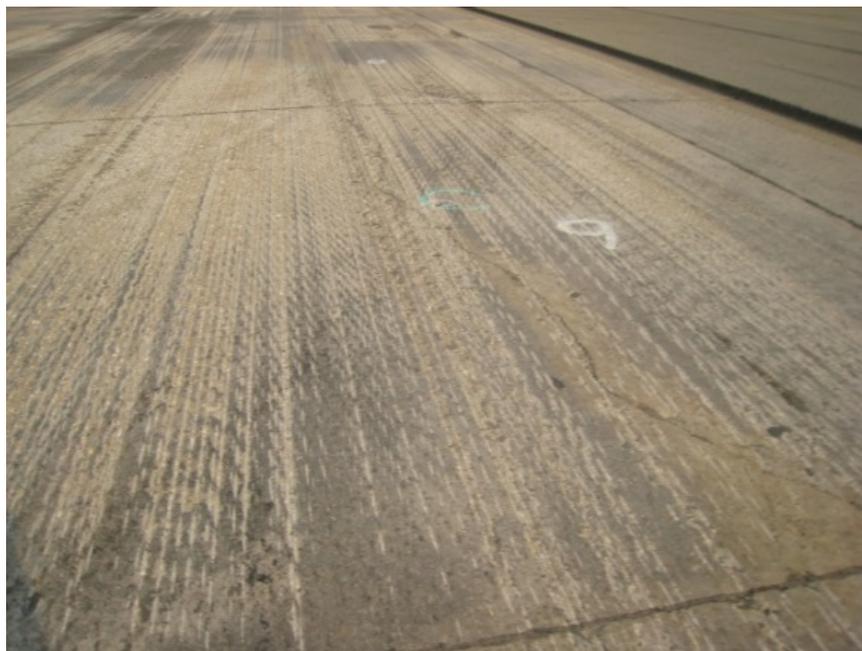
Photograph 6: Example of cross stitched crack in concrete slabs.

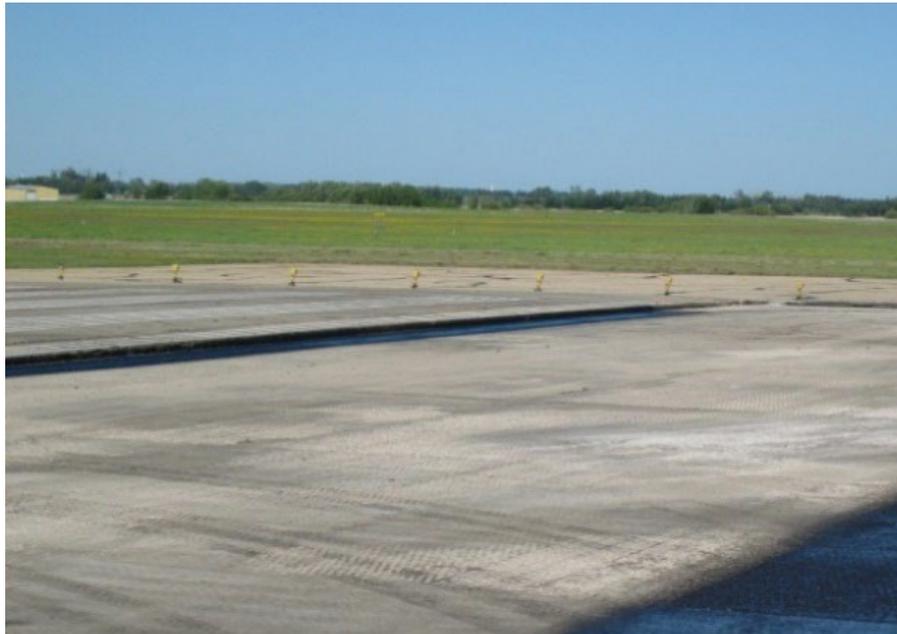
Photograph 7: Prepared surface of the concrete on Runway 12-30 prior to tack coat application and placement of new HMA.

It was noted in the past that even in areas where there was a sufficient thickness of remaining asphalt, the quality of the remaining asphalt was very poor. Essentially, there appeared to be no remaining adhesion in the existing asphalt and it was easily dislodged from the underlying concrete by the passage of the milling machine. Due to the condition of the existing asphalt and due to the variability in thickness, it was considered prudent to increase the milling depth such that the entire thickness of asphalt in all the areas was removed and replaced with new HMA. Removal of the entire thickness of the existing HMA also allowed for a thorough inspection of the underlying concrete slabs for the purpose of determining which slabs need to be removed and replaced, and which slabs should be cross stitched. Photograph 7 shows an example of the prepared surface of the underlying concrete prior to the application of tack coat and placement of the new hot mix asphalt. The surface of the existing concrete was slightly scarified to improve the bond with the overlying asphalt.

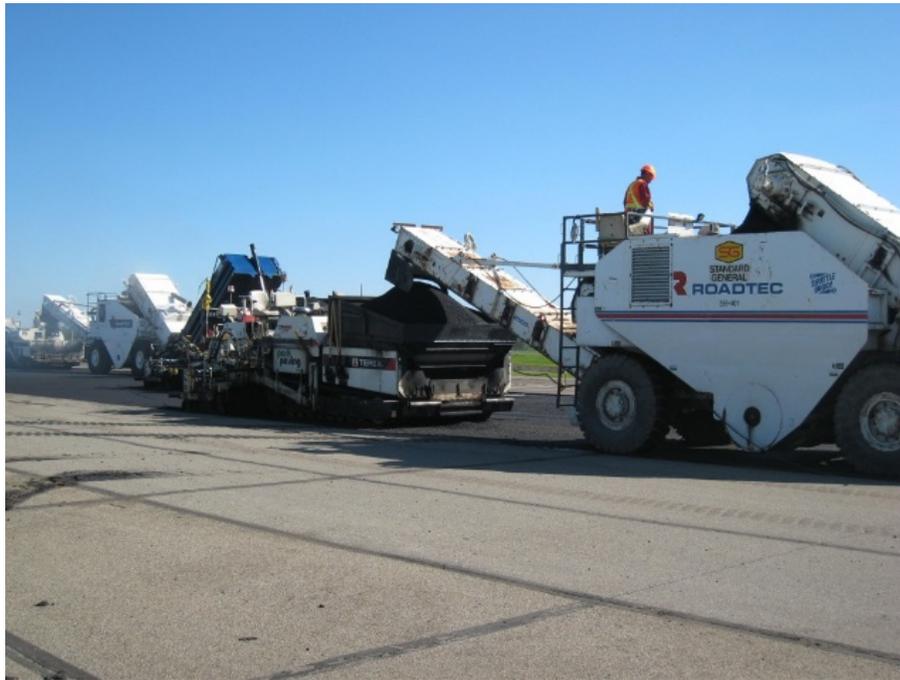
Photograph 8: Asphalt paving operation on Runway 02-20 included three pavers and two ShuttleBuggies®.

Asphalt paving on the runway was carried out with three pavers in echelon and two ShuttleBuggies<sup>®</sup> remixing the material and transferring asphalt mixes from the trucks to the pavers. Photograph 8 shows an example of the paving operation that was carried out Runway 02-20. The figure shows two of the three pavers in echelon and one of the two ShuttleBuggies<sup>®</sup>. This allowed the elimination of cold joints in the newly placed mat thereby eliminating the weakest point in the pavement. Due to the increased width of the mat being placed, a significantly large number of rollers were required to ensure that compaction was being achieved prior to a reduction in the temperature of the placed mix. In order to achieve the tightened compaction requirement of 94 percent of Maximum Relative Density (MRD), whenever possible, the rollers were kept as close as possible to the pavers, as shown in

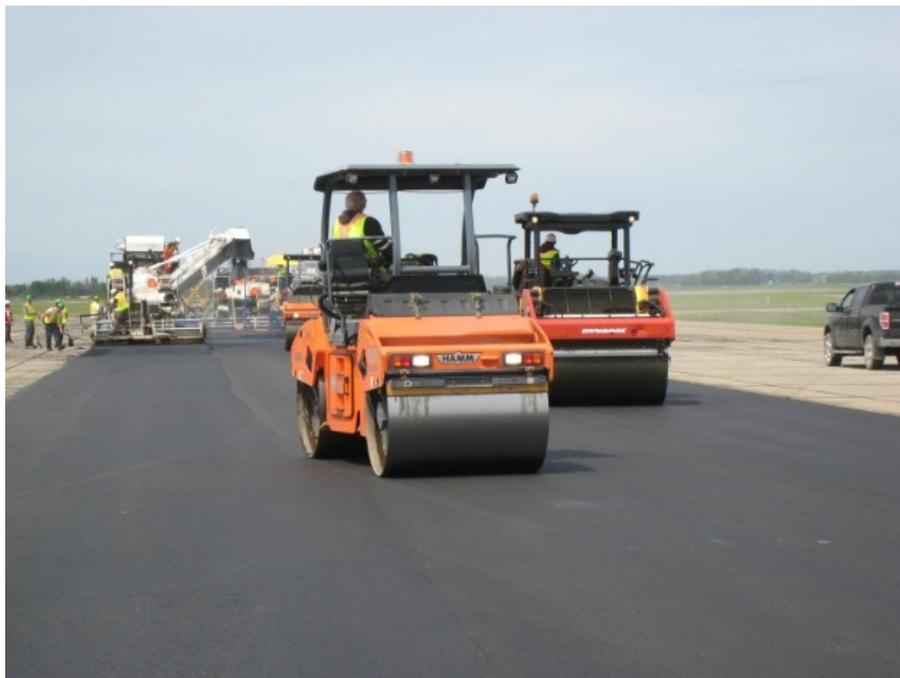
Photograph 9: Compaction operation on Runway 12-30.

Photograph 9. Quality Control (QC) and QA testing of compaction was carried out continuously during paving and the Contractor was immediately notified if the required compaction was not being achieved. Compaction requirements for the mat and the joints were met on both runways.

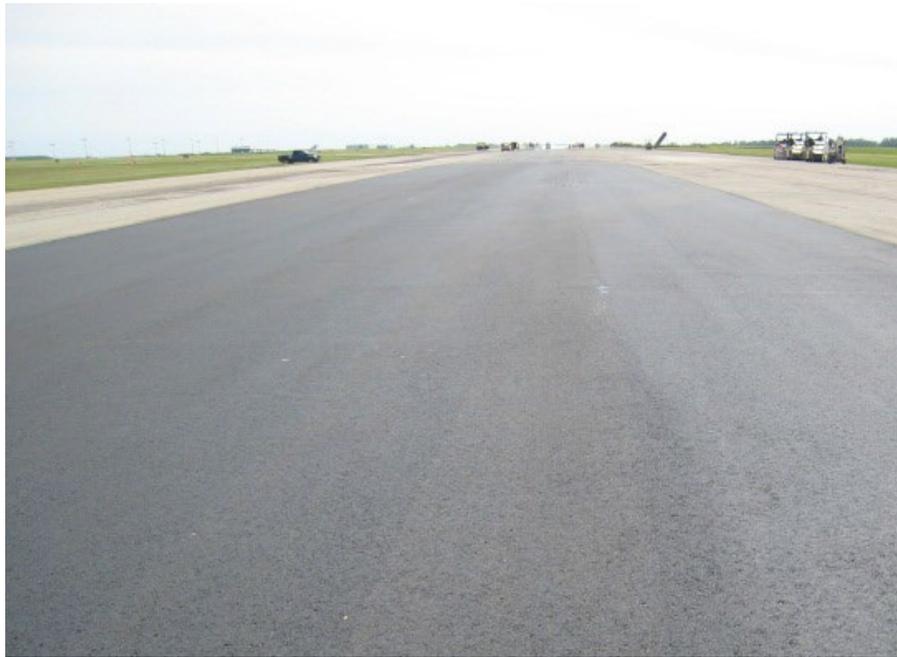
Photograph 10: Paved surface on Runway 02-20.

The smoothness is initially measured with a 3 m straight edge. Final smoothness is evaluated using an Inertial Profiler. Photograph 10 shows the final asphalt mat on Runway 02-20. The quality of the mat including compaction and smoothness was excellent.

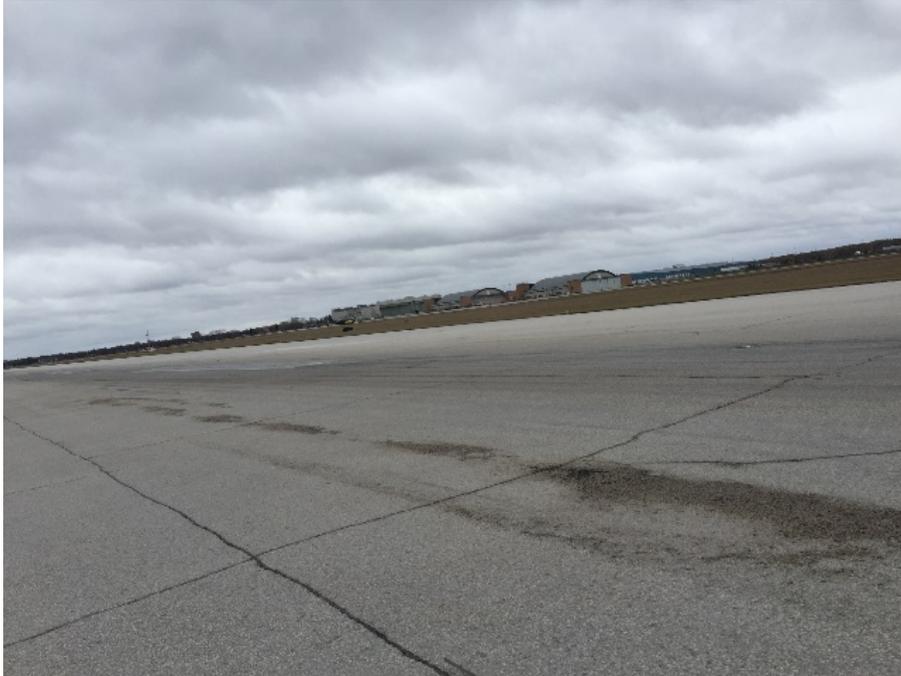
Photograph 11: Localized severe raveling on Runway 13-31.

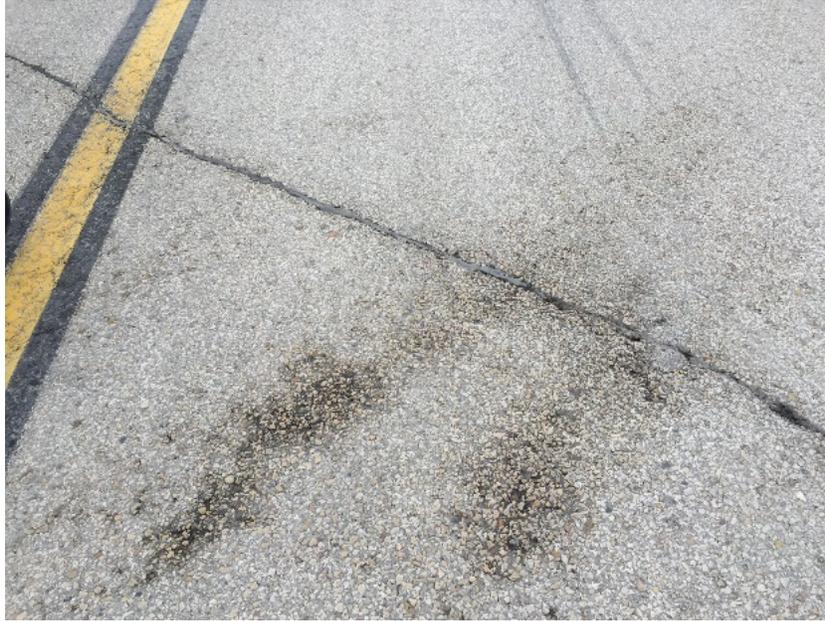
Photograph 13: Ravelling, cracking and polished aggregate.

Typically, limestone aggregates were used in WIA pavements. To improve frictional characteristics of the pavement, the Polished Stone Value (PSV) requirement was included in the specification. The limit was minimum 50. Extensive PSV testing was carried out of locally available aggregates. Generally, limestone aggregates had PSV values lower than granitic aggregates. None of the tested aggregates met the specified minimum of 50. The selected granitic aggregates had PSV of 45. Although it is better than those for limestone aggregates, monitoring of frictional characteristics will be needed and surface friction improvements through skid abrading or similar processes may be needed in the future.

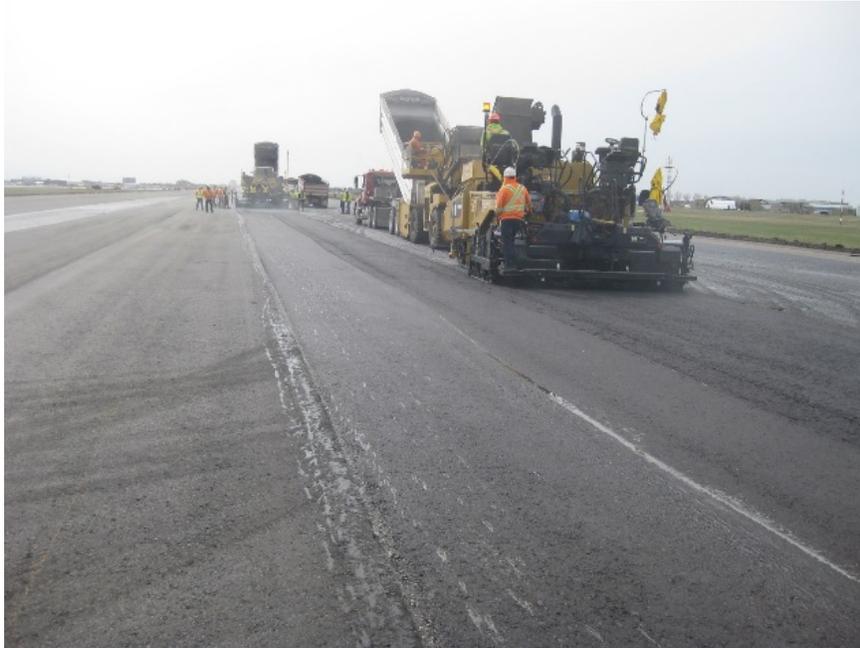
Photograph 14: Echelon paving of the lower course.

Photograph 14 shows echelon paving of the lower course mat and Photograph 15 shows the edge of the mat. Since both pavers used for lower course and surface course paving had excellent side confinement, as shown in Photograph 16, the edge of the paved mats was very good as can be seen in Photograph 15. The mat did not have to be cut or trimmed for cold joint construction. Photograph 17 shows the GlasGrid® application beneath the asphalt lower course to mitigate the potential for reflective cracking.

Photographs 14 and 18 show echelon paving of the base course and the surface course mat, respectively. The quality of the surface course mat is excellent, and the longitudinal joints are very tight, as shown in Photograph 19.

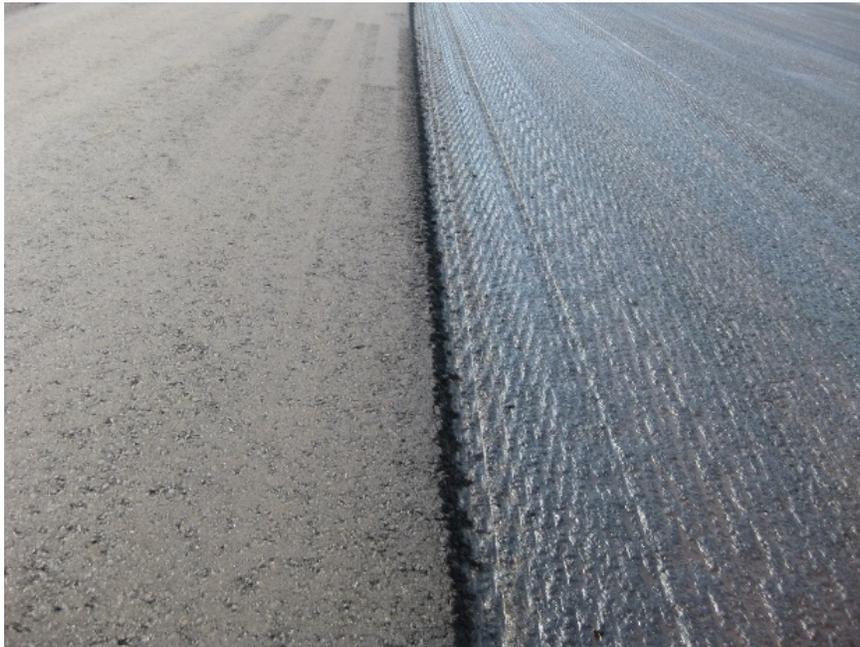
Photograph 15: Paved mat of the lower course. The edge is of very good quality.

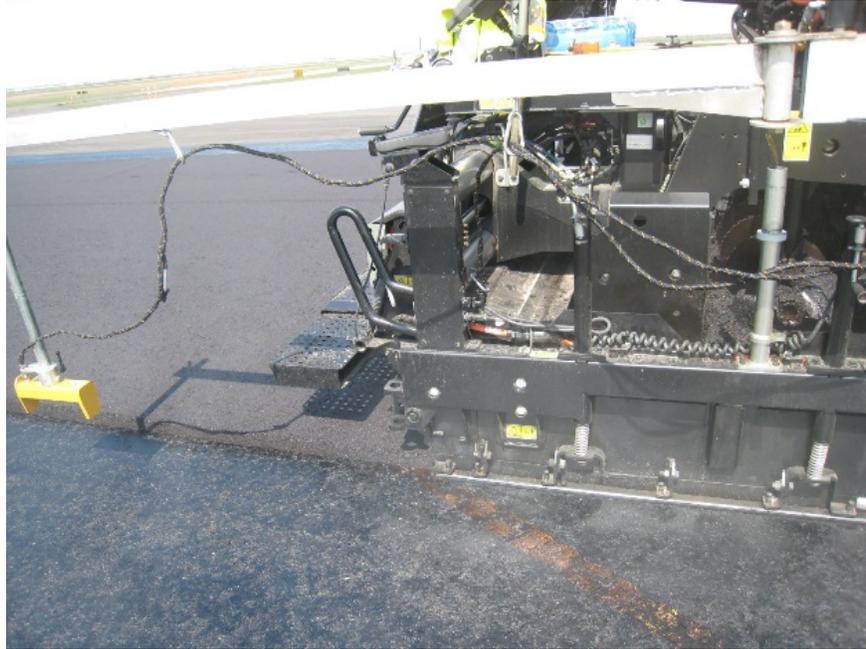
Photograph 16: Excellent side confinement provided by the paver.

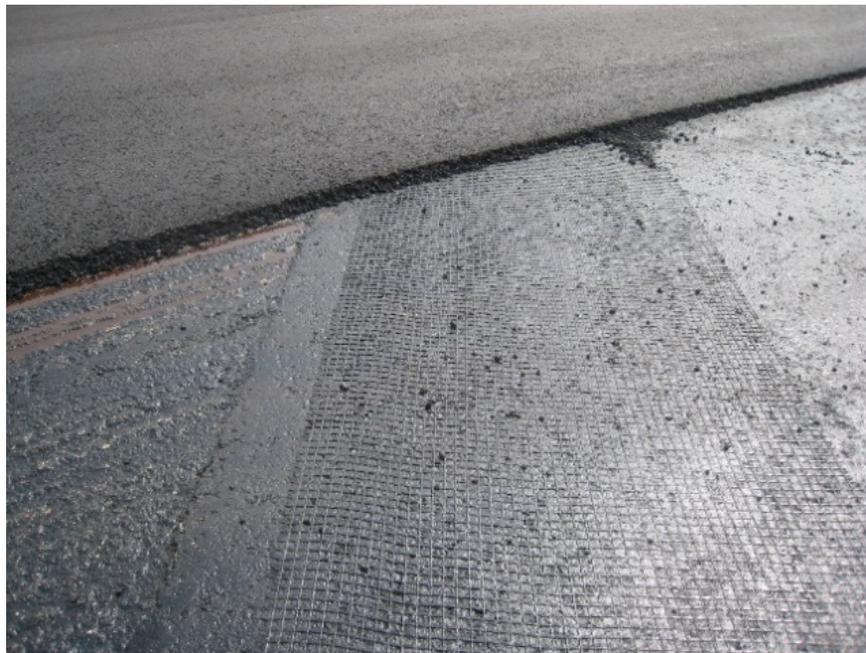
Photograph 17: GlasGrid® placed on existing pavement below the lower course.

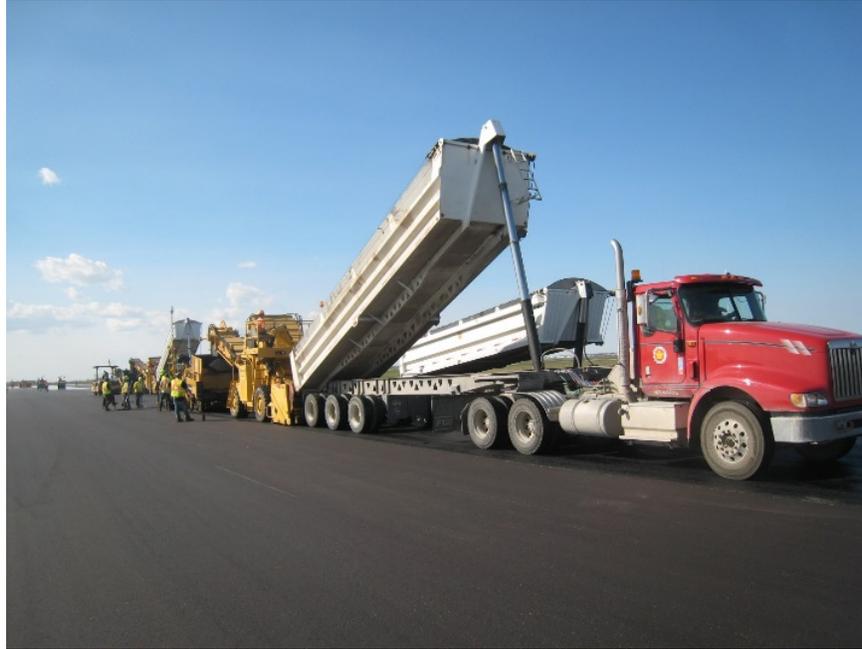
Photograph 18: Echelon paving of surface course.

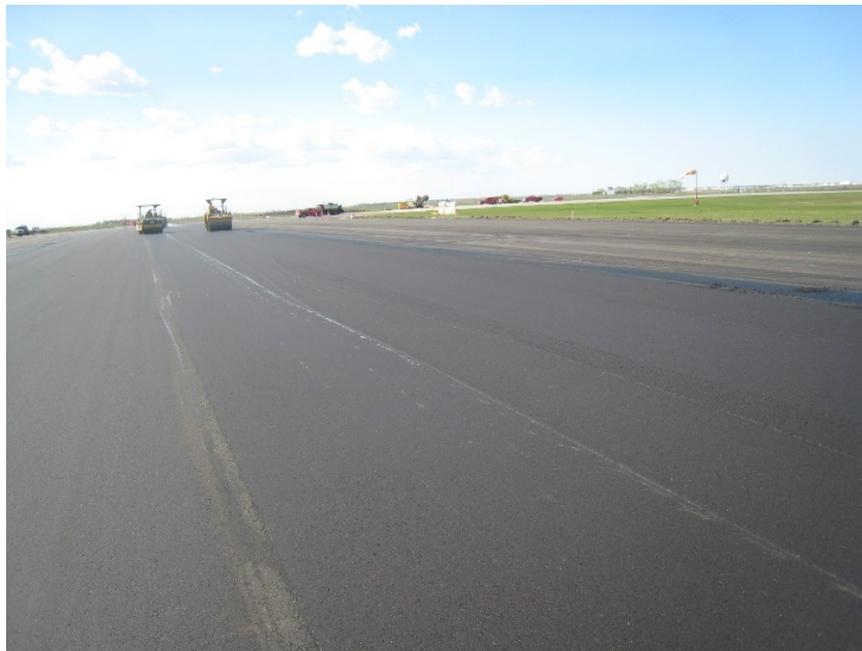
Photograph 19: Excellent quality of surface course mat. Longitudinal joint is very tight.
