**PILE DRIVING EFFECTS ON A STEEL TRUSS RAILWAY BRIDGE DURING  
REHABILITATION**

Jon Osback, P.Eng., Geotechnical Engineer, Clifton Associates Ltd.

Paper prepared for presentation  
at the Structures Session

of the 2018 Conference of the  
Transportation Association of Canada  
Saskatoon, SK

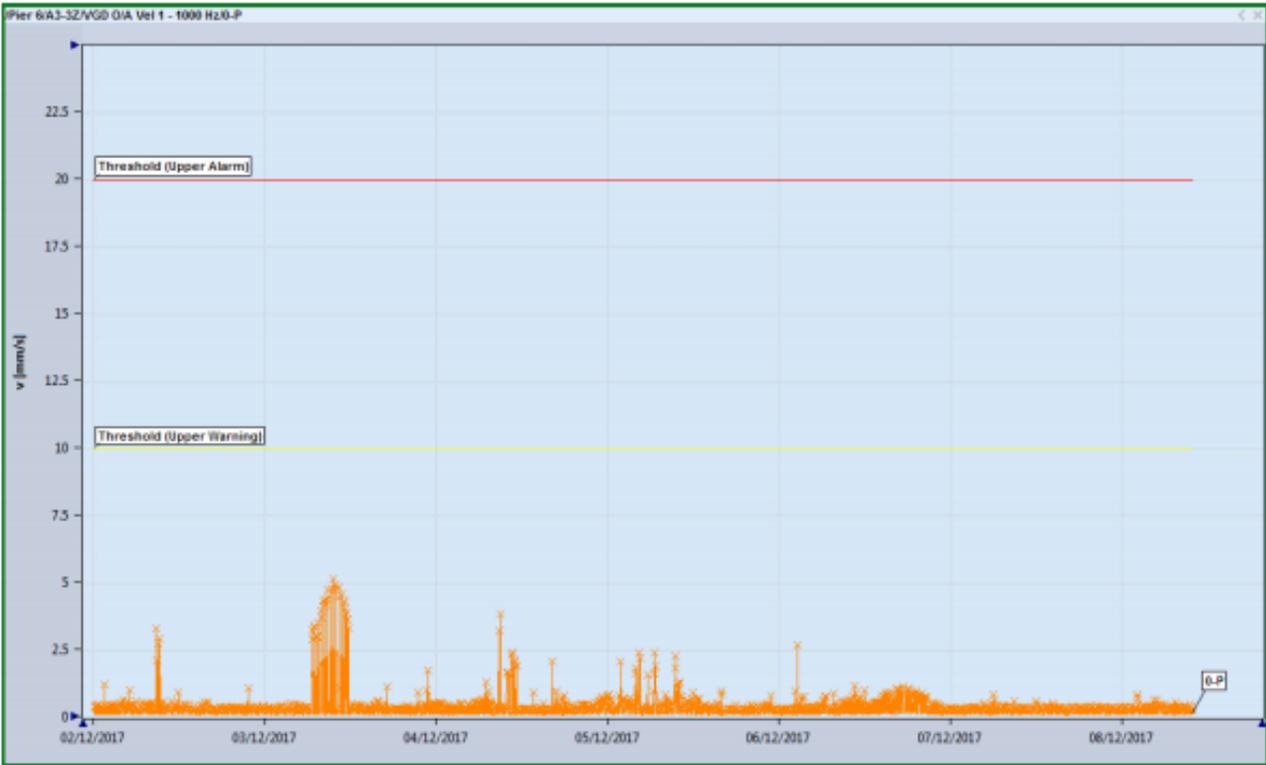
Figure 6 – Example of vibration monitoring, Pier 6

Accelerometers were hard wired to a Pruftechnik Vibguard 20 channel online condition monitoring system, which was installed at the top of Pier 8 to ensure a reliable cellular connection. The monitoring system collected and processed the accelerometer data, which was automatically sent to a remote server via cellular modem. Pruftechnik Omnitrend software was used to complete analysis: an example of typical processed vibration monitoring data is provided in Figure 6.

Figure 6 shows typical results during pile driving – operation of the pile driving hammer is clearly identifiable, with accelerations during pile driving generally within the lower threshold of 10 mm/s. The upper alarm limit of 20 mm/s was rarely met, for durations of less than 30 seconds, for which the impact to the bridge was believed negligible. The time required for vibrations exceeding the upper alarm limit to impose damage to the bridge was not assessed – vibration data was continually monitored, and work was to be stopped immediately if significant exceedance was noted. The judgment of the occasional sub – 30 second event being non-significant was based on the experience of the vibration monitoring consultant. As significant vibration was not experienced, consideration of minimizing vibration from the pile driving hammer was not considered.

Accelerations in the x, y and z direction were comparable, with no distinct trend of higher or lower magnitude in any particular direction. The vibration amplitudes were generally higher for the sensors mounted at the base of the piers during pile driving, and higher at the top sensors during passing of trains. The scope of vibration monitoring was limited to determining whether the vibration limits were met or exceeded; therefore, detailed review of the magnitude of vibrations was not conducted.
