Improving Roadway Safety and Rider Comfort by Implementing Various Design and Construction Solutions – South Fraser Perimeter Road Experience

Paper prepared for presentation at the “Innovation in Roadway/Embankment Materials and Geotechnical Engineering” Session of the 2022 TAC Conference & Exhibition, Edmonton, AB

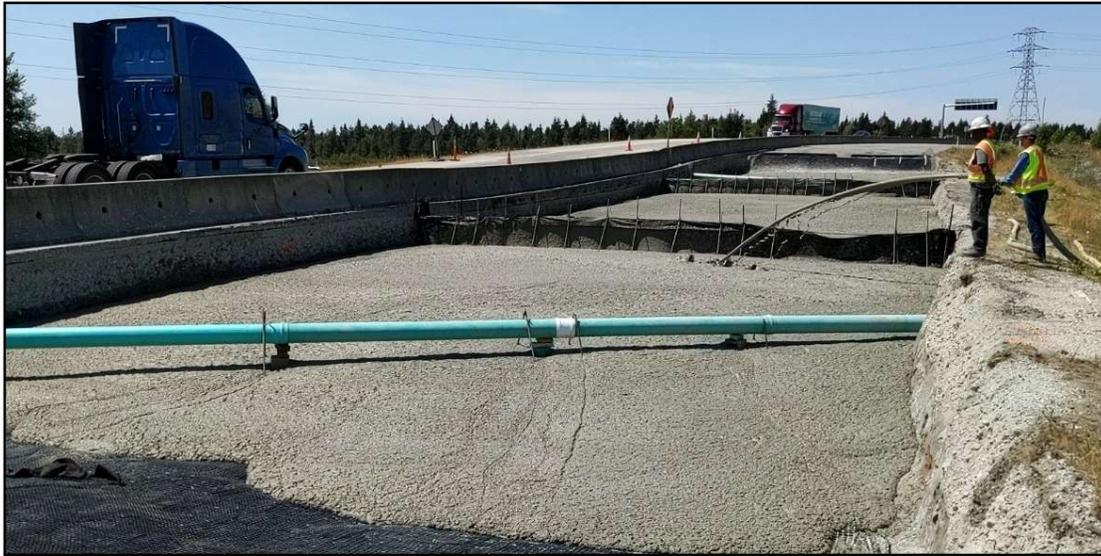
Figure 4: Construction of Light-weight Cellular Concrete (LCC) fill being placed in terraced steps. Partitions, made of geotextile and rebar, were utilized between the steps of different elevations and/or depths of LCC fill.

However, several constructability requirements specific to the LCC material were required to be incorporated in the design were not required for traditional granular fill. The LCC fill is a self-leveling product, and thus sections of the roadway to be reconstructed using LCC on a vertical grade required the LCC to be poured in “steps” in a terraced form with partitions made of geofabric and rebar placed between the steps to attain the desired finished road grade.

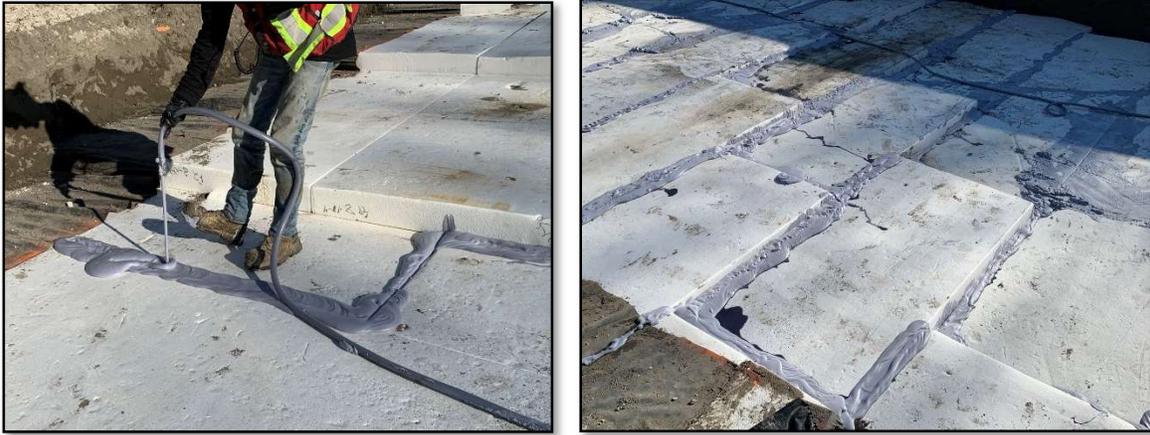
EPS blocks have been utilized as part of the original road embankment at some locations along the highway to relieve deadload weight and thereby reduce future settlement effects. For example, the North Surrey Interceptor forced sewer crosses the highway corridor at two locations and are supported on piled foundations located deep beneath the EPS embankment which is approximately 5 meters in height. Issues with the EPS embankment settlement were experienced in isolated areas where “hog fuel” is present, and in the area of hard points (local differential settlement locations) caused by the North Surrey Interceptor crossings. This resulted in the movement of the EPS blocks, causing voids between the blocks to form, which in turn resulted in the migration of fines/granular materials causing both rideability issues and on some occasions sink holes in the road pavement.

Figures 6 & 7: Application of high-density expanding polyurethane closed-cell foam via injection to fill the voids between the EPS blocks.

To address this issue, and to prevent further loss of fines and movement of the EPS blocks, the pavement and road structure above the EPS blocks were removed to expose the EPS blocks, and the voids between the blocks were injection-filled with high density expanding polyurethane closed-cell foam. Following this, the road structure and pavement above the EPS block was reconstructed.
