2022 TAC Conference & Exhibition
Edmonton, Alberta
October 2nd to 5th, 2022

Presentation Paper:
Infrastructure Improvements within Challenging Soils

For Presentation at the:
Soils and Materials Conference Session

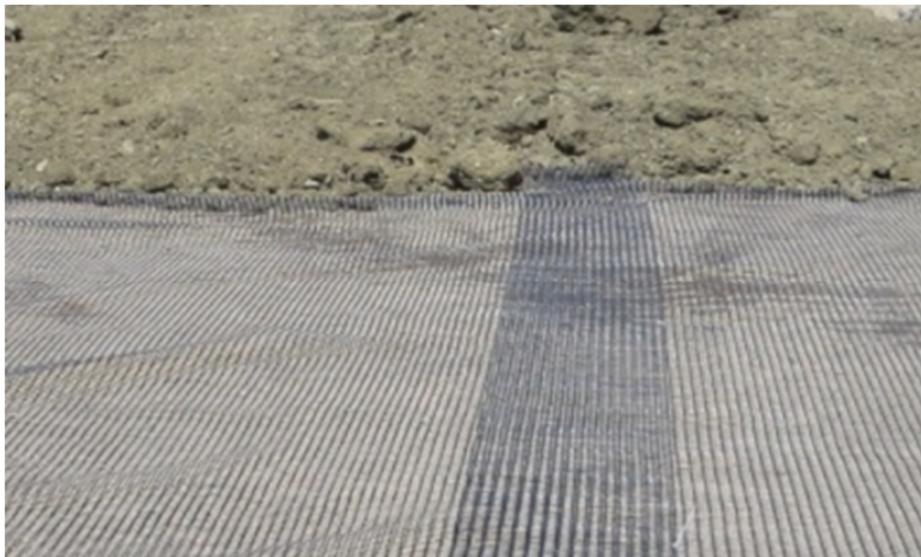
Photo 3.1:

Placement of biaxial geogrid within lower level subbase/subgrade construction. Rolls of geogrid product are overlapped and spread out evenly across the grade and then uniform layers of suitable fill materials are placed and compacted above to create a stable surface for further grade construction.

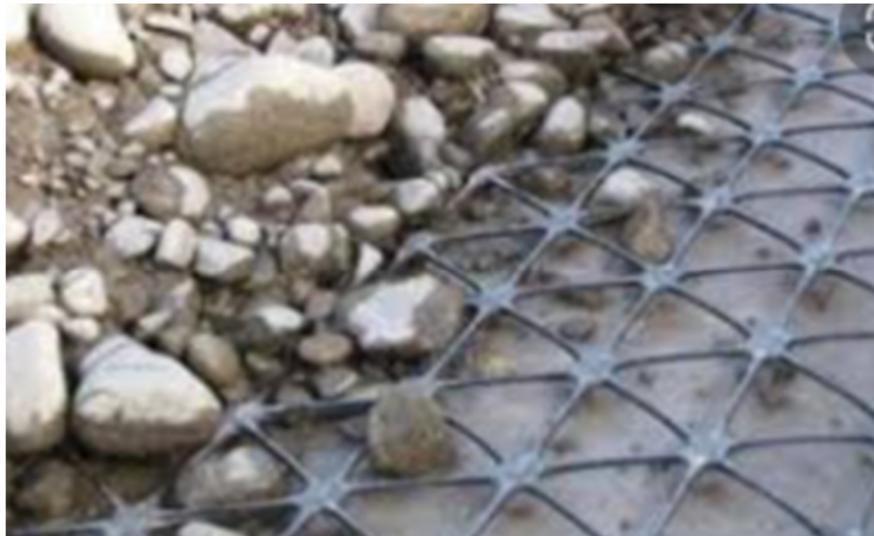
Photo 3.2:

Triaxial geogrid placement with granular fill material. Crushed aggregate material (fractured faces) bind well with the triangular apertures to ensure a consolidated spread of granular material. Following the manufacturers recommendations can significantly reduce the amount of gravel required to produce

Table 3.4 illustrates a sample specification for a triaxial geogrid which would typically be suitable for placement below or within a granular capping application such as for a laydown yard or parking lot. A layer of geogrid is often placed between aggregate classes, to bind and contain the materials and also to maintain separation between material classes (ie: a 50mm nominal size material below a 20mm crush aggregate). Based on cost benefit analysis, the triaxial geogrids are not seen as a significant improvement over biaxial products for subgrade or subbase applications.

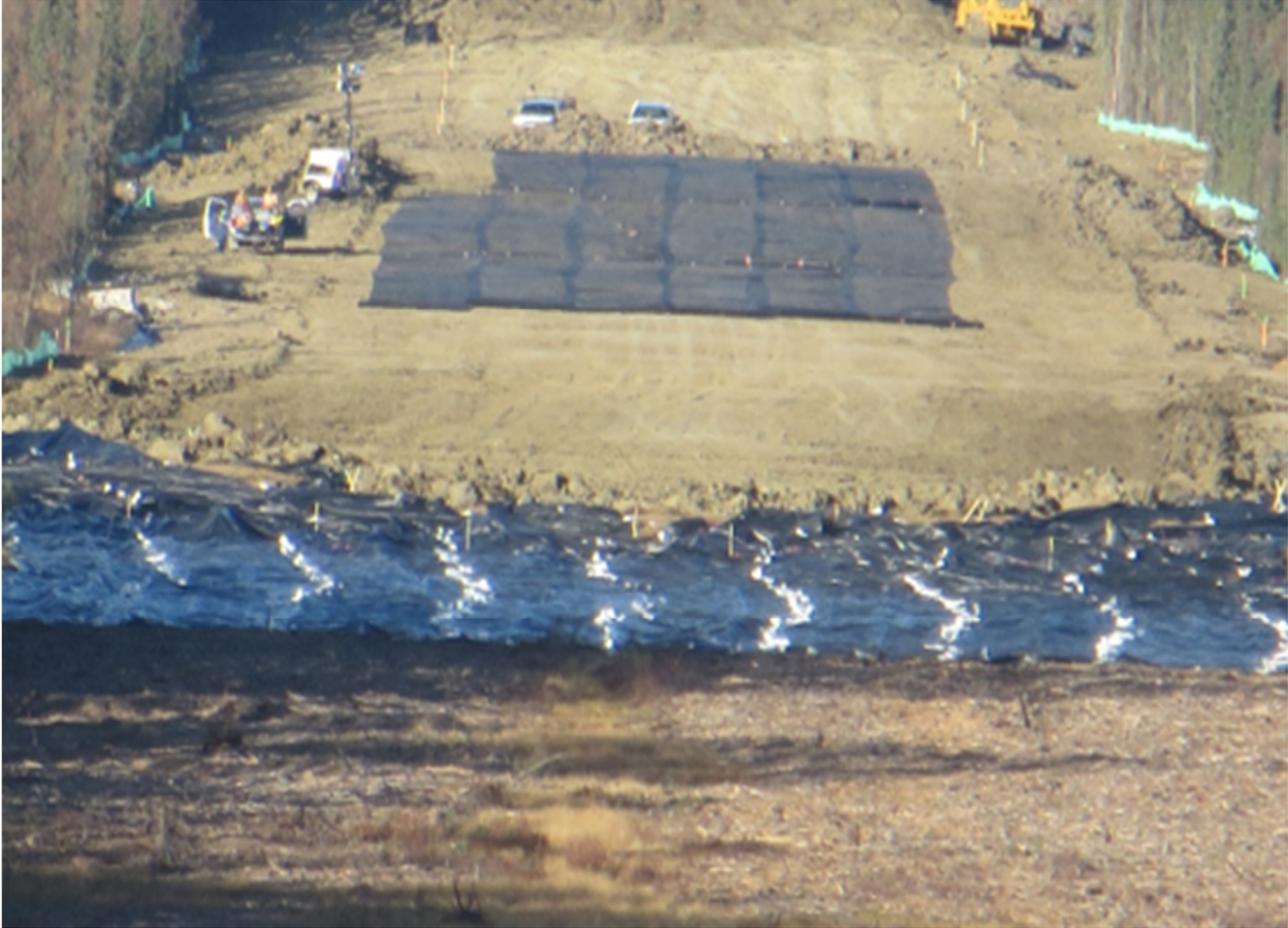
Photo 4.1: Muskeg area with geotextile and geogrid placement separated by fill material

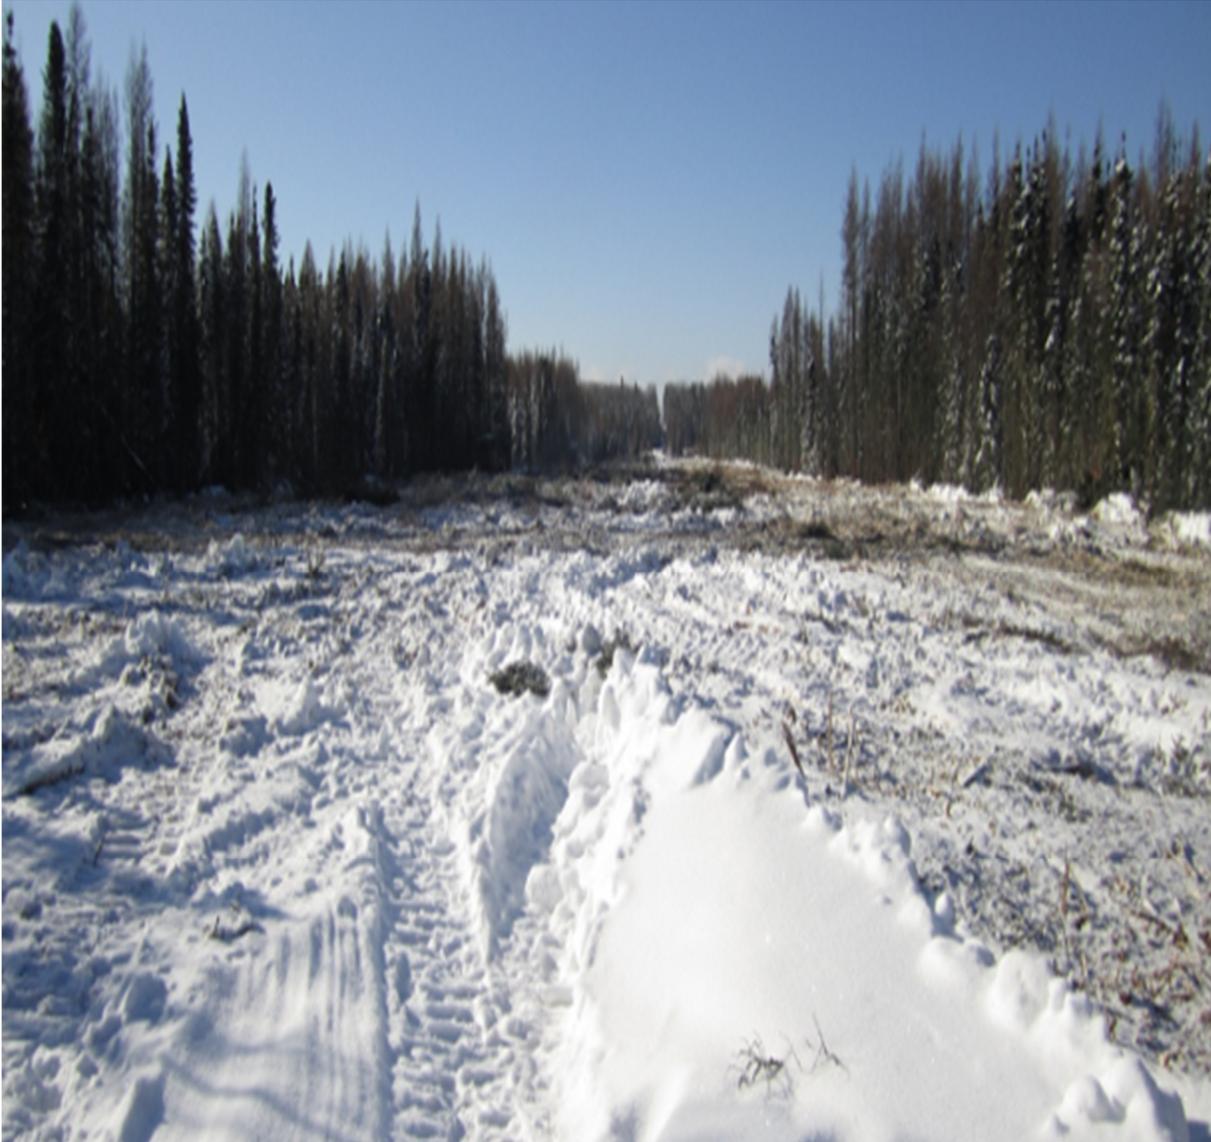
Photo 5.1: showing tree and bush clearing over muskeg areas

Construction activities were staged to allow for tree clearing operations within the appropriate migratory bird window and to gain access to the muskeg region in winter months when the ground was frozen. The muskeg extended for approximately 1600m through the middle section of the project and was padded over with geotextile, geogrid and an initial lift of embankment pre-load during the frozen winter season. Tracked machines in cold conditions were used to apply downward forces and get the frost deeper into the muskeg in order to achieve maximum strength.

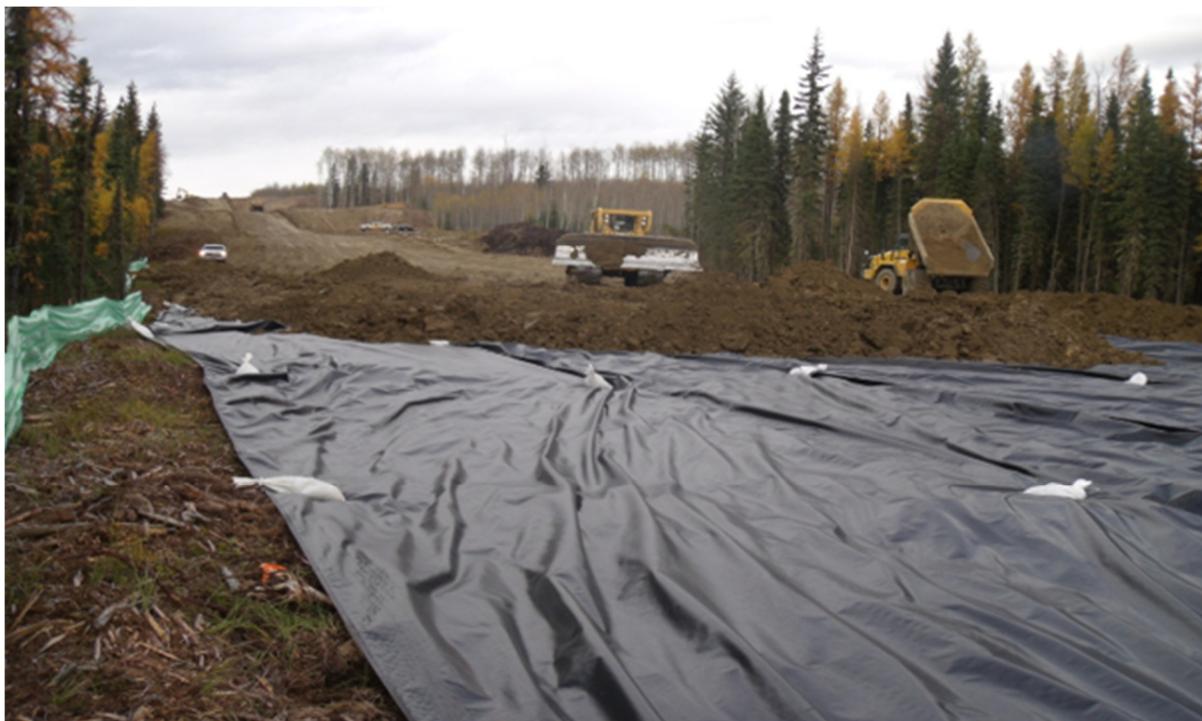
Photo 5.2: showing geotextile fabric placement and initial layers of embankment

Geotextile materials were placed directly over the muskeg after clearing operations were completed and a zone of engineered fill was placed to an approximate depth of 500mm. At this level, a layer of structural geogrid was placed over the prepared surface and followed by additional layers of compacted fill.

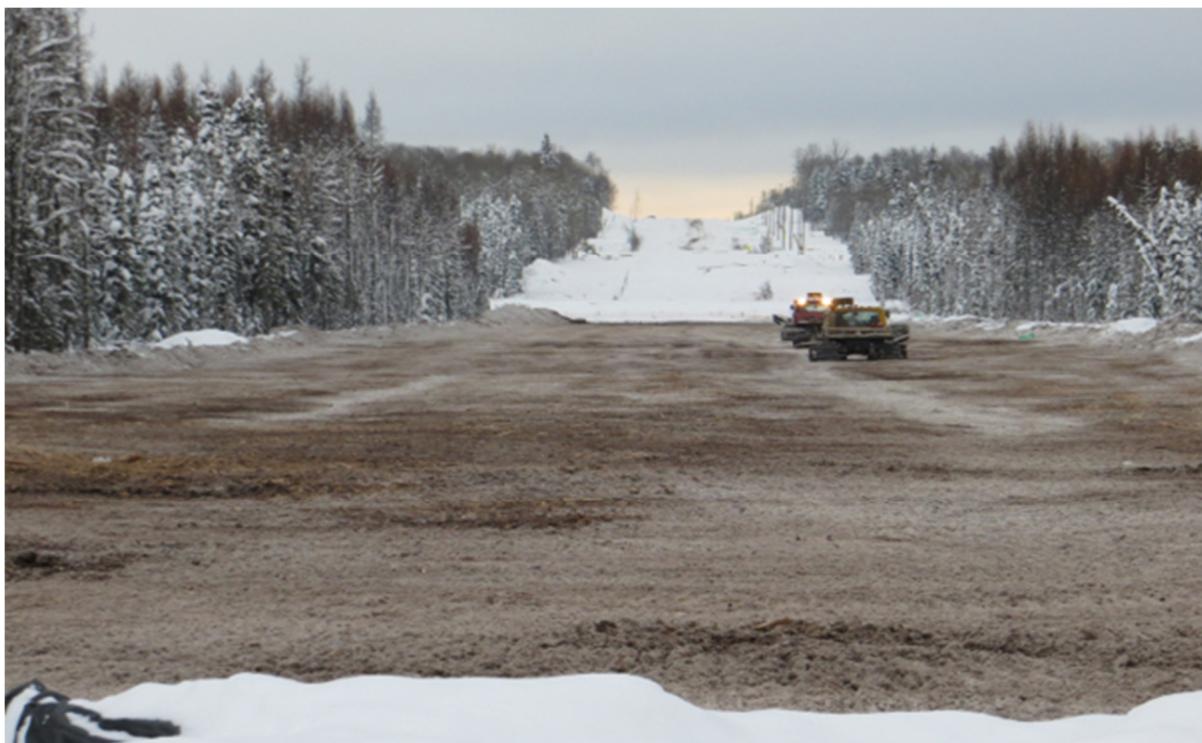
Photo 5.3: showing machine tracking to force frost deeper into the muskeg

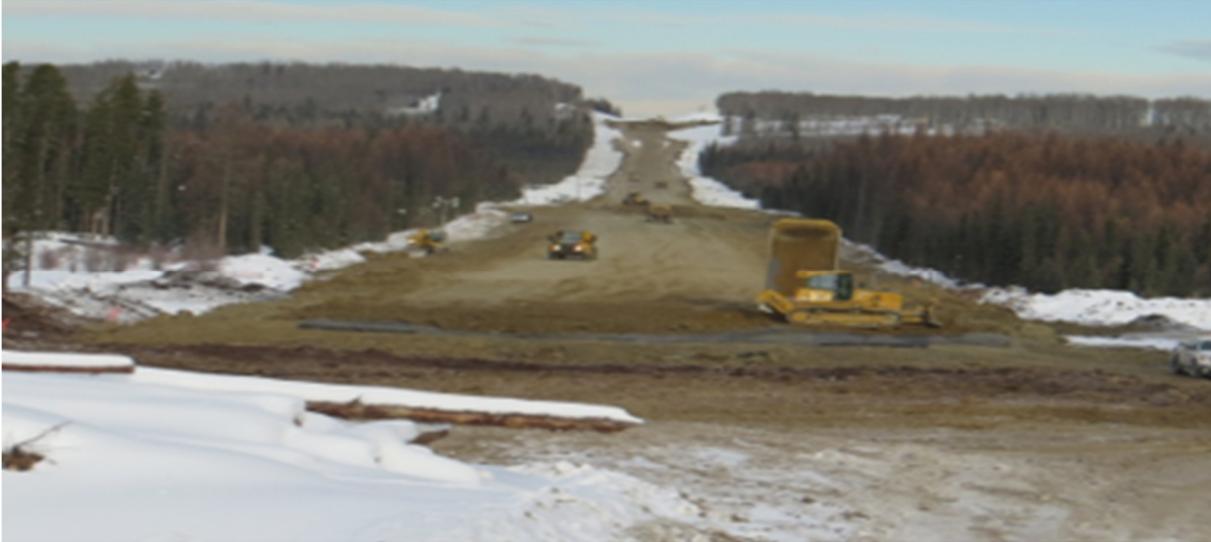
Photo 5.4: showing upper-level grade construction over geotextile and geogrid layers

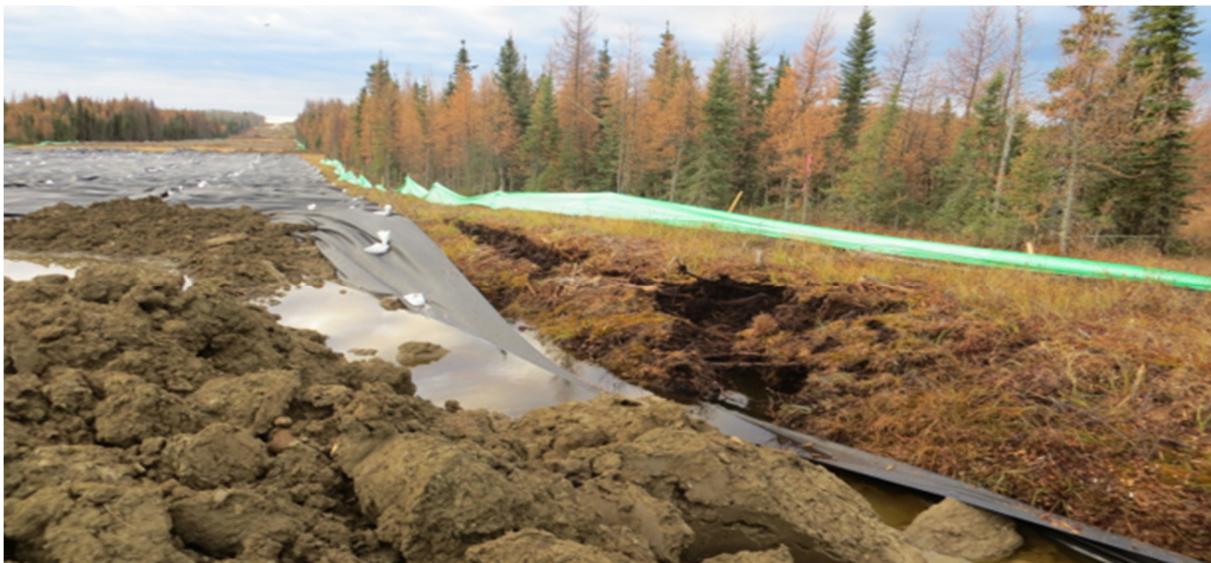
Photo 5.5: shear failure within muskeg zone during placement of initial fill lift

During a night shift operation while placing the first lift of embankment, the muskeg sheared longitudinally along the grade and parallel to the road centerline. The zone of influence was within close proximity to a pipeline right of way with two high pressure pipelines crossing perpendicular to the roadway. The pipeline owner had decommissioned the lines in advance of the road construction work however, they were an asset that was planned for future use and needed to be adequately protected from further stresses.

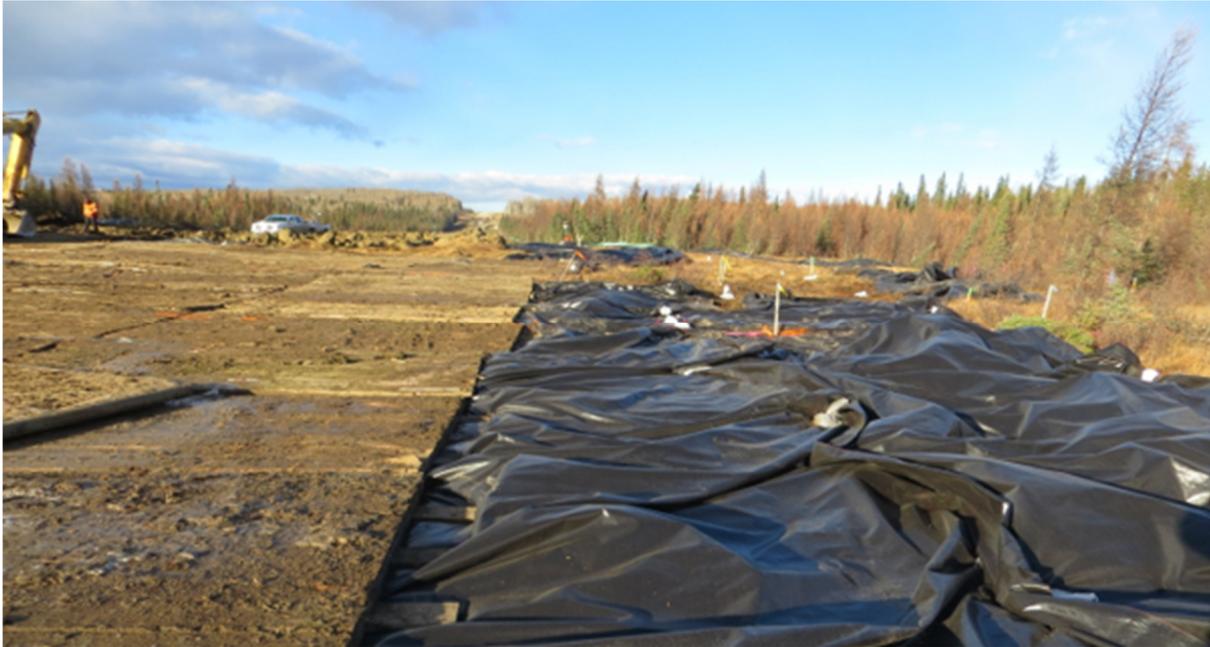
Photo 5.6: swamp mat placement over geotextile as extra layer of protection

After consultation with the pipeline owner and other stakeholders, it was determined that an extra measure would be necessary to satisfy concerns about the integrity of the pipelines. A proposal was put forward to install a layer of swamp mats prior to advancing any further grade construction which was agreed to. The previously placed materials were leveled off and another layer of geotextile was installed in preparation for swamp mat placement.

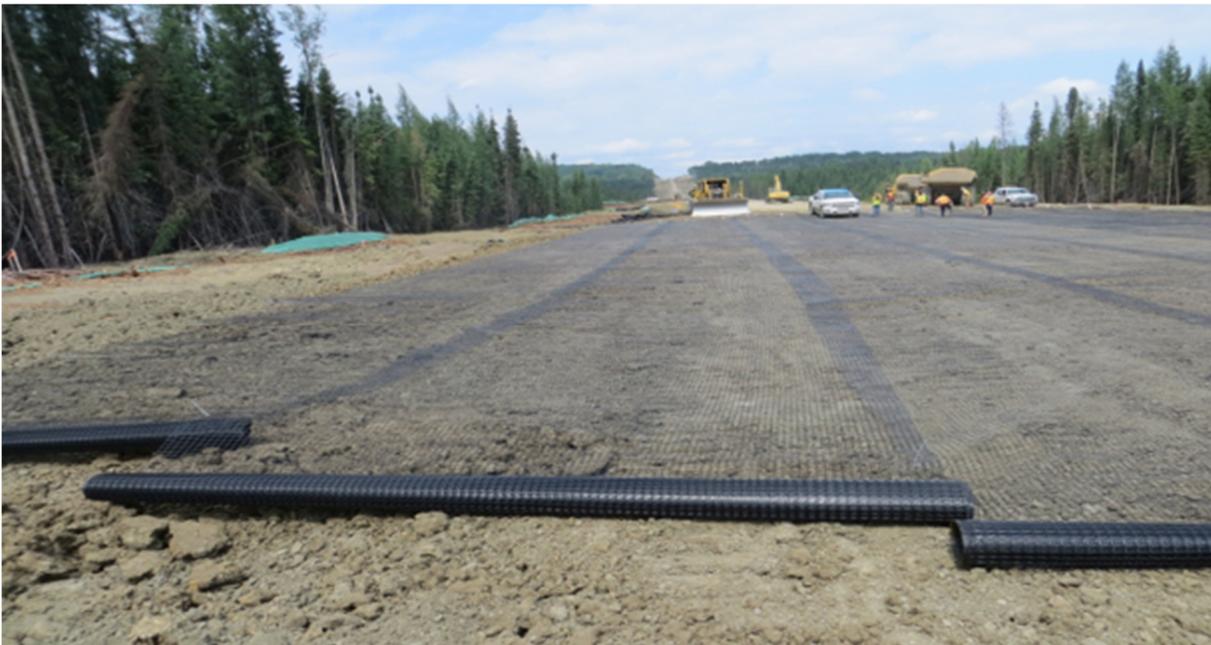
Photo 5.7: additional layers of geogrid used within subgrade layer above failure area

This configuration was successful in stabilizing the area for continued grade construction over the two pipelines. It is worth noting that a layer or two of geocells may have worked adequately in lieu of the swamp mats, however the matting option was viewed as the clear favorite by the affected stakeholders in this situation due to the sensitivity of the pipelines.

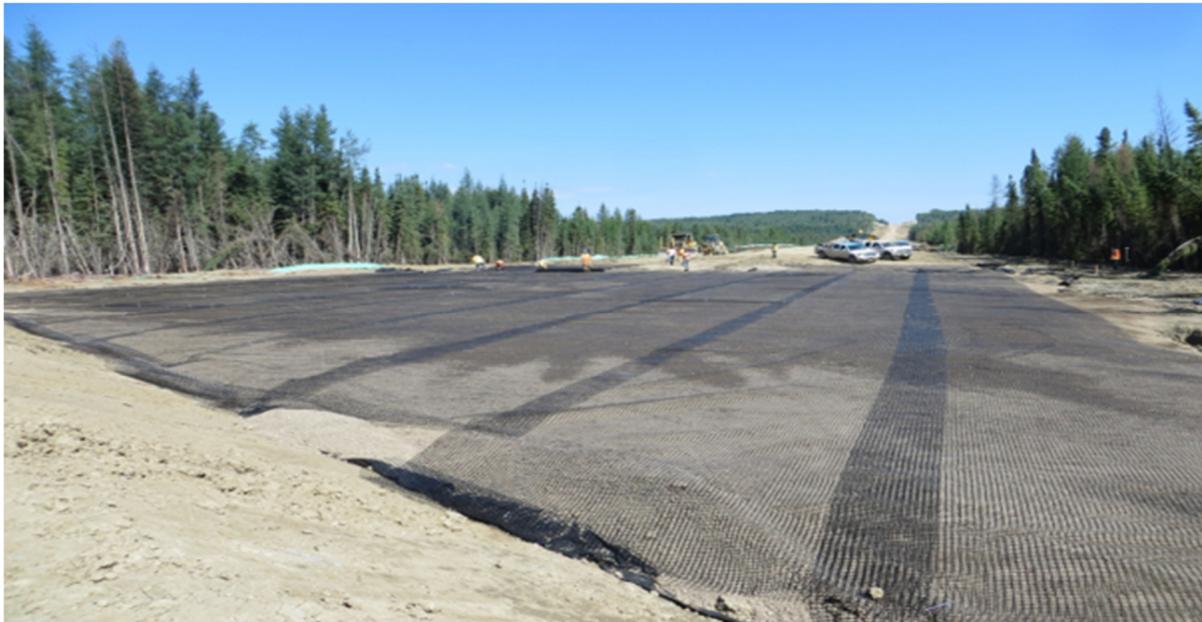
Photo 5.9: showing the fourth level of geogrid placement above the failure area

12. A fourth layer of geogrid was placed above the granular backfill material and clay from the previous set for the full width and length of the excavation.
