**Evaluating the Performance of Tack Coat Materials in Saskatchewan Climate by Means of a
Field Study and Laboratory Study – Part 1 Field Study**

Paper prepared for presentation
at the Testing and Modeling of Road and Embankment Materials Session
of the 2018 Conference of the
Transportation Association of Canada
Saskatoon, SK

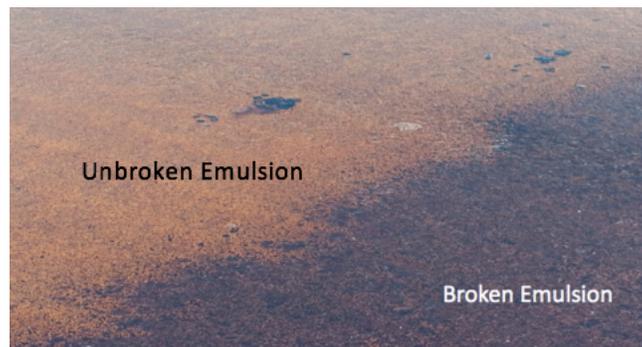
A tack coat material “breaks” when its colour changes from brown to black as shown in Figure 1. Break times vary significantly, depending on the properties of the material itself, whether and how it is diluted with water, as well as with weather conditions. A tack coat sets when the emulsion residue is no longer picked up from the road surface. This can be determined by blotting the surface with a tissue on the emulsion, and by observing product transfer to vehicle tires. Minimal transfer of residue indicates that any water previously present in the material has evaporated and the asphalt bitumen is forming a homogeneous layer on the road surface.

Figure 1. Broken and Unbroken Tack Coat Material

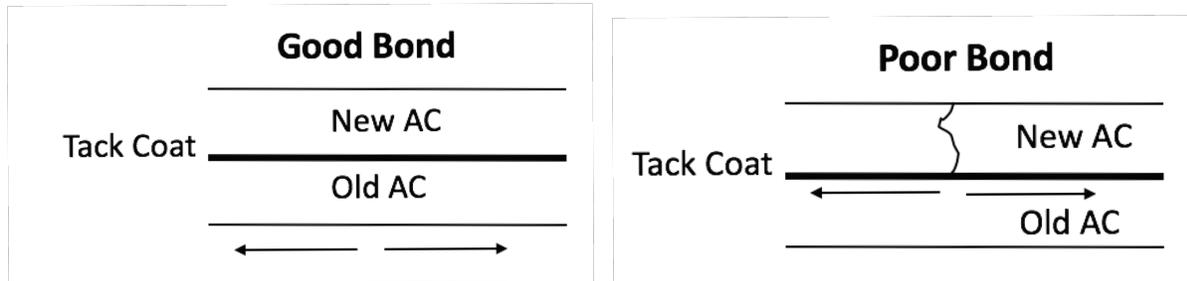
Achieving sufficient proper bond strength between asphalt concrete layers is critical to ensure that the bonded layers will act and resist stresses as one homogeneous system. If the bond is inadequate, asphalt concrete layers will act separately as multiple layers which will increase the stress levels within these layers and lead to cracking and premature failure. Figure 2 shows the difference in asphalt concrete layers behaviour with good and poor bond. In Figure 2b a poor bond between new and old asphalt concrete layers makes the two layers act independently as two thin layers, which leads to exceeding the tensile strength of asphalt concrete and cracking of the new asphalt layer.

Figure 2a. Old and New AC Layers Act as One Thick Layer Figure 2b. Old and New AC Layers Act as Two Separate Layers
Figure 2. Behaviour of Asphalt Concrete Layers with Good and Poor Bond

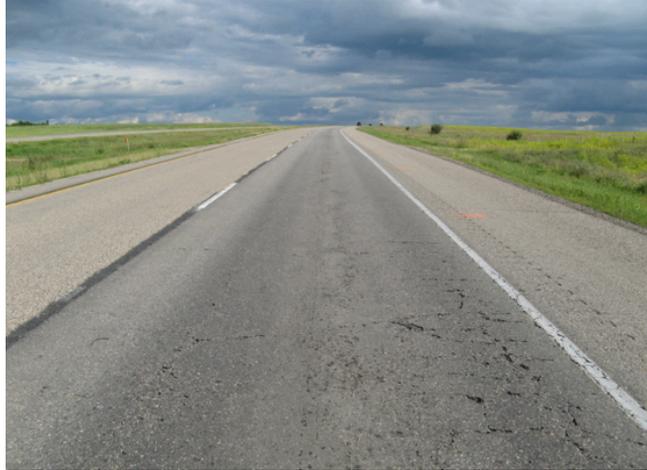
Figure 4. Example of Fatigue Cracking

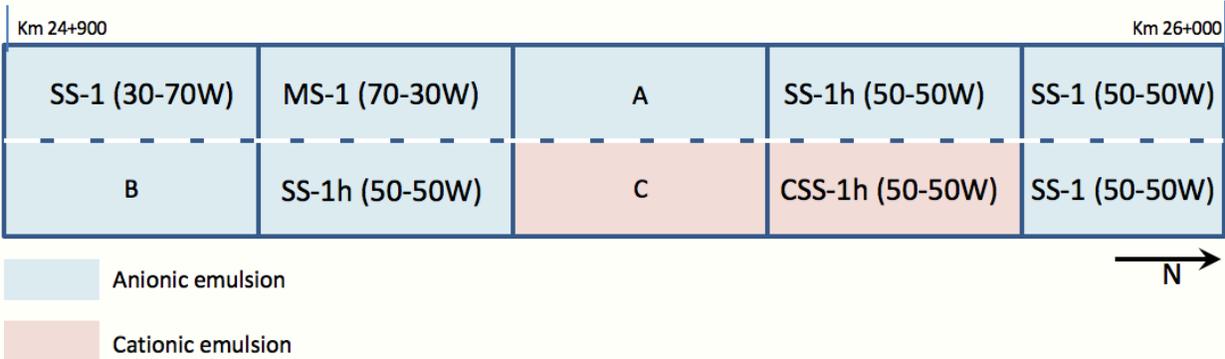
A 1.1km two-way, two-lane road segment on Highway 12 near Blain Lake, SK, was designated for the field study. Within this road segment, ten test sections were constructed, five in each lane. The layout of the products and test sections within the road segment is shown in Figure 5.

Figure 5. Layout of Test Sections and Tested Materials

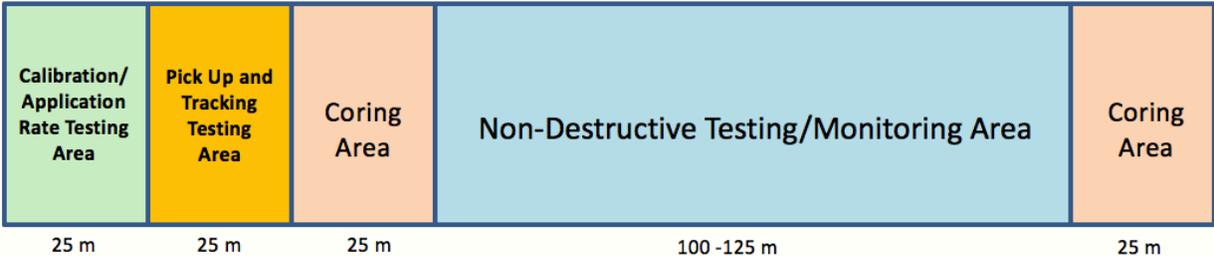
Each test section was approximately 225m in length and was further divided into specific areas. These areas are calibration/application rate testing area, pick up and tracking testing area, non-destructive testing (NDT) area, and two coring areas. Figure 6 shows a schematic of the field test section.

Figure 6. Test Section Schematic

The first area was the calibration/application rate testing area. This 25m area was used to calibrate the distributor by means of a patch test. A patch test was performed to ensure the distributor was applying a consistent desired spray rate [12]. Eleven absorbent patches were placed on the road. The distributor sprayed this first 25m area and stopped. Patches were weighed and actual application rate would be determined. Adjustments were made to the distributor on-board rate control computer if necessary. Figure 7 shows a layout for the patch test.

The second area was the pick-up and tracking test area. This 25m area was used to evaluate the breaking and setting times as well as the material severity to pick-up/tracking by truck tires. Once the product had set, a truck was driven over the section and the material was given a rating of none, low, medium, or high according to its pick-up/tracking by truck tires.

The third area was the non-destructive testing area. This 125m area will be used to perform the distress survey following winter of each year. Falling weight deflectometer (FWD) testing may be performed as well.

The last areas are the two coring areas. Each coring area will have 32 cores extracted from it during 5 coring periods. The first set of eight cores was collected from each zone following the completion of construction. These cores are red in Figure 8 below. Cores were collected from the inner and outer wheel paths (IWP & OWP), and the centre of each lane. Table 2 shows a breakdown of the cores collected post-construction. The remaining 24 cores will be taken from the road following the winters of years 2018, 2019, 2020, and 2021.

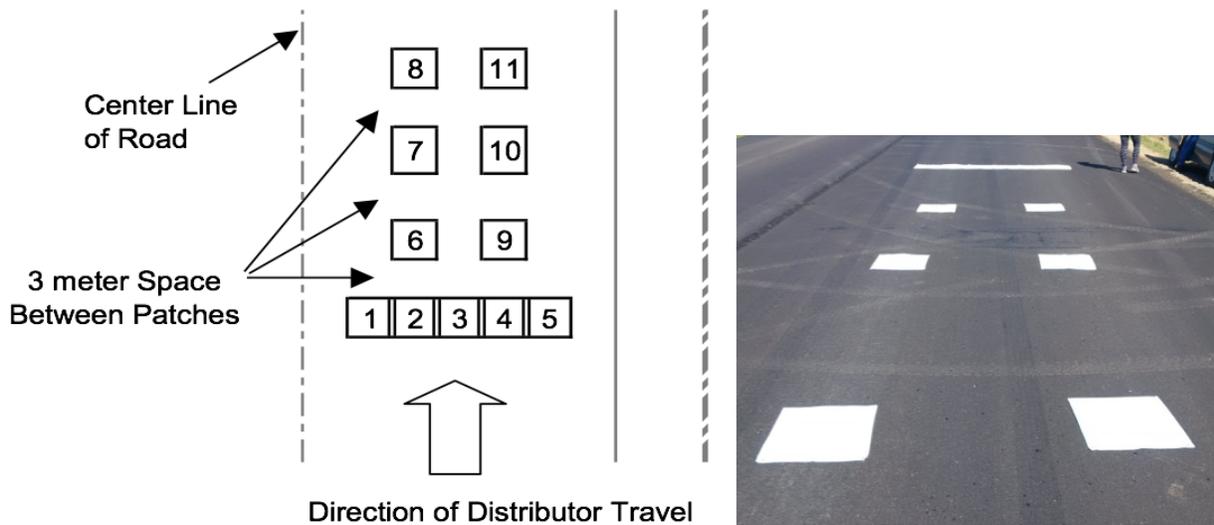
Figure 7. Patch Test Layout [12]

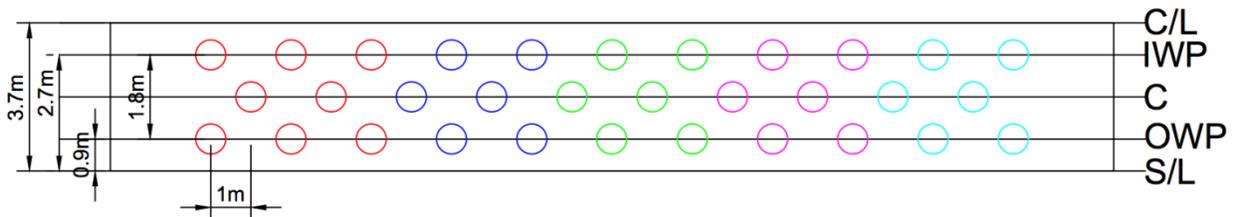
Figure 8. Coring Map

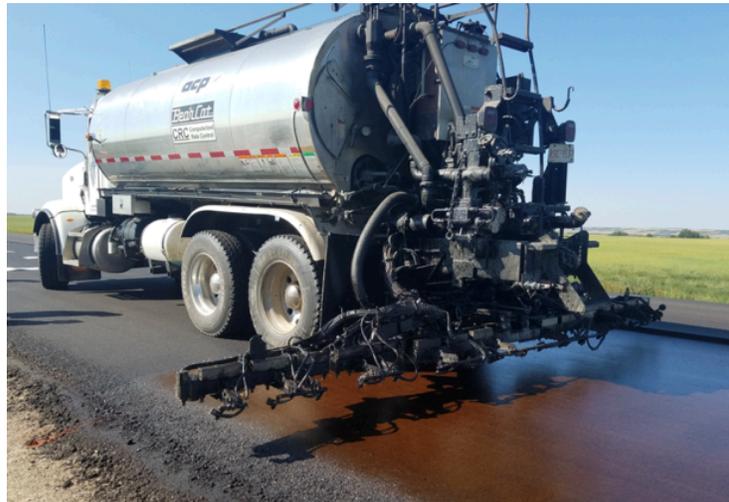
Construction of the test sections was done according to the plan and layout outlined in the methodology section. The distributor used to apply the tack coat materials was a 2015 BearCat

Computer Rate Controlled Distributor and is shown below in Figure 9. The nozzles were set at a height of 15-20cm from the ground, with a nozzle angle of 30 degrees which allowed for triple overlap to be achieved. The distributor computer was set to spray a constant application rate independent of the truck's speed. The distributor's set application rate was adjusted based on the tack coat material's dilution percentage to aim for the same residual application rate for all products. The difficulty in spraying 10 products of both anionic and cationic varieties within a two day period was a challenge to the contractor as the distributor had to be flushed (cleaned) between products to ensure that there were no contamination between the products.

Figure 9. Tack Coat Distributor Truck

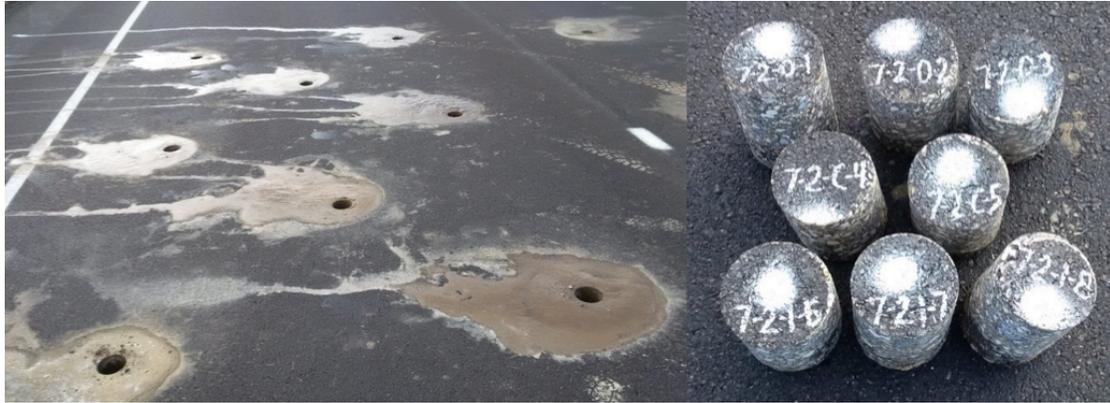
Figure 10 shows the road following coring and the eight four-inch cores taking from a coring area. Core holes were filled with a cold mix asphalt. Cores were drilled using a coring drill mounted on the back of a pickup truck. Following extraction, each core was labelled based on test section number (1-10), coring zone number (1 or 2), and location in the road (inner wheel path, centre, or outer wheel path). Cores were carefully wrapped in bubble wrap to prevent damage during transport and while in storage. Cores were stored at room temperature.

Figure 10. Cores

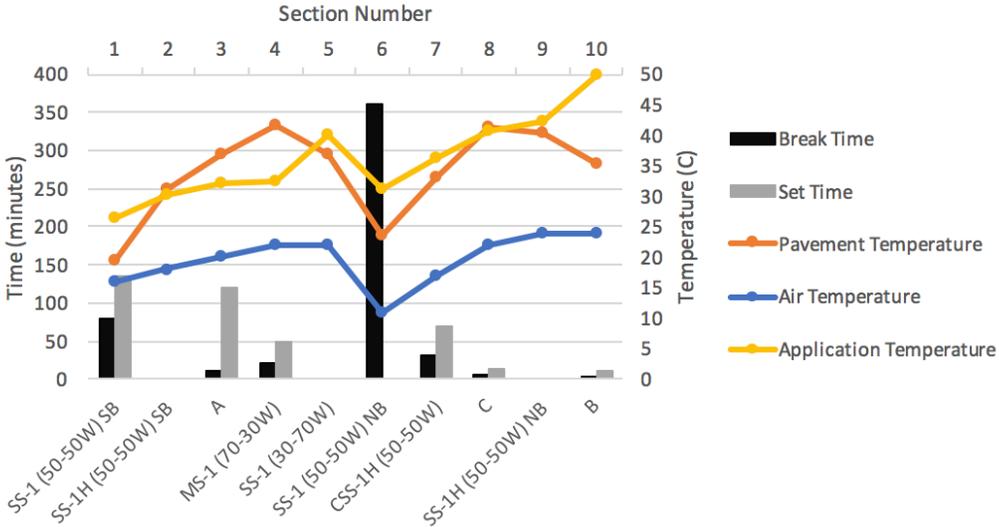
The break and set times of the tested products were plotted with temperature readings to see if any trends can be observed. From Figure 11, it can be noted that break and set times showed some correlation to pavement temperature, air temperature, and product temperature. As application temperature, air temperature, and pavement temperature increase, the break and set times decrease. This indicates that temperature has an effect on these parameters. In addition, Figure 12 shows a correlation between humidity and break and set times. Figure 12

Figure 11. Plot of Break and Set Times with Temperature

Early results show reduced tracking for proprietary products which have faster breaking and setting times than slow setting tack coat materials. The slow setting emulsions CSS-1h and MS-1 broke and set faster than SS-1. These early results indicate that using any of the tested products instead of SS-1 may be beneficial. Supplier proprietary products were the fastest to break and set and proved superior in tracking and pick-up performance. Bond strength testing and long-term resistance to freeze-thaw cycling will confirm if these materials are superior in their performance as well. Finally, the data recorded during construction of the test sections shows that break and set times are correlated to air temperature, pavement temperature, application temperature, and humidity.

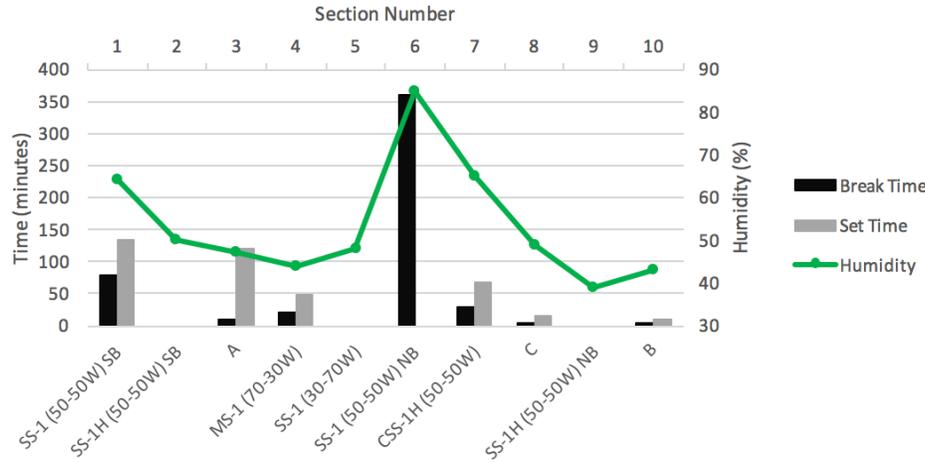
shows that lower humidity correlates to faster breaking and setting times. A lower humidity level accelerates the evaporation rate of water from the tack coat materials.

Figure 12. Plot of Break and Set Times with Humidity
