Achieving Better Performance from Concrete Pavements by a Focus on Design and Construction Fundamentals

Paper prepared for presentation
at the Innovation in Geotechnical and Materials Engineering Session

Of the 2021 Conference of the
Transportation Association of Canada

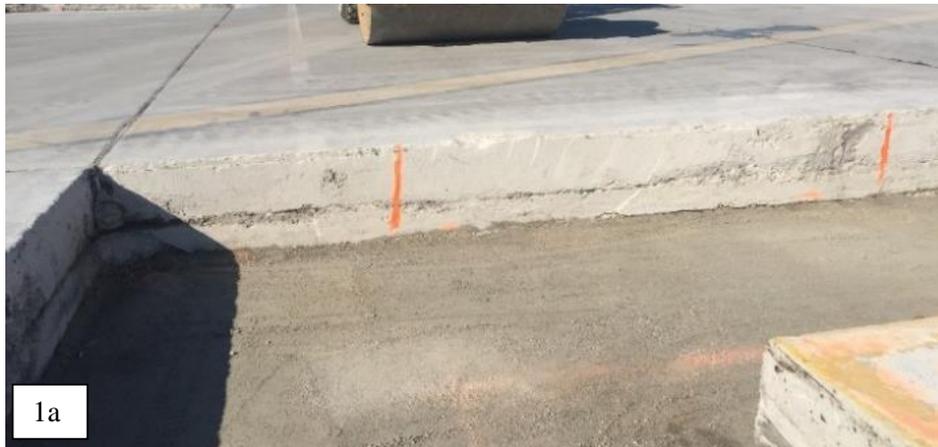
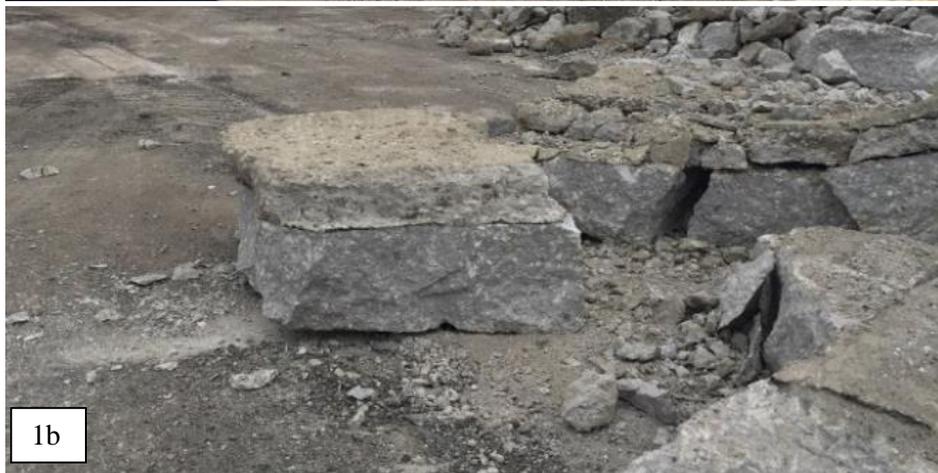
Photograph 1a – Well designed and constructed concrete pavement supported on good quality cement treated base, Photograph 1b – Good condition of excavated cement stabilized base after 60 years of service under an airport pavement (Note that in the photograph the pavement chunk has been overturned so that the cement treated base is on top of the concrete slab)

Photographs 1 to 3 show examples of how the critical elements of a concrete pavement structure should appear when the fundamentals are followed. Photographs 1a and 1b illustrate an example of a well-constructed and uniform cement stabilized base that has supported the overlying heavily loaded concrete slabs for over 60 years. Note that in Photograph 1b after excavation the chunk of cement treated base (CTB) is shown on top of the concrete, but it shows that after 60 years the CTB was still in good condition and well adhered to the concrete. Photograph 2 shows a newly constructed concrete pavement that has been constructed on uniform support provided by well compacted granular base, consolidated and finished properly, cured with double application of curing compound, and sawcut at the right time and to the right depth to eliminate random shrinkage cracking. Photograph 3 shows properly sawcut and sealed longitudinal and transverse joints.

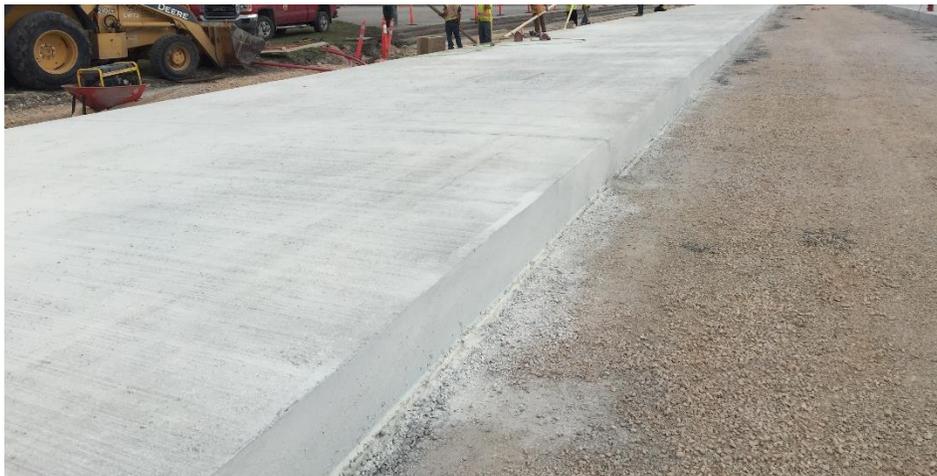
Photograph 2 – Properly constructed concrete slabs. Note uniform finish and well constructed control joints

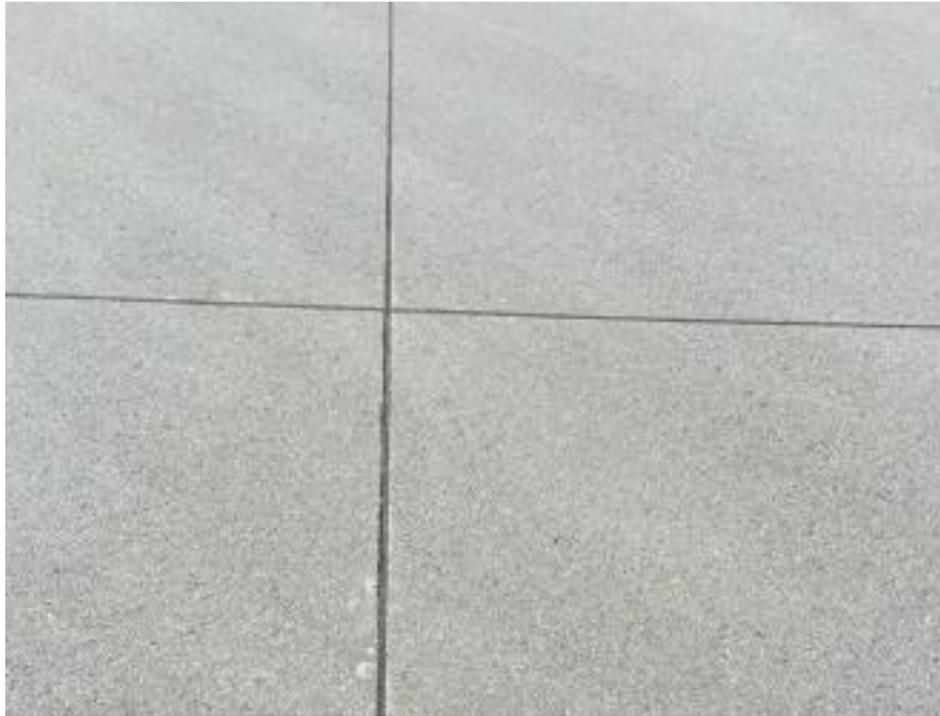
Photograph 3 – Properly sawcut and sealed longitudinal and transverse joints.

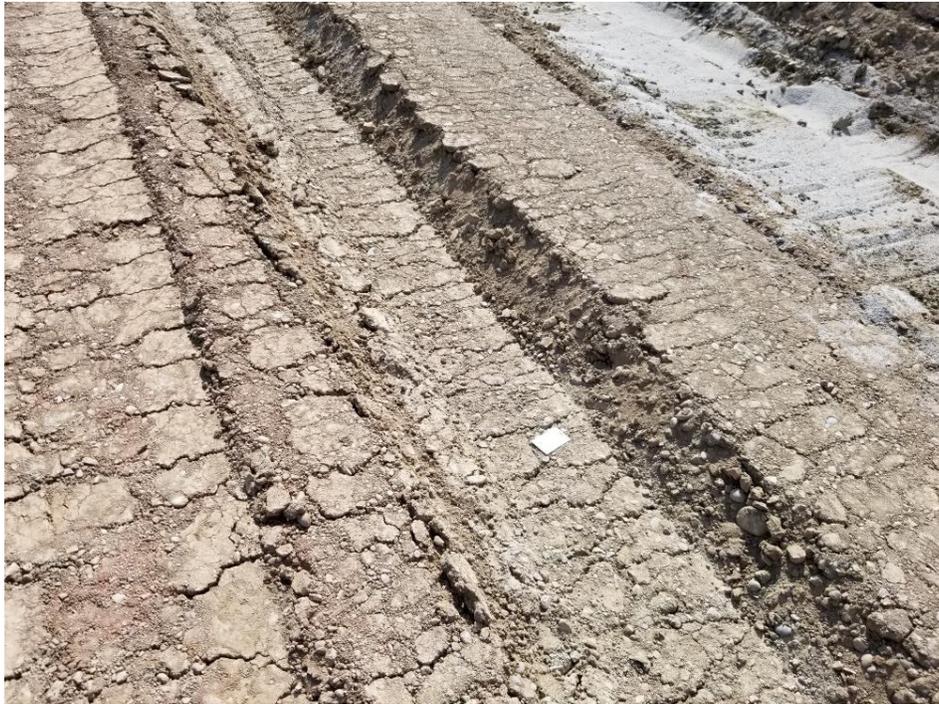
Photograph 4 – Soft subgrade soil that failed proofrolling. Further work is needed prior to placing base course.

Soft subgrade soils beneath a concrete pavement (Photograph 4) if not properly addressed prior to placing the base course will provide insufficient and inconsistent support, which can result in differential slab movement. This can cause early longitudinal cracking, transverse cracking, and corner breaks in concrete slabs, and can also lead to faulting at joints. The movement of the slabs at the joints under load application can result in pumping of fine materials from underneath the concrete slabs and creates voids over time [5]. Faulting also occurs due to a lack of load transfer devices, such as dowel and tie bars, at the concrete joints. However, it should be noted that the purpose of load transfer devices is not to address inconsistent support since irrespective of the joint details, the pavement still remains a ground-supported structure.

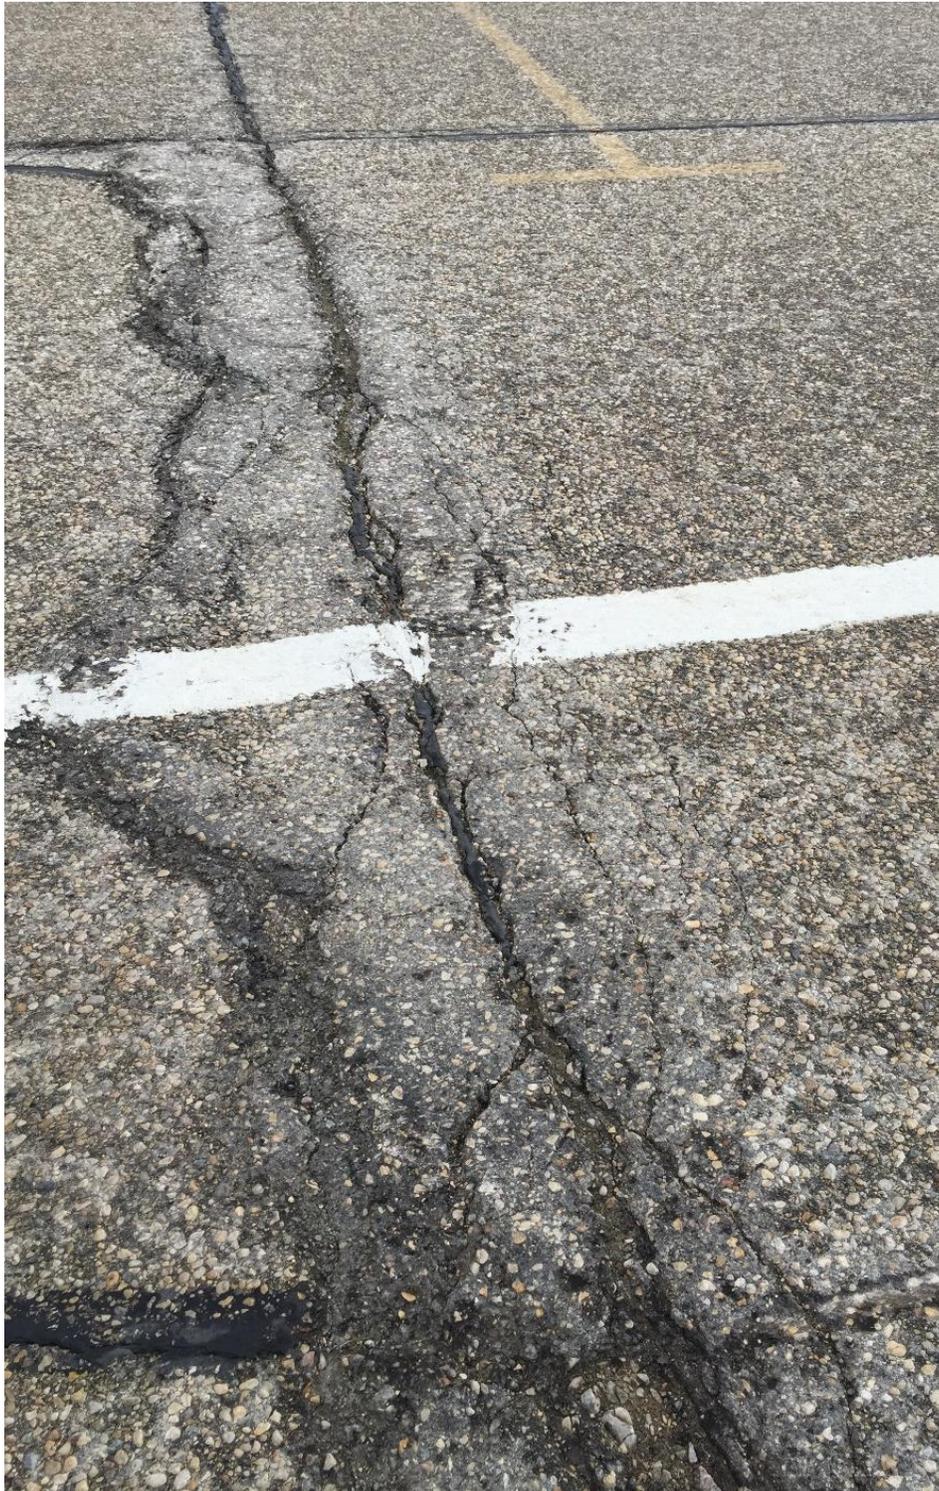
Photograph 5 – Frost heaving of concrete slabs unsuccessfully repaved with asphalt overlay

Subgrade soil condition including its moisture content, drainage and susceptibility to frost action should also be considered when designing concrete pavements. Additional subsurface drainage may need to be installed or in extreme cases, a portion of the frost susceptible soil may need to be removed and replaced with select subgrade or granular material. Photograph 5 shows an example of a concrete pavement that has severely heaved and then the failure was repaired with a hot-mix asphalt overlay. However, the repair did not work, and the heave bump reappeared the following winter, and the asphalt also distorted and cracked. Since this was an airside pavement, it created foreign object debris risk potential. In this case, the permanent fix requires improved localized subdrains possibly in conjunction with some replacement of the problematic soils.

There are three conditions for the frost heaving to occur: frost susceptible soils, sub-freezing temperatures and the presence of water. Removing water by installation of a proper subsurface drainage system is often considered to be the most practical and effective. If localized frost heaves are repaired, tapers may be necessary to achieve a gradual transition.

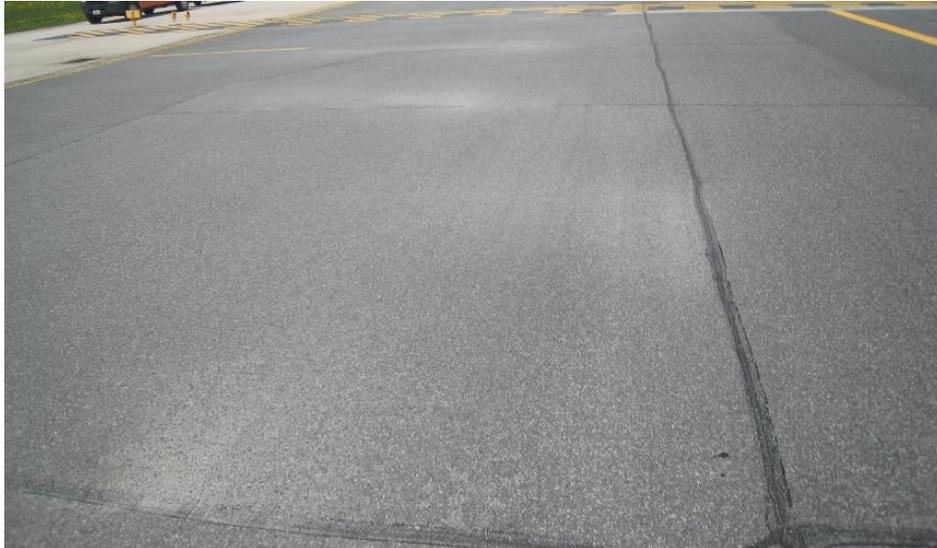
Photograph 6 – Pumping of fines through longitudinal and transverse joints

Voids can develop beneath a pavement for a number of different reasons; however, they generally occur when the fines in the granular material directly underlying the bound pavement layers is removed by pumping and washed away. Such voids generally form under both concrete and

composite pavements. The evidence of pumping of fines, as seen in Photograph 6 is a good indicator that there are likely voids under the concrete slabs. Such voids will continue to progress until the root cause is addressed.

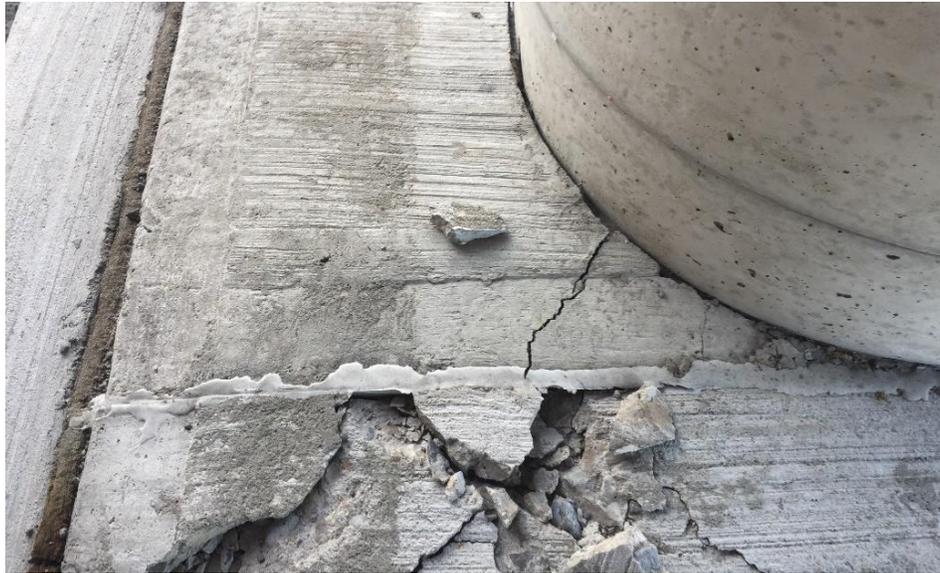
Photograph 7 – Not Providing Isolation Joint

Effective joint design is a key component of a properly designed concrete pavement. In addition to a regular network of expansion/contraction joints, additional joints may be needed depending on the geometry of the slabs and the locations of discontinuities and cut outs. The inclusion of isolation joints in a concrete pavement may be necessary where differential movement may occur between the slab and an adjacent structure, such as may occur when a slab abuts a concrete foundation base for a generator. Additional joints are also required to avoid situations where irregular shaped slabs are needed. The isolation joints should provide complete separation between the two different structures allowing them to move independently. Joints will also be needed where right angled cut outs will give rise to stress concentrations at the abrupt change in geometry. If a proper isolation joint is not constructed around discontinuities in the slab, such as columns, maintenance holes and inset lights, cracking and slab breakage will occur at the point of stress concentration or where the adjacent structure impedes the normal seasonal movement of the slab. The isolation joint should extend through the entire depth of the concrete slabs. Photograph 7 shows cracked concrete slabs adjacent to a concrete column due to lack of an isolation joint. The differential movement caused the concrete slab to crack and break into multiple pieces.

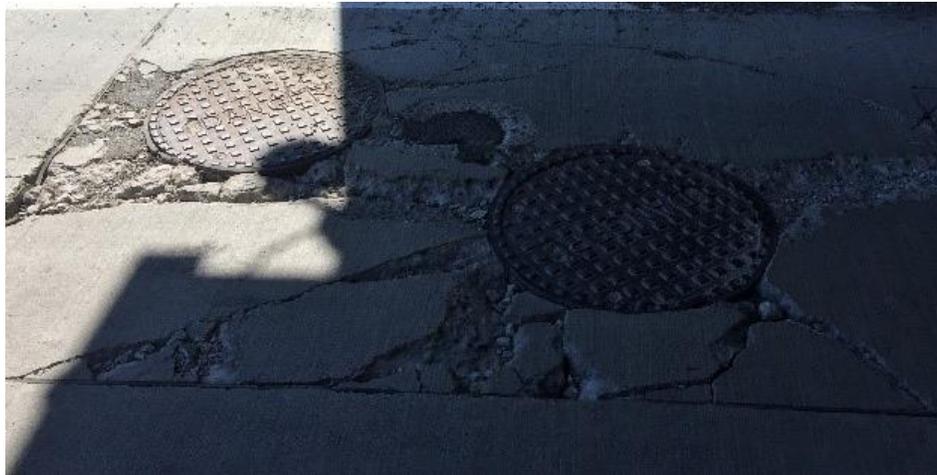
Photograph 8 – Concrete slab shattered into pieces due to failure to adhere to good design and construction fundamentals

Photograph 8 shows an example of concrete slab damage with two maintenance holes in very close proximity, without isolation joints around the circular cut-outs. Due to a lack of effective isolation joints and likely inconsistent support due to failure to adequately compact the service trench backfill, as well as poor design, the slab shattered into pieces within a year requiring costly repairs.

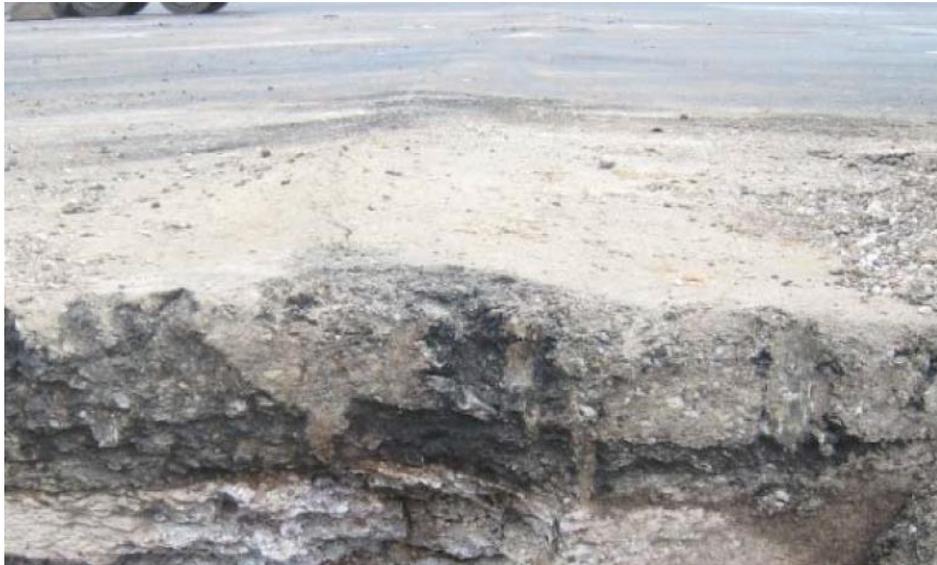
Photograph 9 – ASR-induced swelling of concrete under asphalt overlay.

Poor concrete aggregate selection and failure to confirm compliance to CSA standards can also be the source of performance problems. Photograph 9 shows an example of concrete failure caused by Alkali-Silica Reactivity (ASR). ASR caused swelling, cracking and expansion of the concrete. Some aggregates containing reactive amorphous silica react with the cement paste having high alkalinity and produce an expanding gel. This expanding gel over time causes

deterioration in the form of swelling and ultimately cracking in the concrete pavement in the presence of moisture and warm temperatures [1].

The risk of ASR damage can be mitigated by the use of supplementary cementitious materials. Good surface and subsurface drainage, minimizing contact of concrete slabs with de-icing chemicals, and sealing cracks at the pavement surface can help reduce the severity of ASR deterioration.

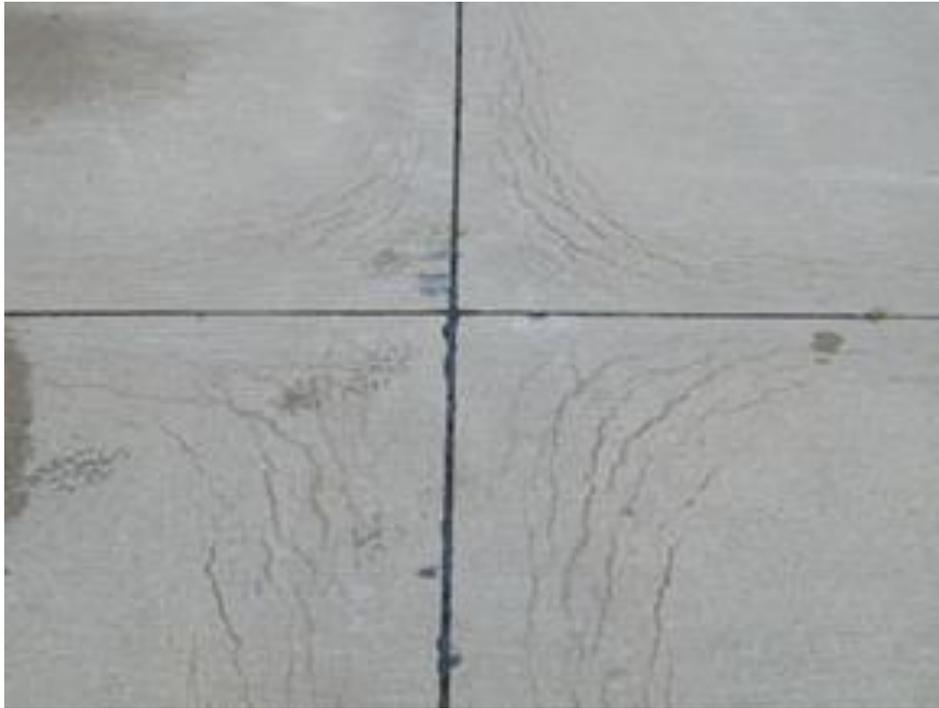
Photograph 10 – D-cracking of concrete pavement

D-cracking also known as durability cracking is another form of deterioration in concrete pavements that is caused due to improper selection of coarse aggregates used in the concrete mix. D-cracking presents as a series of hair line cracks along concrete joints and occurs when coarse aggregates are susceptible to freeze-thaw deterioration [5]. Since this type of cracking is primarily observed in concrete with larger coarse aggregate size, i.e. 37.5 mm, consideration can be given to using smaller top size aggregates, i.e. 20 mm, in the concrete mix [1]. Photograph 10 shows an example of concrete pavement D-cracking.

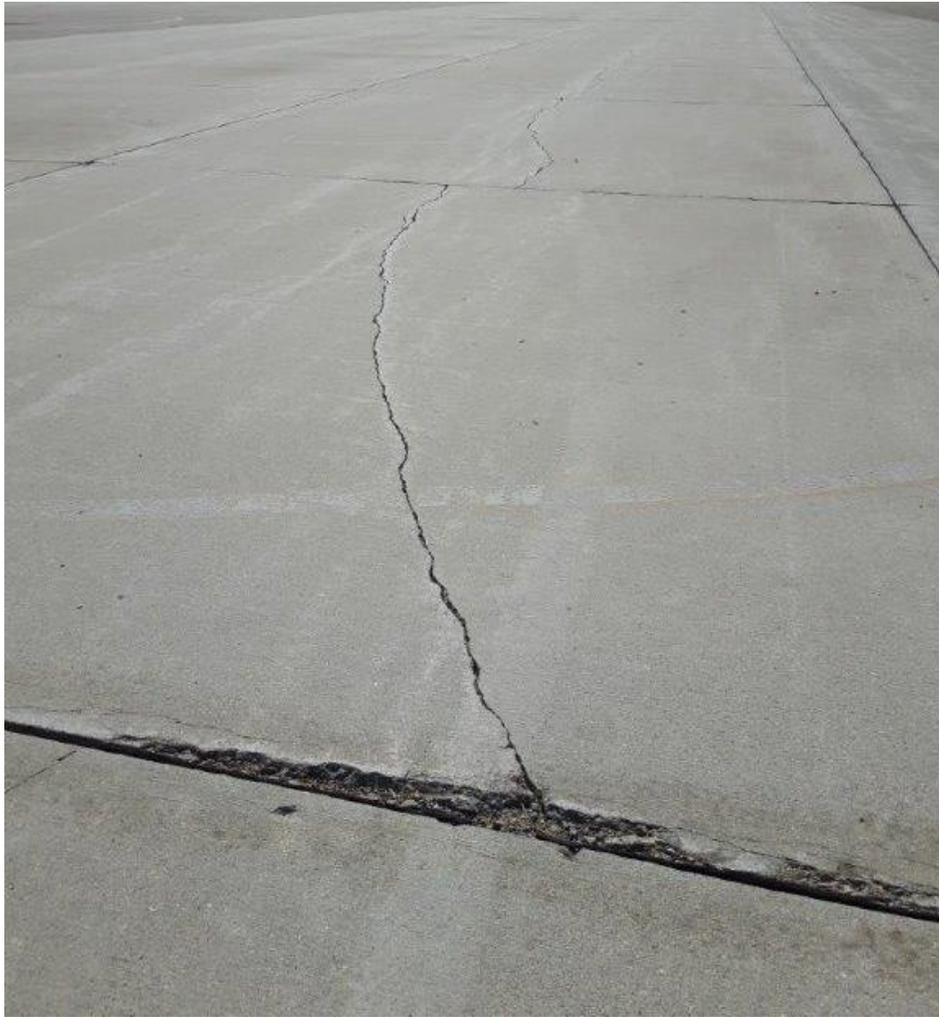
Photograph 11 – Full depth longitudinal crack due to the presence of a utility trench under concrete slabs

The presence of underground utilities below concrete slabs may create uneven support which in turn can result in concrete cracking. Embedding conduits in concrete pavements will reduce the effective concrete thickness and represents a zone of weakness in the slab that makes it prone to preferential cracking. Photograph 11 shows full depth longitudinal cracking that developed due to the presence of an old utility trench under the concrete pavement.

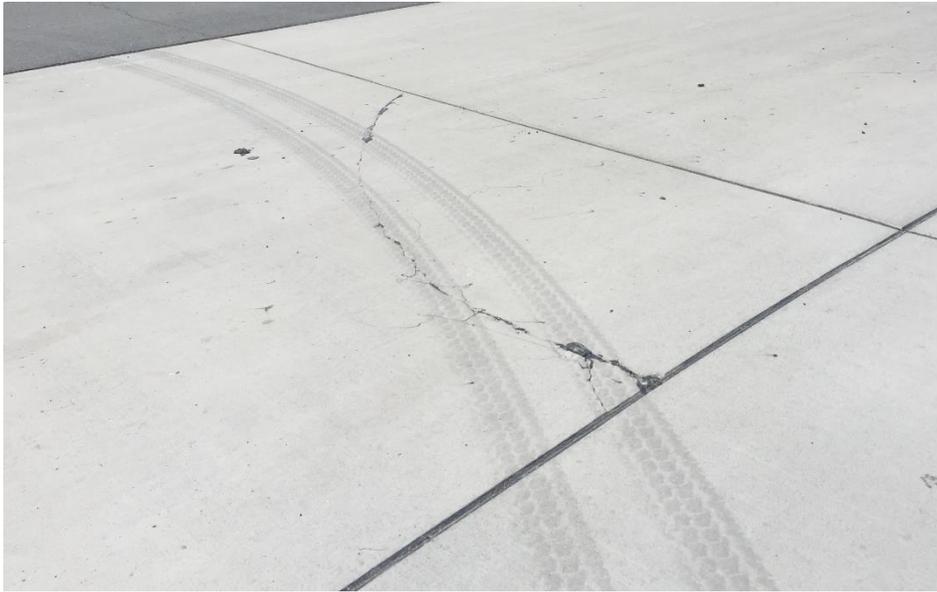
Photograph 12 – Severe corner break due to inconsistent support

Providing a uniform support layer beneath the concrete slab is also critical due to the fact that inconsistent support beneath concrete slabs allows the slabs to pivot or tilt and causes cracks to develop full depth. This cracking could be in the form of corner breaks, longitudinal, and transverse cracking. Photograph 12 and Photograph 13 illustrate a full depth corner break and longitudinal crack that developed due to inconsistent support.

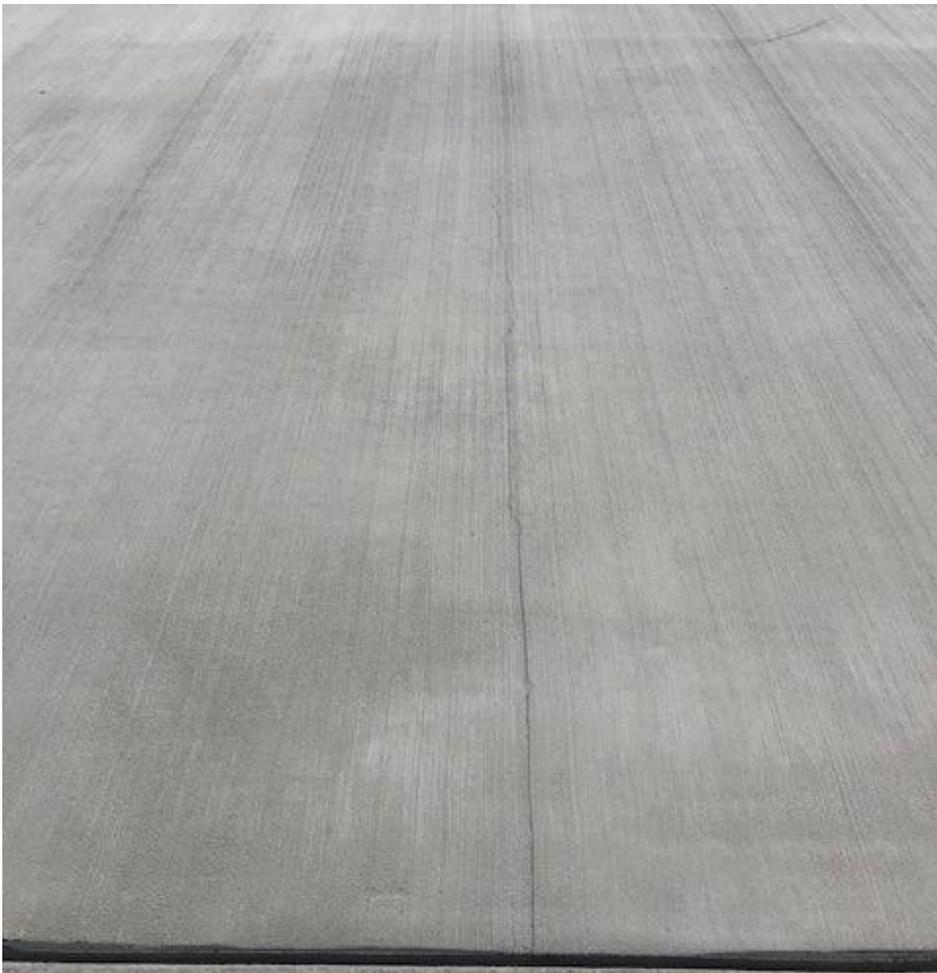
Photograph 13 - Full depth longitudinal crack due to inconsistent support

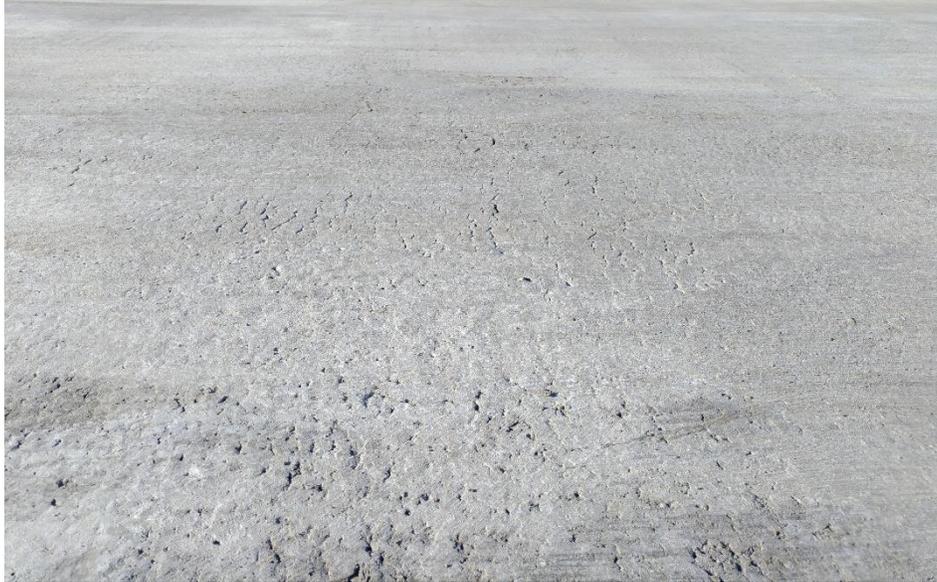
Photograph 14 - Poor concrete consolidation and finishing work

Photograph 14 shows another example of poor construction. Poor concrete consolidation and finishing techniques resulted in drying shrinkage, surface cracking and surface voids which will lead to progressive surface deterioration.
