SOLUTIONS TO DRIVER ERRORS AT MULTI-LANE ROUNDABOUTS

Paper prepared for presentation at the
Human Factors and Road Safety Culture Session
of the 2017 Annual Conference of the
Transportation Association of Canada (TAC)
St. John's, Newfoundland and Labrador

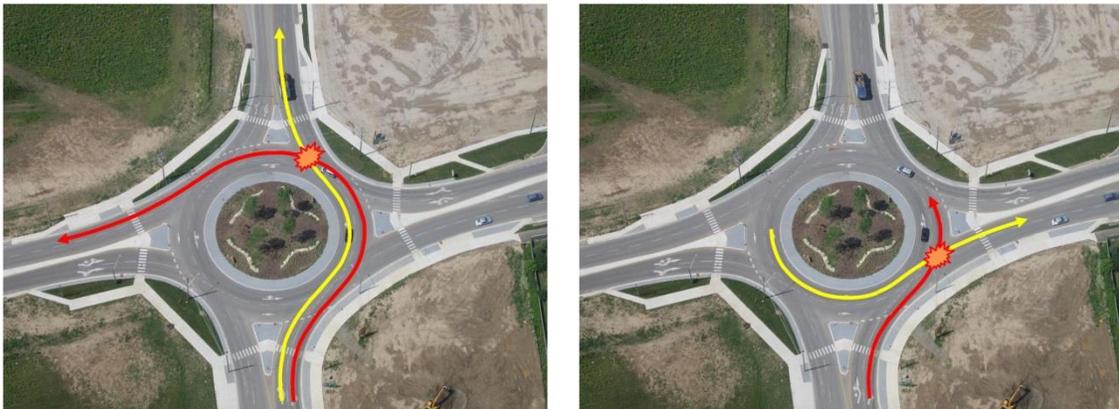
Figure 1.1 Common Crash Types at Multi-Lane Roundabouts

Several collision types can occur at multi-lane roundabouts that are not possible at single-lane roundabouts. The two most common are the left-turn crash and the “merge” crash. Both tend to be low-speed sideswipe crashes and are shown in Figure 1.1.

The left-turn crash is an exit-circulating crash that can occur after a driver makes a left turn from the right entry lane and collides with a driver making a through movement from the left lane. Typical countermeasures are repeated Lane Designation signs and pavement arrows to get drivers into the correct lane before entering, and to otherwise convey to drivers that a roundabout is a single intersection (albeit with an island in the middle) such that left turns should be made from the left entry lane like at other intersections.

The other problem is an entry-circulating or failure-to-yield crash sometimes referred to as a merge-type crash. This is where a driver in the right lane enters beside traffic circulating in the inside lane and collides with a circulating driver exiting immediately downstream. Here, “merge” is used in quotations to denote that the movement is not a true merge because drivers entering in the right lane are not necessarily merging with traffic in the outside lane. Rather, they are turning in beside someone in the inside lane.

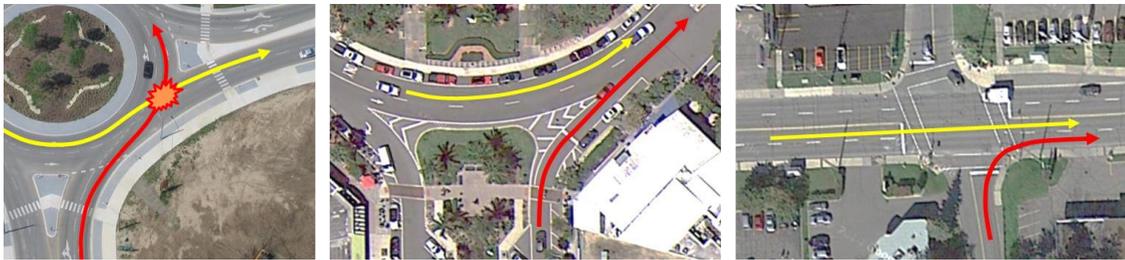
Figure 1.2 “Merge” Behaviour at Intersections

This situation is similar to what can occur at other intersections, as depicted in Figure 1.2. In the case of a roundabout (left illustration) turning in beside circulating traffic is a problem because the circulating driver may be exiting the roundabout immediately downstream. However in the case of a rotary or traffic circle (middle) a weaving section provides some space for the entering driver to change lanes and circulate, and for the circulating driver to change lanes and exit. At a stop- or traffic signal-controlled intersection (right), drivers are free to enter and turn right if there is no traffic in the curb lane of the cross-street (although such a move is not a defensive one, as drivers in the median lane of the cross-street could change lanes).

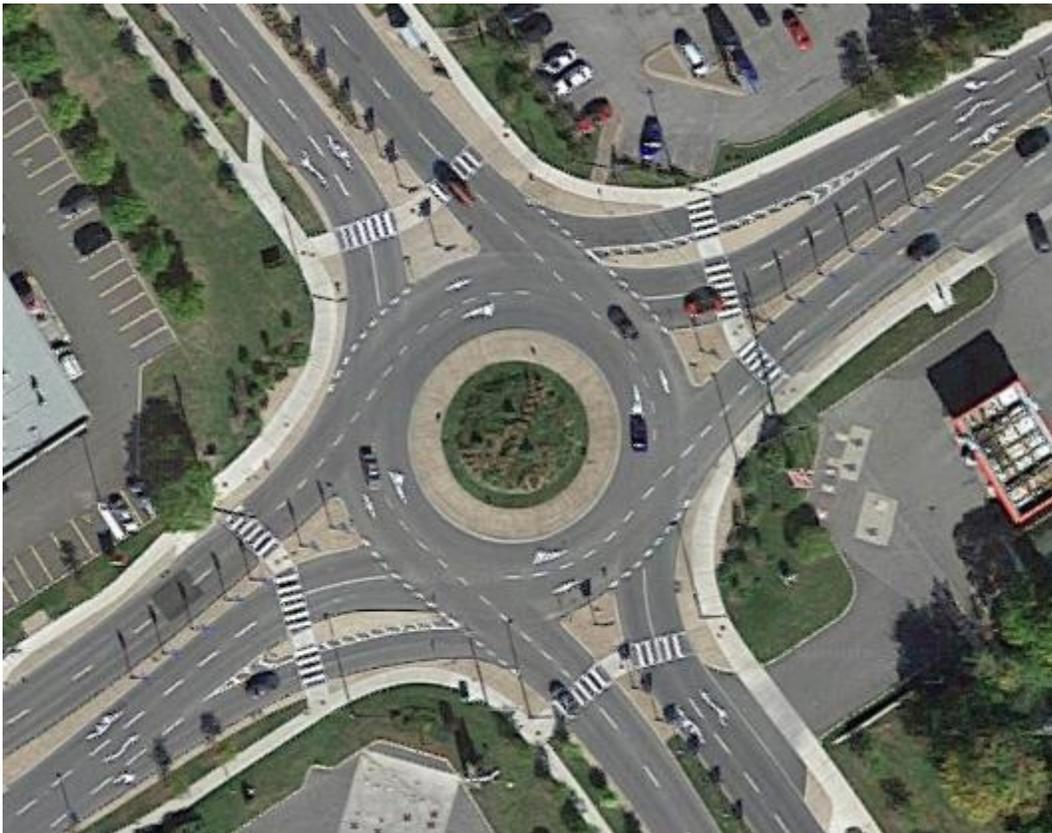
Figure 2.1 St. Joseph Roundabout

This roundabout is located in the east side of the City of Ottawa in a built-up suburban setting. It has two-lane entries on all approaches and yield-controlled right-turn bypass lanes eastbound and westbound on St. Joseph Boulevard. The inscribed circle diameter (ICD) is 48 metres. Average annual daily traffic (AADT) in 2015 was 42,700 vehicles per day (vpd). The roundabout is shown in Figure 2.1.

Since opening in late 2010 the roundabout has experienced a high collision frequency. It is by far the busiest roundabout in the City so comparison with other similar roundabouts is not possible. Nevertheless the sheer number of collisions is a concern, especially compared to the previous signalized intersection, even though only 6% resulted in injury. Almost half of the total collisions have been classified as entry-circulating (EC) crashes, and it is suspected many of them are of the “merge” type. The other predominant crash type is exit-circulating, likely the result of drivers entering in the right lane and making a left turn.

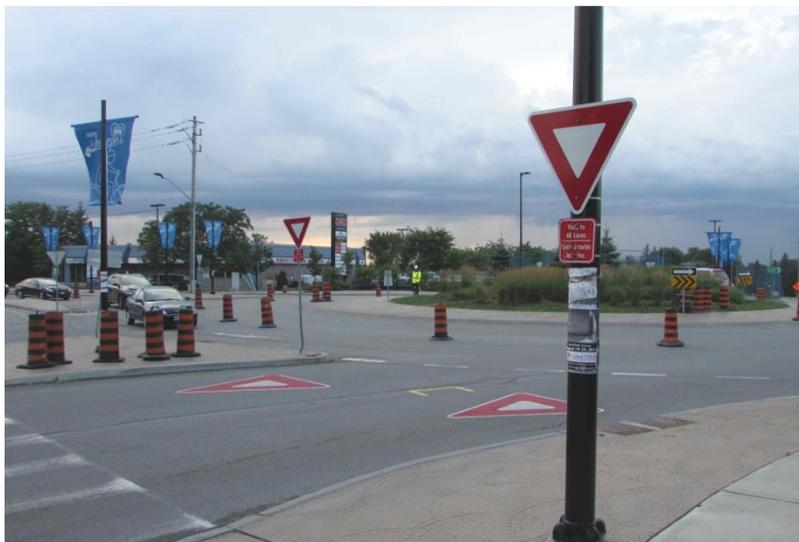
Figure 2.2 Yield Sign Tabs and Pavement Symbols at St. Joseph Blvd.

In November 2011 tabs were installed under the Yield signs reading “Yield to All Lanes”, and in October 2013 Yield pavement symbols were painted at the entries. Both are seen in Figure 2.2. It is acknowledged by the City the Yield sign tabs are likely too small to be effective.

In April 2014 it was directed that the circulatory road lane lines not be refreshed. Since then the markings have been allowed to wear out. Table 2.1 shows that the percentage of EC crashes decreased significantly in 2015. Although some other crash types, such as sideswipes in the circulatory road, have gone up overall crash frequency seems to be on the decline since this countermeasure was adopted.

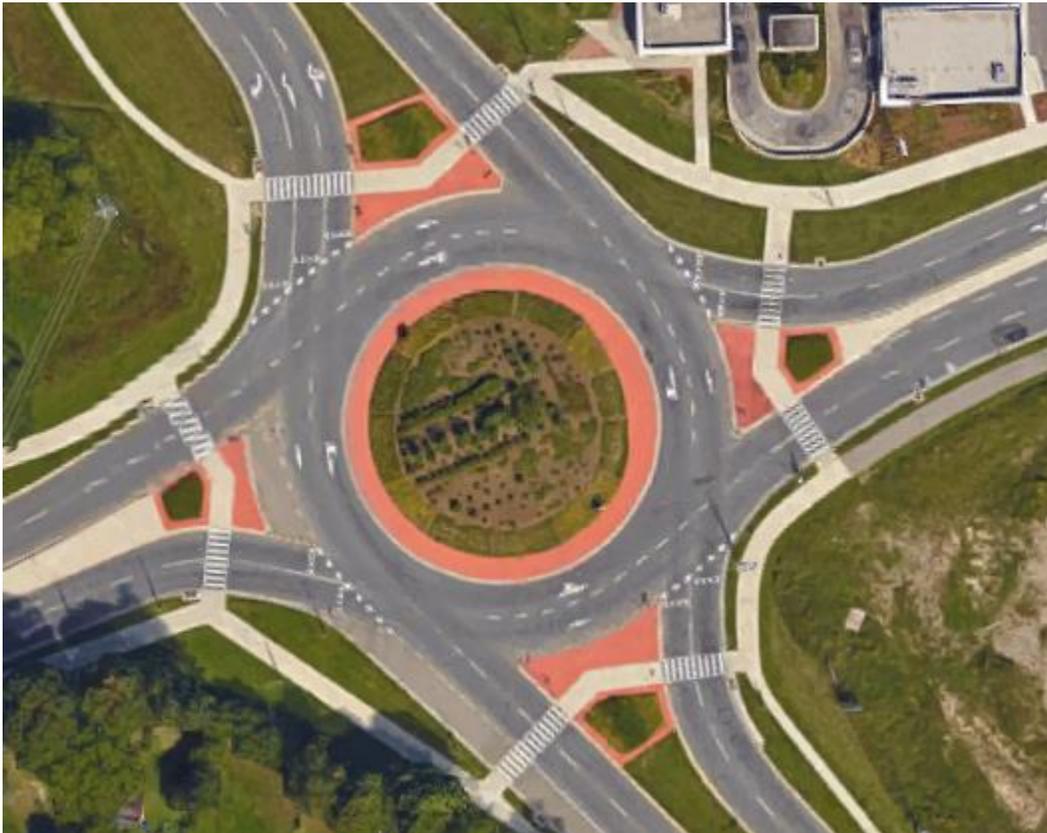
Figure 2.3 Homer Watson Roundabout

This roundabout is located within the Region of Waterloo in a low-density suburban setting. It has a three-lane entry southbound on Homer Watson Boulevard and two-lane entries on the other approaches. The ICD is 62 metres. Homer Watson Boulevard is a limited access arterial with high operating speeds. AADT in 2015 was 38,100 vpd. The roundabout is shown in Figure 2.3.

- November 2011 – “Stop for Pedestrians” signs at the pedestrian crosswalks (replacing the smaller “Yield to Pedestrians” signs).
- May 2012 – “sharks teeth” markings to supplement the yield lines, and conversion of the third entry lane southbound to a right-turn-only lane with corresponding installation of flexi-posts in the circulatory road (as seen in Figure 2.3).

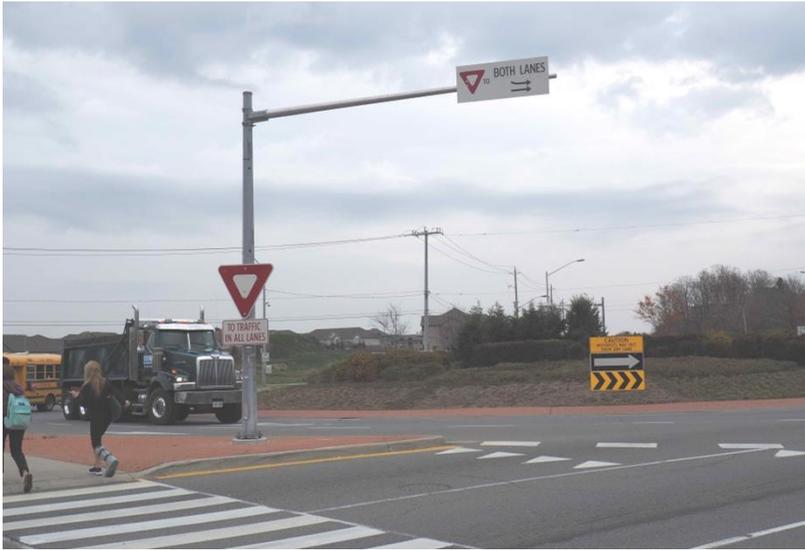
Figure 2.4 Extra Signs at Homer Watson Blvd.

Several of the countermeasures are depicted in Figure 2.4. Table 2.3 indicates that none seem to have had a demonstrable effect on safety performance, although it may be too early to draw conclusions about a couple of the more recent additions.

It was out of this assessment that the “Yield to Both Lanes” sign in Figure 2.4 was suggested and subsequently installed overhead at the northbound and southbound entries.

- An approach sign reading “Yield to Both Lanes” (the overhead sign in Figure 2.4).
- Yield sign tabs reading “Do Not Merge”.
- Yellow box markings in the trapezoidal section of circulatory road between an entry and downstream exit. This corresponds to a treatment sometimes used to indicate that drivers are not to enter and block an intersection.

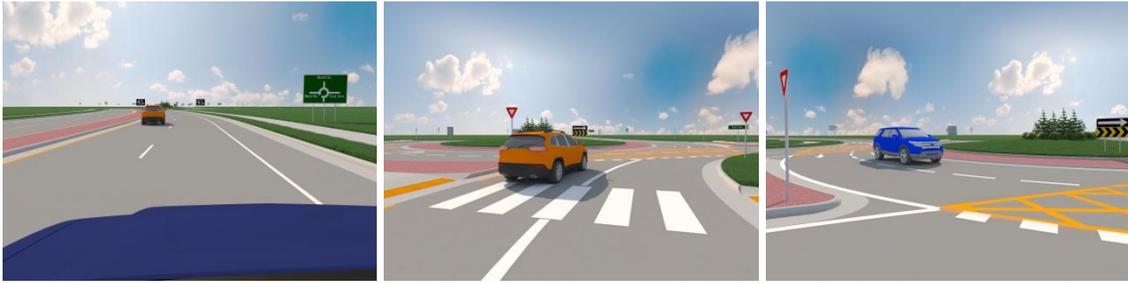
Figure 3.1 Example Sequence of Sign Effectiveness Slides

Three slides were developed for each test case: 1) an approach to a two-lane roundabout, 2) just upstream of the entry crosswalk, and 3) at the yield line looking left. An example sequence of slides (case 23, in Table 3.1) is shown as Figure 3.1.

The test cases of interest are 5, 11, 17 and 23, all having an approaching driver in the right lane and a circulating vehicle in the inside lane as seen in Figure 3.1. Here the percentage of correct responses is lower than for the other cases by a considerable margin. At first glance it appears the countermeasure corresponding to case 17 (the Yield sign tabs reading “Do Not Merge”) is the most effective, followed by the one corresponding to case 11 (the approach sign reading “Yield to Both Lanes”). It is worth noting that neither resulted in a correct response rate close to the other test cases. It is also interesting the yellow box markings (test case 23) produced fewer correct responses than doing nothing (test case 5).

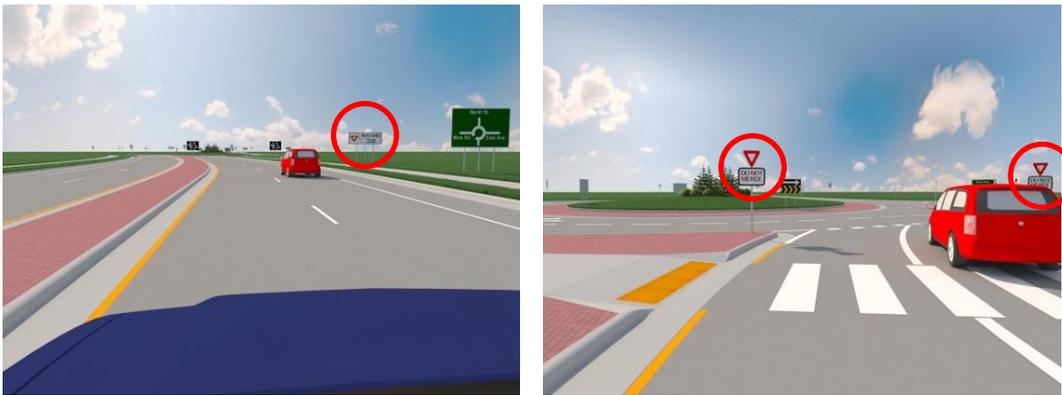
Figure 3.2 Slides Showing the “Yield to Both Lanes” Sign and “Do Not Merge” Tabs

Given the lack of success with the yellow box markings, further analysis concentrated only on determining whether there was any statistical difference in correct responses between the approach sign reading “Yield to Both Lanes” and the Yield sign tabs reading “Do Not Merge” (test cases 11 and 17). They are seen circled in Figure 3.2.

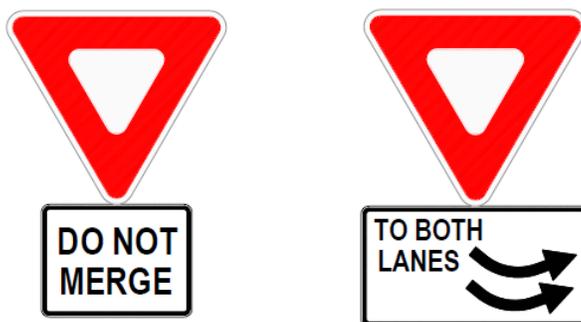
Figure 4.1 Recommended Signing Countermeasures

Accordingly, it is recommended both the “Do Not Merge” and “Yield to Both Lanes” messages be considered for implementation through the use of Yield sign tabs as illustrated in Figure 4.1. Further experimentation is still advisable due to the limitations of the sign comprehension testing, the outcome of which may be that one tab is preferred over the other. An important consideration will be size such that either message is sufficiently legible to drivers. This may include some experimentation to find the optimal layout for the “To Both Lanes” tab. Another is the need for bilingual messages in certain regions in Canada.
