Early Pavement Life Cracking Performance of Asphalt Concrete Overlays in Saskatchewan

Paper prepared for presentation at the Testing, Modelling and Innovation of Roadway/Embankment
Materials and Geotechnical Engineering Session
of the 2024 Transportation Association of Canada (TAC) Conference & Exhibition
Vancouver, British Columbia

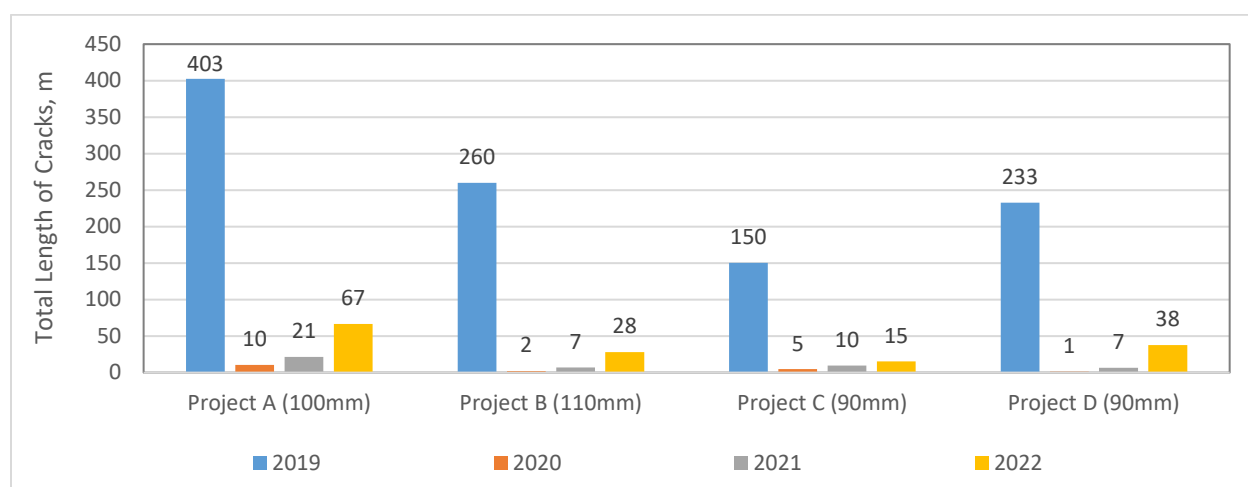
Figure 1. Pre- and Post-Construction Cracking on 150-m Segments of Four Repaving Projects from 2019

To highlight the network issue of early cracking on newly rehabilitated asphalt pavements, annually collected Laser Crack Measurement System (LCMS) pavement network condition cracking data from randomly selected 150 m highway segments from four repaving projects completed in 2019 was investigated. The asphalt concrete overlay thickness varied from 90 mm to 110 mm for these four projects. Each segment had no recorded cracks in 2019, immediately after repaving was completed. The sum of all cracking, including block cracking, meandering, longitudinal and transverse cracking, within a 150-meter segment of each repaving project, is presented in Figure 1, for 2019 pre-construction, and for each of the first three years after construction. As can be seen, cracking increased each year for all four pavement segments, and in year three (2022), cracking increased more than 50% from the previous year (2021), for each of the pavement segments.

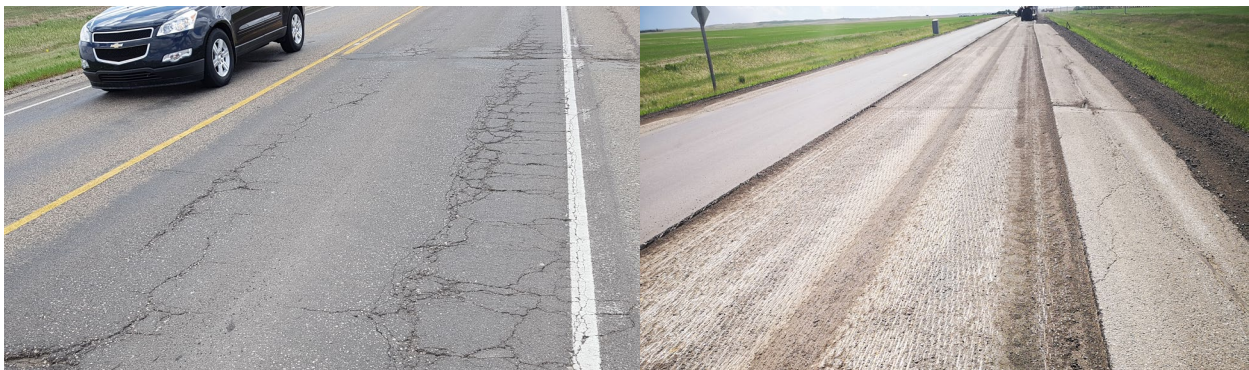
Figure 4. Highway 7 150-200A+HL Test Section, Pre- and Post-Milling

The predominant types of cracking observed on the test sections prior to milling and paving included fatigue cracking, block cracking, longitudinal cracking, and transverse cracking. There was high extent and high severity cracking on both test sections with spalling at many of the cracks. Cracking condition of the test sections and the post-milling pavement surfaces are shown in Figure 4 and Figure 5.

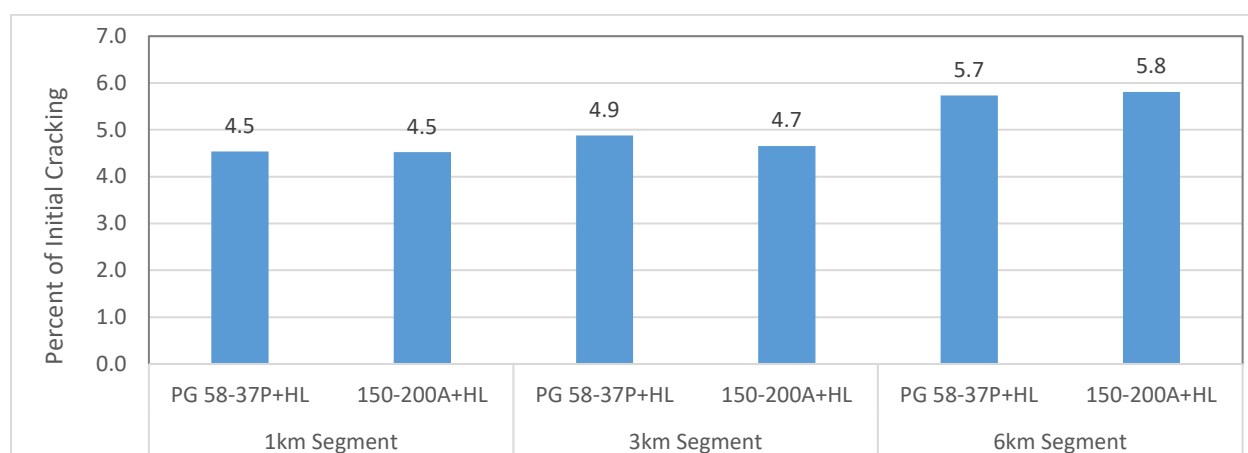
Figure 11. Total Cracks Observed by LCMS Expressed as Percentage of Initial Cracks

Figure 11 shows a comparison of total cracking in 2022 expressed as a percentage of the initial total cracking observed in 2019 (pre-construction). The percentage of cracking three years after paving was similar between the PG 58-37P+HL and 150-200A+HL asphalt materials for all three segment lengths. When analysing the cracking data for these larger segments of the repaving project, it was encouraging to see that only a small percent of pre-existing cracks is present, ranging from 4.5 to 5.8%.

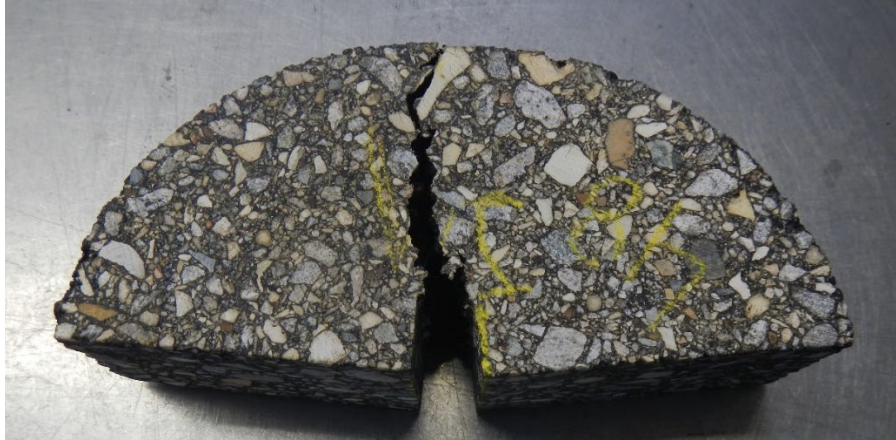
Figure 12. Example Photo of an Asphalt Concrete Core Specimen after I-FIT Testing

The testing procedure for the I-FIT test is defined in AASHTO TP 124 *The Standard Method of Test for Determining the Fracture Potential of Asphalt Mixtures Using the Illinois Flexibility Index Test (I-FIT)*. This test method determines cracking resistance properties of asphalt mixtures at intermediate test temperatures. The test simulates Mode I, which is the tensile opening mode during crack propagation. Specimens are tested using the semicircular bend geometry, which is a half disc with a notch parallel to the direction of load application. The fracture energy (G_f) and post peak slope (m) of the load-load line displacement (LLD) curve are used to calculate a Flexibility Index (FI) to predict the fracture resistance of an asphalt mixture at intermediate temperatures. A high FI value over 6.0 can be associated with good cracking performance [17]. Figure 12 is an example of an I-FIT test specimen after testing is completed, showing the mode of failure.

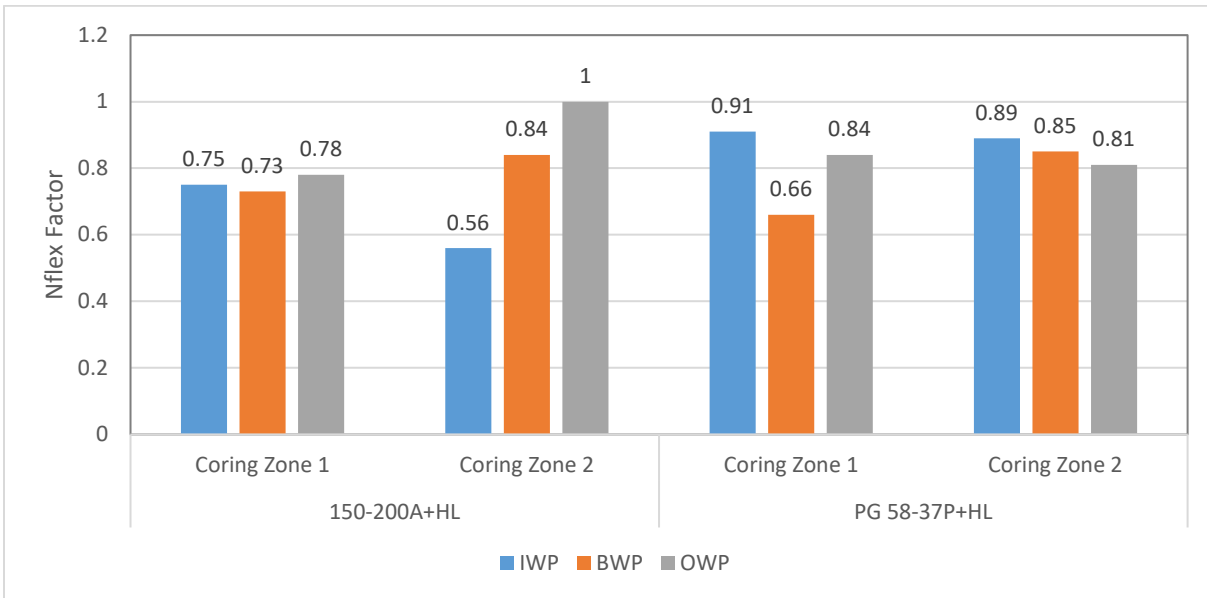
Figure 15. IDT - Highway 7 Test Sections N_{flex} Factor Results from 2022 Cores

IDT N_{flex} specimens were prepared by saw-cutting the top lift of asphalt concrete from pavement cores obtained from IWP, BTW, and OWP, from coring areas 1 and 2, for each of the test sections. A total of 12 specimens were tested. After performing statistical analysis (ANOVA single factor and multi factor, with $\alpha = 0.05$), it was determined that no statistically significant trends were found, and the test sections performed comparably. IDT N_{flex} test results are presented below in Figure 15.
