**Mechanistic Design and Structural Evaluation of
Time Sensitive Urban Full Depth Strengthening Projects**

Paper prepared for presentation at the
Soil Stabilization for Changing Environment Session
of the 2009 Annual Conference of the
Transportation Association of Canada
Vancouver, British Columbia

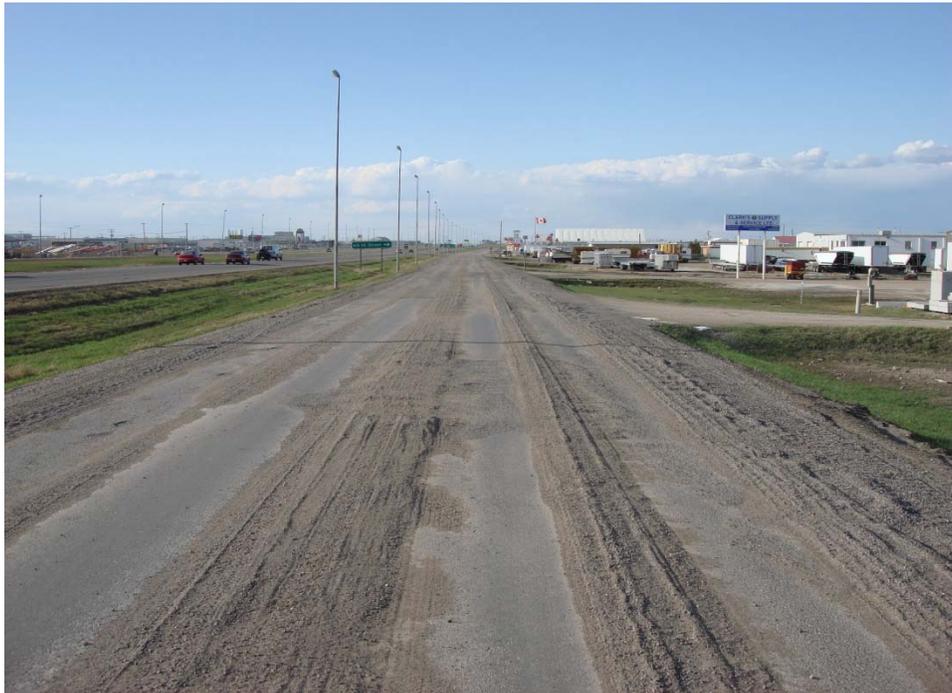
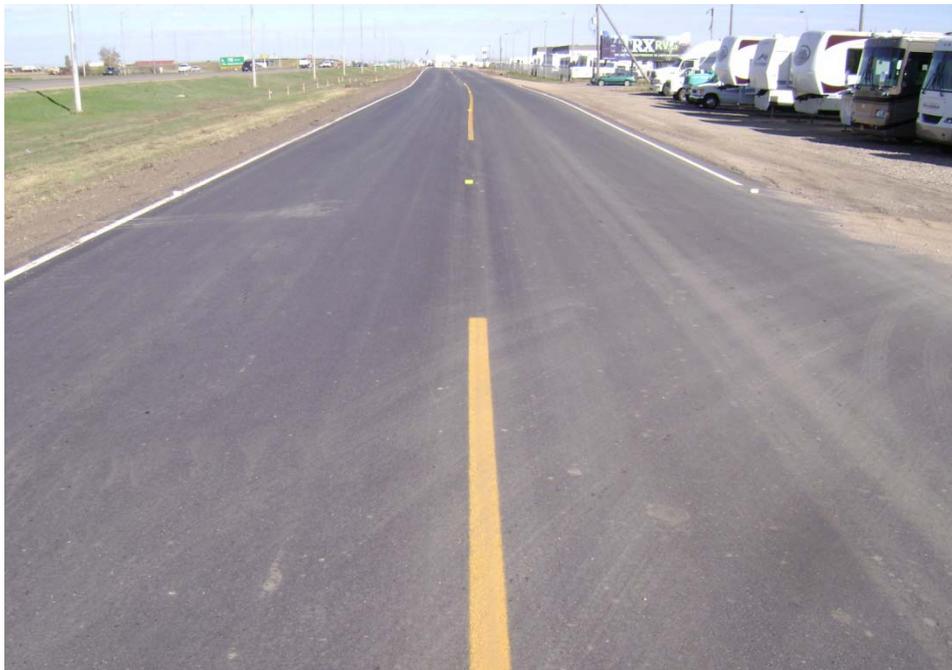
Figure 3 Idylwyld Service Road Typical Photos

In 2007, the City of Saskatoon structurally upgraded the Idylwyld Service Road from km 0.500 (0.5 kilometers north of 51st Street East) to km 1.700 (60th Street East). Full depth reclamation was a time efficient upgrade solution that did not require major upgrading of the gradelines of the road. A non-destructive structural asset management survey was performed on the entire length of the Idylwyld Service Road in spring 2007 as part of the design analysis (prior to upgrading), and in fall 2007 and spring 2008 as part of the post construction survey. As seen in Figure 3 (a), primary distresses observed included severe permanent deformation, surface disintegration, and localized fatigue cracking in the wheelpaths.

The Idylwyld Service Road was rehabilitated using a full depth reclamation strengthened cement-emulsion system as illustrated in Figure 4. Reclaimed asphalt concrete material was surgically added to Idylwyld Road to provide a uniform structural surface of 350 mm for reclamation and cement-emulsion stabilization illustrated in Figure 4. Figure 3 (b) shows the typical post construction surface condition of Idylwyld Service Road.

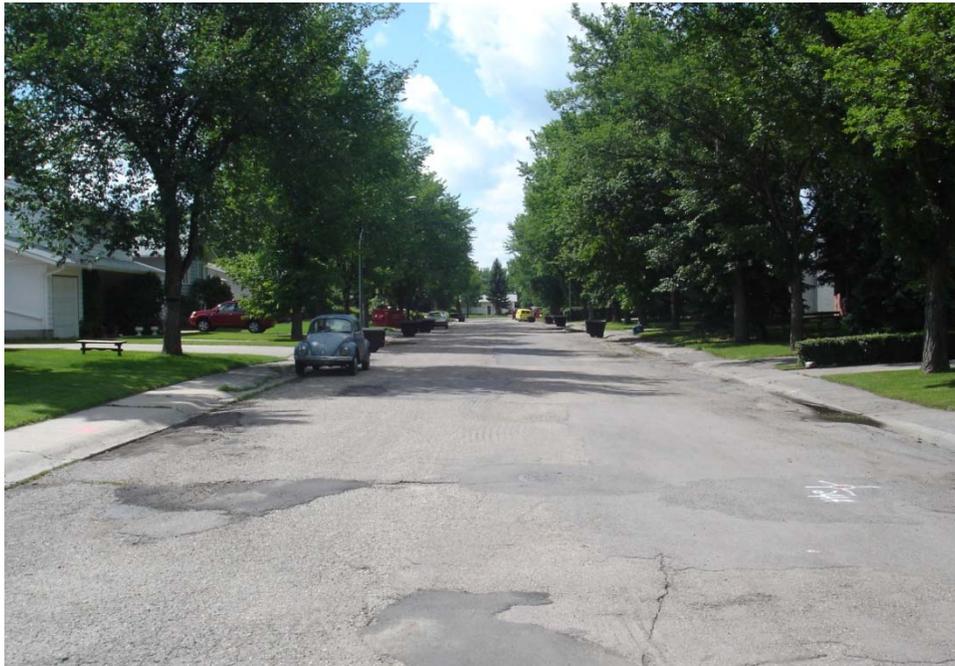
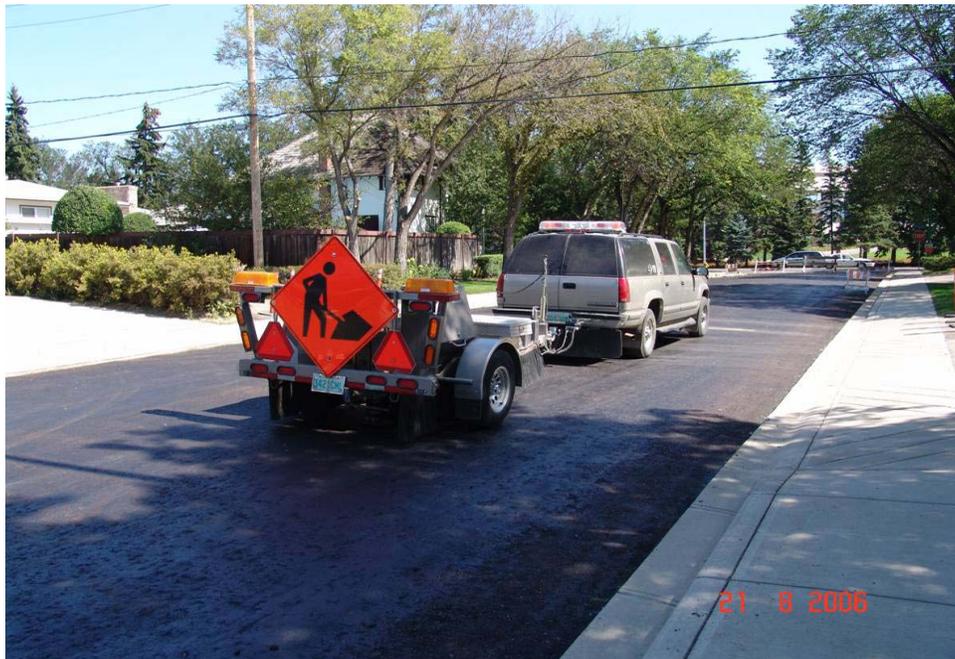
Figure 10 Shannon Road Typical Photos

In 2006, the City of Regina undertook a cold in-place recycling and full depth reclamation of Shannon Road from Grant Road at km 0.000 to Grant Road at km 2.270. Shannon Road is located in the south end of Regina known for high water table as well as a highly plastic *in situ* lacustrine clay subgrade. Shannon Road is also a bus route for the City of Regina transit system. As part of the engineering design process, a non-destructive structural asset management survey was performed on Shannon Road. The purpose of the *a priori* survey was to quantify the *in situ* structural thickness and the structural primary response of the road prior to strengthening. The *a priori* pavement distresses on Shannon Road included several localized fatigued areas as pictured in Figure 10 (a), and a depressed centerline most likely associated with settled utilities and/or differential heaving expansive clay subgrade.

Based on the structural assessment performed, Shannon Road was rehabilitated using a full depth strengthening system as seen in Figure 11. The reclaimed asphalt concrete materials were cement-emulsion stabilized to a uniform structure. Figure 10 (b) shows the typical post construction surface conditions of Shannon Road.
