# Combination of Impressed Current and Galvanic Cathodic Protection System for Bridge Deck Corrosion Mitigation

Paper prepared for the session Transportation Structures  
2025 Transportation Association of Canada (TAC) Conference & Exhibition  
Québec City, Québec

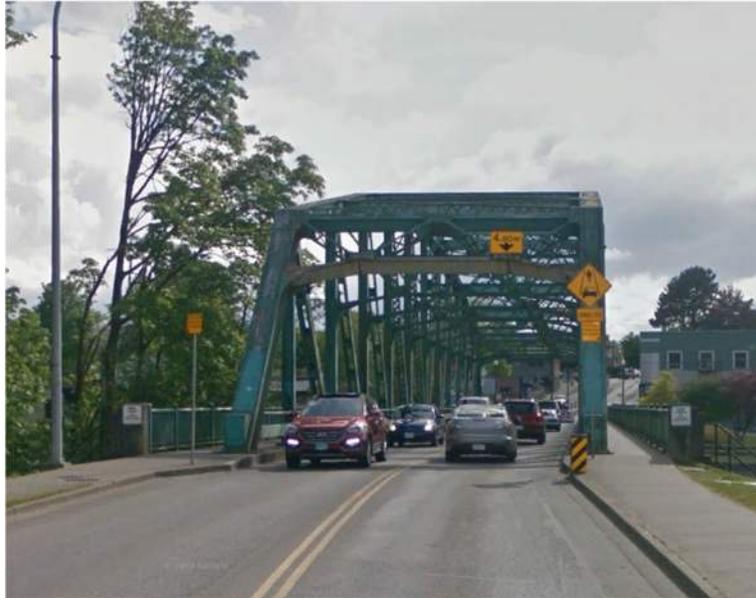
Figure 1. Fifth Street Bridge

The Fifth Street bridge is located in Courtenay, BC and carries the Fifth Street over the Courtenay River. The bridge is a two-lane steel truss structure constructed in the 1960s supported by steel I-beam girders and reinforced concrete abutments (Figure 1). Over time, exposure to deicing salts led to chloride-induced corrosion of both the reinforcement and the embedded top flanges of the steel girders. The deck could not be easily replaced due to the presence of embedded girders, so the City of Courtenay, the bridge owner, requested the design and installation of an impressed current cathodic protection (ICCP) system to protect the reinforcement in the deck from corrosion.

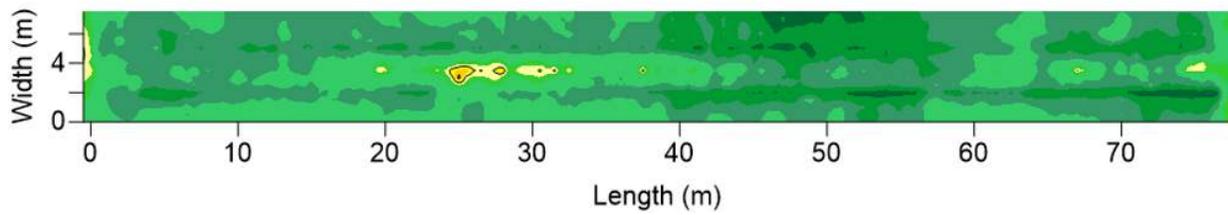
Figure 2. Corrosion Potential Survey Map of the Top of Deck

Generally, most of the corrosion potential measurements were in the range of 90% probability of passive reinforcement, although some areas in the uncertain range and in the 90% probability of active corrosion were observed in the top of the deck and along the embedded I-beams in the deck underside (Figure 2 and Figure 3). It is not unusual for corrosion potential testing to show measurements in the range of 90% probability of passive steel, even in areas of active corrosion. This can happen when the concrete resistivity is quite high, which affects the interpretation of the corrosion potential data.

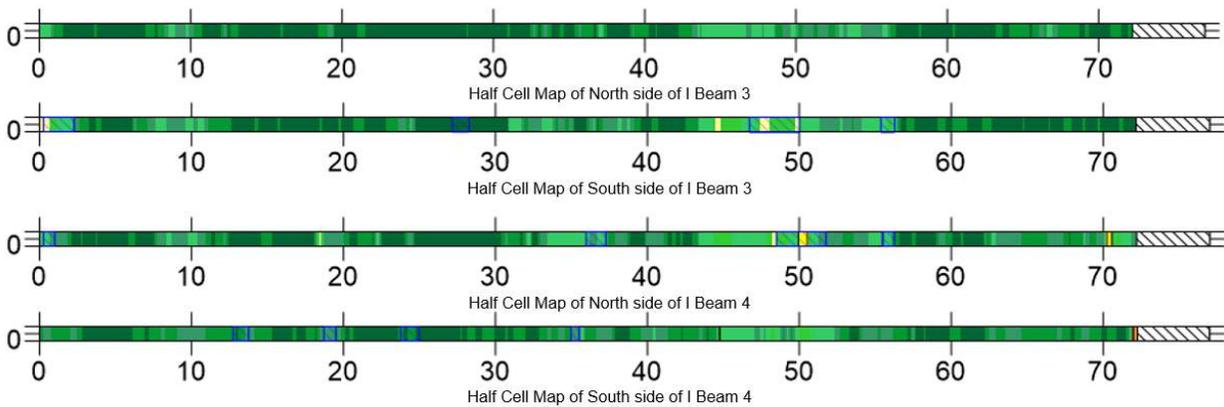
Figure 3. Corrosion Potential Survey Maps of the Deck Underside along the Beams, Typical

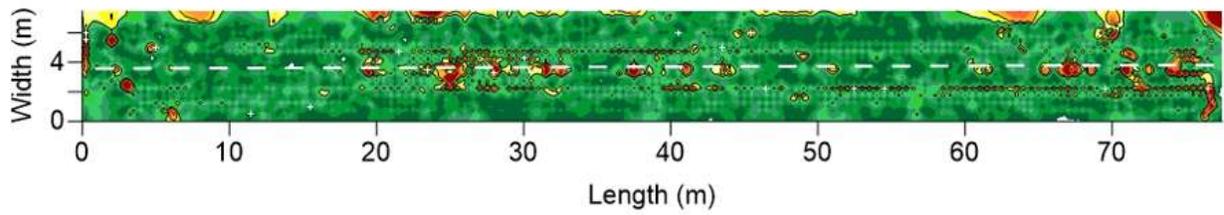
Figure 4. Potential Difference Plot for the Top of Deck

To better assess the probability of corrosion in the deck, relative change in potential between adjacent measurements were plotted for the deck. When corrosion occurs, there is a potential difference between the anodic and cathodic regions of the corrosion cell. Anodic and cathodic regions throughout a structure will be near to each other and have varying potentials that create potential gradients between adjacent points. A large potential difference between two locations indicates a high probability of active corrosion. Potential difference plots for the top of the deck and the deck underside are presented in Figure 4 and Figure 5, respectively. It is clear that despite low corrosion potential values recorded for most of the deck and I-beams, there are still areas with a high probability of active corrosion in some areas as indicated by the large difference in potential between adjacent measurements.

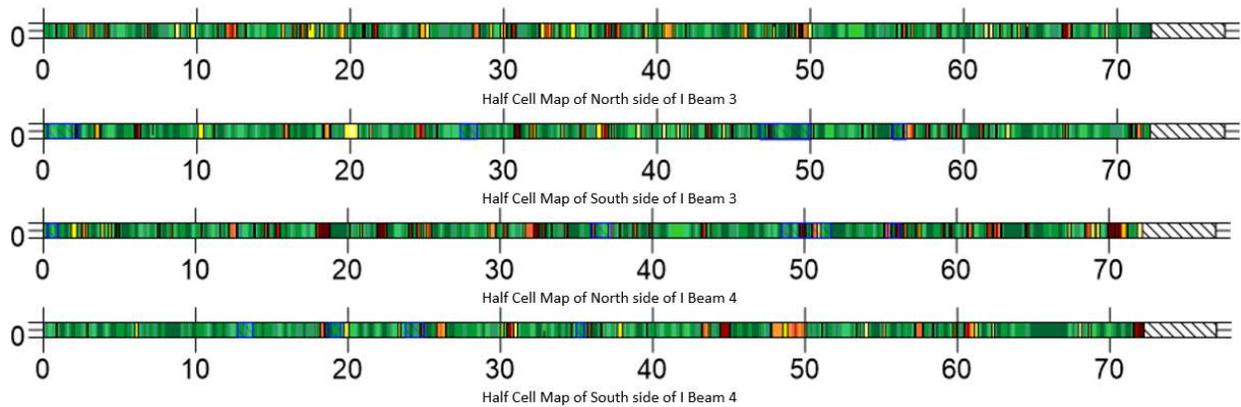
Figure 5. Potential Difference Plot for the Deck Underside along the Beams, Typical

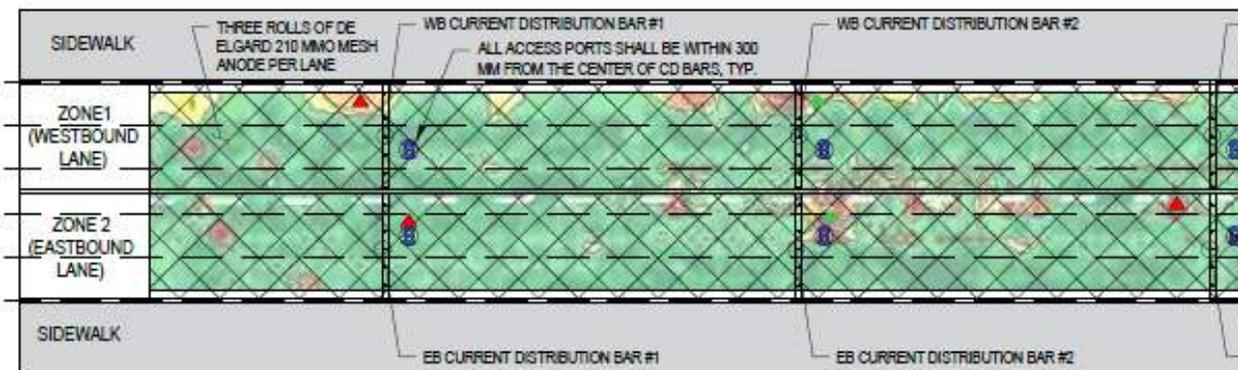
Figure 6. ICCP System Plan View, Top of Deck

The top of the deck was divided into 2 zones or circuits; zone 1 was dedicated to the westbound lane, and zone 2 to the eastbound lane (Figure 6). This allowed the contractor to maintain 1 lane of traffic across the bridge during construction. Each ICCP zones had 5 access ports and 3 reference electrodes as well as structure, test anode connections. Access ports were drilled in the deck and junction boxes were installed on the deck underside to rout all the wires to the distribution box (Figure 7).

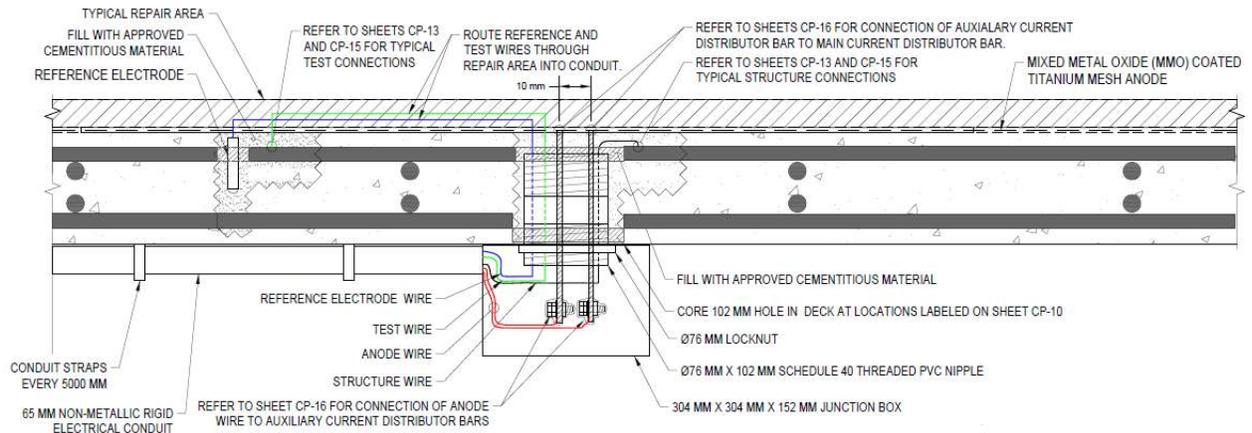
Figure 7. ICCP System Deck Section View

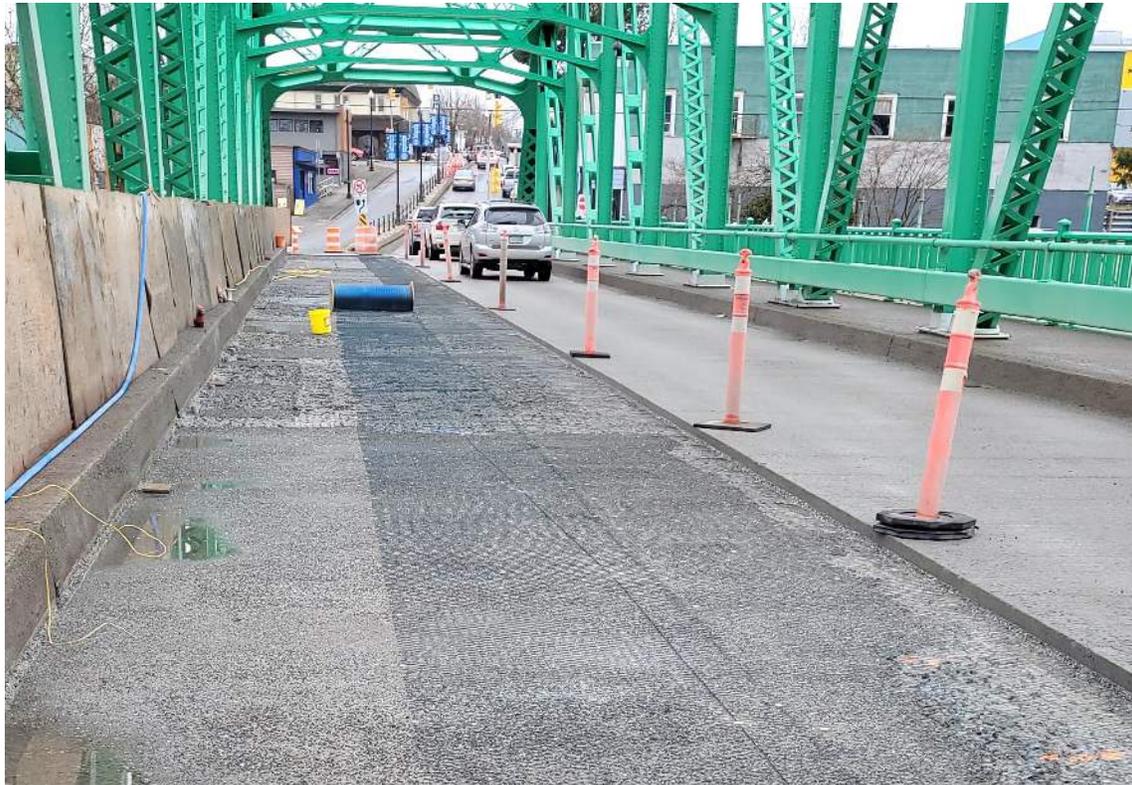
Figure 8. ICCP Anode Placement

After the top of the deck was removed, the mesh anode was installed in each zone together with distribution bars, reference electrodes and all the ICCP system connections and wiring (Figure 8). All wires were color-coded for ease of identification and individually labeled with their respective IDs (Figure 9). After all the wires were pulled through the access ports into the junction boxes, the overlay concrete was placed on top of the mesh anode (Figure 10). On the deck underside, the ICCP wires were routed from the junction boxes to the distribution box installed at one of the abutments, which was then collected to the RMU and the transformer-rectifier (Figure 11 and Figure 12).

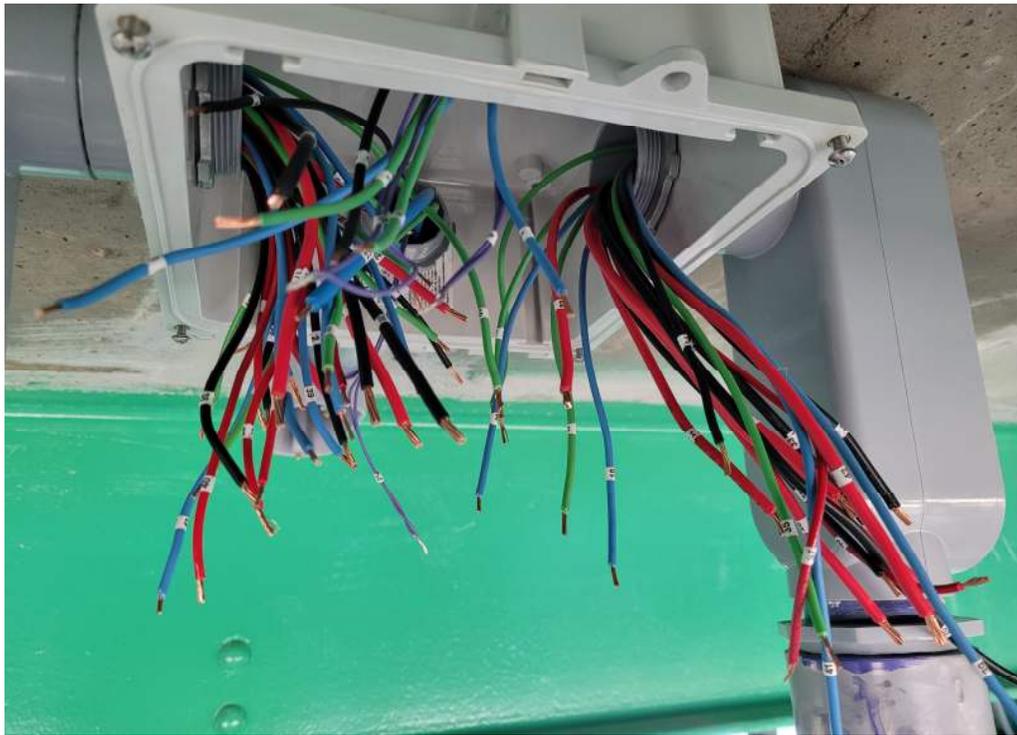
Figure 9. Junction Box with ICCP Wiring

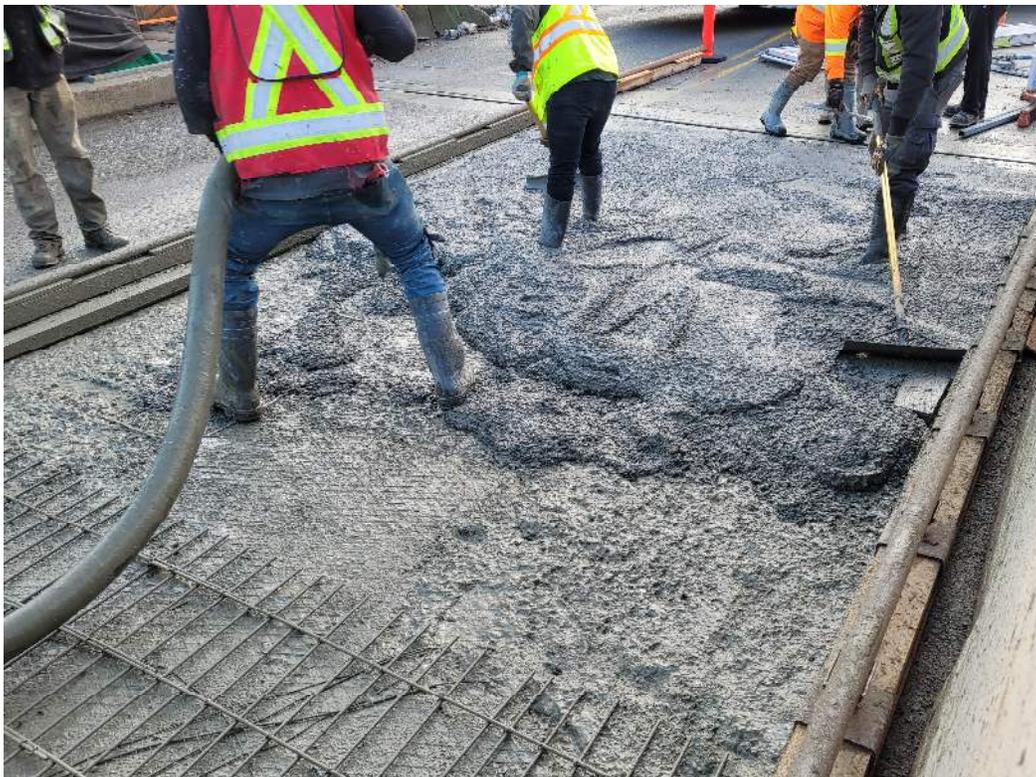
Figure 10. Deck Overlay Placement

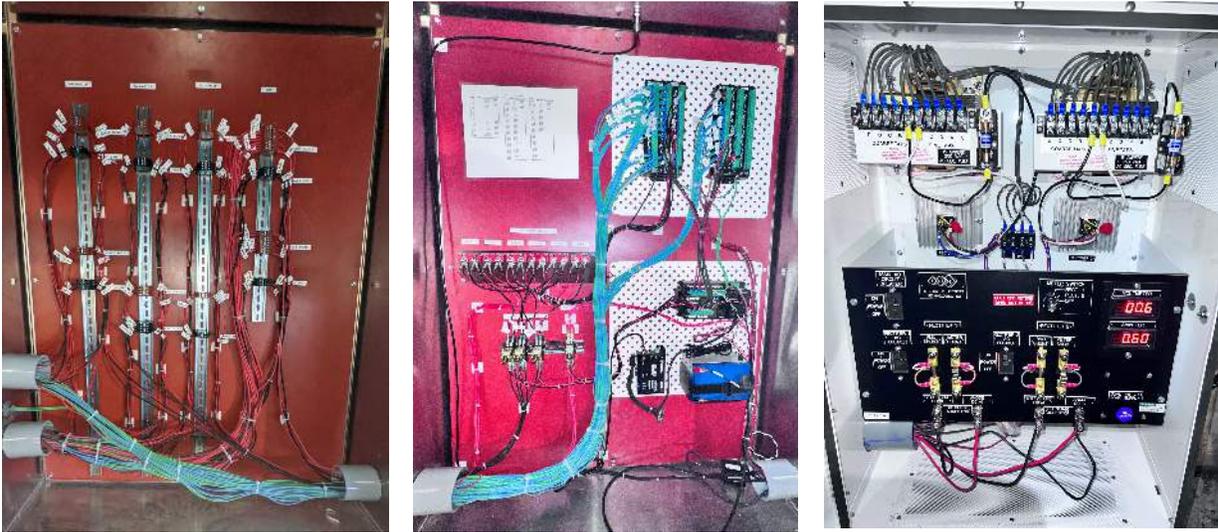
Figure 11. ICCP Distribution Box (Left), RMU (Middle) and Transformer-Rectifier (Right)

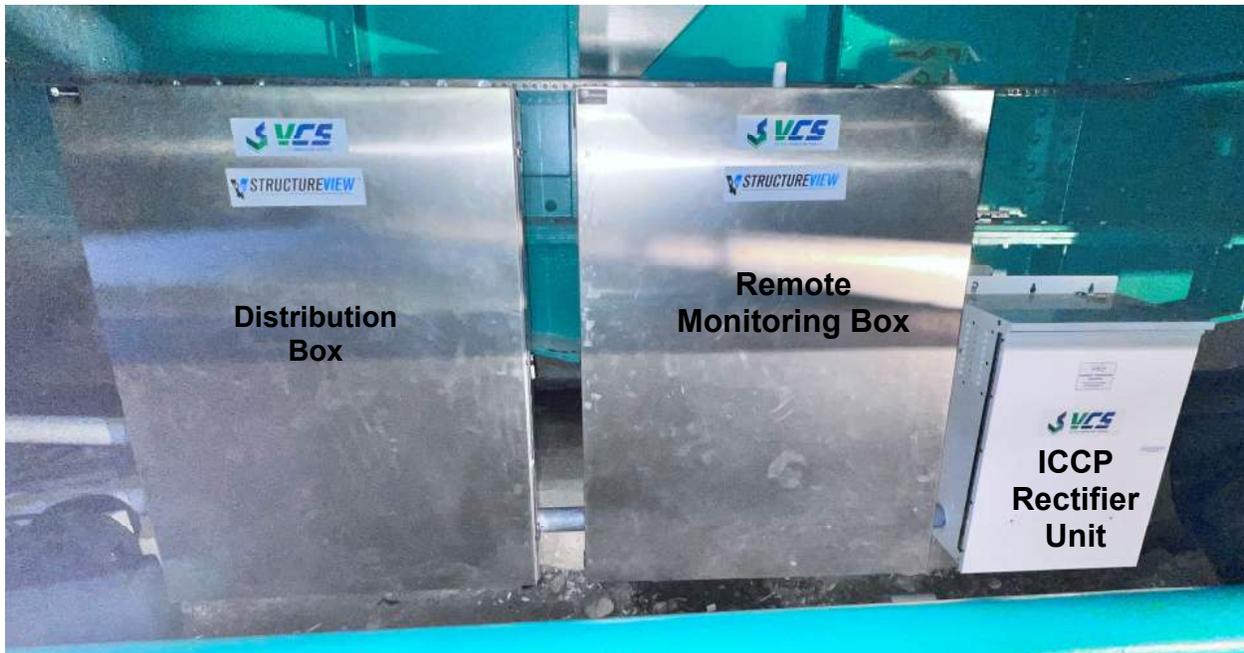
Figure 12. Completed Installation

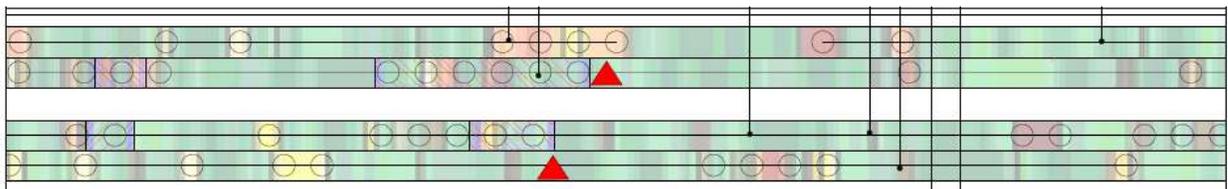
Figure 13. Plan View of the GCP System Installation along 2 I-Beam Girders, Typical

A targeted galvanic cathodic protection system was designed to protect the top flanges of the I-beam girders embedded in the bottom of the deck. A targeted approach was selected to protect the steel girders in locations where pre-design corrosion potential testing indicated a high probability of active corrosion and in areas of concern identified by the Engineer of Record (EOR) (Figure 13). Drilled in Type 2A galvanic anodes with a zinc core encased in an alkali-activated mortar were installed on each side of the I-beam girders (Figure 14). The GCP system was divided into 6 zones, with 1 zone per girders. Each zone included smaller grouping of anodes which were referred to as subzones, structure and test connections, 4 reference electrodes and 2 junction boxes.

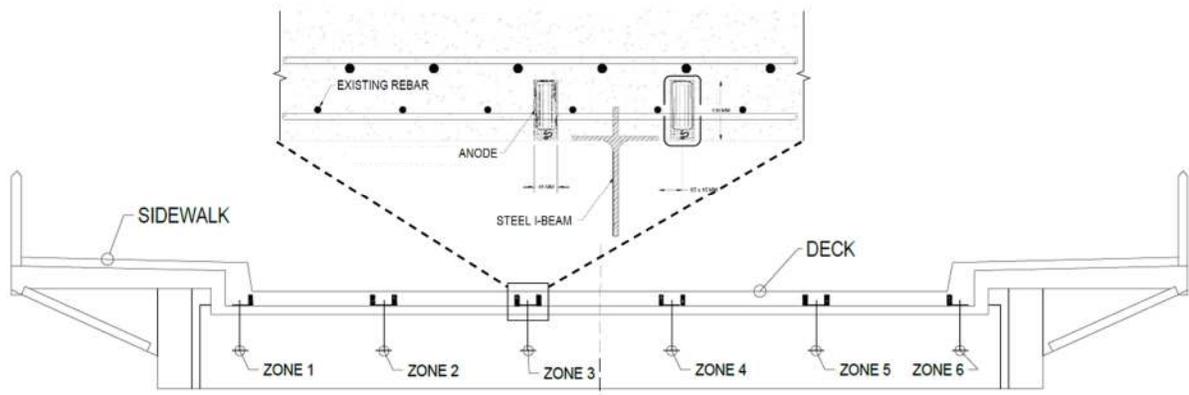
Figure 14. Cross-Section of the Deck Showing Galvanic Anode Installation

Prior to anode installation in each subzone, all the reinforcement in this area was located with a ground penetrating radar (GPR) and marked out on the concrete surface. Core holes were then drilled into the concrete from the deck underside avoiding the reinforcing steel and shallow wire chases were cut between the anode holes to accommodate the anode wires (Figure 15). In areas of full-depth deck repairs, removable forms were placed in the bottom of the deck in areas of anode installation to create holes for the anodes to avoid coring into the new concrete (Figure 16). To allow for monitoring of the GCP system, the anodes were not directly connected to the girders. Instead, anode wires, reference electrode wires, structure and test connections were routed to the distribution box at the abutment where anode and structure connection wires were connected through a shunt. Just like the ICCP, the GCP system was then connected to the RMU to allow for remote monitoring of system performance.

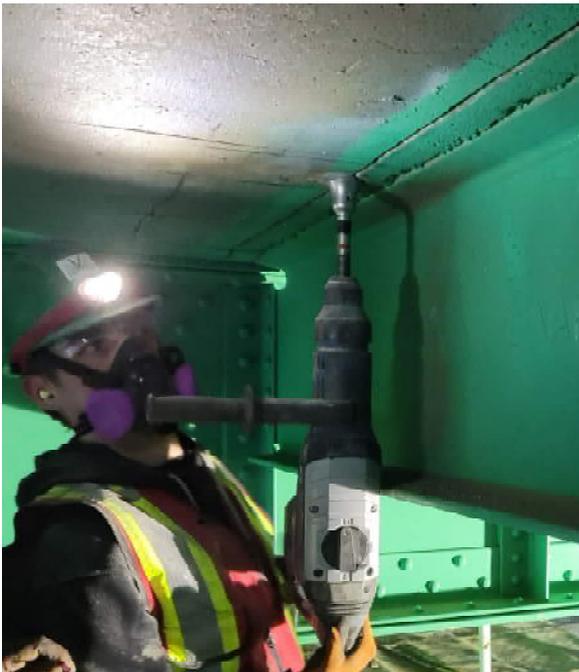
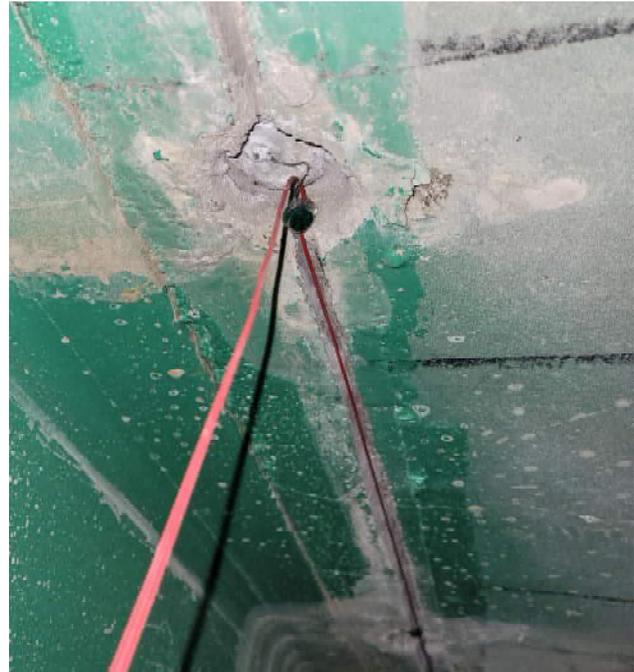
Figure 15. Coring Anode Holes (Left) and Grouted Anode Connected to a Red Anode Wire (Right)

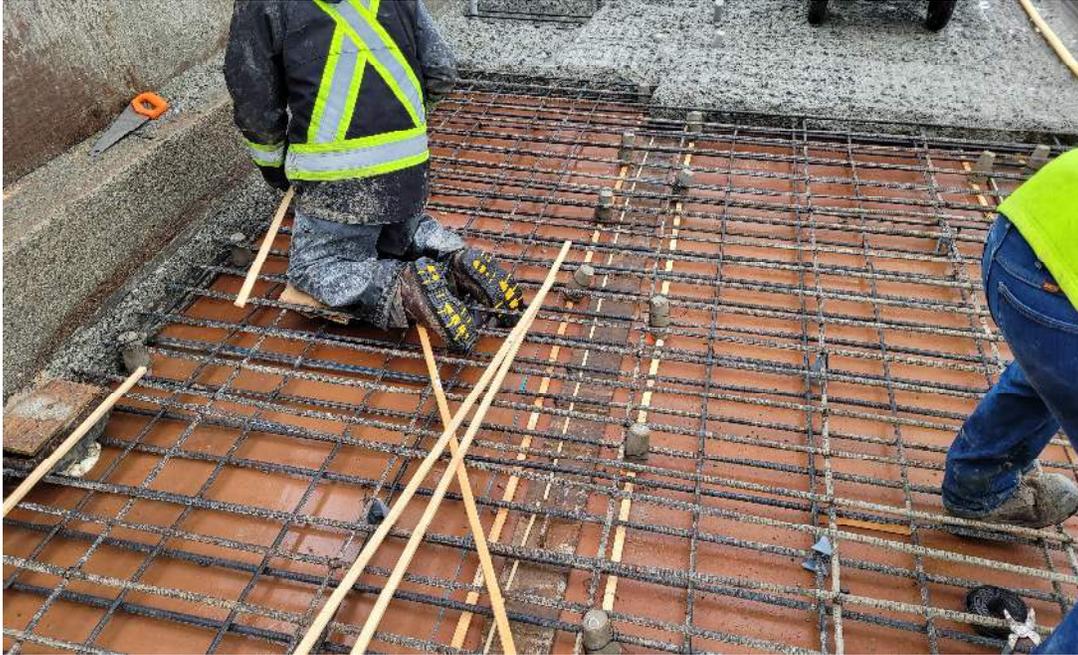
Figure 16. Full-Depth Deck Repair with Removable Forms for Anode Holes

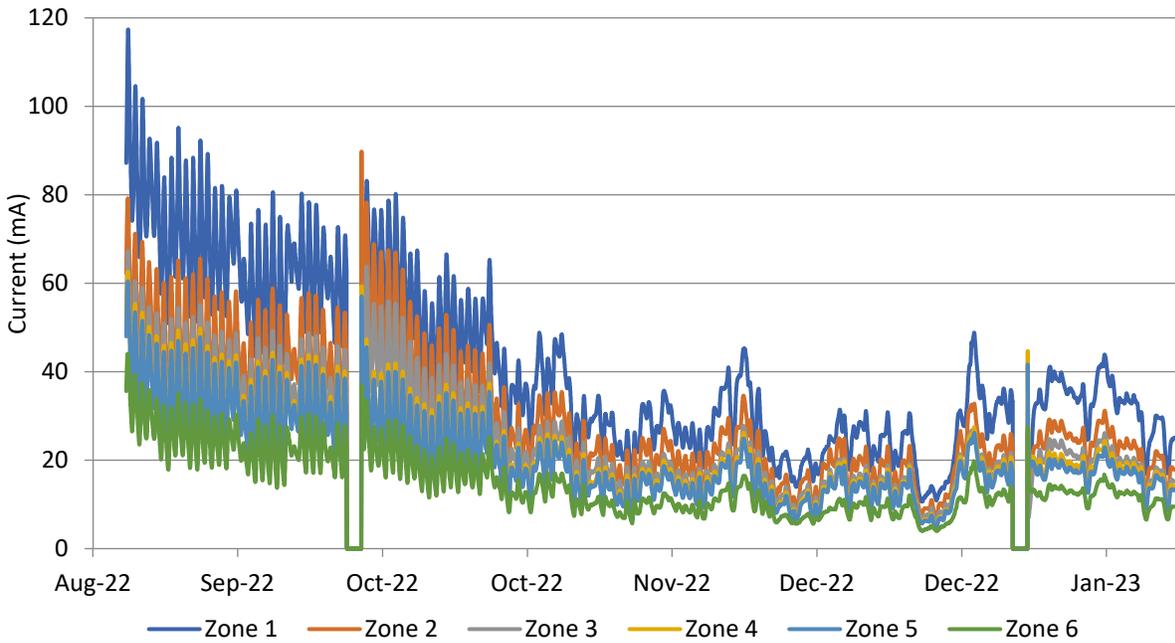
Figure 17. Current Output of the GCP System

Immediately after activation of the GCP system, the anodes exhibited a high initial current output. This behavior is typical for galvanic systems because galvanic anodes are self-regulating unlike the ICCP systems where the amount of current is controlled at the rectifier. Newly installed galvanic anodes provide a large amount of current due to low resistivity of the grout surrounding the anodes at early stages. Over the first several weeks, the current output decreased significantly as the grout resistivity increased due to cement hydration and the steel began to polarize. After approximately two months of operation, current output from the GCP anodes stabilized at a lower steady-state level, consistent with ongoing polarization of the reinforcing steel and reduction in corrosion activity (Figure 17). Polarization measurements shown as the vertical spikes in the OFF potential data shown in Figure 18 showed that the GCP system was meeting the polarization criterion for CP approximately 3 months after activation.

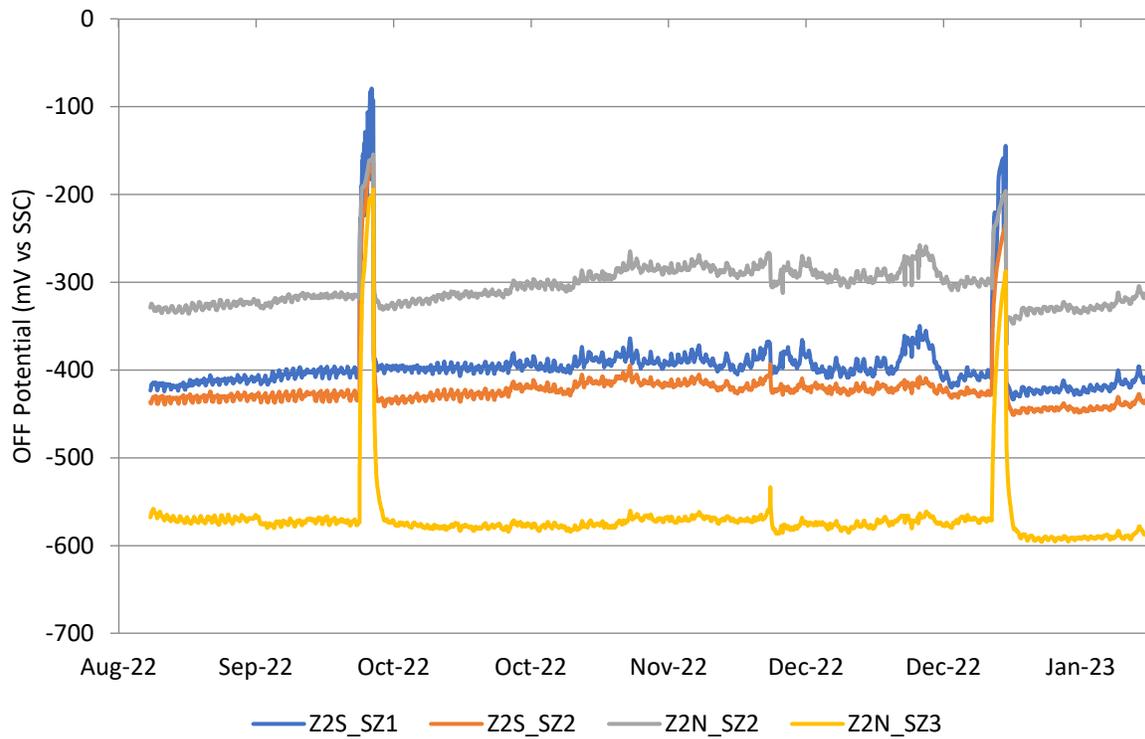
Figure 18. OFF Potential Measurements for Zone 2 of the GCP System

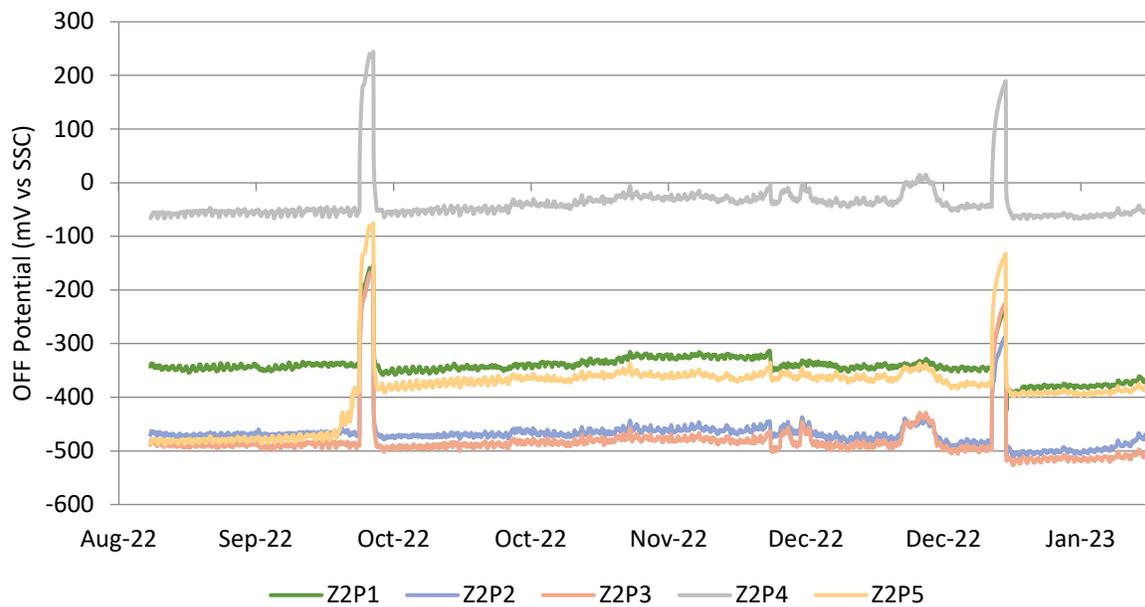
Figure 19. OFF Potential Measurements for Zone 2 of the ICCP System

a short period of time. Polarization measurements of the ICCP system showed that it was also meeting the 100 mV polarization criteria for CP (Figure 19).
