A success story, Eight-year pavement performance assessment for Highway 407, East Extension phase 1 in Ontario

Paper prepared for the session PV - Innovations in Pavement Management, Engineering and Technology
2024 Transportation Association of Canada (TAC) Conference & Exhibition
Vancouver, British Columbia

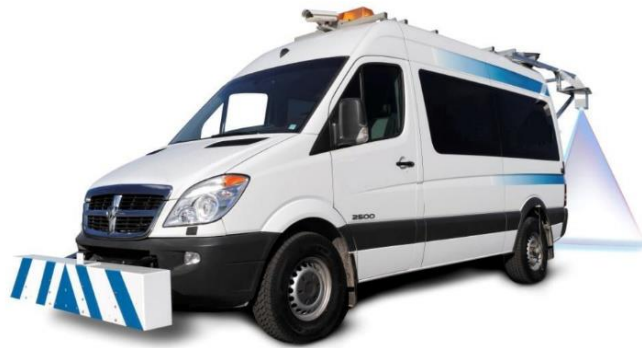
Figure 3 Multifunctional data collection vehicle (MFV)

The pavement condition assessment of the East extension of Highway 407 was performed between 2016 and 2023 using a specialized multifunctional data collection vehicle (Figure 3). This vehicle meets internationally recognized standards and methods in the fields of image capture, roughness measurement, crack and distress measurement, rutting and satellite positioning. The data collection was conducted continuously, at the legal speed limit, without being a road hazard or impacting normal traffic flow. The data included the extent of degradation and pavement cracking, the roughness, and the rut depth.

The multifunctional vehicle is equipped with a high-performance inertial navigator system and GPS with a high level of accuracy. Moreover, a high-definition camera mounted to the front and rear of the multifunctional data collection vehicle allows to capture and record images of the pavement. Cracking and distress on the pavement surface are then readily identifiable.

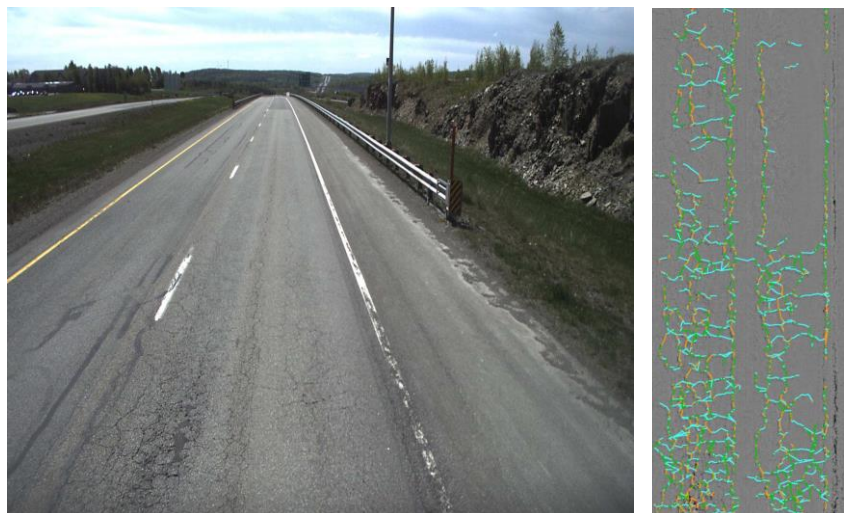
Figure 4 Automatic crack detection (3D image)

The LCMS, mounted to the rear of the multifunctional vehicle, is a high-speed and high-resolution transverse profiling system. Capable of acquiring full 4-meter width 3D profiles of a highway lane at normal traffic speed, the system uses two laser profilers that acquire the shape of the pavement. Both the resolutions and acquisition rate of the LCMS are high enough to enable the detection of cracks at highway speeds. Custom optics and high-power pulsed laser line projectors allow the system to operate in full daylight or in nighttime conditions. The collected data were analyzed using a data processing library that has the capability of detecting and analyzing cracks and other defects, based on AASHTO R85 standard.

Surface distress survey aims to identify the cause, extent, and severity of distress. This survey was conducted on the East extension of Highway 407 using the multifunctional data collection vehicle equipped with the latest pavement measurement technology, the Laser Crack Measurement System (LCMS).

The distress data obtained from the post-processing was compiled for 50 m segments in order to produce the DMI. This index was computed based on the severity of length or area and weighting factors of the different types of cracks and surface defects observed on the pavement.
