## **Keep Those Buses Moving, Safely!**

Paper prepared for the session RS.7 - Road Safety in Construction and Temporary Work Zones  
2025 Transportation Association of Canada (TAC) Conference & Exhibition  
Québec City, Québec

## Broadway Subway Project

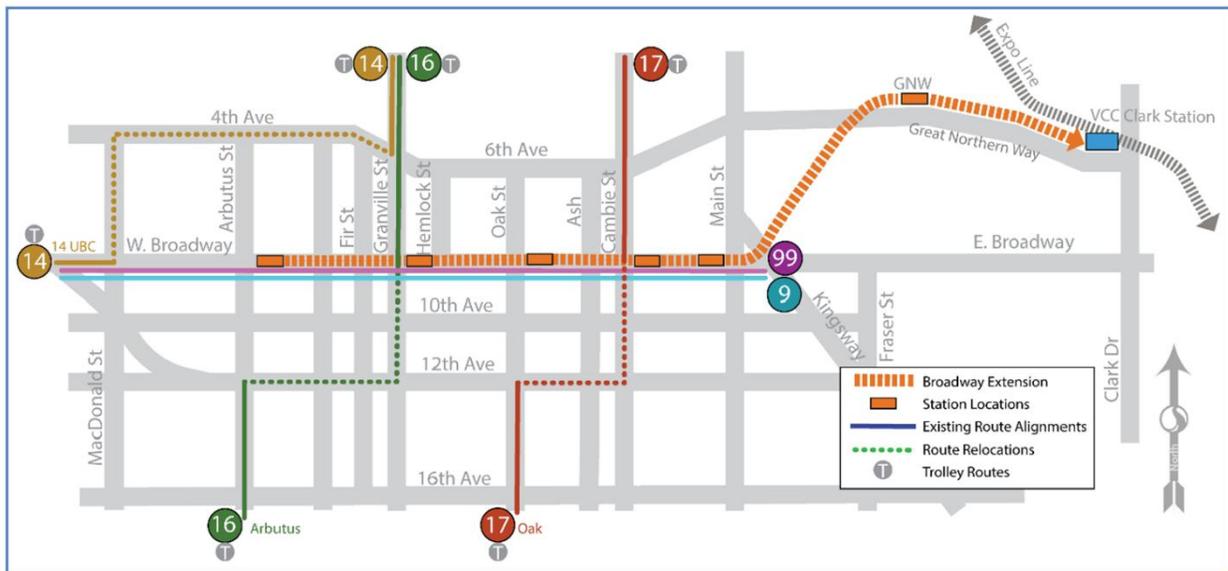
Figure 4. CMBC Bus Routes impacted by BSP Construction

In the early stages of planning for BSP, the Province, TransLink, and CMBC all worked to develop solutions for affected bus routes along the Broadway corridor. BSP required for trolley wires along the corridor to be de-energized, and as a result, three (3) bus routes had to be re-routed (Figure4) to ensure they can maintain their preferred trolley operation. Two (2) bus routes remained on Broadway – bus routes # 009 and 099.

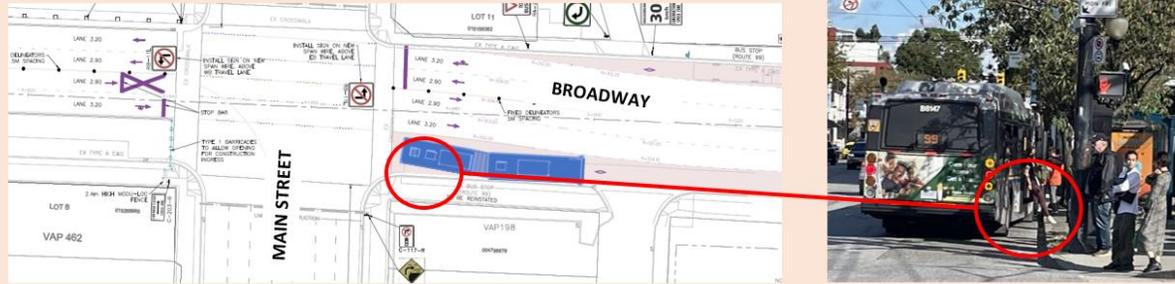
**REPORT # 2022-013**

**Description:** East-bound # 099 buses at Main Street are not able to pull parallel to the curb, leaving a gap at rear doors. This creates a stepping hazard to TransLink customers getting on or off the bus.

**Implemented Resolution:** CMBC has swapped the EB stops so that # 099 is at NS Kingsway and # 009 is FS Main.

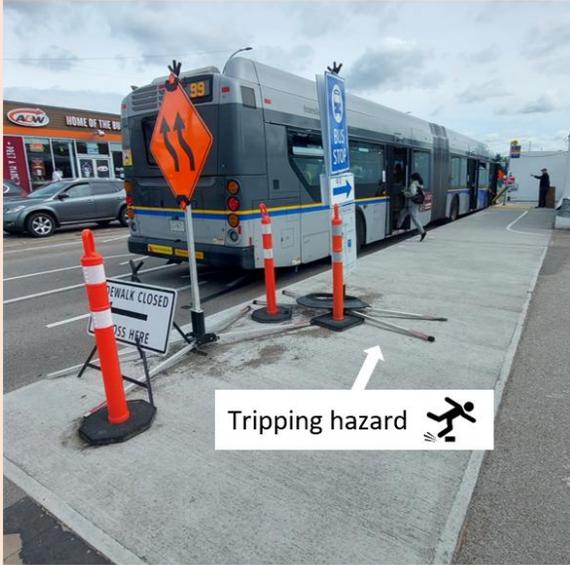
**REPORT # 2023-007**

**Description:** The legs of the Windmaster traffic sign stand create a tripping hazard for customers walking to or from the # 099 bus. This issue was reported by a CMBC Operator directly to the BSP Project team.

**Implemented Resolution:** Project Co removed the Windmaster sign stand and relocated the “Bus Stop” and arrow signs to the hoarding wall.

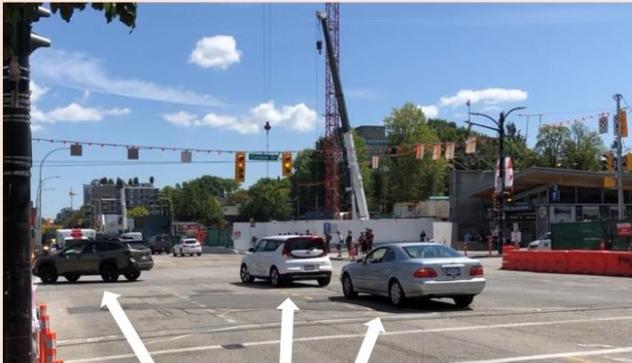
**REPORT # 2023-010**

**Description:** Advanced turn signal for EBLT vehicles on W Broadway at Cambie creates unnecessary congestion. Vehicles try to turn onto NB Cambie but can't because there is no room, blocking the WB Broadway travel lanes. Buses sometimes miss one or two green lights because of this.

**Example:** Advanced green turn signal allowed the 1<sup>st</sup> vehicle to move forward, blocking all WB traffic; ambulance missed the whole green light and 2 other turning vehicles are also stuck in intersection.

**Implemented Resolution:** Project Co reprogrammed signal lights at 4 intersections to improve flow of WB and EB traffic on W Broadway.

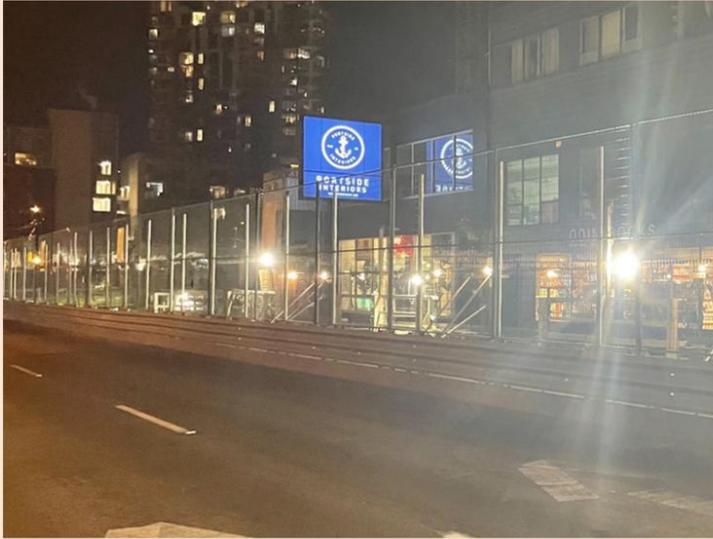
**REPORT # 2023-013**

**Description:** 099 bus operators reported that the construction flood lights at Mount Pleasant Station, between Main St. and Quebec St., are shining bright onto Broadway, blinding the operators as they drive by.

- 2. Frequent communication** – frequent communication was vital to the success of this project. There were weekly meetings, but in addition the weekly meetings the project team established direct communication channels with each other, so as incidents came up, they were resolved in a timely manner. One example of this was TransLink's Sr. Project Manager receiving a text late on a Friday night from the BTC Union Representative that bus operators were experiencing a blinding light at one of the construction sites. The PM visited the site at night, found the offending flood lights, took photos to show the problem, sent them to the project team and in 24 hrs, the flood lights were repositioned to be less of a distraction to the operators.

**Implemented Resolution:** Redirect the flood lights to shine more down into the excavation and less into the street.
