Transforming Bridge and Railway Asset Management A Case Study of the Rideau River Railway Bridge Inspection Using Advanced Drone Technology and AI

Paper prepared for the session New Technologies in Asset Management
2025 Transportation Association of Canada (TAC) Conference & Exhibition
Québec City, Québec

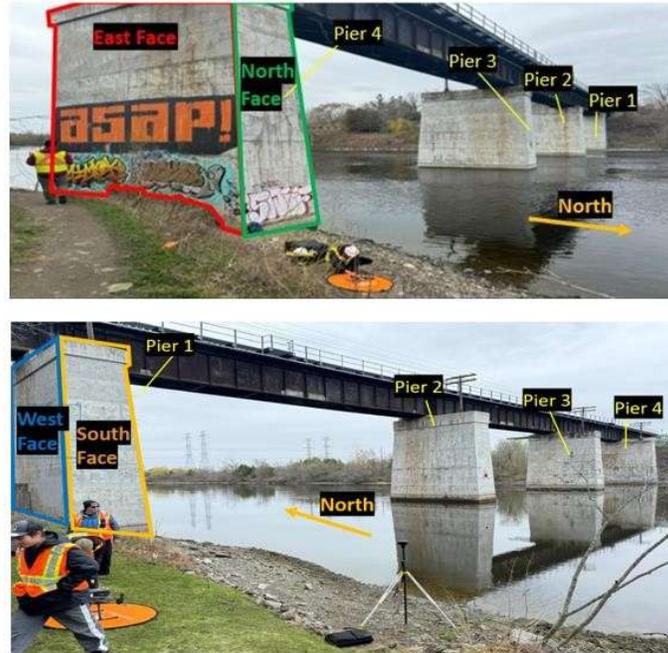
faces using a DJI M300 with a Zenmuse P1 camera with a 35mm lens. For testing purposes, data from Pier 2 and Pier 3 were also collected using Skydio X10. Two takeoff locations were set – one on each side of the river. This helped ensure the pilots maintain visual line of site with the UAV throughout the condition assessment. The site sectioning defined the structural components as outlined below:

Figure 2, Rideau River Bridge Site Sections

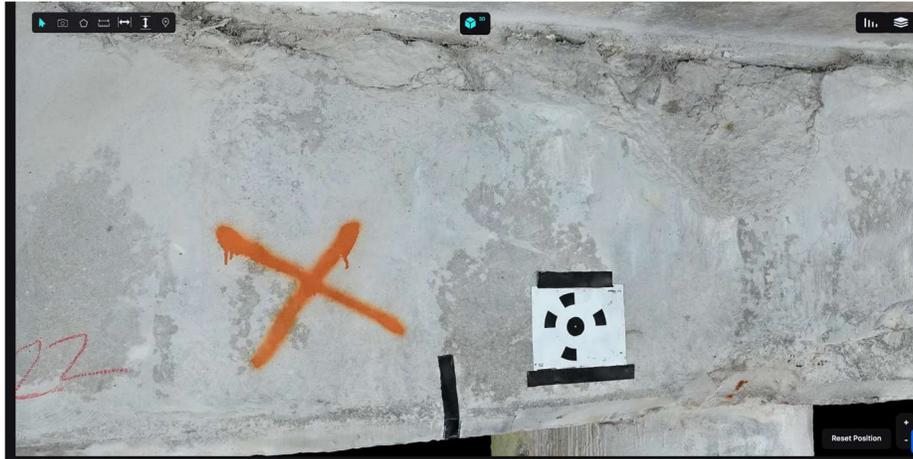
Ground control points were set at various location throughout the site and at accessible portions of the structure. Local survey monuments were used, and new ground control points were set as needed. Ground control points (GCPs) improve the accuracy and reliability of photogrammetry-based condition assessments and 3D mapping. GCPs are fixed, precisely surveyed markers placed on the ground that serve as reference points for aligning aerial imagery with real-world coordinates. By incorporating these points into its data processing workflow, Niricson ensures that the spatial models and measurements derived from imagery are highly accurate, consistent, and georeferenced. This allows for precise defect localization, repeatable condition monitoring over time, and integration of inspection results with engineering design or asset management systems. An example of a ground control point, visualized in a bridge 3D model, is shown below:

Figure 3. Example of Survey Target, Visible in 3D Model

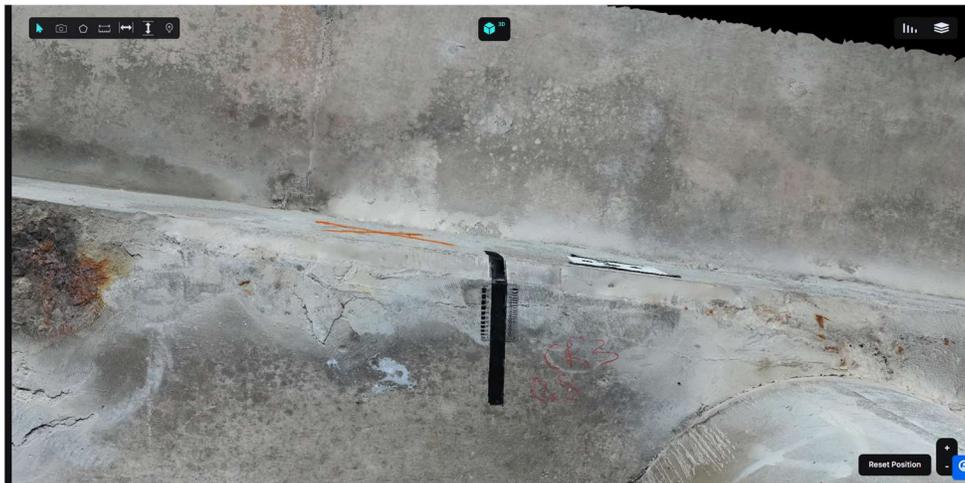
Niricson uses crack gauges as part of its validation process to ensure the accuracy of crack width measurements captured through its advanced imaging technologies. Crack gauges, which provide precise physical measurements of crack displacement, serve as a ground-truth reference against which digital or automated measurements can be compared. By deploying these gauges in the field and cross-referencing the recorded data with readings from their AI tools, Niricson can confirm the reliability of its crack width assessments. This validation step supports compliance with engineering standards and strengthens confidence in the digital inspection results. An example of a crack gauge, visible in a digital 3D Model, is shown below.

Figure 4. Example of Crack gauge, visible in 3D model

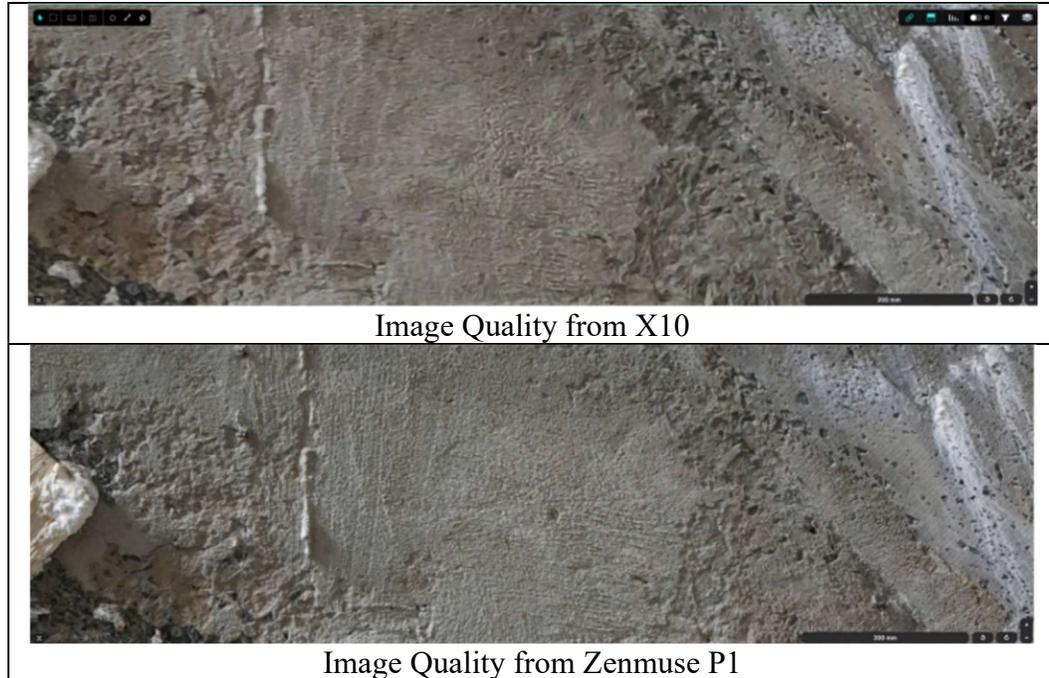
The following images are the results of the two tested imagery systems. Both images were collected at 0.7mm/pixel GSD and with similar data capture settings: 1) Drone stops and capture each photo, and 2) similar ISO and shutter speed settings. However, as is visually apparent, the Zenmuse P1 data performed with higher clarity and crispness than the X10 camera. As a result, the Zenmuse P1 camera was selected for the operation, resulting in higher quality quantification and detection of visual defects.

Figure 3. Image Quality Comparison X10 camera and Zenmuse P1 camera

As demonstrated in the tables and figures above, camera type, vehicle, capture speed, camera aperture, pilot expertise, and a variety of other factors can result in different outcomes when it comes to quality and the ability to detect defects. As a result, the team decided to proceed with using the data from the Zenmuse P1 Camera data.

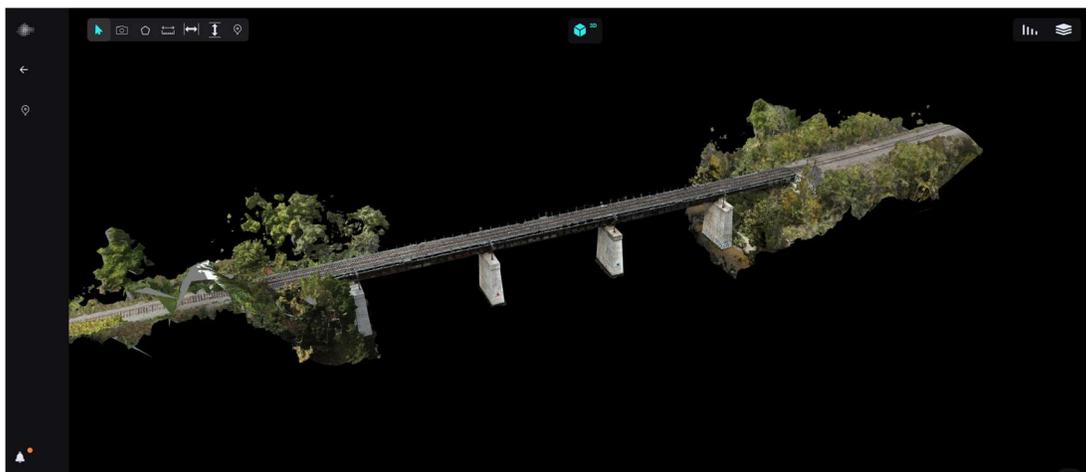
Once the imagery was captured with proper frontlap and sidelap, the adequate ground sampling distance, and coverage of the proper structural elements, the imagery data was organized and processed using server-grade processing power to stitch the images into a 3D model. The 3D model for Rideau River Railway Bridge is shown below:

Figure 5. 3D Model, Rideau River Railway Bridge

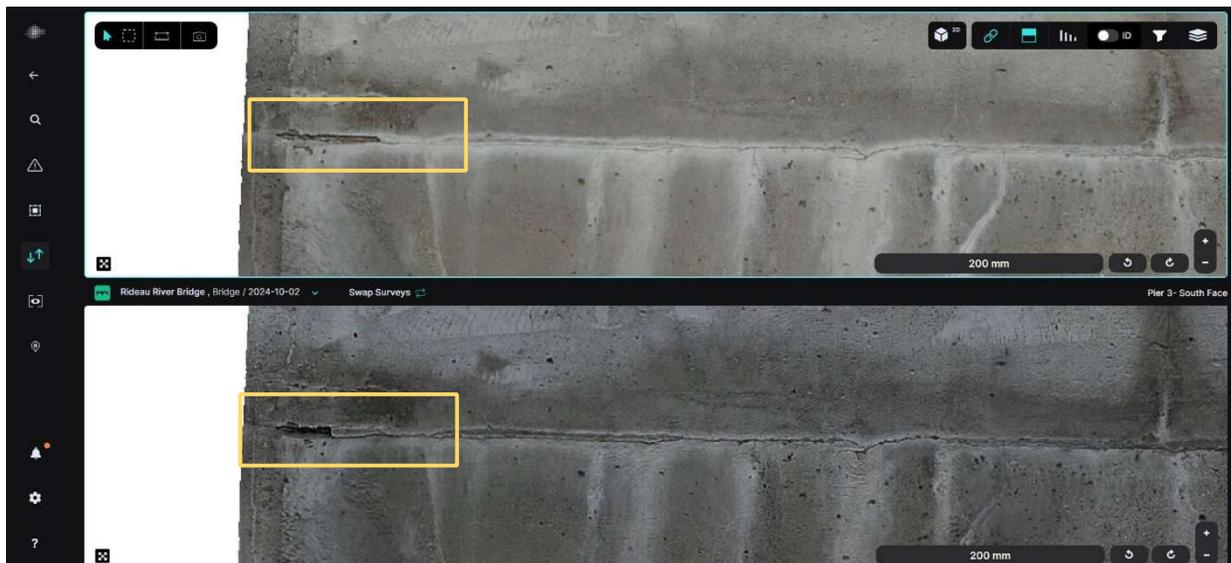
Since the two surveys took place five months apart over summer months, minimal changes were identified on the structure. However, analysis of the April 2024 and October 2024 data revealed an increase in the size of a spall in one area, which can be visualized using AUTOSPEX™'s change detection function. This may have been the result of freeze-thaw cycles, concrete expansion during the summer months, or another factor. An example of that change is shown below:

Figure 18. Example of Change Detection Found on Rideau River Bridge
