Sensing-based Structural Health Monitoring and Novel Data-driven Approach for Bridges Using Ambient Vibration Testing

Paper prepared for presentation
at the ST - Transportation Structures Session
of the 2024 Conference of the
Transportation Association of Canada

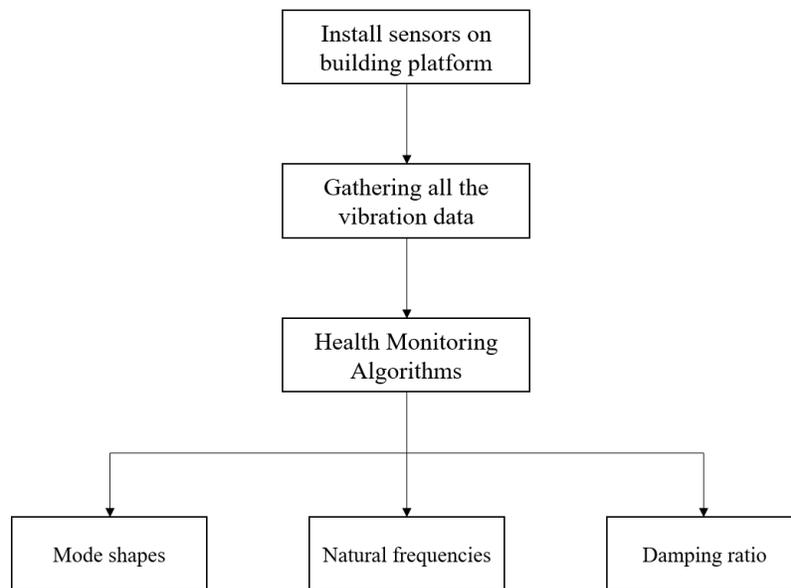
Sensing-based structural health monitoring is briefly demonstrated in Figure 1 [14-16]. This approach directly utilizes the in-situ derived modal properties and therefore bypasses the need for detailed structural drawings and finite element (F.E.) analysis models. Sensequake patented technology, 3D-SAM™ [17], can perform both structural health monitoring and seismic assessment on existing structures solely based on ambient vibration sensing data.

Figure 1: Methodology for sensing-based structural health monitoring

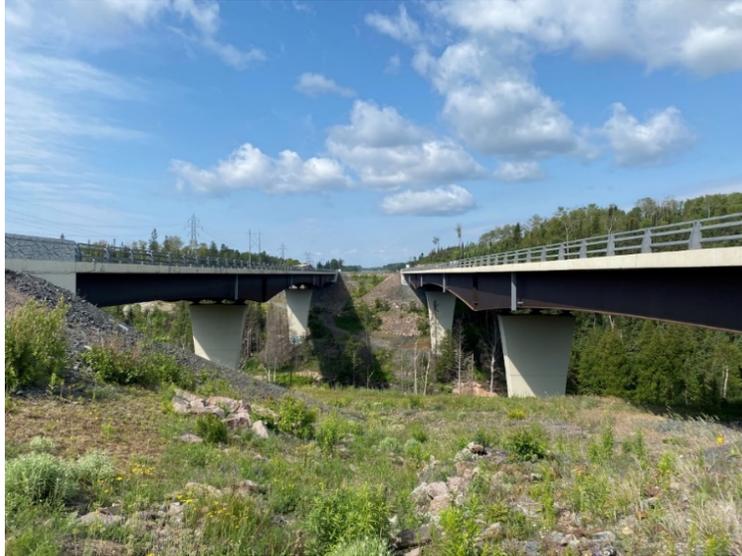
Figure 2: Mackenzie River Twin Bridges, Ontario

This study is focused on the ambient vibration data gathered from three continuous bridges in Ontario including the Mackenzie River Twin Bridges and Pic River Bridge. The Mackenzie River Twin Bridges were built in 2011 outside of Thunder Bay, Ontario (Figure 2). The Twin Bridges are continuous three-span and, at the time of construction, were North America's largest field-cast ultra-high-performance concrete-connection bridges. The Pic River Bridge is located along the Trans-Canada Highway 17, approximately 7 kilometres East of the town of Marathon in Ontario (Figure 3). The bridge was originally constructed in the early 1960s as a 3-span overhead truss bridge. In 2016, the bridge was reconstructed, utilizing the existing 1960s pier foundations, as a 3-span, steel girder, concrete deck bridge. State-of-the-art technologies are capable of significantly enhancing the performance of structural health monitoring systems and contributing to a rapid and more reliable assessment of bridges.

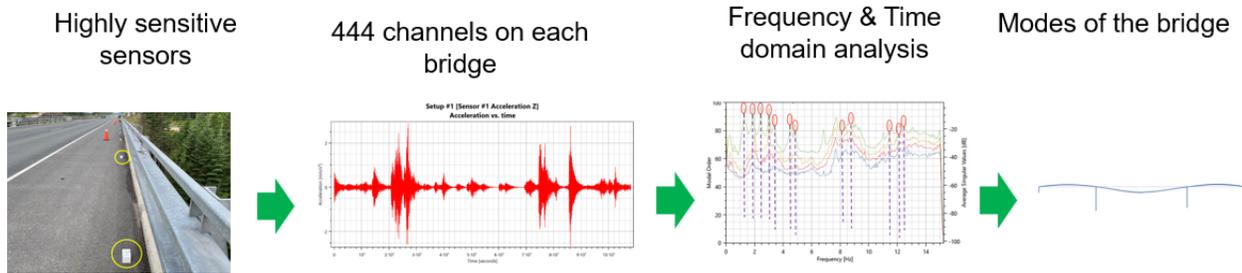
generated through the analysis, the condition of all major bridge components including foundations, piers, abutments, bearings, deck, and scouring potential can be evaluated from sensors that were deployed only at the deck. Finally, the last step is to assess the overall structural integrity of the bridge. The steps to extract dynamic properties for Mackenzie River Twin Bridges are briefly depicted in Figure 4.

Figure 4: Steps used for the structural health monitoring of Mackenzie River Twin Bridges

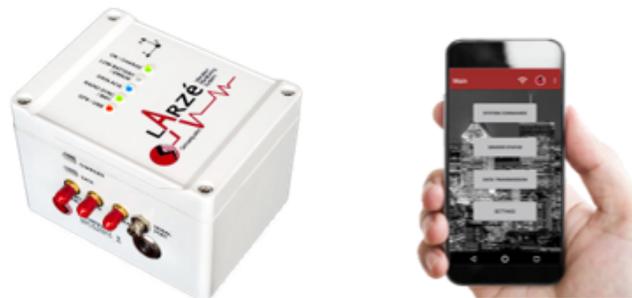
Comprehensive ambient vibration sensing tests are designed and performed on a structure to derive its dynamic properties (natural frequencies, mode shapes, and damping ratios). These tests provide important information about the current condition of the structure. Sensequake Larzé wireless sensors [18] are utilized to perform sensing tests and gather ambient vibration data. These sensors are capable of measuring the horizontal and vertical vibrations in structures as presented in Figure 5 (a). A smartphone application is used to configure the sensor network as presented in Figure 5 (b).

Figure 5: (a) Sensequake Larzé sensors [18]; (b) Larzé control application

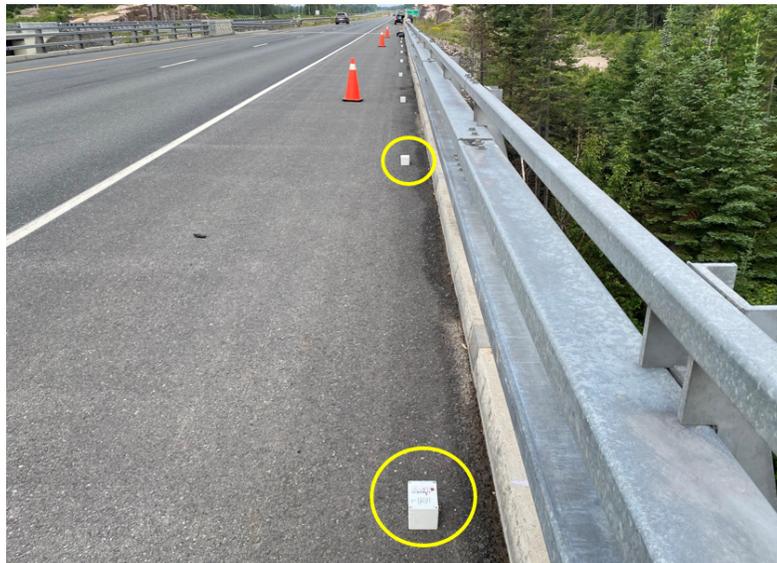
The Mackenzie River Twin Bridges were tested in July 2023 as presented in Figure 6 with a sampling frequency of 122 Hz. The average temperature on the day of testing was around 18 °C. To extract the dynamic properties of the Mackenzie River Twin Bridges, 74 locations on each bridge were selected to deploy wireless sensors and collect ambient vibration data across six channels resulting in 444 channels per bridge.

Figure 6: Testing of the Mackenzie River Twin Bridges

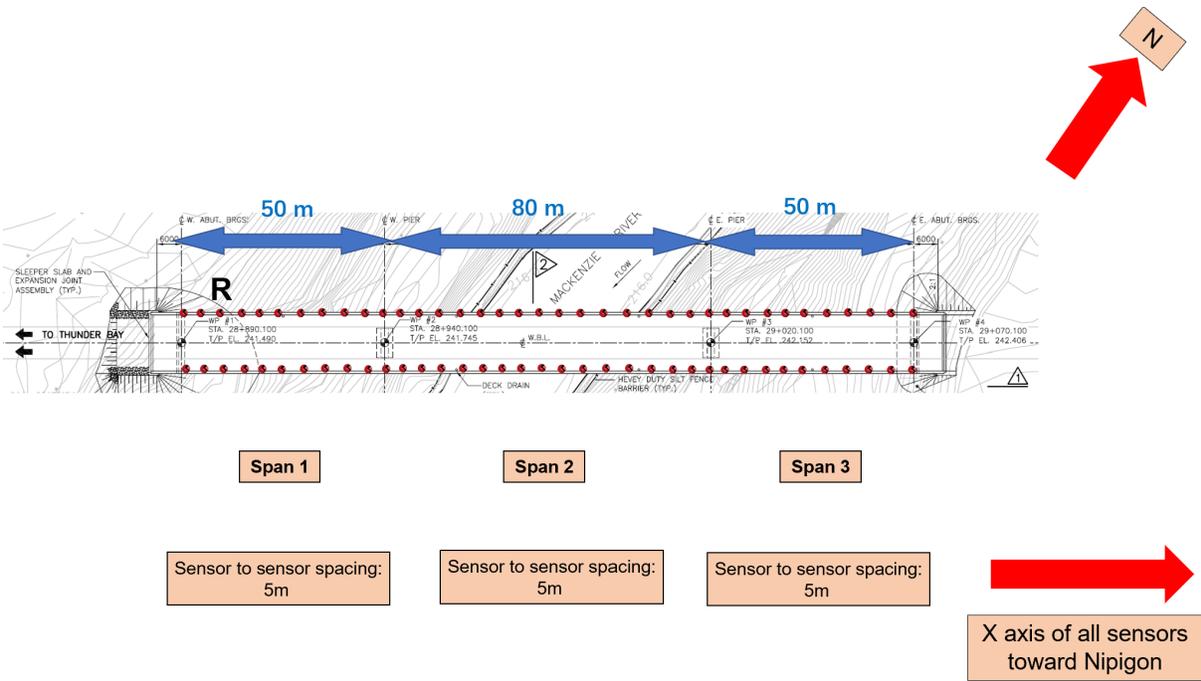
The sensor layout for a sensing test is designed considering the geometry, structural configuration, and current condition of a bridge. The detailed sensor layout to gather ambient vibration data from the Mackenzie River Twin Bridges is presented in Figure 7. After the test, the gathered ambient data is transferred to a PC via a USB connection or through Wi-Fi.

Figure 7: Sensor layout of the Mackenzie River Twin Bridges (Westbound)

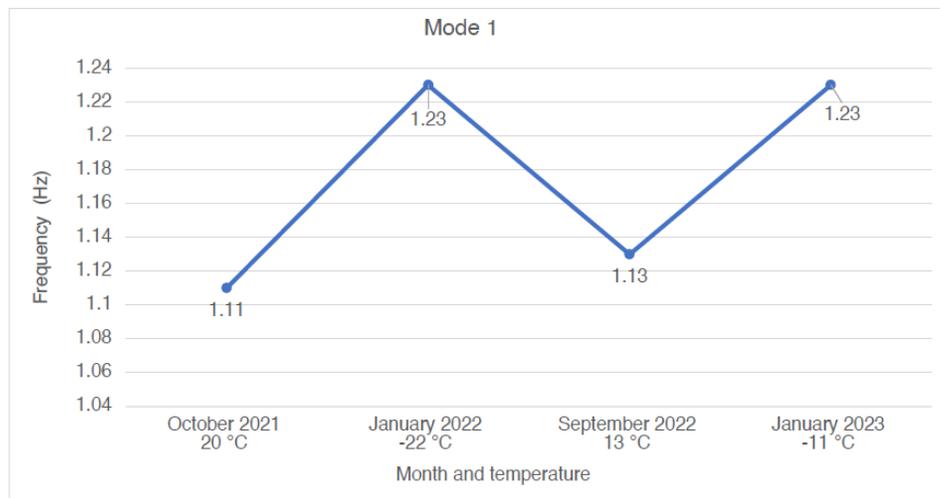
This study is focused on the ambient vibration data gathered from three continuous bridges in Ontario including the two Mackenzie River Twin Bridges and Pic River Bridge. Four sensing tests were performed on the Pic River Bridge using the wireless sensors. After in-depth post-processing of the gathered ambient vibration data, seven sets of dynamic properties (natural frequencies and 3D mode shapes) were identified for the bridge. The natural frequencies extracted for the Pic River Bridge from the first sensing test performed in October 2021 are as follows 1.11 Hz, 1.60 Hz, 2.12 Hz, 2.63 Hz, 3.58 Hz, 4.15 Hz, 6.03 Hz. An average damping ratio of 1.7% was detected for the Pic River Bridge. The variations of the first natural frequency within a 2-year period are presented in Figure 8. Natural frequencies must be compared in summer and winter separately since they are sensitive to temperature. As presented in Figure 8, both summer and winter frequencies are stable. A reduction in frequency could indicate a symmetrical deterioration in the bridge which will not be visible with mode shape comparison. Symmetrical degradation is a consistent weakening of the structural components, causing a drop in natural frequency. Despite this reduction, the symmetry of the mode shape may still be retained.

Figure 8- Variations of the first natural frequency within a 2-year period

As was presented, through in-depth processing of the measured data, multiple dynamic properties (natural frequencies, high-quality animated 3D mode shapes, and damping ratios) were precisely identified for the Mackenzie River Twin Bridges and Pic River Bridge. The variations of the first natural frequency within a 2-year period were identified for the Pic River Bridge. By comparing the mode shapes of the Pic River Bridge to similar bridges within the unique database, no major anomaly or damage was observed and the bridge exhibited healthy structural behaviour. After completing the four sensing tests, the "range of stable baselines" was mathematically established for the Pic River Bridge using mode shape distortion area criteria and frequency thresholds. By comparing the dynamic properties of Mackenzie River Twin Bridges to similar bridges within the database, no major damage was observed. However, an anomaly corresponding to an asymmetrical distribution of stiffness between two edges of the bridge was observed in the middle span of one of the Twin Bridges. Comprehensive information about the studies on the three bridges will be provided by the authors in an upcoming journal paper.

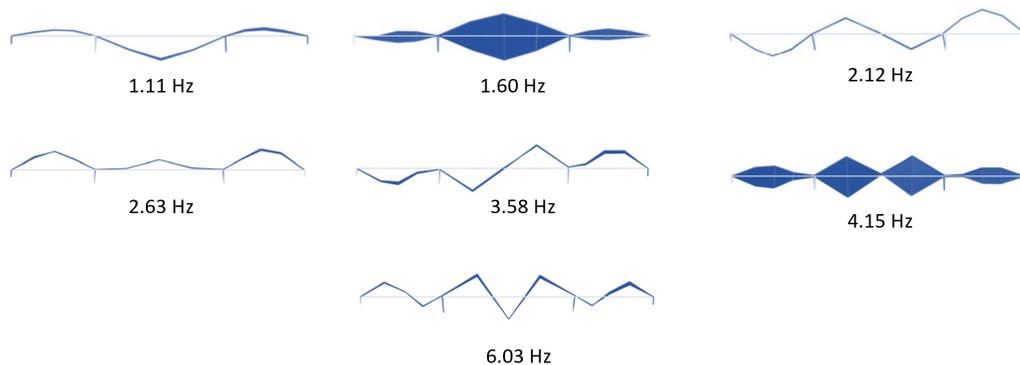
In addition to symmetrical deterioration, bridges could undergo asymmetrical degradation. Asymmetrical degradation affects the uniformity, continuity, and symmetry of the mode shape. This asymmetry originates from an uneven distribution of stiffness between two edges of bridges. The mode shapes extracted for the Pic River Bridge from the first sensing test are presented in Figure 9.

Figure 9: Mode shapes of the Pic River Bridge extracted from the first sensing test

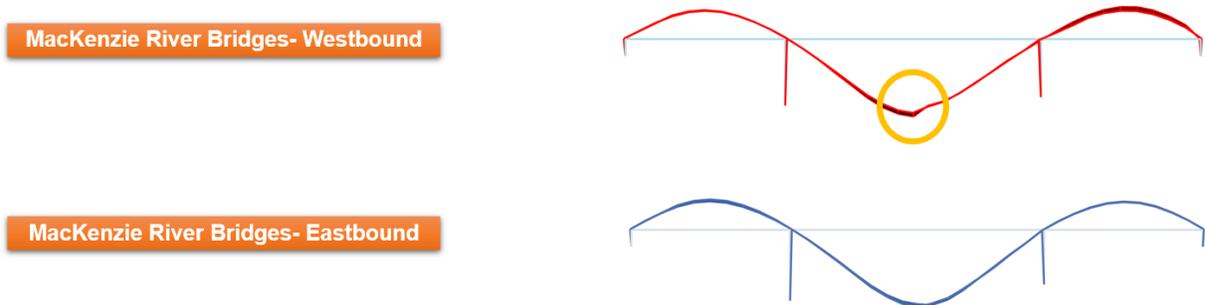
After in-depth post-processing of the ambient vibration data gathered from Mackenzie River Twin Bridges in July 2023, several sets of dynamic properties (natural frequencies and 3D mode shapes) were identified for the bridges. The first vertical mode shape extracted for Mackenzie River Bridges (Eastbound and Westbound) is presented in Figure 10.

Figure 10: 1st vertical mode shape of the Mackenzie River Bridges (Eastbound and Westbound)

By comparing the dynamic properties of Mackenzie River Twin Bridges to similar bridges within the database, no major damage is observed. However, an anomaly corresponding to an asymmetrical

distribution of stiffness between two edges of the bridge is observed in the middle span of one of the Twin Bridges as presented in Figure 10. Detailed inspection at that location and future monitoring of the bridge were recommended as the next steps. Comprehensive information about this study will be provided by the authors in an upcoming journal paper.
