St Vital Bridge Riverbank Pier Stabilization

Paper prepared for presentation at the “Transportation Structures” Session of the 2024 TAC Conference & Exhibition, Vancouver, BC

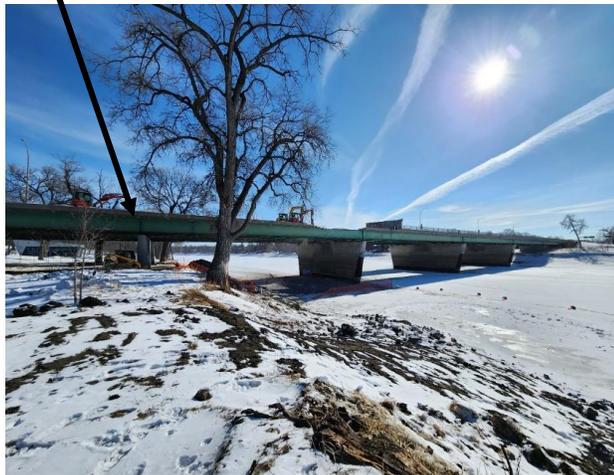
Figure 3: North Riverbank Pier Location

During the initial phase of bridge deck demolition, movement of the north riverbank pier (Pier 3) towards the river was noted, which initiated the requirement to stabilize the pier. Figure 3 shows a cross-section of the north riverbank as surveyed prior to construction; Pier 3 is the pier that required stabilization. This paper outlines the overall pier stabilization works process, including identification of pier movement, structural analysis, design of remedial works, and construction.

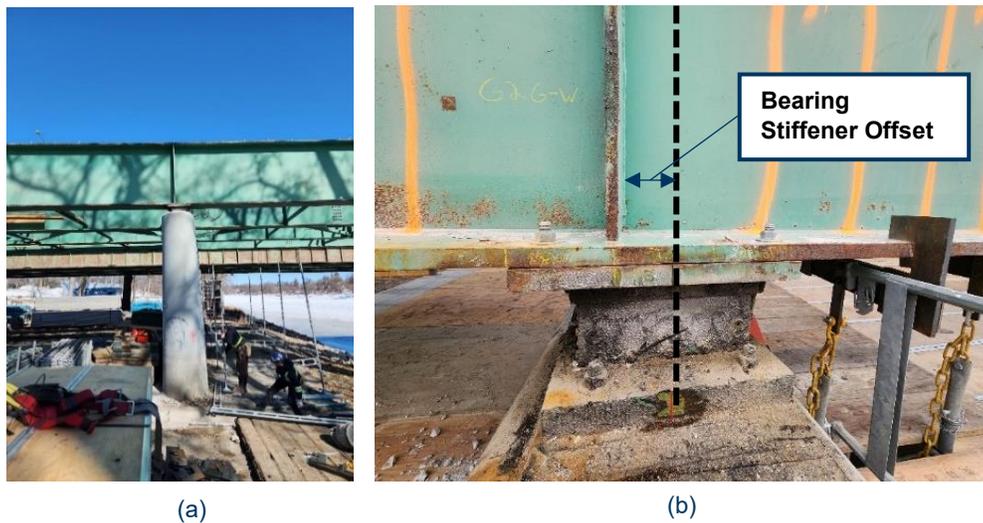
Figure 6: Bearing Stiffener Eccentricity (a) Overall Pier (b) Close up of Bearing

Bearing stiffener offset measurements were taken on April 17, 2023, following the desktop study of previous Pier 3 bearing measurements. The measurements were taken at -2°C when the bearings should be near their design centred position. Figure 6 shows the bearing stiffener offset measurement location and the offset amount.

Table 1 provides a summary of key bearing measurements reviewed for assessment of the bearing position relative to potential substructure movement. The measurements indicated the bearing stiffeners were, on average, offset 104 mm with respect to the centre of the pier. Based on assessment of the April 2023 bearing offset measurements and comparison to the 2019 bearing top plate shift file records, 21 mm of movement, on average at the four girder lines measured, was noted at the Pier 3 bearings between the 2019 bearing reset and the April 2023 bearing measurements.

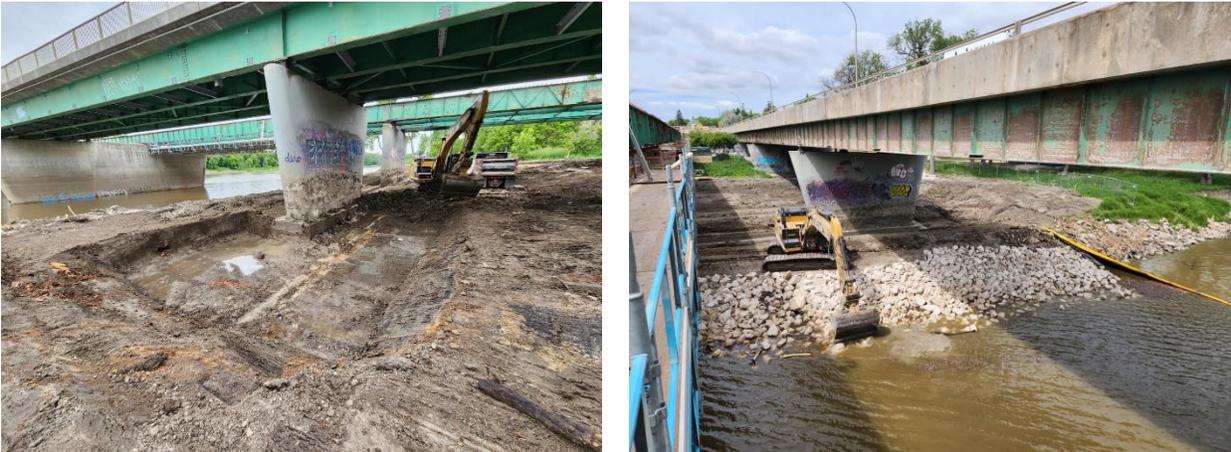
Figure 14: Riverbank Offloading and Stabilization Berm Rock Placement

1. The soil surrounding the pier was offloaded to reduce the slope driving pressures and a rock berm was placed on the toe of the slope in the river channel to increase the short-term slope stability Factor of Safety, as shown in Figure 14. The slope offloading removed between two and three metres of fill over the existing pile cap. A silt curtain was used to control sedimentation from rock placement in the river. No cofferdam was required to complete the pier stabilization works as ground seepage from the river was able to be controlled by pumping.

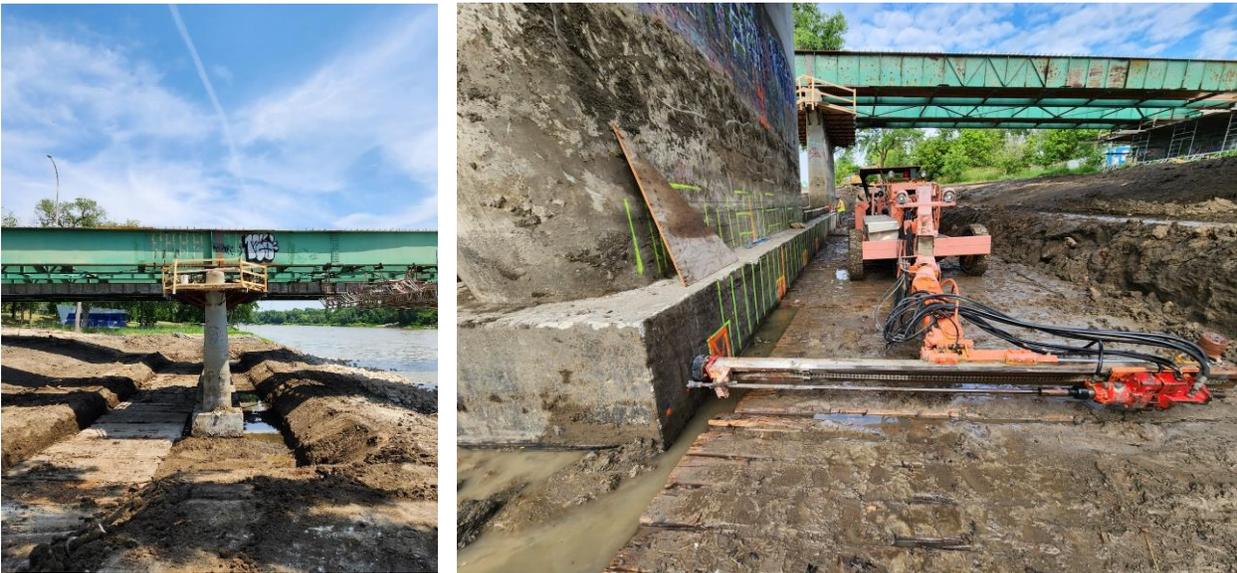
Figure 15: Fully Excavated Pile Cap and Rock Drilling of Tension Ties Through Pile Cap

2. The existing reinforcement in the pile cap and the steel H-piles were located using a GPR reinforcement survey. Holes were cored through the existing pile cap for grouted tension ties, which were installed following pile driving. Coring was completed using a tractor mounted rock drill, as shown in Figure 15. Layout of core holes considered the locations of existing piles, future piles, and pile cap reinforcement. The design of tension ties was adapted to accommodate a range of distances from the underside of the new cap to facilitate rock hammer drilling. The track mounted rig provided a cost-effective alternative to coring the holes through the existing pile cap. Careful monitoring was required to confirm the holes were cored as level as possible through the pile cap.

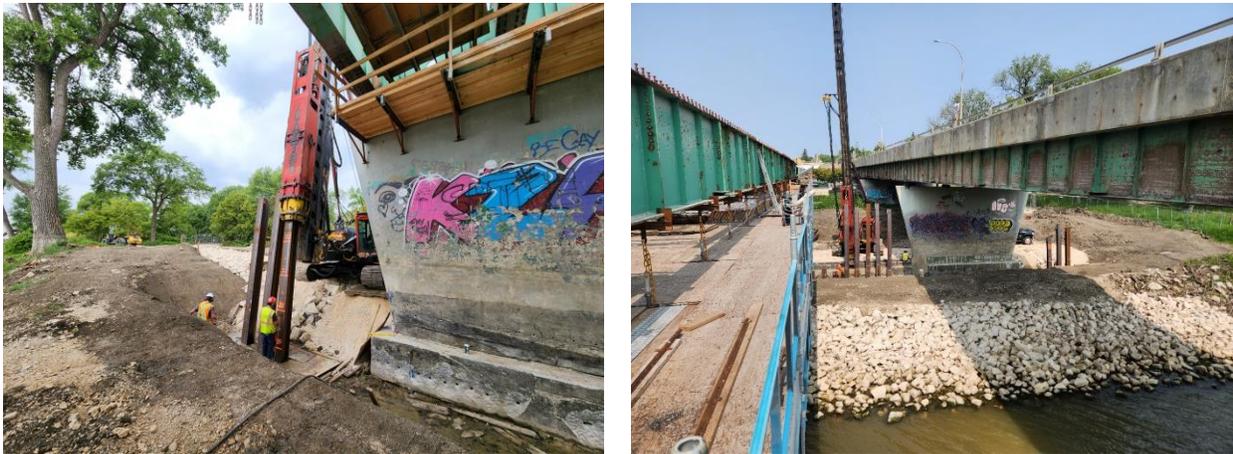
Figure 16: Driving H-Piles to Refusal

3. Six pile driving rig setups were required to gain access to appropriate zones and a total of 28 steel H-piles (HP310 X 110) were driven to refusal surrounding the pier at locations and offsets that accommodated the existing bridge, ongoing construction activities, and traffic staging (e.g. deck was removed from southbound carriageway at this point in the rehabilitation and traffic was bi-directional on the northbound carriageway). Figure 16 provides images of the pile driving. Pile driving works had to avoid the deck overhangs and girders of the existing bridge as well as accommodate overhead clearances for extending the pile driving lead. Pile capacities were validated using pile driving analysis (PDA) test results.

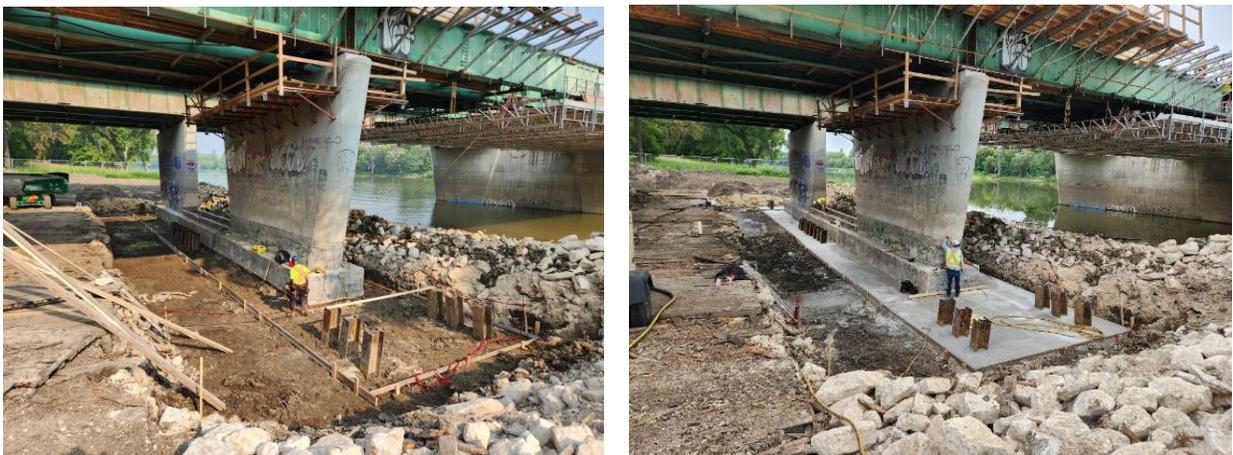
Figure 17: Pile Cutoff and Working Base Concrete

4. The piles were cutoff to the desired embedment into the new encasement pile cap. A working base slab was placed surrounding the existing pile cap to allow for assembly of the reinforcing steel cage around the piles, as shown in Figure 17. The working base slab further allowed the contractor to control seepage from the river, which was near the same elevation as the excavation base.

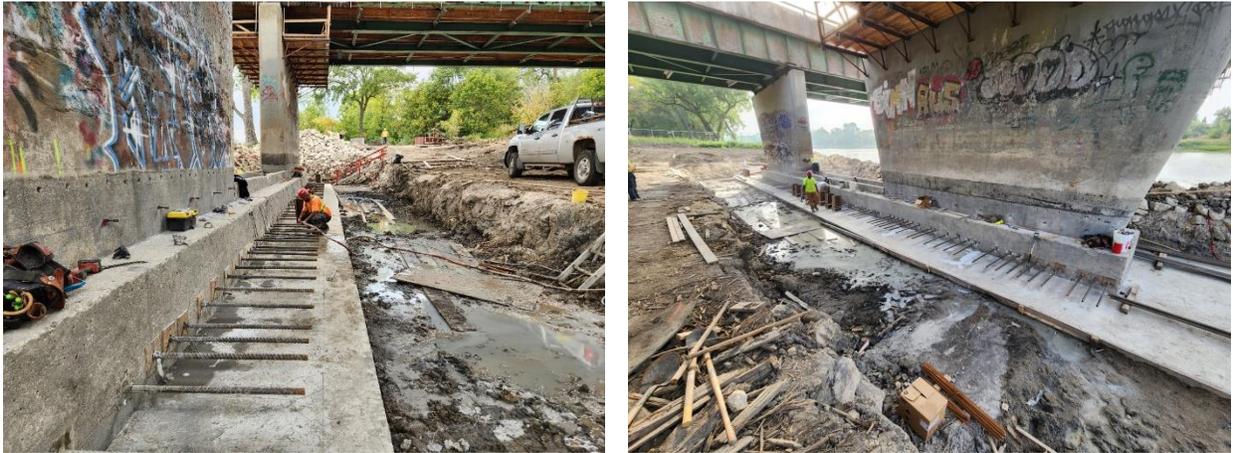
Figure 18: Tension Tie Arrangement and Grouting

- Following pile installation, the existing pile cap was blasted to roughen the surface and tension ties were placed and grouted across the existing pile cap as shown in Figure 18. Bulkheads were placed on one side of the bar and flowable grout injected from the other side. Dowels were also drilled and epoxied around the perimeter of the pier shaft and the remaining two faces of the existing pile cap that would be embedded within the new pile cap.

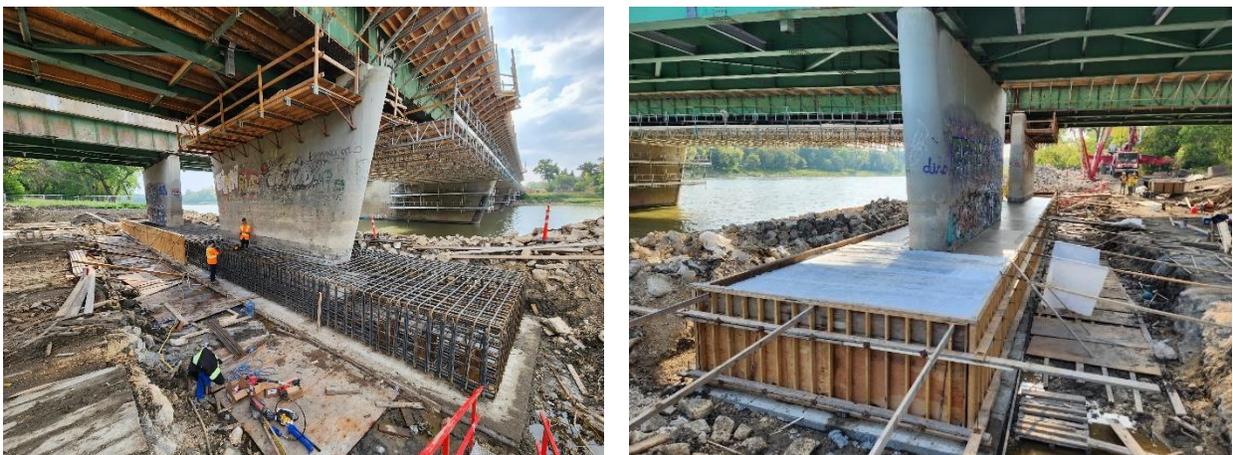
Figure 19: Final Reinforcement and Concrete Placement

- New pile cap reinforcement was placed surrounding the existing pile cap and perimeter formwork was erected, as shown in Figure 19. Temperature sensors were embedded within the concrete to monitor the heat evolution and maintain appropriate thermal gradients for a mass concrete pour. Approximately 180 cubic meters of concrete was placed within the form over eight (8) hours by means of concrete pumping. The formwork was left in place for seven (7) days while the concrete cured with a wet cure maintained on the surface until form stripping. Following the formwork removal the pile cap was coated in damp proofing and backfilled with granular material.

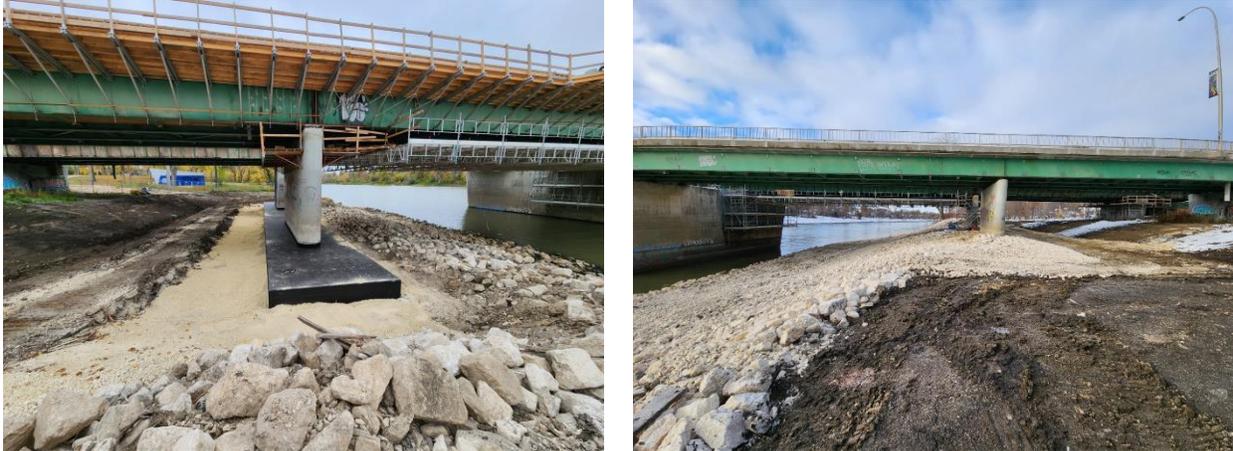
Figure 20: Backfill around Pile Cap and Final Rip Rap

7. Lastly, the overall riverbank surrounding the pier was covered in a rip rap apron to provide further slope stabilization and erosion control, as shown in Figure 20.
