Deconstruction of the original Champlain bridge

Samir Gouider
Senior bridge engineer, Bridges team manager
AtkinsRéalis
Montréal, QC
Samir.Gouider@atkinsrealis.com

Paper prepared for the Structures Session
2024 Transportation Association of Canada (TAC) Conference & Exhibition
Vancouver, British Columbia

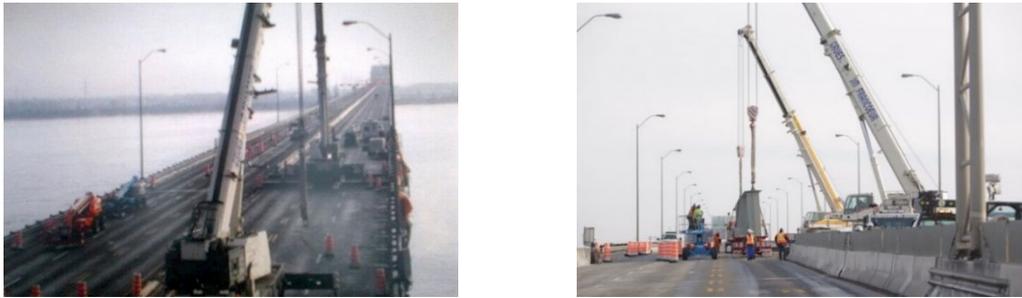
Figure 3. Installation of the temporary external beam reinforcement in 2013

- 1989: Replacement of the concrete deck with an orthotropic deck for the steel truss portions of the bridge
- 2011: Announcement that the Champlain bridge will be replaced by a new one
- 2013: During an inspection in November 2013, a crack was discovered in a critical part of the superstructure. A temporary external beam of 75 tons was urgently installed to reinforce the structure as shown in Figure 3. In June 2014, the beam was replaced by a modular truss.

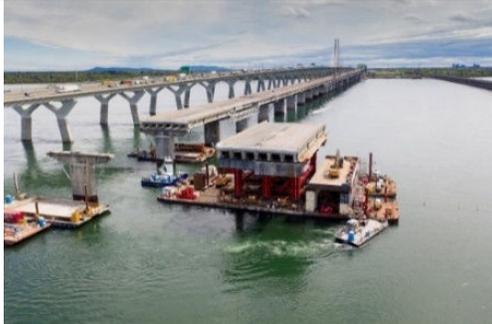
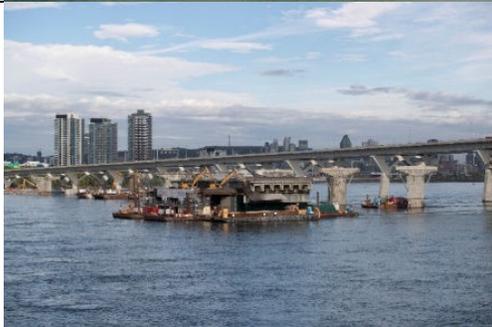
Figure 7. Description of the jacking of the span method of deconstruction

This process allowed for better control of the demolition since it was carried out from a lower height than if it was still sitting on the piers. This method was made possible using a special catamaran barge specifically designed for the project. The piers were then mechanically demolished using excavators installed on barges. The method is shown on Figure 7.

<p>1. Jacking and transportation of the span</p>

<p>2. Demolition of the span on the barge-catamaran</p>

<p>3. Demolition of the piers on barges</p>

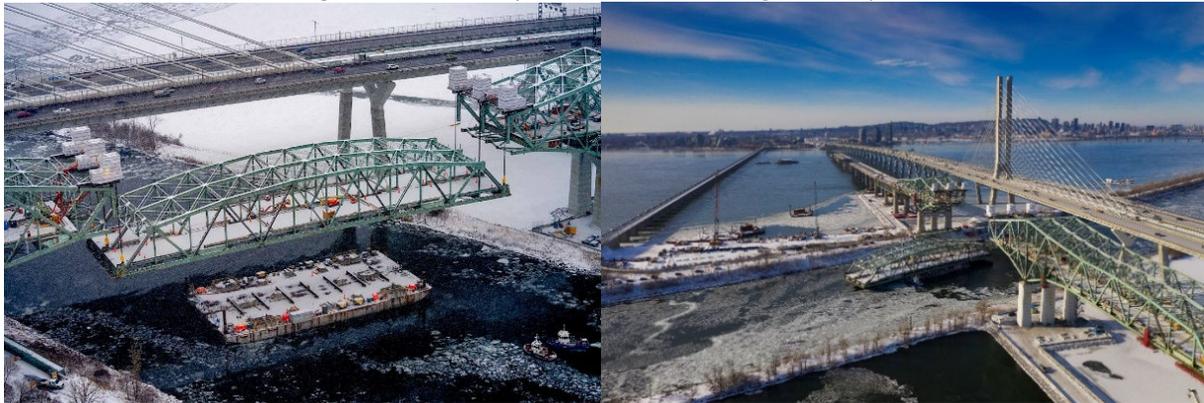
Figure 20. On-site photo of the lowering of the span

The lowering of the suspended span and its deconstruction on the barge were successful with the implementation of the proposed measures and strengthening approach. The on-site result of the deconstruction method is shown in Figure 20.

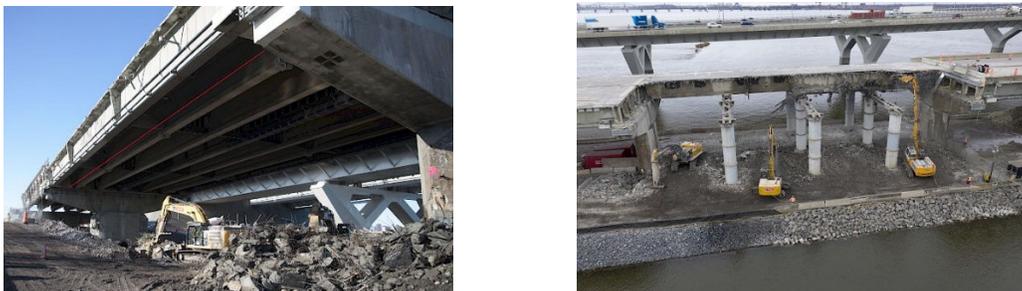
Figure 27. Pictures of the traditional mechanical demolition of the spans and piers

The method used for the deconstruction of the spans and piers on the portion of the Section 5 of the bridge located on the jetty was the traditional mechanical demolition. This method was selected since there was no specific restriction at this location. Figure 27 illustrates the traditional mechanical demolition of the span and piers at the deconstruction site.

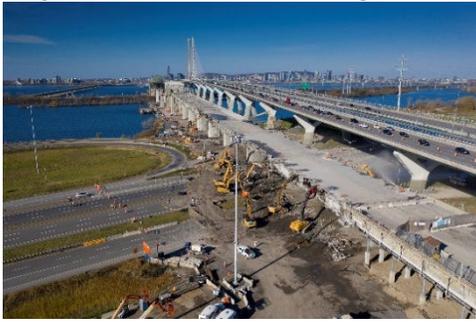
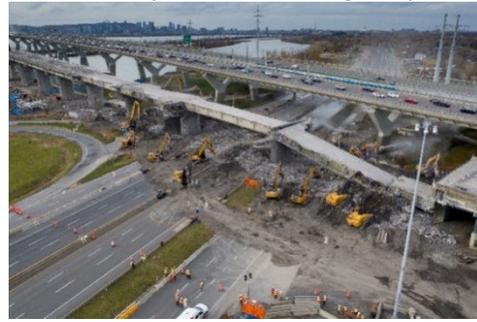
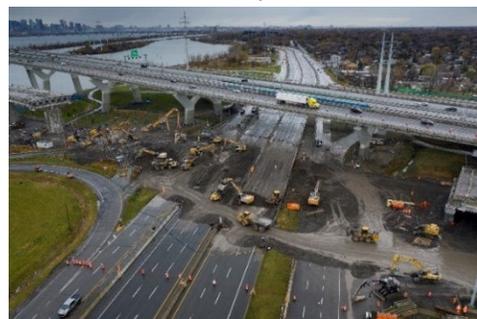
Figure 29. Pictures of the stages for the deconstruction of the spans over the highway 132

One major challenge was the fact that highway R132 is a major road with strategic importance for the Montreal region. Any road closure or interruption on highway 132 had to be minimized. This created a time constraint for both the deconstruction of the spans above highway 132 and the reopening of the highway 132 afterwards. In order to minimize the time between the deconstruction and the reopening of the road, it was decided to protect highway R132 and the public utilities before starting any controlled drop of the girders. The protection system's role was to reduce the impact of the falling girders on the highway. This protection system was composed of uncompacted backfill which helped preserve the road and utilities. As a result, the road could be reopened after only cleaning up the debris. Figure 29 shows the whole process of the method used for the spans over highway R132.

Mechanical demolition of girders P1

Controlled drop of P3 to P5

Cleaning up the debris from the deconstruction

Cleaning up the highway for the reopening
