NBDTI Implementation of a Culvert Rehabilitation Program to Address a Deteriorating Inventory

Paper prepared for the session ST – Transportation Structures
2024 Transportation Association of Canada (TAC) Conference & Exhibition
Vancouver, British Columbia

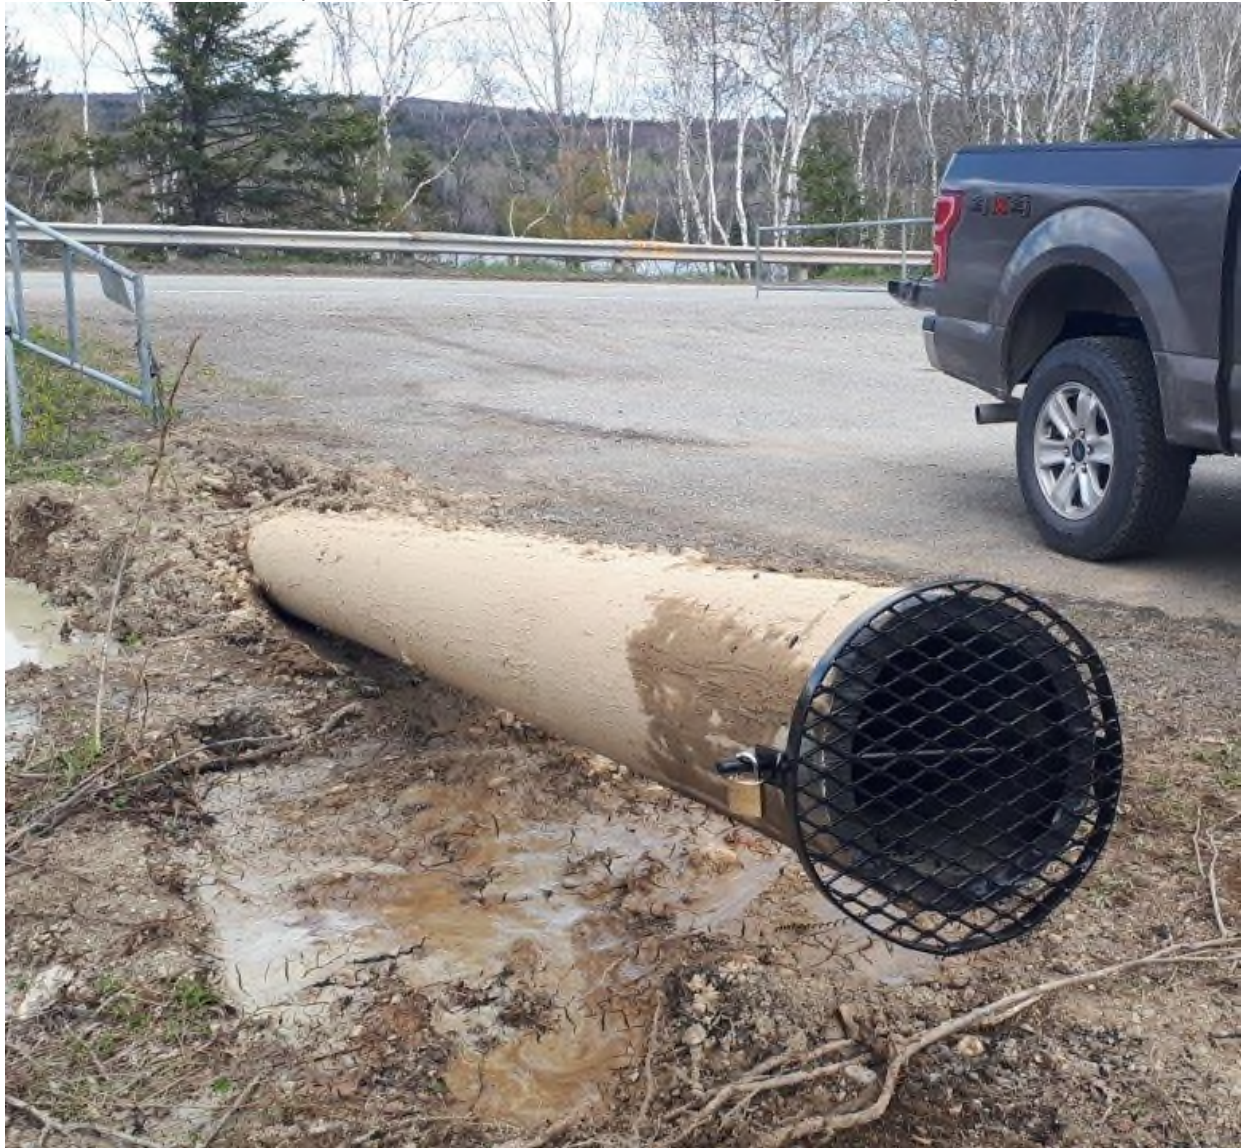
Figure 2. YT16 – Pipe Casing Installed by Directional Drilling for Temporary Water Diversion

Directional drilling, shown in Figure 2, was used at two sites to provide a conduit for water diversion. At the first site, YT16, the Department engaged a drilling contractor to conduct the work and install the conduit prior to tendering the rehabilitation project. The lowest bid submittal for the Temporary Water Control (TWC) item was 37% lower than the design engineer's estimate.

Directional drilling during the design phase and prior to issuing a tender for rehabilitation work leads to a more flexible schedule for the drilling contractor and less uncertainty for bidders on how they will address TWC. In contrast, when TWC installation is left to the general contractor, and directional drilling is the only feasible option, the work is often requested with a quick turnaround and during construction season.

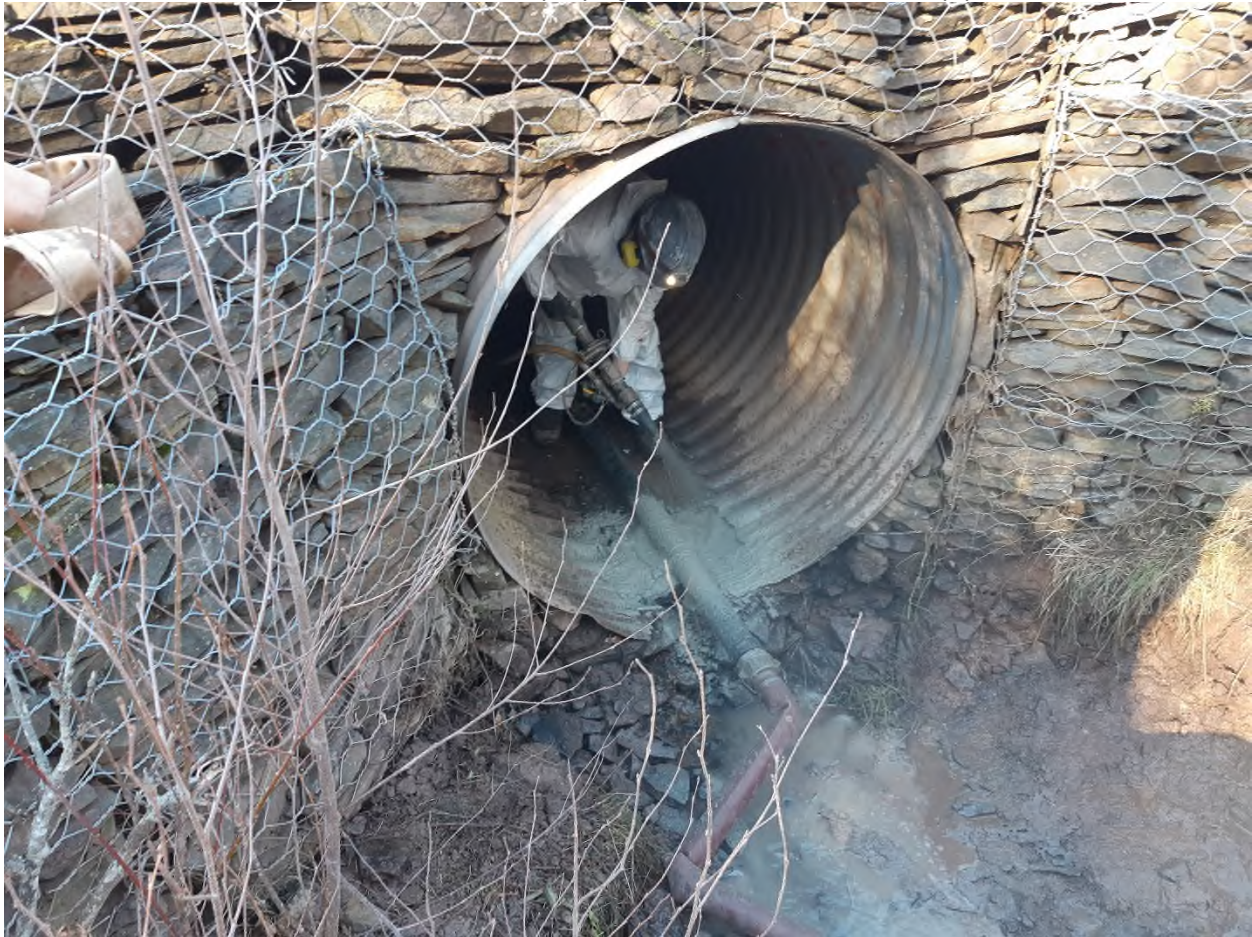
Figure 3. QC17 - Hand spraying over ABS water diversion pipe

With geopolymer application using an automated spin caster, it has been necessary to divert the watercourse flow outside of the host culvert and around the site. One exception to this was on site QC17 where the flow was directed through a 4" ABS pipe placed along the invert of the host pipe and eventually covered with geopolymer, plugged and left in place after project completion. Although this is possible for particularly low flow diversions, it is not preferred due to the protrusion in the invert that remains upon completion. This method is shown in Figures 3 and 4 below:

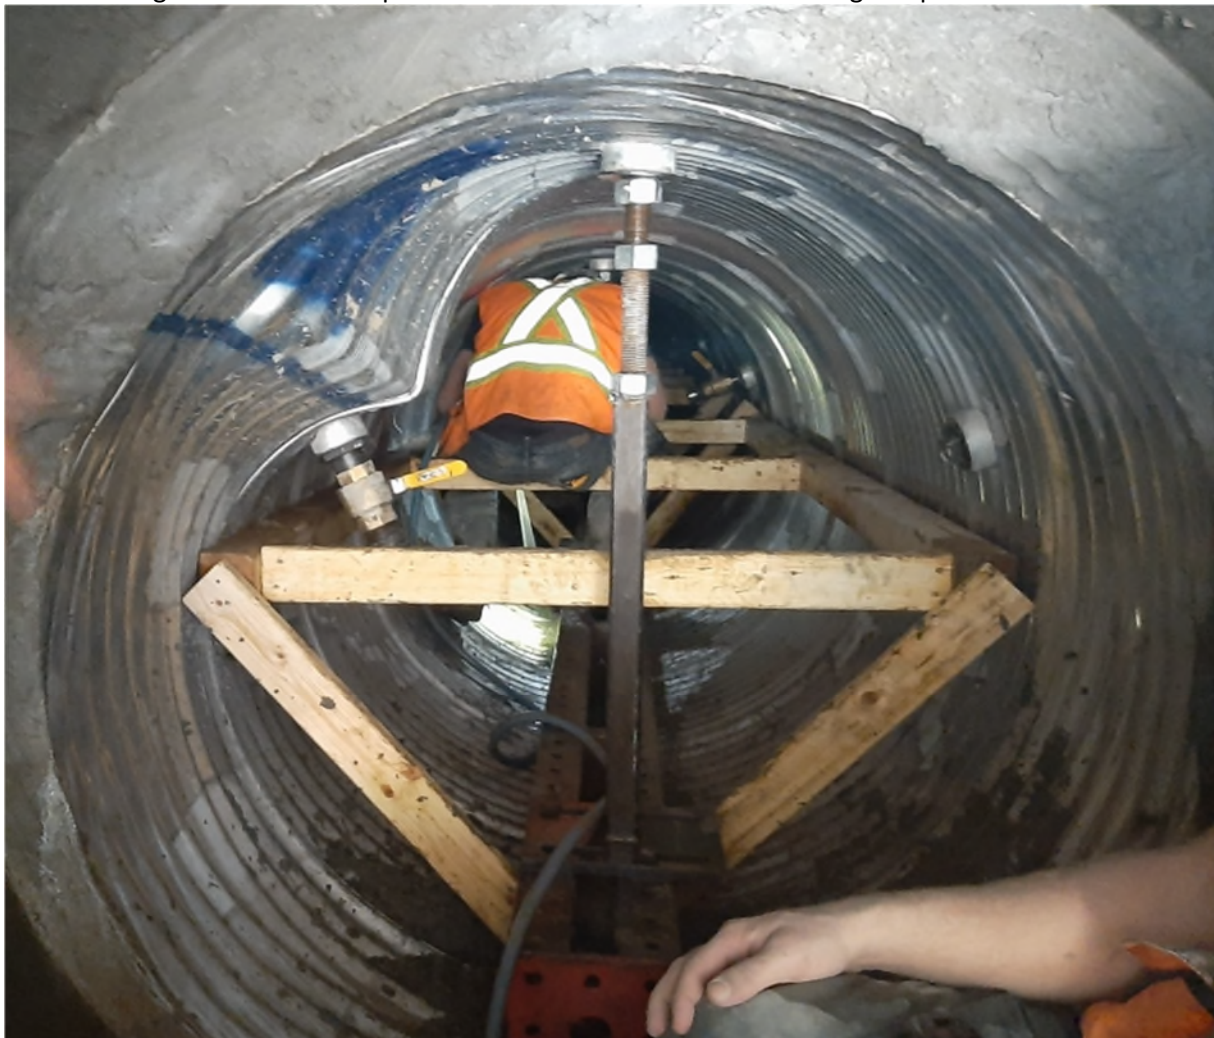
Figure 5. YT16 - Collapse of CAP Section due to Over Grouting – September 2021

On a typical slip lining project, CLSM is placed within the annular space between the host and liner pipes. Culverts on steeper slopes are especially susceptible to over grouting. The material flows relatively quickly on higher slopes, with the outlet end receiving higher than expected lift heights.

One instance of over grouting was experienced in 2021 at site YT16, a 90m long, 1.5m diameter SPCSP with a slope of 11% that was being slip lined with a 1.25m diameter Corrugated Aluminum Pipe (CAP). This resulted in one of the sections of CAP collapsing under the pressure. added approximately 10 days to the project duration and was a costly repair for the contractor.

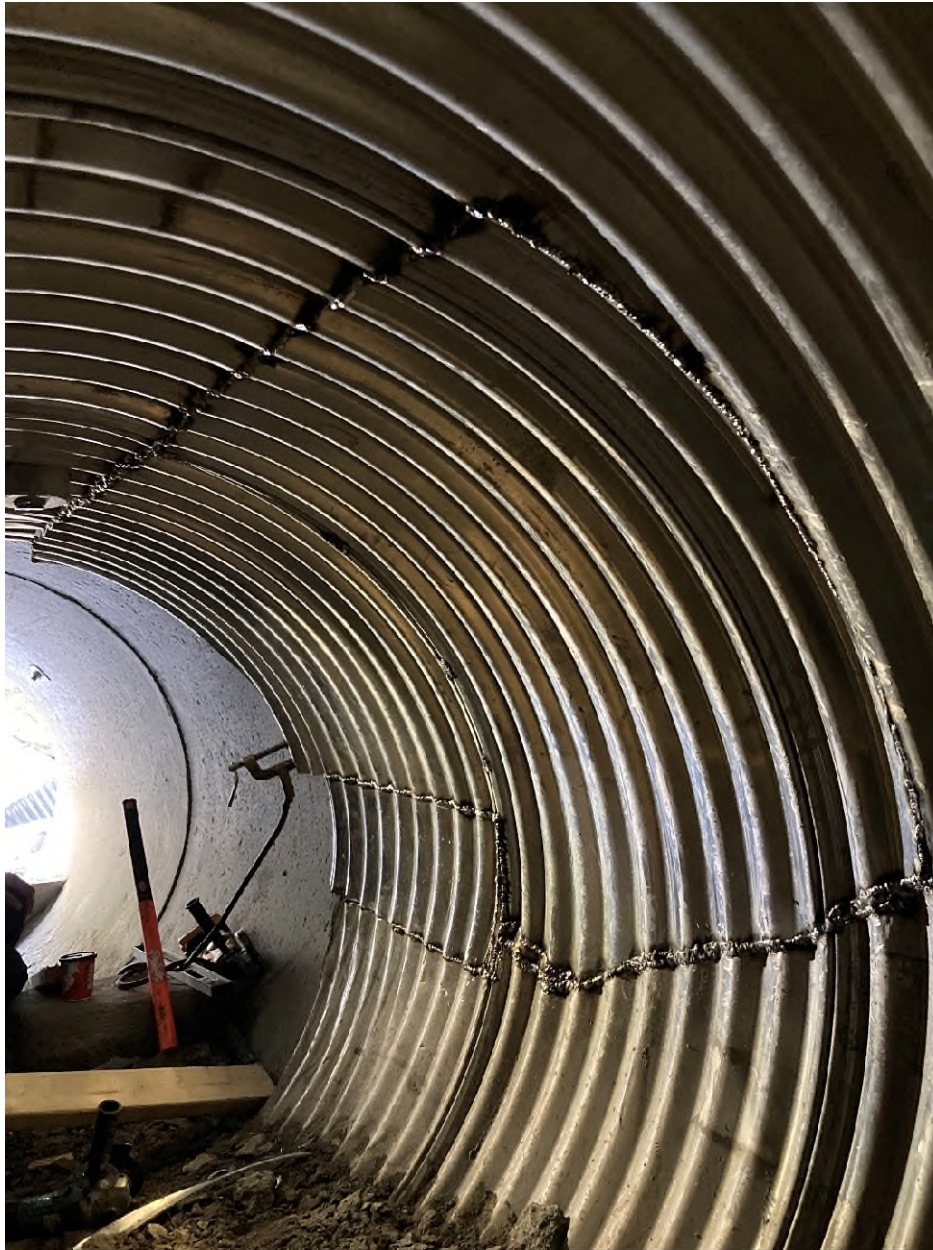
Figure 6 – YT16 - Repaired CAP - October 2021

The collapsed portion of the CAP needed to be cut with a mini grinder and removed. The cured CLSM was then hammered out before a new section of pipe was welded back to the remaining intact sections.
