Pattullo Bridge Replacement: Rehabilitation of Royal Avenue Underpass

Greg Bajus
Senior Structural Engineer
Hatch
Greg.Bajus@hatch.com

Paper prepared for the session **ST – Transportation Structures**
2025 Transportation Association of Canada (TAC) Conference & Exhibition
Québec City, Québec

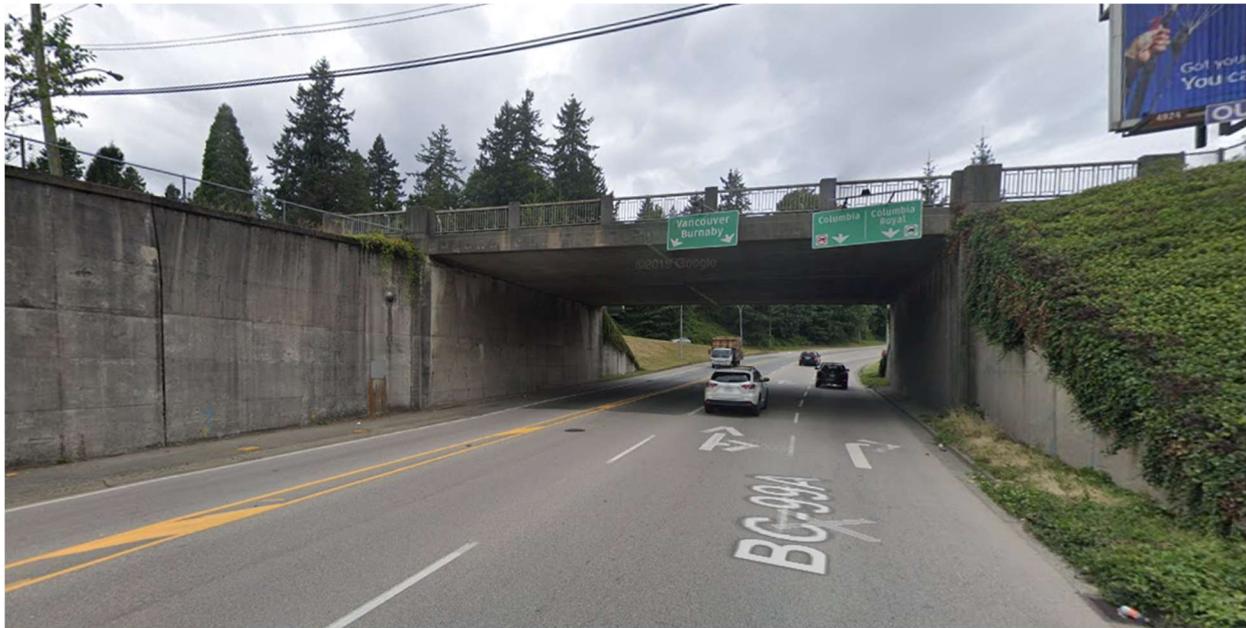
Figure 2. Pre-Construction Google Maps Streetview of Structure (2019) – Looking North

The single span structure consisted of 6-7m tall cast in place concrete cantilever retaining wall abutments supporting a voided post-tensioned concrete slab deck simply supported at the top of both abutment walls. Independent cast in place concrete wingwalls parallel to the abutment walls and Bridge Connector retained the embankment fill at all four corners of the structure.

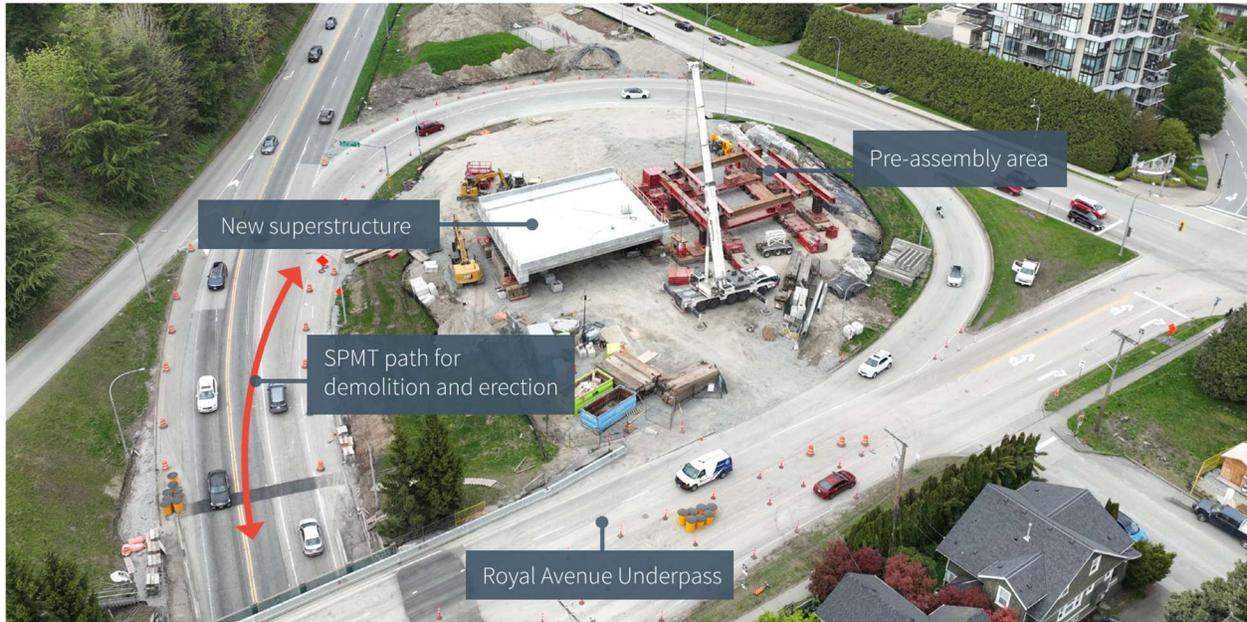
Figure 9. Staging Area and SPMT Path

The staging area for all of this work was located inside the northbound Bridge Connector exit ramp to westbound Royal Avenue, just north of the underpass as shown in Figure 9 below. This is where assembly of the replacement superstructure was completed in parallel with the abutment wall rehabilitation and strengthening works, and later where the SPMT equipment was configured for the superstructure replacement.

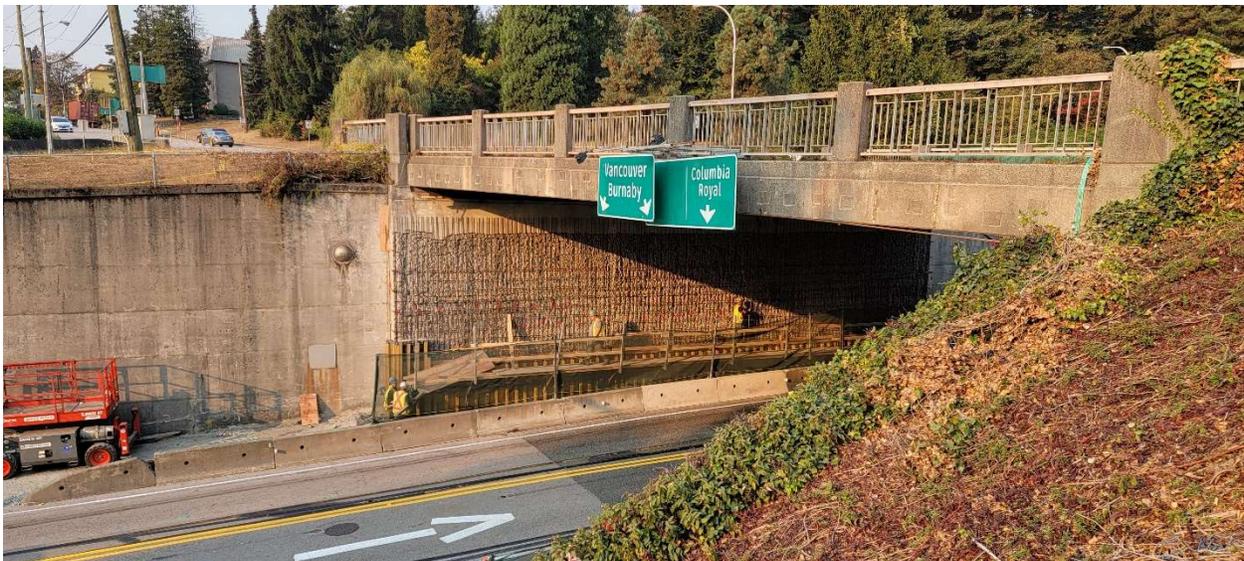
Figure 12. Substructure Rehabilitation & Strengthening

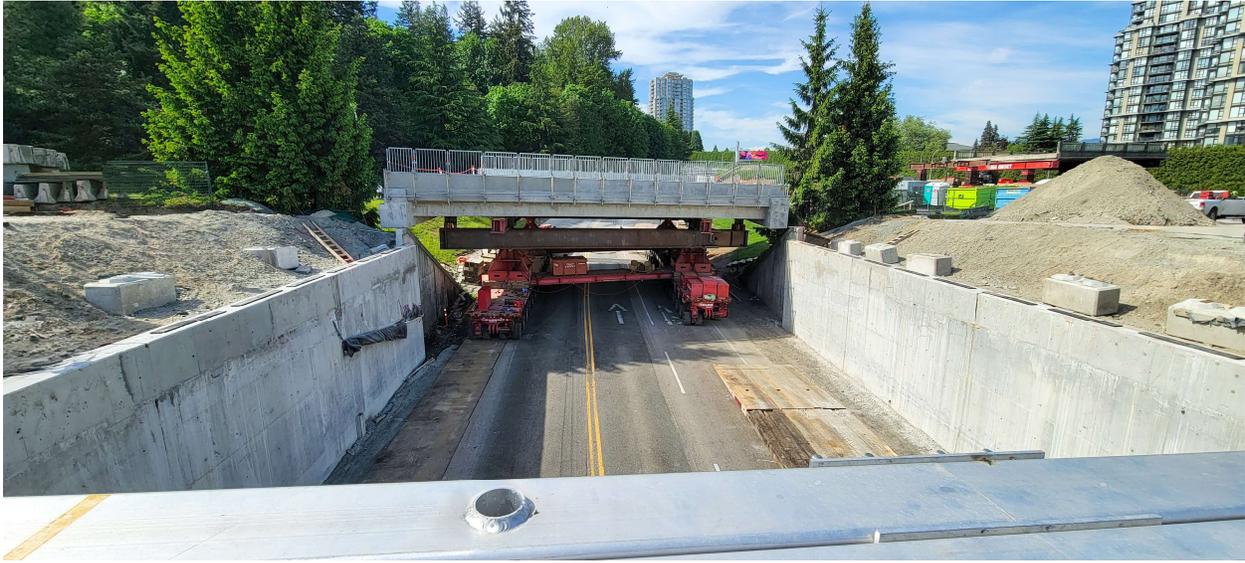
Figure 15. Installation of New Superstructure

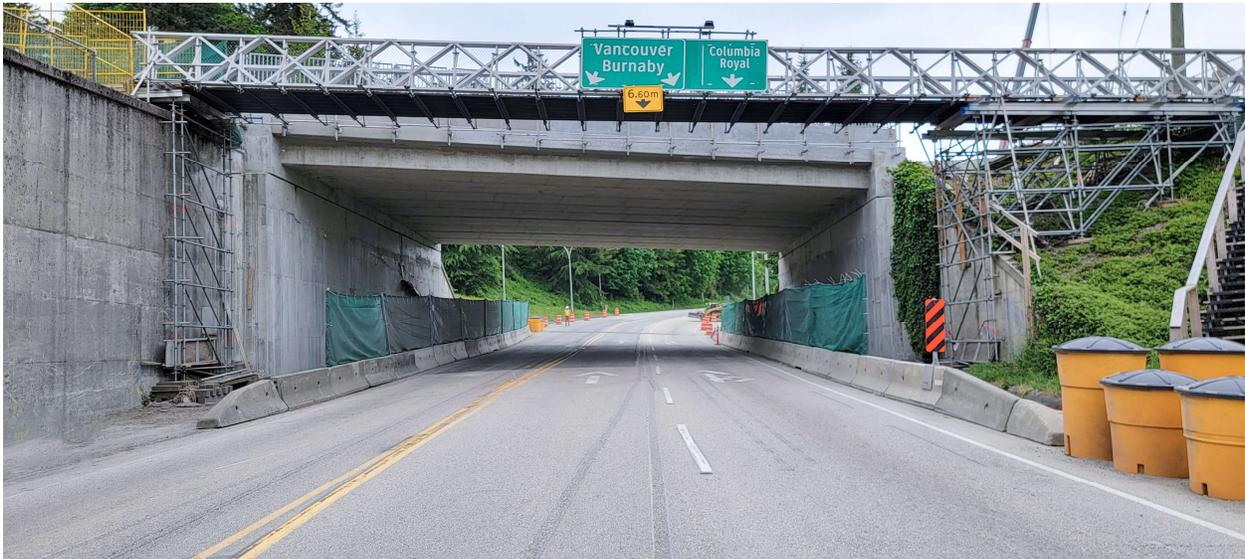
Figure 16. New Superstructure Installed
