**Lester B. Pearson Airport
Greater Toronto Airports Authority**

**Old Terminal 1
Decommissioning and Demolition**

Kevin Seow, MBA, P.Eng., Hatch Mott MacDonald

**Paper prepared for presentation
at the "Innovations in Bridge Engineering (A)" Section
of the 2005 Annual Conference of the
Transportation Association of Canada
Calgary, Alberta**

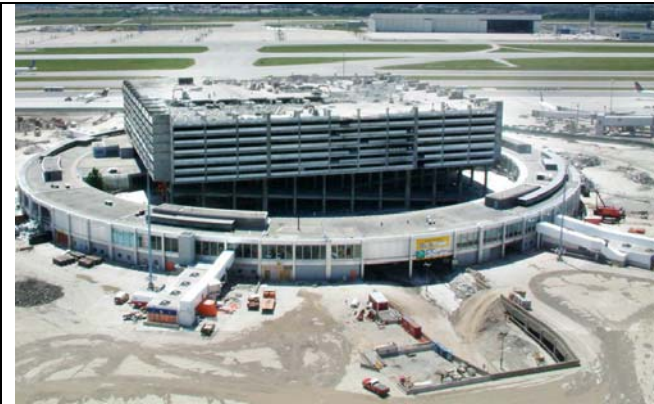
Figure 1: Old Terminal One – Demolition on Level 9 (June 25, 04)

Demolition of the Old Terminal 1 structure ⁽⁴⁾ was considered Canada's largest demolition contract prior to 2004. Due to the project's immense size and complexity, the project's priority was focused on safety. Safety perimeter fence, demolition sequence, utilities and services decommissioning, water supply, and fire watch were the main safety considerations items stipulated in the Demolition Plan.

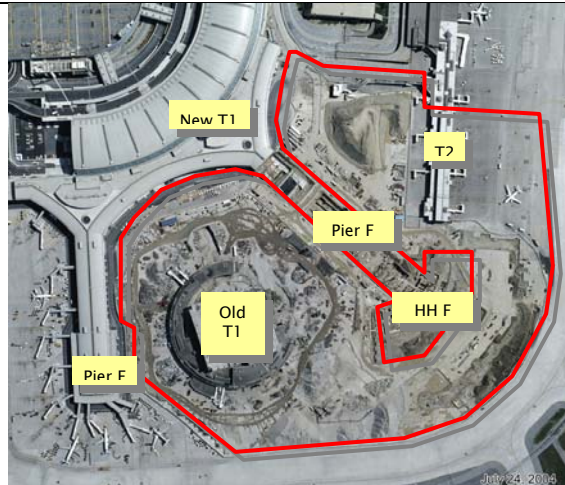
Figure 2: Old Terminal One located in the new apron development between the new Pier E and the constructed Pier F.

The Old Terminal 1⁽⁵⁾ was located in the middle of the new apron development between the new Pier E on the west, the currently constructed Pier F on the east and an operational airport taxiway at the south. "Airport in Use" constraints was a specified criteria required by the GTAA, which the demolition contractor had to abide too.

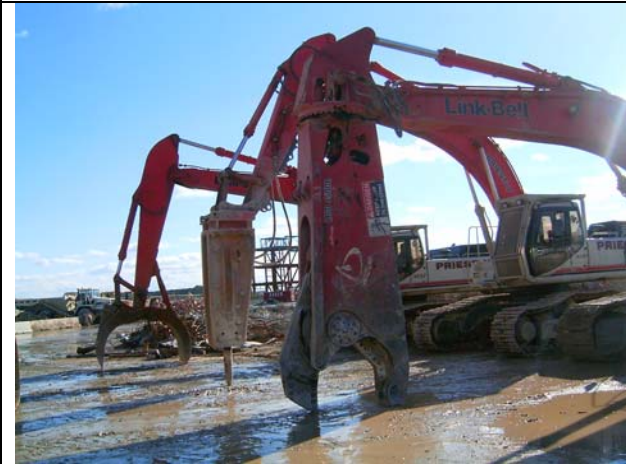
Figure 3: Demolition Equipment – Shear (right), Pneumatic Hammer and Grapple (left)

Conventional demolition is the use of pneumatic impacts, shears, grapples, torches and other equipment and methods to destroy and demolish the structure. The equipment used on old Terminal 1 during conventional demolition involved a variety and quantity of Skid Steer Loaders i.e. Bobcat 763 and Cat 246; excavators - Linkbelt 135, Komatsu PC400, Komatsu PC850C; bulldozers – Dresser TD-7; Rock trucks – Volvo A25C and cranes. These equipments had a variety of attachments, such as buckets, shears and crushers, clam and grapples and impact point and sheep's foot pneumatic hammers⁽⁶⁾.

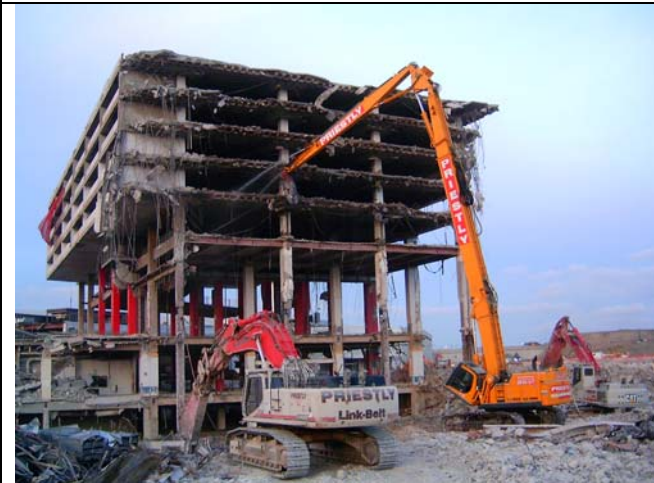
Figure 5: Demolition Equipment – Shear (left), Pneumatic Hammer and Grapple (right)

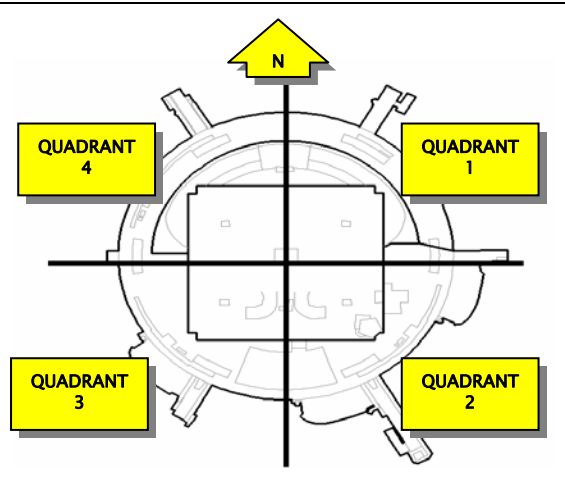
Figure 6: Demolition Quadrants

The demolition of the ring structure was removed effortlessly using standard conventional means. The demolition commenced from Quadrant 1 and continued in a clockwise rotation towards Quadrant 4 (¹⁰).

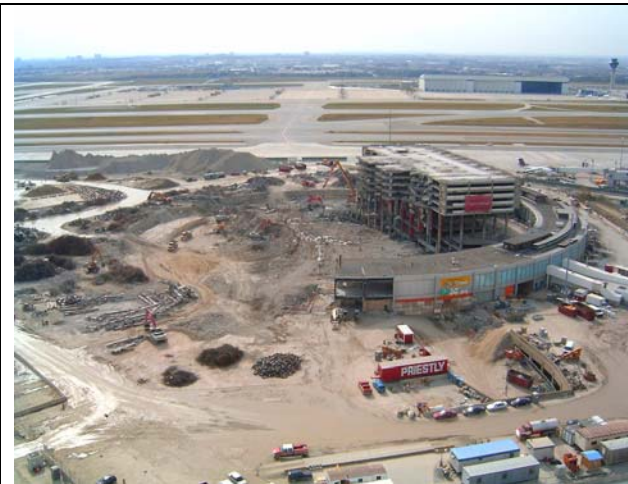
Figure 7: Demolition Site – Stockpiled Salvaged Material around Old T1

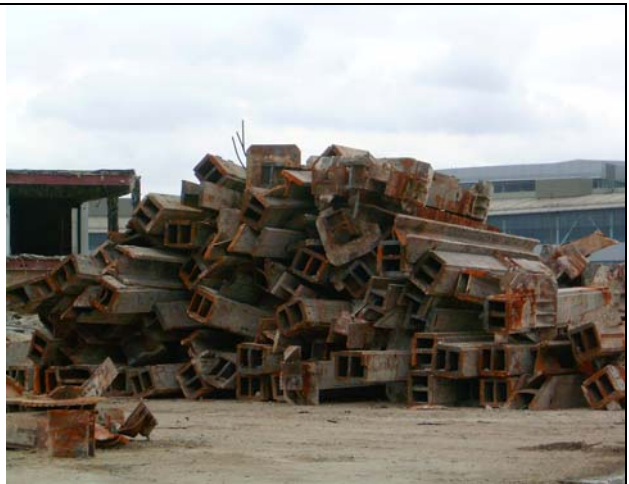
Figure 8: Plate and Structural (P+S) Scrap Steel

Plate and Structural (P&S) are considered ¼" thickness and/or greater Heavy Grade steel. The scrap steel (¹⁴) is commonly processed from the larger length columns, girders and beams to sizes 4 feet and under. Speciality sizes are considered 2 foot and 1 foot under. The sale of the processed sizes depends mainly on the demand and is determined by which Mill and the size of furnaces it operates. The larger scrap steel is usually torched into manageable short lengths for processing.

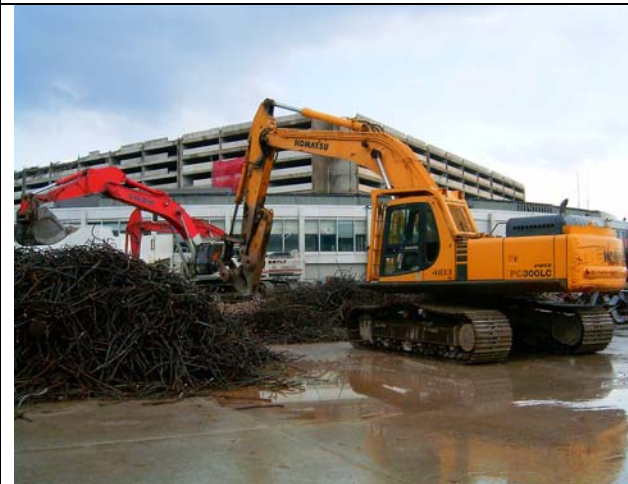
Figure 9: Rebar Scrap being processed

Heavy melt scrap is considered to be rebar. Rebar (¹⁵) are processed into short 1-foot to 2-foot lengths for ease of shipment. A higher scrap material price can be received when processing the rebar to these lengths. Cast Iron scraps are usually underground pipes, valves, manhole covers, culverts and other larger miscellaneous steel sections.

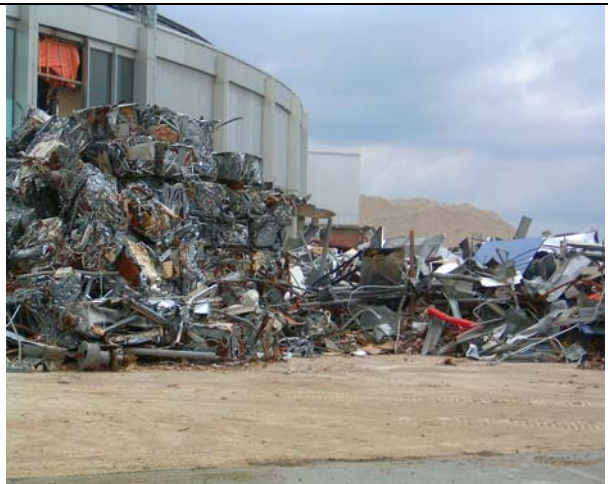
Figure 10: Bale Steel

Bale Steel (¹⁶) is any material capable of being compressed, such as clean light gauge metal sheets, ducting, siding, lightweight steel or soft metals. These materials are sorted and compressed into bales weighing approximately 700 to 900 lbs each. These bales can be efficiently stacked and shipped onto trailers for processing to scrap vendors and brokers.

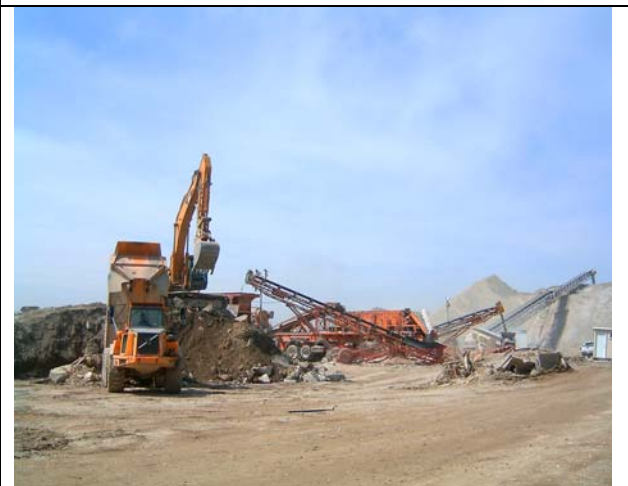
Figure 11: Concrete Crushing Plant and Processed Concrete Backfill

The concrete crushing plant (¹¹) is an Eagle Model 1400 measuring approximately 15 metres in length, 4.5 metres in width and 6 metres in height. It is located at the south end of Hammerhead F (HHF). The concrete debris is feed from the top into the feeder using an excavator. The impactor consists of a drum with 3 blow bars rotating at 1800 rpm crushing the debris to the specifications used for granular subbase (¹²). The crushed material drops onto the first conveyor belt where magnets pickup unwanted stray rebar and metal debris. It is then dropped through a 1.5 metre by 2 metre screen onto a second conveyor belt with the recommended 2" minus spacing. Material that passes the screen (less than 2") is directed towards the finished engineered backfill stockpile otherwise it is redirected to a third return conveyor and feed back for reprocessing. The whole process repeats.

The production of crushed material is dependant on the type and size of material the plant crushes and processes. The crushing plant processes and produces an average of 1800 to 2000 tonnes of engineered 2" minus backfill material.
