Civil & Mineral Engineering
UNIVERSITY OF TORONTO

De-icing Operations for Permeable Interlocking Concrete Pavements

Prepared for: Interlocking Concrete Pavement Institute Foundation for Education and Research

Jennifer Drake Ph.D. P.Eng.
Jeff Marvin M.A.Sc., P.Eng
Jody Scott Ph.D. Student
4-1-2020

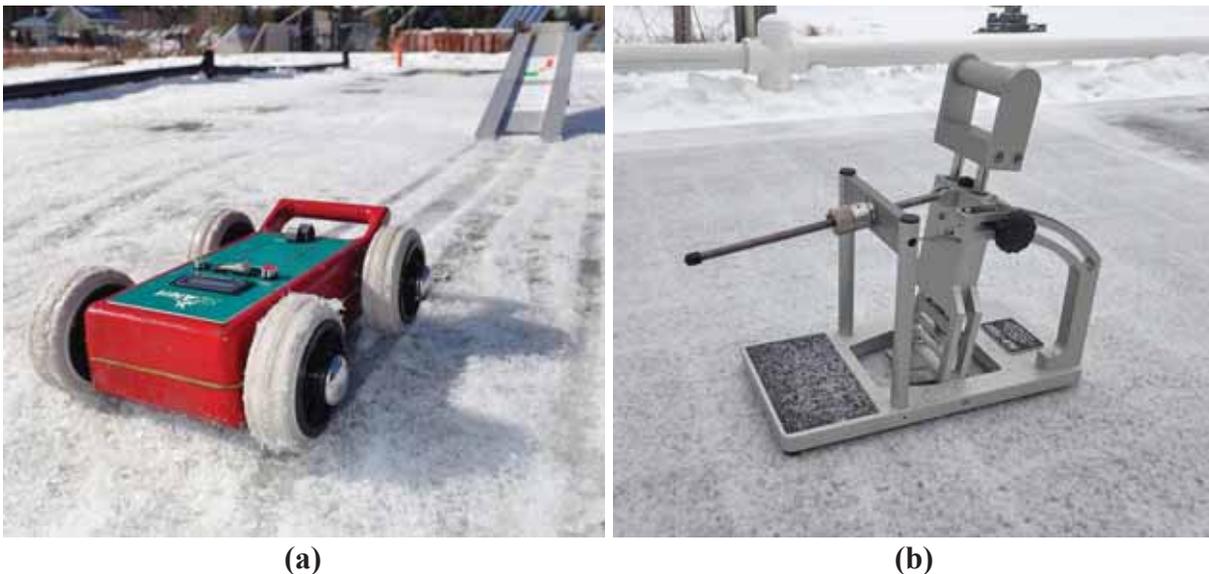
Figure 3-1: Friction measuring devices in use on ice-covered PICP surfaces: (a) SlipAlert and (b) Mark IIIB.

With practice, field crews were able to predict based on site conditions (i.e. icy, snowy, wet, dry) an appropriate initial foot angle for the Mark IIIB that was slightly steeper than when a slip would occur. The foot angle would be adjusted down by one unit until a slip occurred. If the initial angle selected was too shallow and the foot slipped on the first trial the device would be moved to a different location and repeated in the same general area on the pavement.

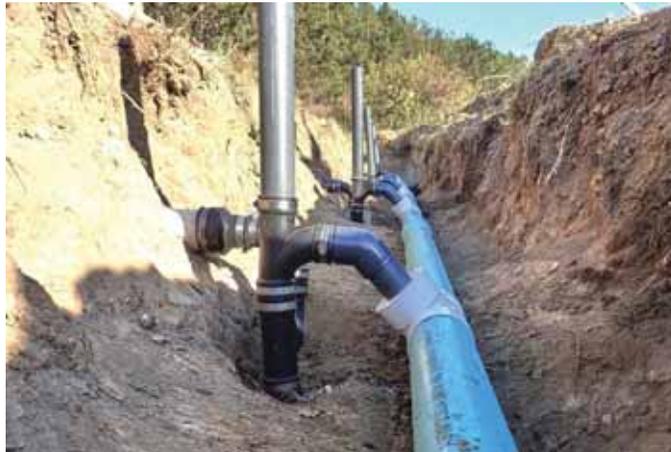
Figure 3-2: Installation of traps for housing conductivity sensors.

Conductivity was continuously monitored in the outflow from the four PICP underdrains (installed at the bottom of each cell) and from the outlet pipe of the catch basin on the asphalt cell using CT2X sensors. Two-point calibration was performed on each sensor using conductivity solutions of 1,413 and 12,880 $\mu\text{S}/\text{cm}$. The sensors were installed within U-shaped rubber pipe traps connected to the PICP underdrains and catch basin outlet pipe. Rubber traps with clamp connections were used such that the traps could withstand soil expansions and contractions throughout the winter period without leaking, and monitoring wells were connected to the traps such that the sensors could be installed and accessed. The traps were bedded in a 400 mm deep layer of ASTM No. 8 washed aggregates to minimize movement of the traps, and the bedding layer was covered with 2 inches of foam insulation to minimize frost penetration. The native soil was backfilled above the insulation. Trap installation was completed on 31/Oct/2019. A photo of the traps during installation before being covered and backfilled is provided in Figure 3-2.

Within the traps, the conductivity sensors were submerged within a permanent pool of water that was approximately 300 mm (12 in) deep and stored approximately 1.2 L of water, and conductivity was measured approximately 110 mm (4.3 in) from the bottom. Measurements were collected every five minutes throughout the 2018/2019 winter beginning on November 8, 2018. While flows were not monitored, the sensors also measured water depth and temperature. Changes in these data were used to identify the presence of flows. Water depth varied throughout the monitoring period as a result of periodic water sampling but was always kept at above 200 mm (8 in) to maintain submergence of the sensors.

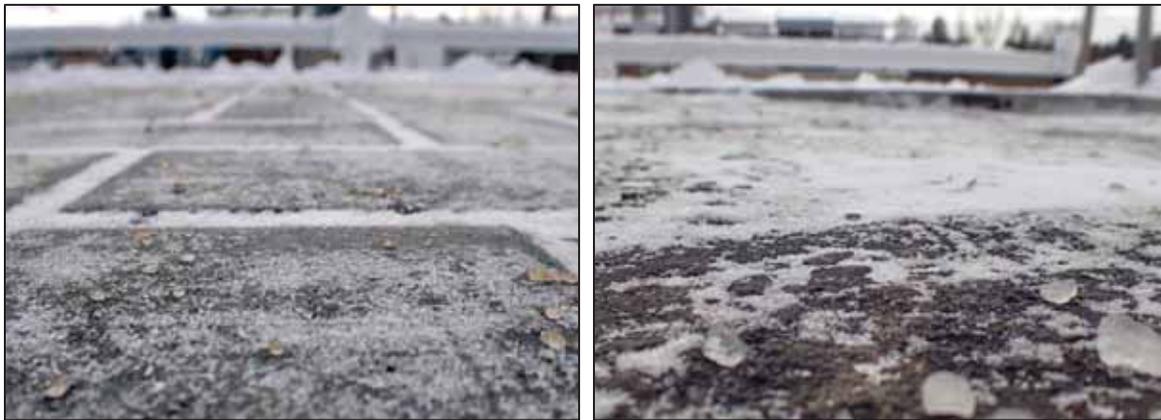
Figure 4-3: Comparison of pavement textures between PICP (left) and asphalt (right).

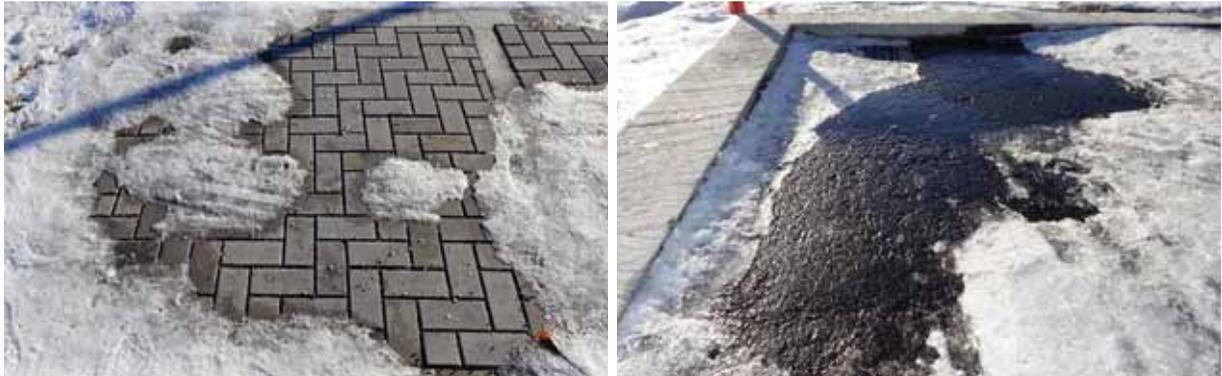
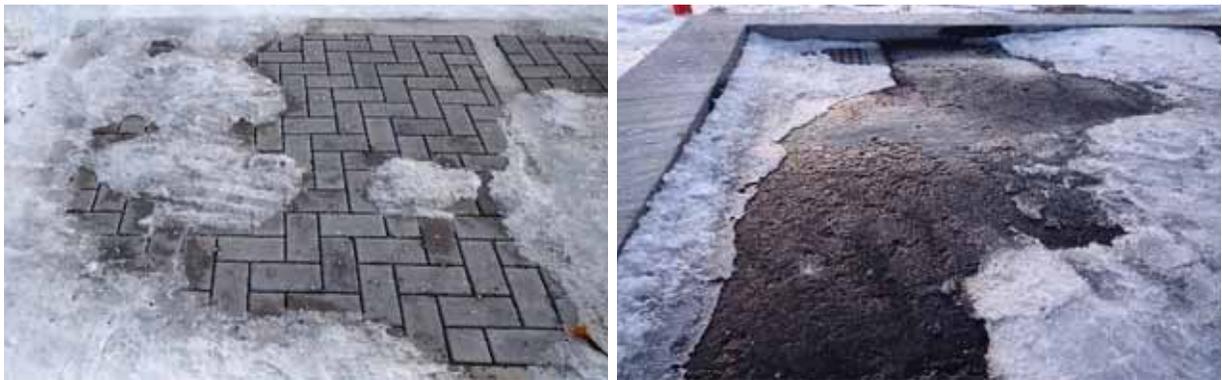
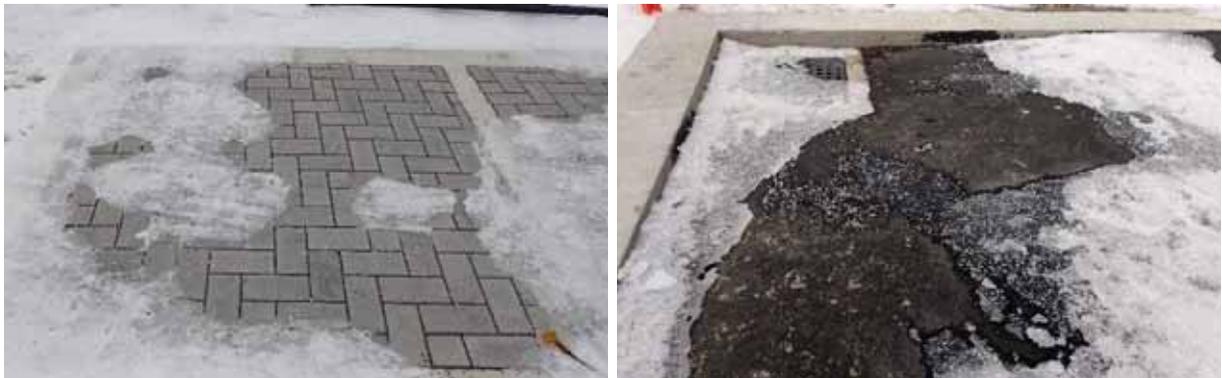
Figure 4-6: Surface conditions after ice cover melting on 16/Feb/2019.

(a) before sunset when PICP surfaces were slightly damp at locations where ice had just melted while the meltwater path along the asphalt surface remained wet, (b) after sunset when damp areas on the PICP surfaces were reduced while meltwater had refrozen on the asphalt surface, (c) the next morning when all previously damp area on PICP surfaces were dry while refrozen meltwater remained on the asphalt surface at locations where the ice was thickest.

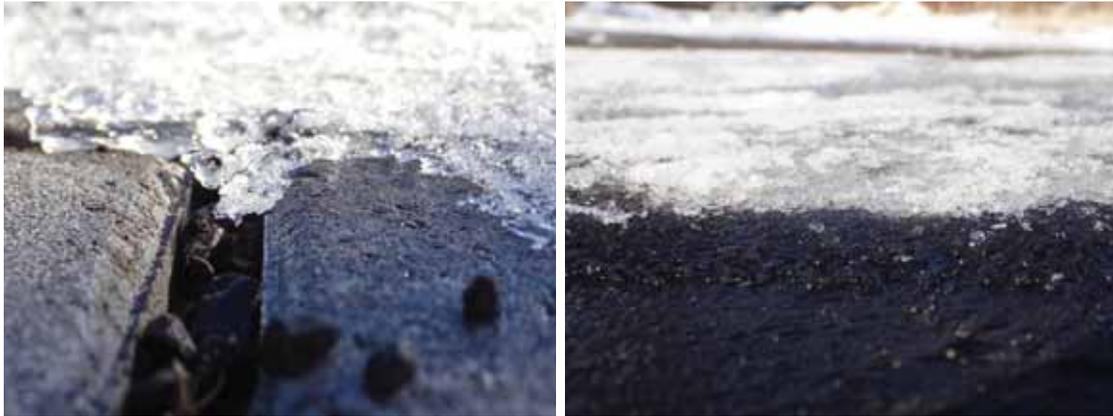
Figure 4-7: Ice cover characteristics on 16/Feb/2019: partially detached ice cover on PICP (left) and ice transition into wet pavement on asphalt (right)

During the two ice cover experiments, surface ice appeared to adhere to the asphalt surface more than the PICP surfaces. As shown in Figure 4-7 and Figure 4-8, gaps between ice and PICP surfaces are present at the perimeter of ice patches. In contrast, the ice spatially transitioned into a liquid state on the asphalt surface without losing contact. Similar observations occurred on 15/Apr/2018 after the sleet and freezing rain event, where ice pellets were notably easier to shovel down to a thin layer on the PICP cells compared to the asphalt cell.

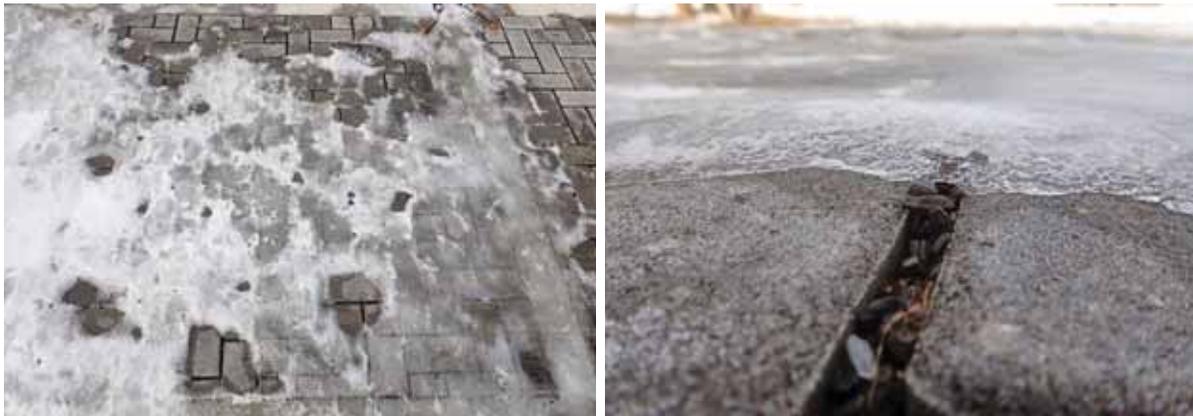
Figure 4-8: Refreeze of partially melted compacted snow at sunset on 09/Mar/2019 following rapid melting during the afternoon.

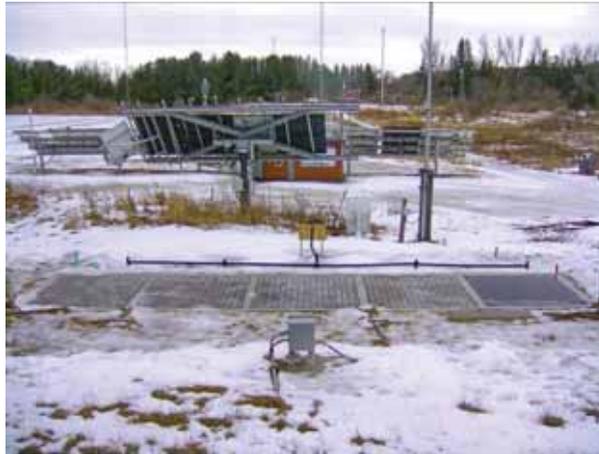
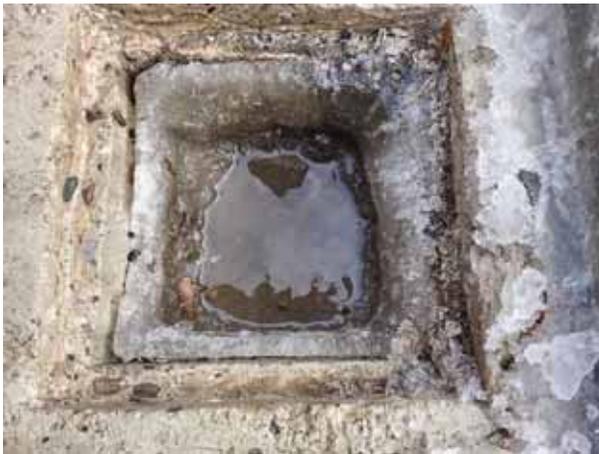
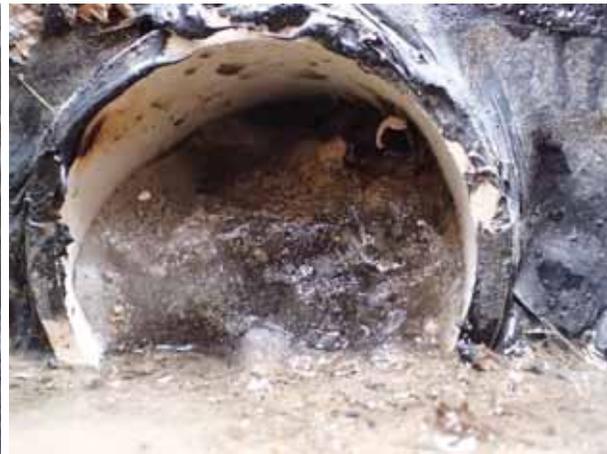
Figure 4-10: Flooding of asphalt cell on 24/Feb/2019 caused by frozen catch basin.

Flooding of the asphalt cell occurred during a rainfall event on 24/Feb/2019 as a result of ice accumulation in the catch basin and outlet pipe (Figure 4-10). The ice formed after three days of air temperatures fluctuating above and below 0 °C while snow on the surface was gradually melting. Manual ice removal was carried out on 25/Feb/2019 so that winter observations and experiments could continue. No surface flooding on the PICP cells occurred through the study.

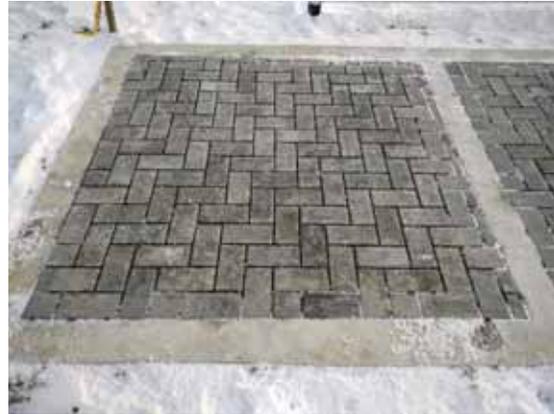
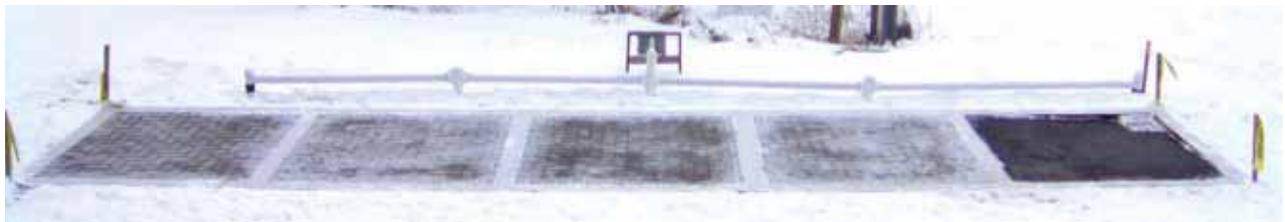
Figure 4-11: Impacts of leftover salt particles from 08/Feb/2018 de-icing treatment after the snow had melted and meltwater had drained and evaporated.

Undissolved salt particles remained on the five pavement cells after the shovelled snow experiments. Some of the salt particles entered the joint spaces where meltwater drains vertically around the aggregates instead of radially over the pavers inhibiting the overall salt dissolution on the PICP surfaces. After meltwater had evaporated from the pavement surfaces, a portion of the dissolved salt remained as a precipitate. This salt created anti-icing conditions for subsequent snowfall events when there was no rainfall to flush it away (Figure 4-11). Precipitated salt particles

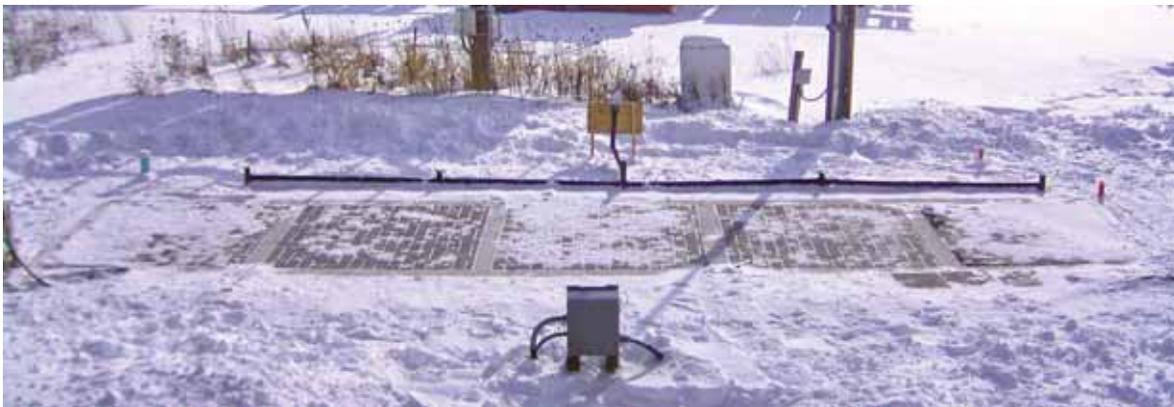
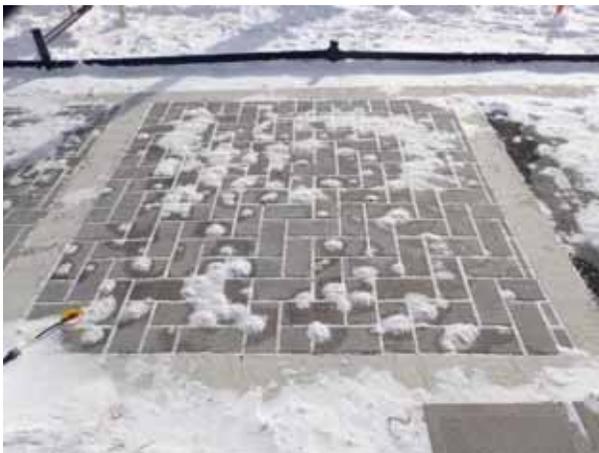
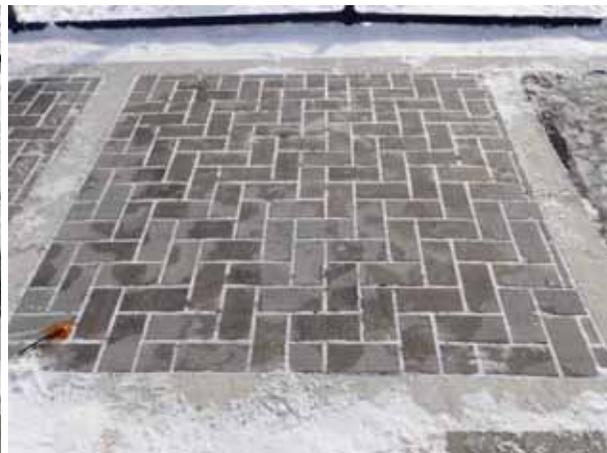
Figure 4-12: Impacts of blowing snow on 31/Jan/2019 after salt particles remained on pavement surfaces.

(a) comparison of blown snow quantities based on spatial coverage of salt particles and pavement topography, (b) blown snow on PICP, (c) ice patches on PICP where blown snow was shovelled.

Both the undissolved and the precipitated salt particles created isolated patches of ice during temperatures below $-15\text{ }^{\circ}\text{C}$ where blowing snow would adhere to the salt, partially melt, and refreeze (Figure 4-12). On 31/Jan/2019, almost the entire asphalt cell was covered in ice due to its more widespread coverage of precipitated salt particles that had been applied the previous day. In contrast, ice on the PICP cells was limited to the locations where there were leftover salt particles. Cells that received medium de-icer application rates were covered 90% in ice, while cells that received a low de-icer application rate were covered 50% by ice. Friction measurements collected after shovelling the blown snow to a thin layer reflect slippery conditions created by the higher ice coverage (Figure 4-13). Despite surface temperatures on these days being below the operational range for road salt, no reduction in ice or increase in friction occurred on the cells that received road salt pre-wetted with beet juice, as most of the beet juice coating drained off during the 30/Jan/2019 experiment. Observations during these blowing snow conditions exemplify the safety hazards of using road salt when temperatures are below its operational range.
