MacDonald Bridge Rehabilitation

TAC Environmental Achievement Award submission

THE CITY OF
CALGARY
ROADS

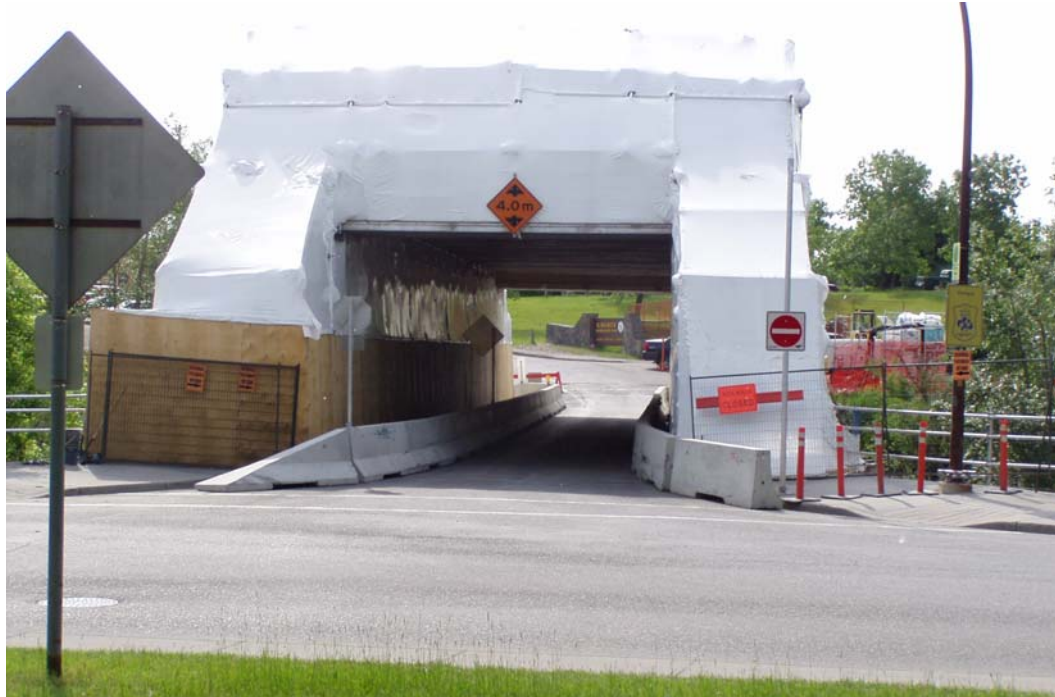
Photo 1: Transportation

A sidewalk remained open for pedestrian use, and a through lane was maintained for emergency and Transit vehicles.

For the duration of the project, which began in May and was completed in late July, the entire steel framework was 100% contained in shrink-wrap plastic, while permitting critical vehicle and pedestrian access to neighbouring communities. Vehicular traffic was mostly limited to essential transportation such as emergency vehicles and Calgary Transit service. For a visual explanation, see Photo 1.

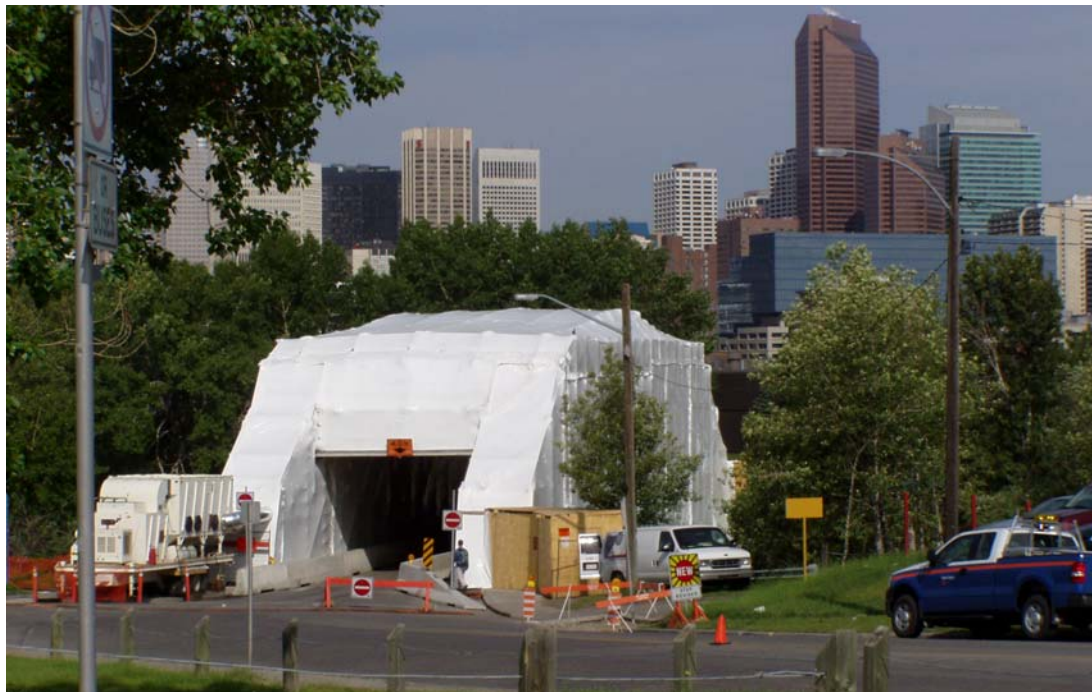
Photo 2: Containment

The shrink-wrap plastic and the vacuum truck created a negative pressure containment system.

A goal of 100% containment control was unusual and was a challenge to meet; 95% was the recommendation from the Society for Protective Coatings (SSPC). The containment was constructed not from the normal polyethylene (poly) plastic, but a shrink-wrap plastic wrapped around standard construction scaffolding. The airtight, 100% containment was constructed by putting up plastic sheets one at a time and heating them so they would adhere tightly around the aluminium scaffolding frame and the edges of neighbouring shrink-wrap sheets. For a visual explanation, see Photo 2.

A vacuum truck, which contained high-efficiency filters that collected airborne particulates to prevent them from entering the environment, was connected to the containment area, drawing all dust and particles out. The truck created negative pressure that would make it difficult for contaminants to leave the contained area if a breach occurred. In fact, because of the high volume of air being drawn out by the vacuum truck, fresh air vents had to be strategically cut into the containment to permit adequate air exchanges.

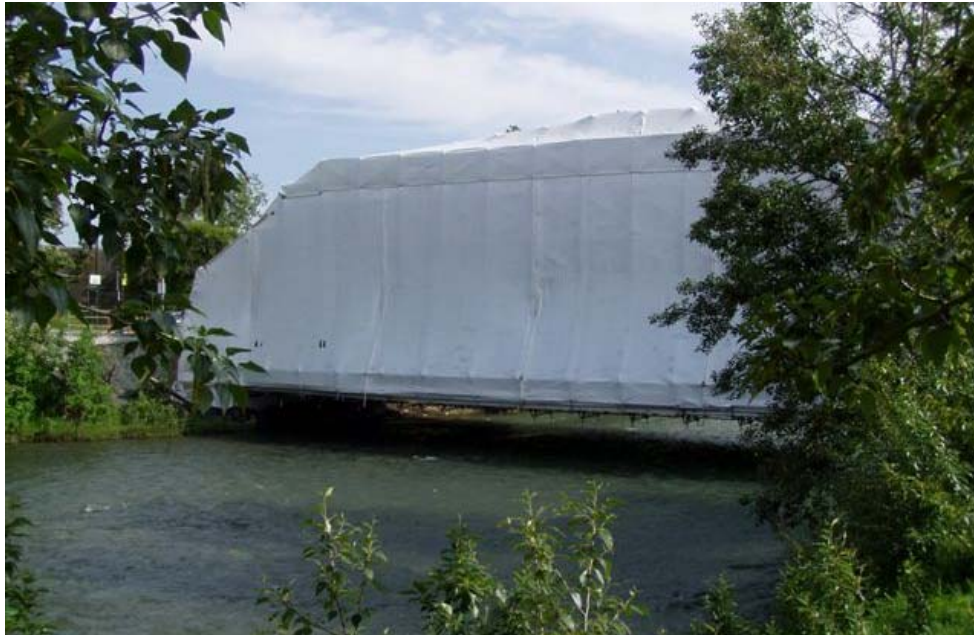
Photo 3: Elbow River

The access floor below the bridge deck was cleaned routinely as a precautionary measure to minimize potential impact to water quality if water levels rose and immersed the floor.

Calgary receives most of its rain during May and June. In June 2006, below the Glenmore Dam, the Elbow River water levels had risen to over 2m; the average water levels for the river were 0.58m in 2006. With the water at times only a few feet below the dance floor, extra environmental and safety precautions became part of the daily procedures. To prevent a dance floor washout, an open communication line was established upstream with the Glenmore Dam, which released water volumes periodically to prevent dam overflow. In the event of a water release from the dam, the contractor had to be prepared to evacuate the crew and open the containment to allow water to flow through.

To ensure the containment did not negatively affect water quality if this occurred, the dance floor was cleaned daily during this high-risk period. For a visual explanation, see Photo 3.

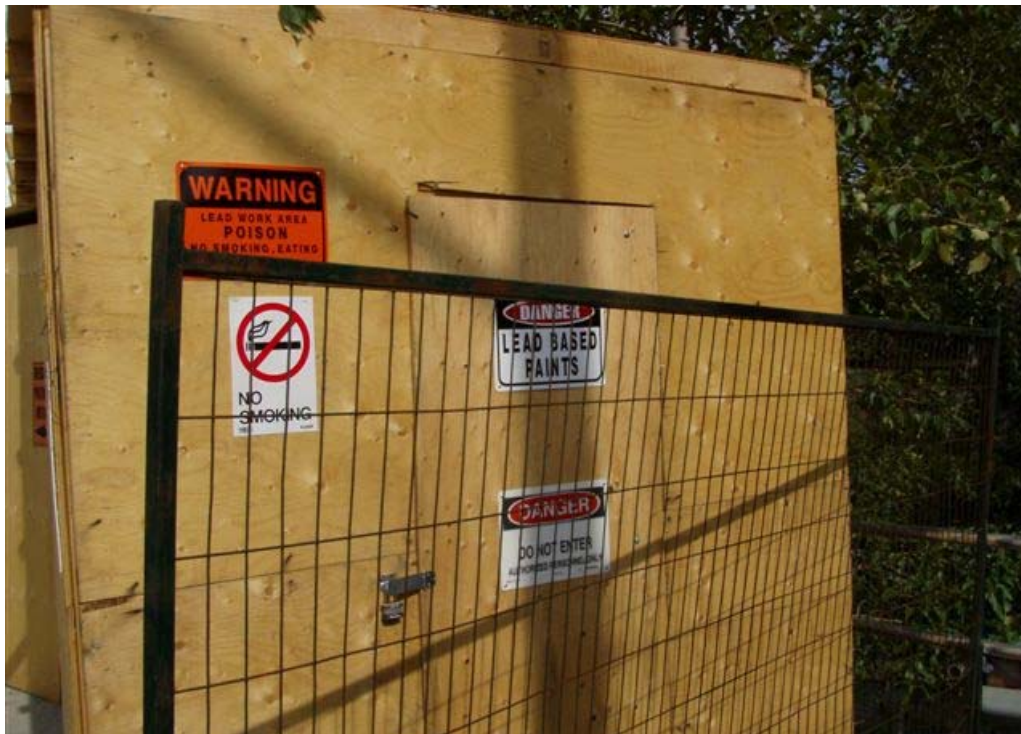
Photo 4: Dirt Room

A plywood "Dirt Room" was constructed outside the containment area that was kept locked to prevent public access. Plywood also covered the containment walls along the sidewalk, protecting pedestrians from rogue sandblasting materials that could tear through the plastic.

To eliminate the potential of contaminants leaving the containment area, a detailed procedure was set up. Outside of the containment, workers put on their PPE, which included a long-sleeve Tyvek suit with hood, hard hat, steel toed boots, leather gloves, eye protection, and dust mask. Dust masks were deemed appropriate and effective as garnet abrasive blasting media was used instead of silica, which reduces airborne inhalation hazards. Each worker wrote his name on a board, indicating he was inside the containment, and then entered the dirty room, which was separated from the containment area by a plastic barrier. For a visual explanation, see Photos 4 and 5.

After their shifts, workers would leave the containment through the dirty room, where they used compressed air to remove loose particles from their suit. Outside, they would dispose of the Tyvek suits and dust masks, and proceed to the onsite trailer for a thorough wash at a wash station set up especially for this purpose.

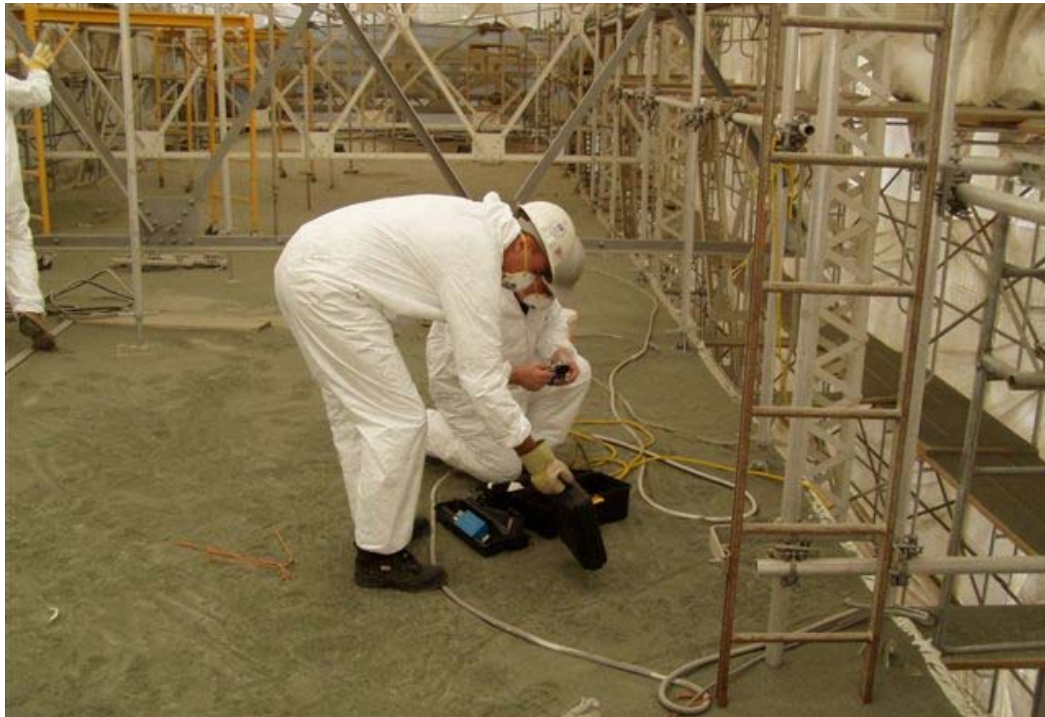
Photo 5: Protection

Protective suits and dust masks, combined with the “dirt room” and full containment, was effective in keeping lead particles from affecting the environment.

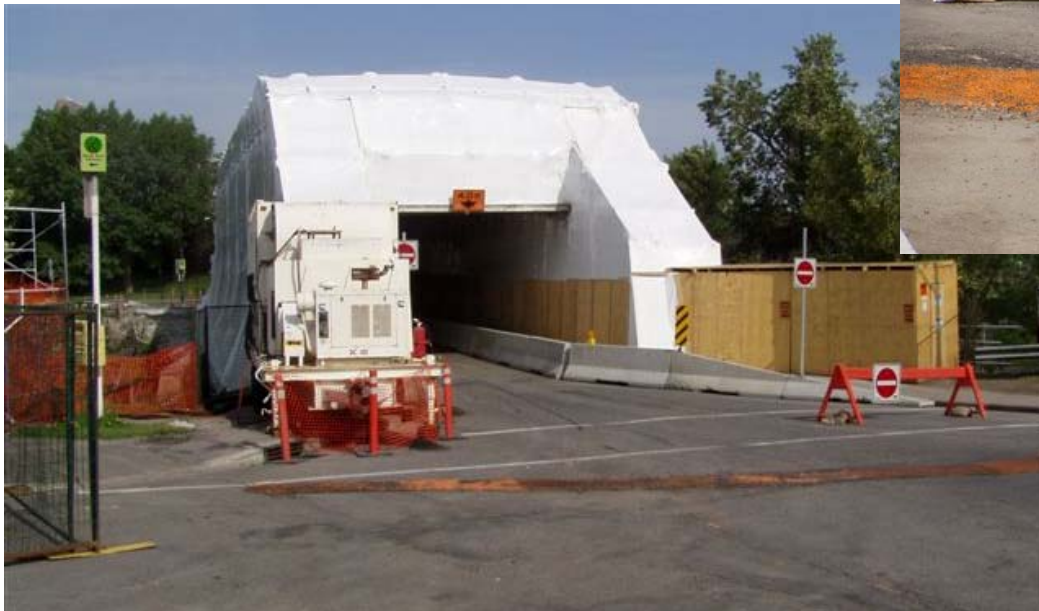
Photo 6: Berm

A temporary berm was created to divert water flowing down St, which is located on a steep hill, into the catch basins to prevent flooding of the containment area.

For the standard bridge rehabilitation project, silt socks are set up in surrounding catch basins to prevent excess materials from entering waterways. For the MacDonald Bridge rehabilitation project, an opposite approach was taken. Because the east side of the bridge road was on a slope, rainwater naturally flowed down, onto, and over the bridge. To prevent rainwater from washing out the bridge deck and dance floor during a rain event, a rough asphalt berm similar to a speed bump was constructed across the sloped roadway to divert water towards the catch basins located across on the north and south sides of the road. This berm also cut off water from the stationary vacuum truck, so there was a low probability that a spill/release would breach the controls and negatively impact the environment. For a visual explanation, see Photo 6.

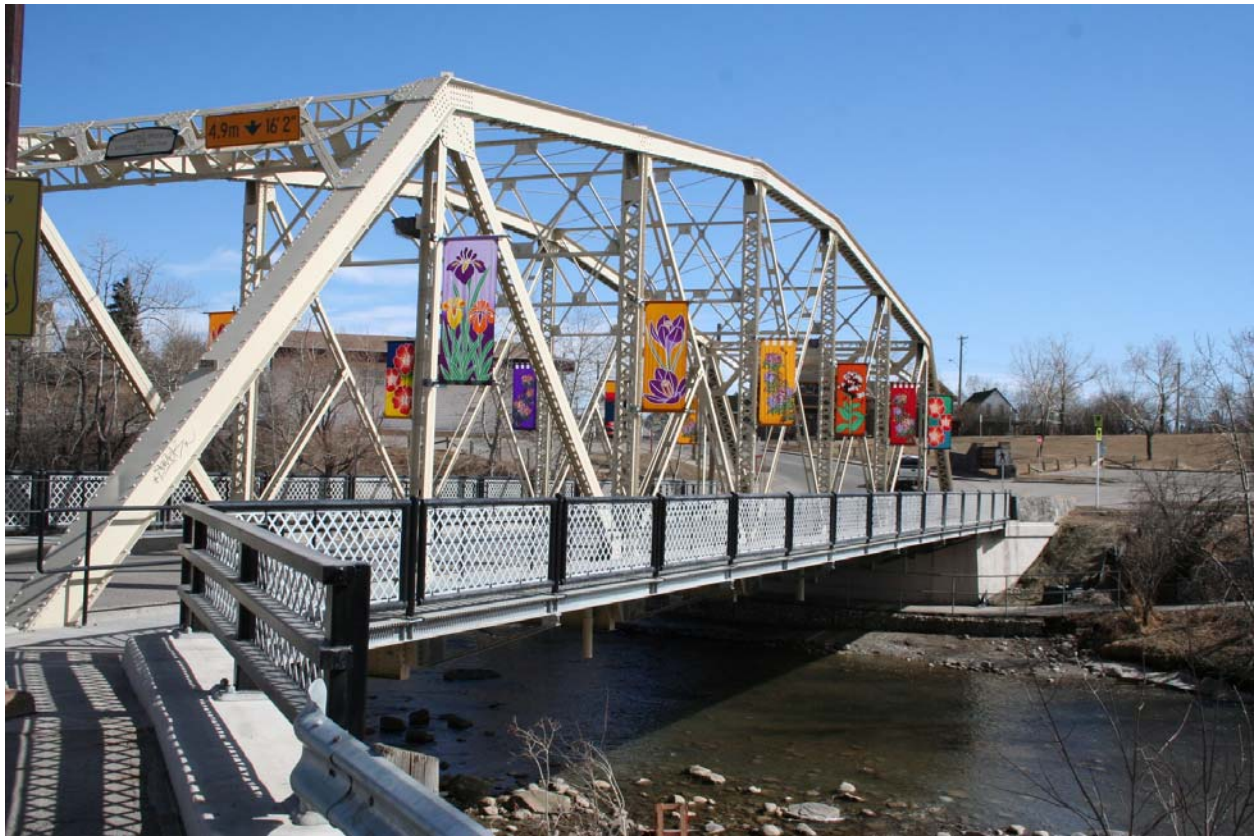
Photo 7: MacDonald Bridge Today

A current image of the bridge showing the replaced railings, new paint, and early springtime water levels.

As well as repainting, a new pedestrian railing was installed, and long-lasting Fiber Reinforced Polymer (FRP) sidewalks replaced the old timber pedestrian walkway. In keeping with the many parks and bridges in Calgary that make the city beautiful, MacDonald Bridge's appearance was greatly enhanced by the rehabilitation project and the upgrades.

Settled in the shadow of the Rocky Mountains, and surrounded by rivers and water reservoirs, the City of Calgary continues to take environmental protection and sustainability seriously. The MacDonald Bridge project demonstrated The City's commitment to the environment, as environmental issues were central to every process. See what the bridge looks like today in Photo 7.
