# **The Use Of Ground Penetrating Radar To Determine An In-Situ HMAC Surface Course Lift Thickness Profile: A Case Study – Highway 401, Trenton Ontario**

Paper prepared for presentation at the Advances in Pavement Evaluation and Instrumentation Session  
of the 2012 Conference of the Transportation Association of Canada Fredericton, New Brunswick

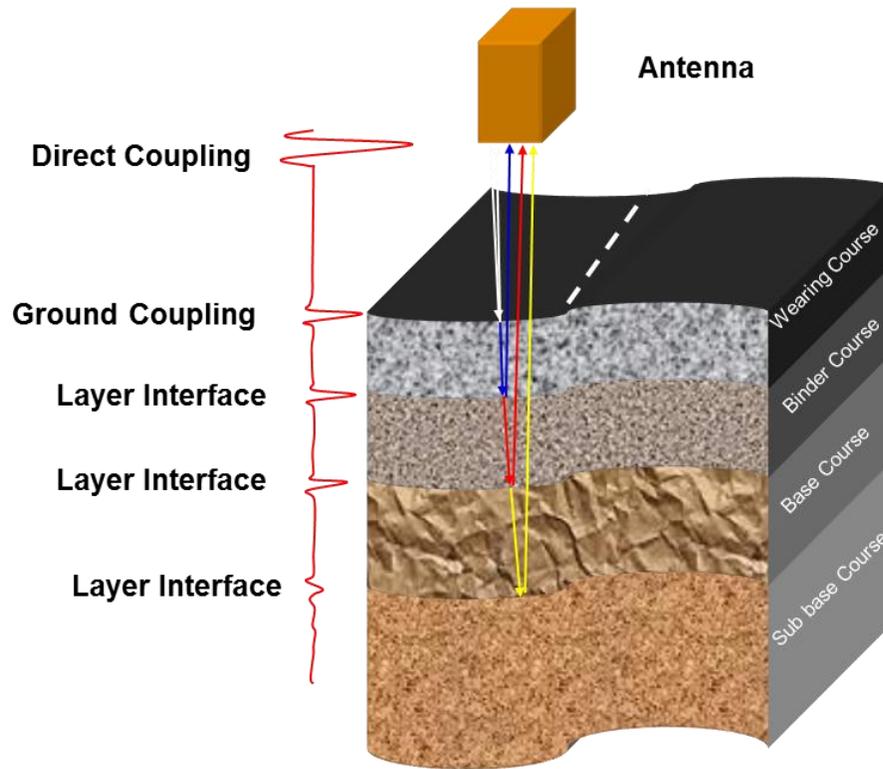
Figure 1: Principle of GPR Data Collection

Ground Penetrating Radar (GPR) is a technology that is able to collect layer thickness data at a rate of more than 300 km per day. The GPR field survey combined with data reduction software, trained engineers can create continuous sectional images of the pavement subsurface by measuring the reflected high frequency waves’ intensity and arrival times emitted from the GPR antenna. As shown below, in Figure 1, the technology is based on one of the fundamental laws of physics; energy will be reflected at interfaces having significant differences in dielectric constants. The data reduction software is then used to calculate the conductivity of the material. By comparing the results to known dielectric constants, the software can isolate each individual layer of material and determine a thickness of that material.

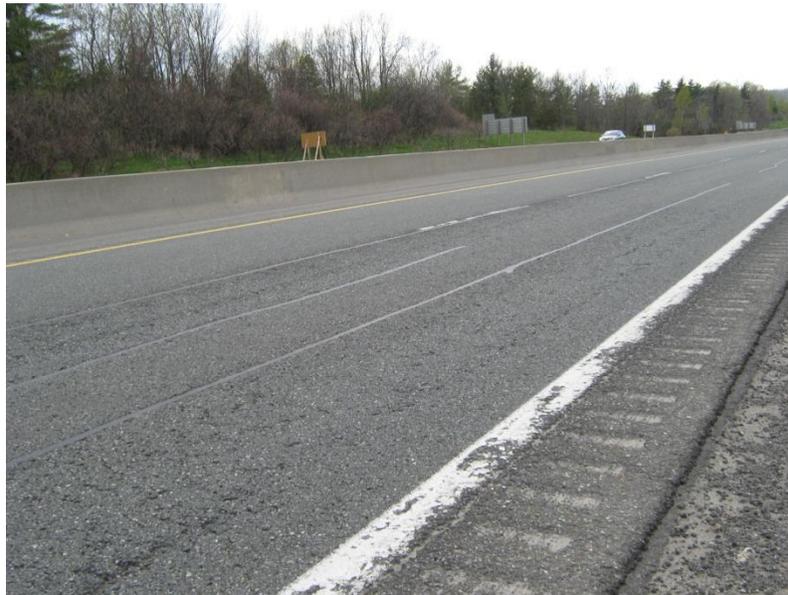
The dry open textured appearance of the pavement can be seen in a photograph of the pavement surface shown in Figure 3.

Figure 3: Dense Friction Course (DFC)

The DFC placed under the 1994 contract used a specification that allowed lower asphalt cement to stone content. The resulting mixes, as in this case, often displayed a dry, open-textured appearance. This specification was amended in the years following this project and has now been superseded by the adoption of Superpave Mix Design methodologies by the Ministry. Overall, the pavement was considered to be performing well 16 years after the rehabilitation with a Pavement Condition Rating (PCR) of approximately 80 on a scale of 100.

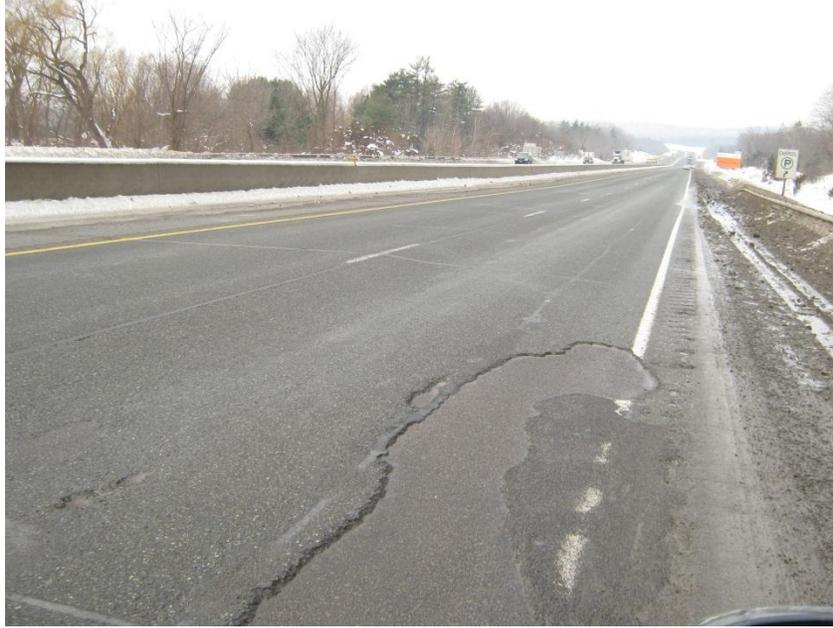
A photo depicting the typical delamination of the surface is shown below in Figure 4.

Figure 4: Delamination of DFC

During the winter months of 2007 and 2008, the DFC layer was observed to be delaminating in large sections requiring unplanned repairs by maintenance crews. Field reviews identified that in areas where delamination occurred, the surface course was atypically thin.

A review of the construction records from 1994 indicated issues with low percentages of asphalt cement content in the mix as well as the absence of a tack coat during paving of the surface course as contributing factors to the premature deterioration of the pavement.

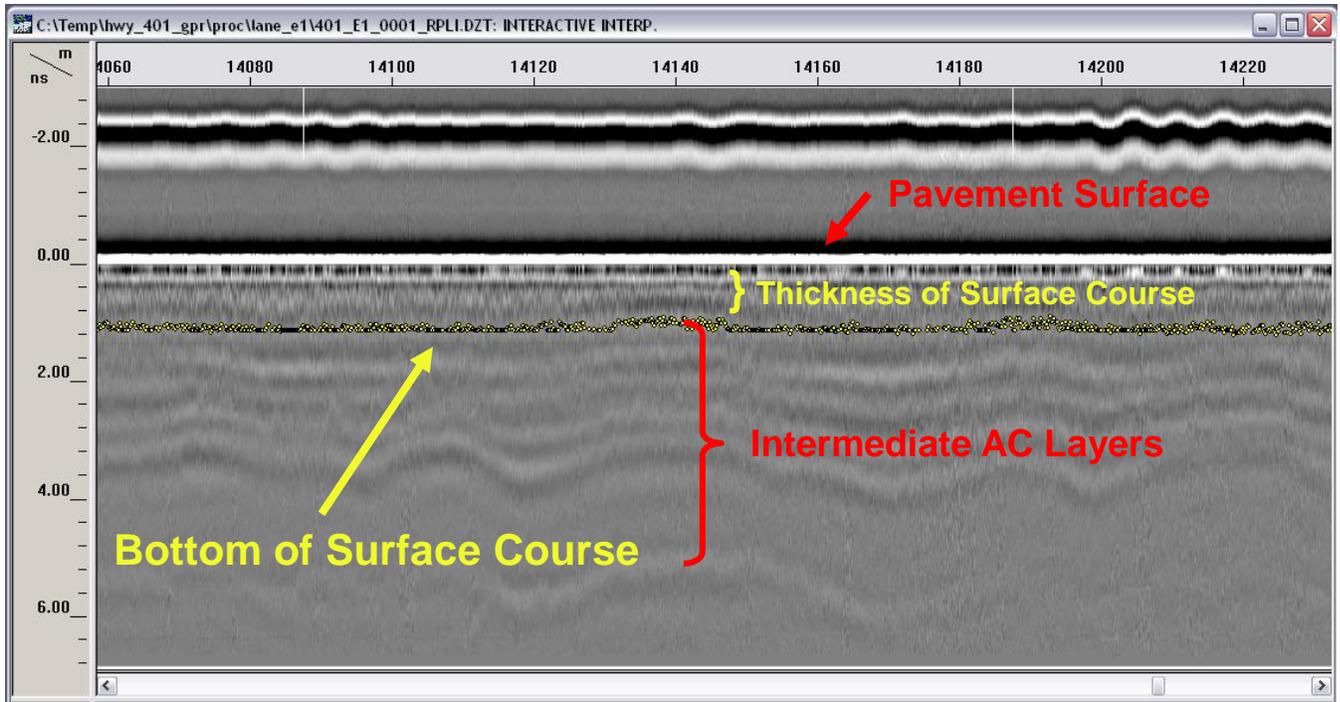
Figure A.3: Sample GPR Profile from RADAN

As shown in the above tables, all lanes were observed to contain areas of thin DFC surface course. Table 4.6 identifies westbound lane 2 as having the lowest average thickness of DFC surface course. A sample screenshot from the RADAN software illustrating the quality of the wave reflection is presented in Figure A.3 in Appendix A.
