## **Fast Track Precast Concrete Pavement Rehabilitation Pilot Project**

Paper prepared for presentation at  
SES - Innovations in Pavement Management, Engineering and Technologies Session  
of the 2017 Conference of the  
Transportation Association of Canada  
St. John's, NL

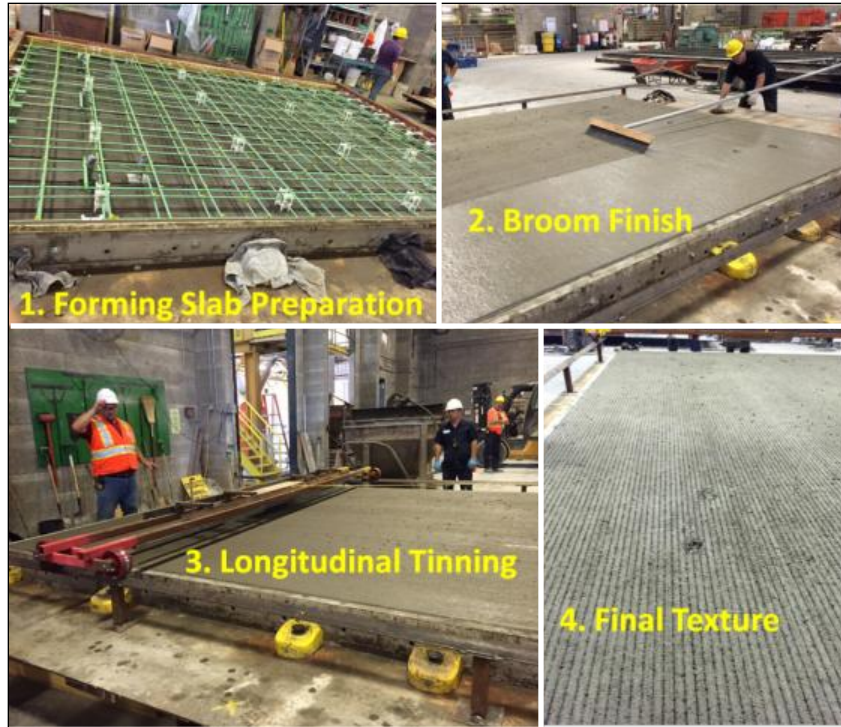
There were a total of 22 reinforced precast slabs required for this contract and they were fabricated in late August to early September 2016 at the Armttec production facility located in Mitchell, Ontario. To ensure good friction, sufficient micro and macro texture on the precast surface was mandatory. Several trials were performed on the precast concrete surface to produce an acceptable surface texture. The final surface texture was a broom finish, followed by longitudinal tining. Care was exercised to ensure a constant pressure was applied during the brooming and longitudinal tining processes to provide the required texture. Figure 2 below shows the precast concrete slab production.

**Figure 2: Precast Slab Production**

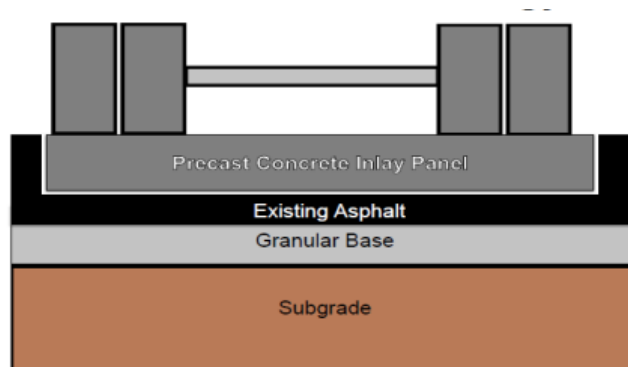
Cores of the site location were taken to ensure sufficient asphalt depth was available to provide uniform support of the precast slabs. Three cores indicated the northbound lane 3 asphalt thicknesses were 355, 375 and 375 mm. With a precast concrete slab of 205 mm, there was sufficient asphalt thickness to mill down and place the precast concrete inlay slab, with about 150 mm asphalt remaining as the base support. Figure 3 is the schematic of the precast concrete slab inlay repair of the flexible pavement.

**Figure 3: Precast Concrete Slab Repair Rehabilitation on Asphalt Pavement**

The precast concrete slabs were 205 mm thick, 3.7 m wide (lane width) and 4.6 m long. Epoxy-coated dowels at 300 mm centers were embedded at the transverse joints. The precast concrete was designed for 30 MPa at 28 days with 3% air void. The precast slab was reinforced by 2 mats of 15M bars at 300 mm spacing.

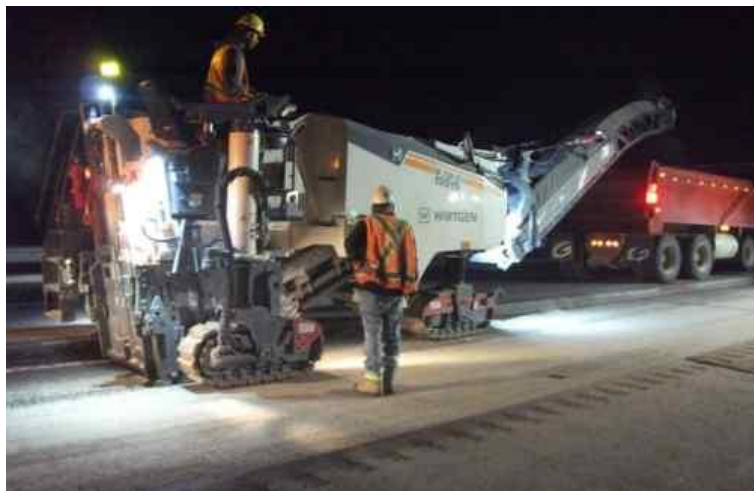
The milling machine was a Wirtgen Model W120 CFI, with a 1.2 m-wide milling head. Three passes of the milling unit were carried out to mill to the required width. (Figure 8)

**Figure 8: Wirtgen Milling Machine**

The same milling machine (Figure 8) and Fort Miller Grade Checker (Figure 9) were used as in the Asphalt Supported Slab method. The CPATT instrumentation was installed underneath the second and fourth slabs prior to placement of the CTBM. The CTBM was graded using a manual leveling screed and compacted using the plate tamper to the correct elevation. The material was wetted to begin hydration and the slabs were placed directly on this bedding layer (Figure 13).

The same milling machine (Figure 8) used for the Asphalt Supported Slab method was used to remove the asphalt for this support method, and the CPATT instrumentation was installed prior to slab placement. Three grout mixers were used to produce the increased amount of bedding grout required to fill the void beneath the Grout Supported Slab. Figure 14 below shows the adjustment of the levelling screw for this method.

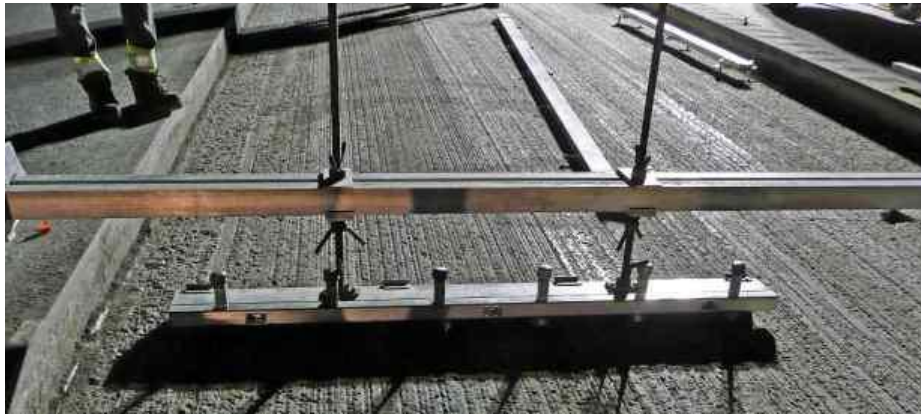
Since the Asphalt Supported Slab method requires a precise milling depth of the asphalt (tolerance of  $\pm 3$  mm), the Fort Miller grade check apparatus was adopted to ensure milled surface tolerances were achieved prior to placing the slab (Figure 9). (2)

**Figure 9: Fort Miller Grade Checker Apparatus**

After first slab placement, the surface differential between the adjacent lane surface and the precast slab surface was found to be approximately 9 mm. This was corrected by slab removal and additional milling of 12 mm based on the readings from Fort Miller's grade checker. The surface differential between adjacent slabs was found to be small (within  $\pm 3$  mm tolerance as required in the specification) for the remainder of the slabs. The CPATT instrumentation was installed beneath the fourth and eighth Asphalt Supported Slab. Figure 10 shows the installation of the precast concrete slab.

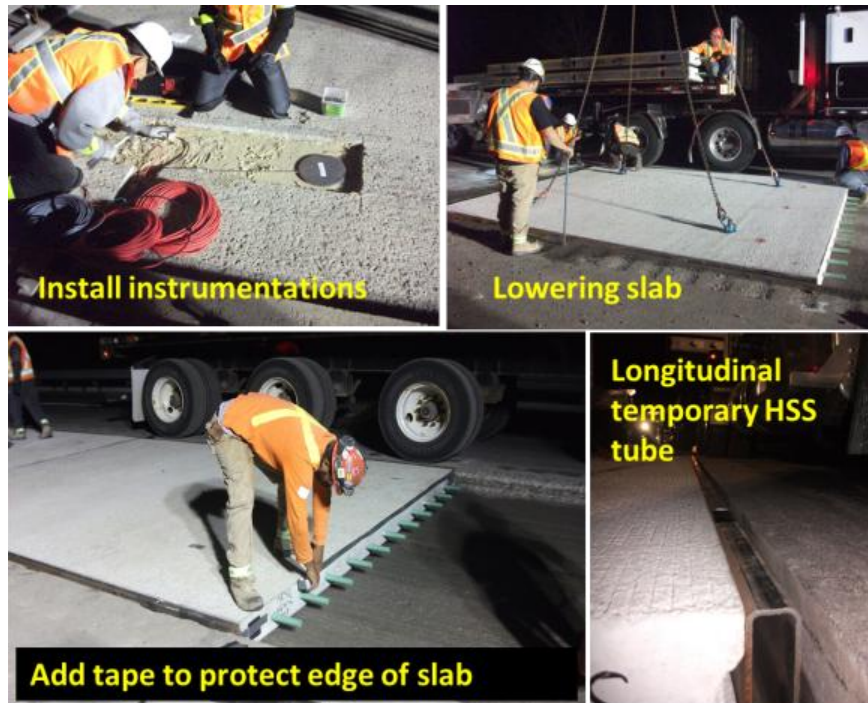
**Figure 10: Precast Concrete Slab Installation (Asphalt Supported Slab)**

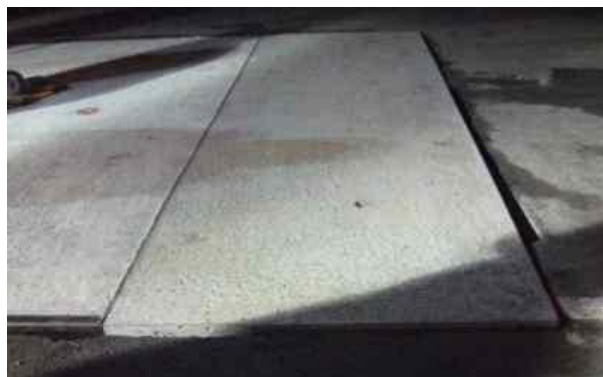
A total of 8 asphalt supported slabs were placed in approximately 1 hour 10 minutes, for an average placement time of approximately 9 minutes/slab. Following placement of the 8 slabs, the temporary end slab was then installed (Figure 11). The fast-setting bedding grouting, dowel grout and edge grout for longitudinal joints were applied the next night (Figure 12).

**Figure 11: Asphalt Supported Slab and Temporary End Slab**

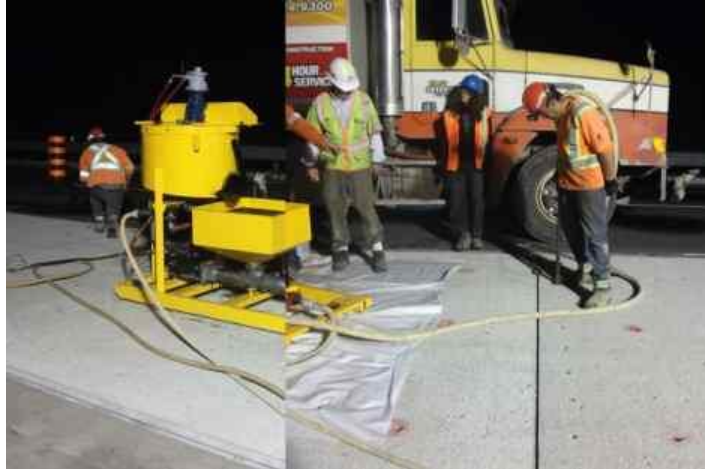
**Figure 12: Pumping the Dowel Grout**

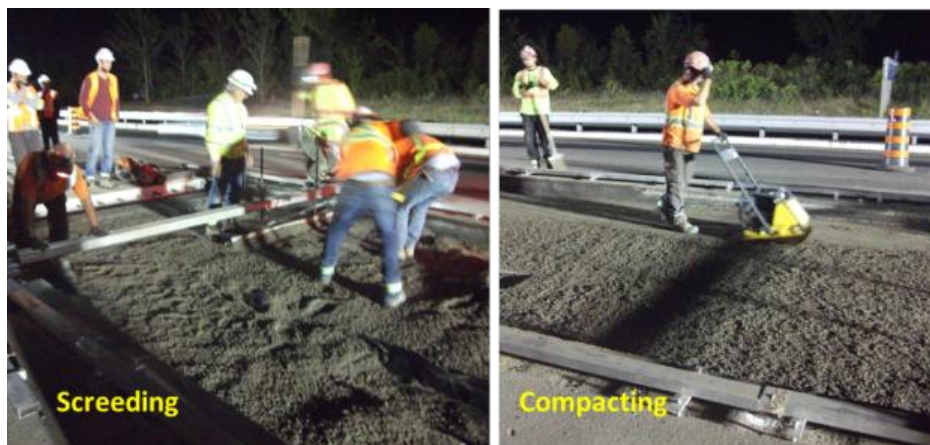
**Figure 13: Compaction of the CTBM Grade Supported Slab Method**

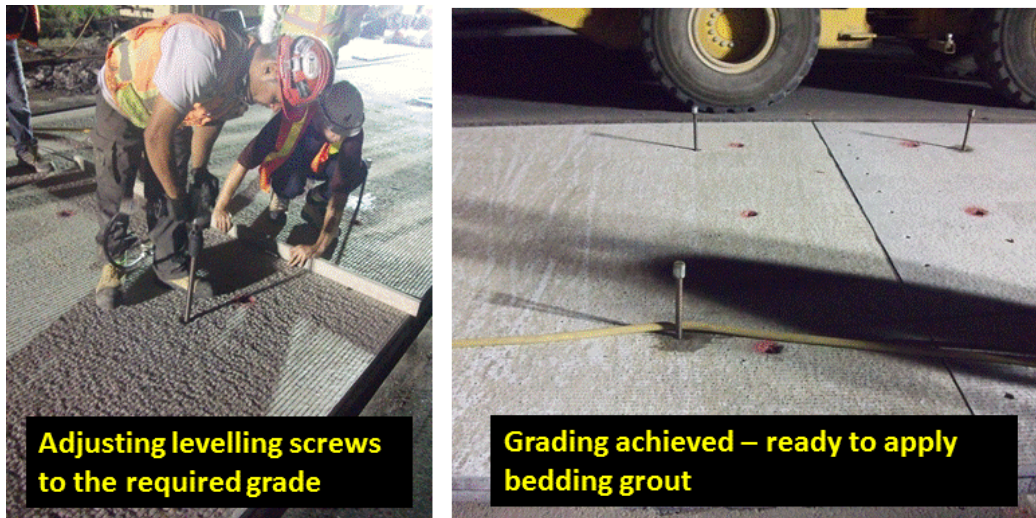
The Grout Supported Slabs were placed on September 22<sup>nd</sup>, 2016. This method used built-in leveling screws (or jacking bolts) which rested on the milled asphalt surface. These leveling screws have the capability of adjusting the level of the concrete slab to the required elevation, Quick setting bedding grout was then injected to support the slab.

**Figure 14: Grout Supported Slab Levelling Screw and Adjustment**
